REPORT ON

Phase One Environmental Site Assessment 258 Carruthers Avenue Ottawa, Ontario

Submitted to:
258-262 Carruthers APTS Ltd.
5689 Power Road
Ottawa, Ontario
K1G 3N4

Report Number: 1671453-1000 Rev.0

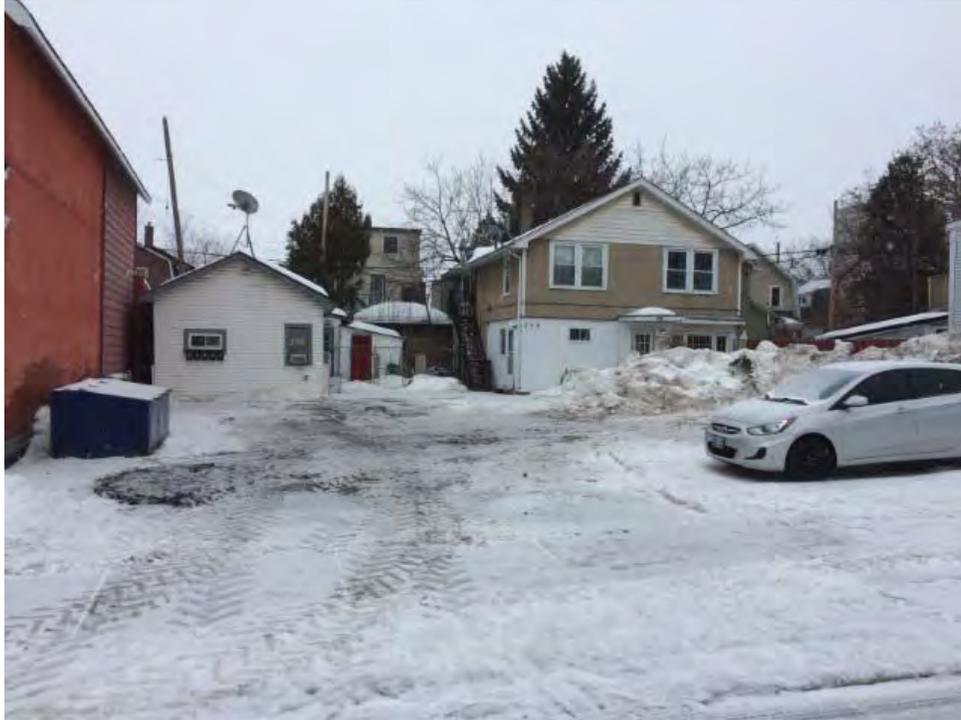
Photo 1: Looking west at the Site from Carruthers Avenue.

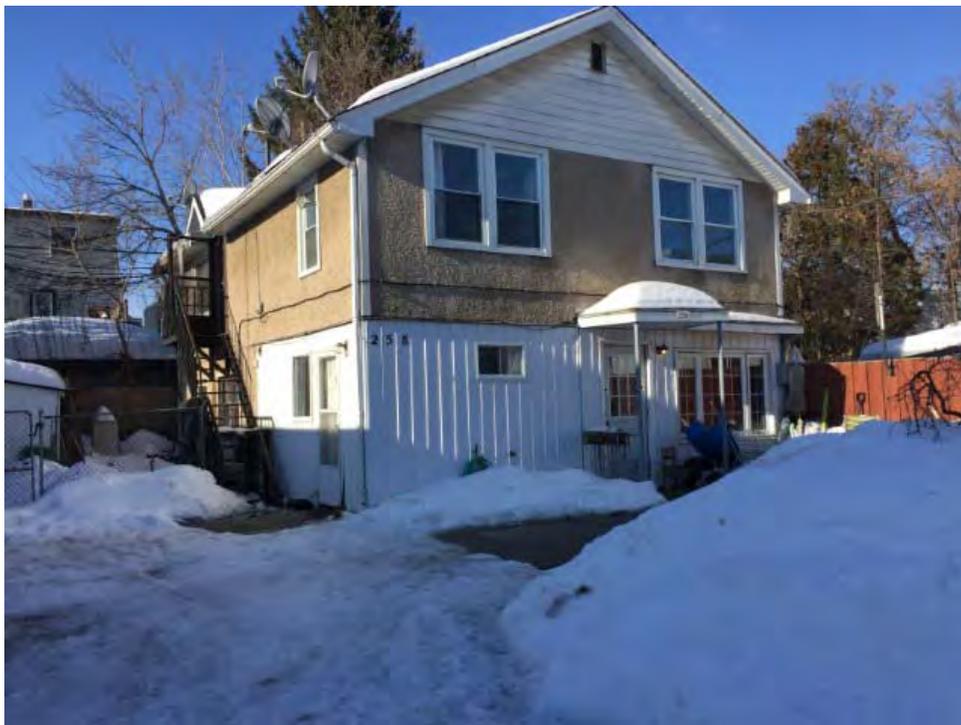
Photo 2: Looking northwest at the main/northwest residential house located on the northwest corner of the Site.

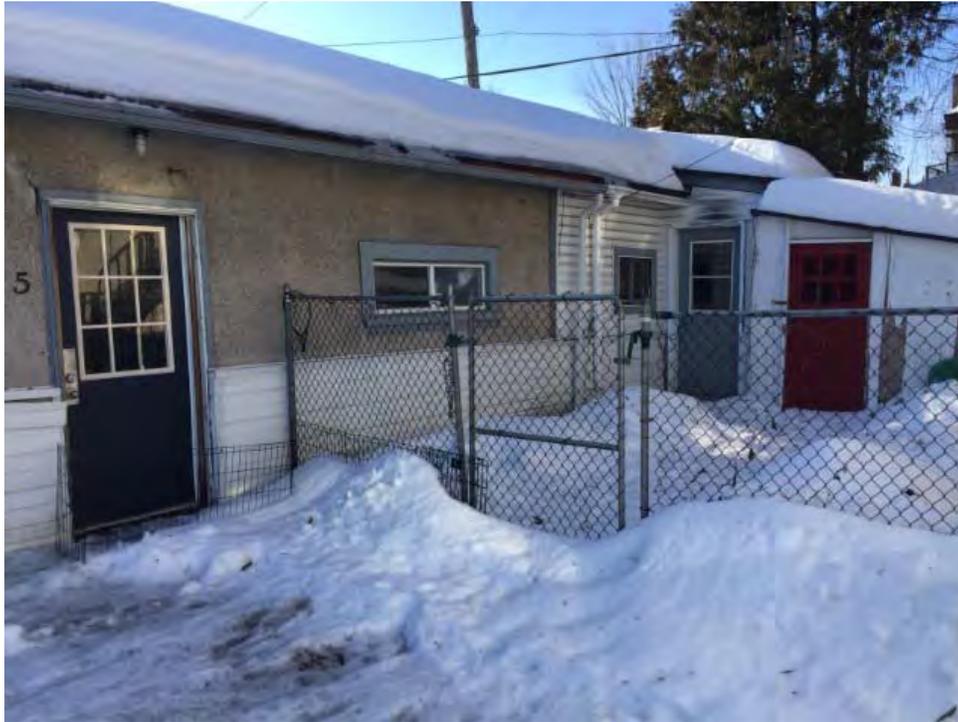
Photo 3: Looking southwest at the small residential building located on the southwest corner of the Site.

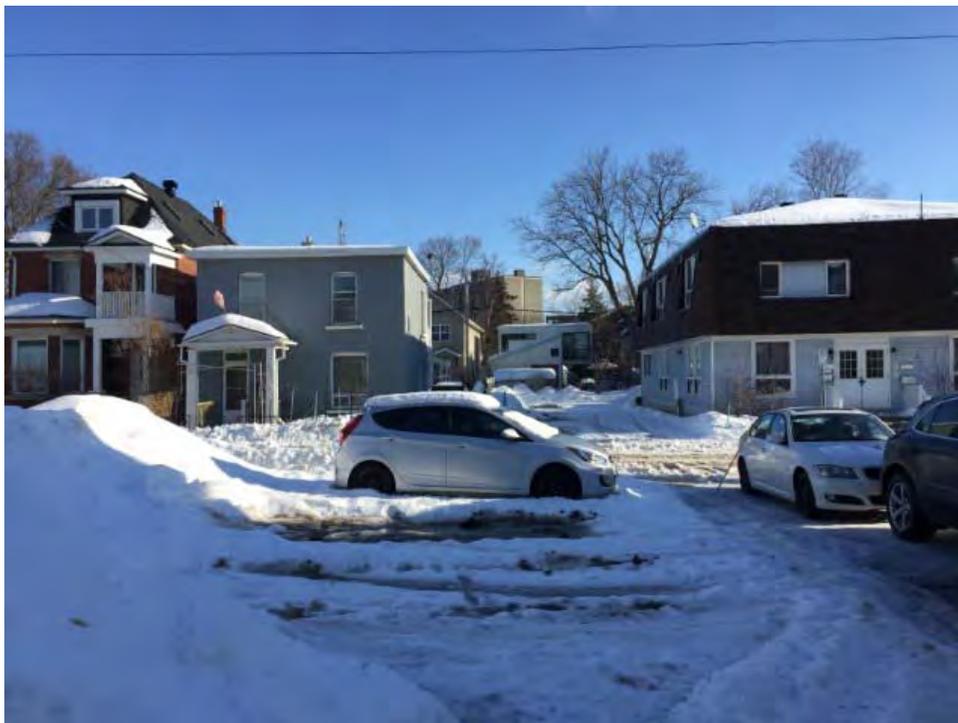
Photo 4: Looking east at the snow covered front yard and paved driveway located on the eastern portion of the Site. Carruthers Avenue followed by residential houses on the adjacent lands east of the Site is also visible.

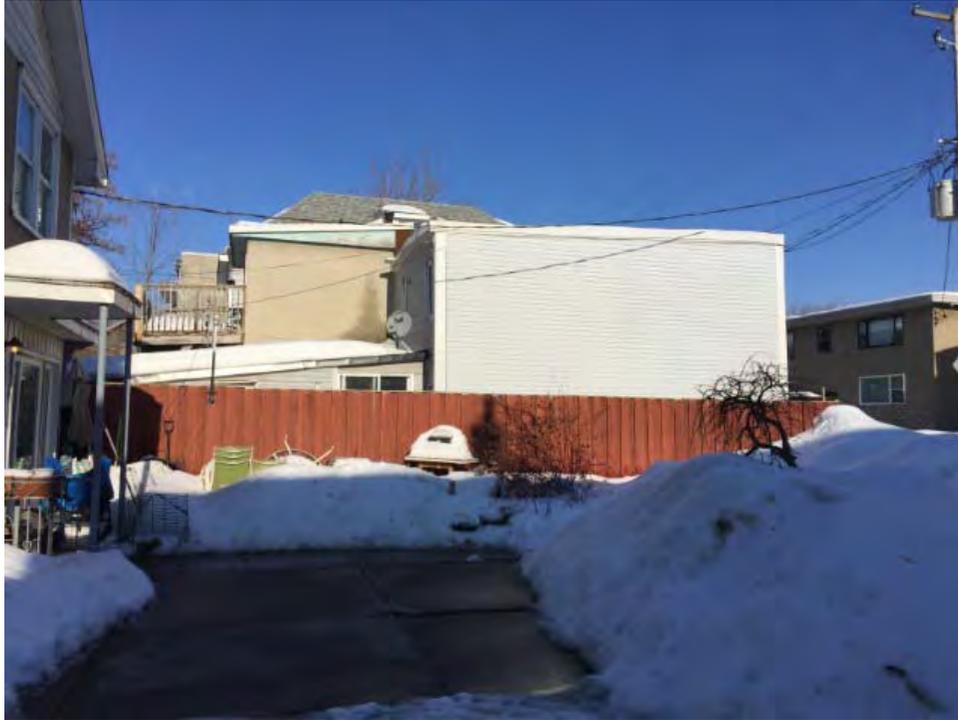
Photo 5: Photo of the residential house located on the adjacent property north of the Site. The concrete pads located on the west side of the main/northwest residential building and the overhead hydro lines along the northern Site boundary are also shown.

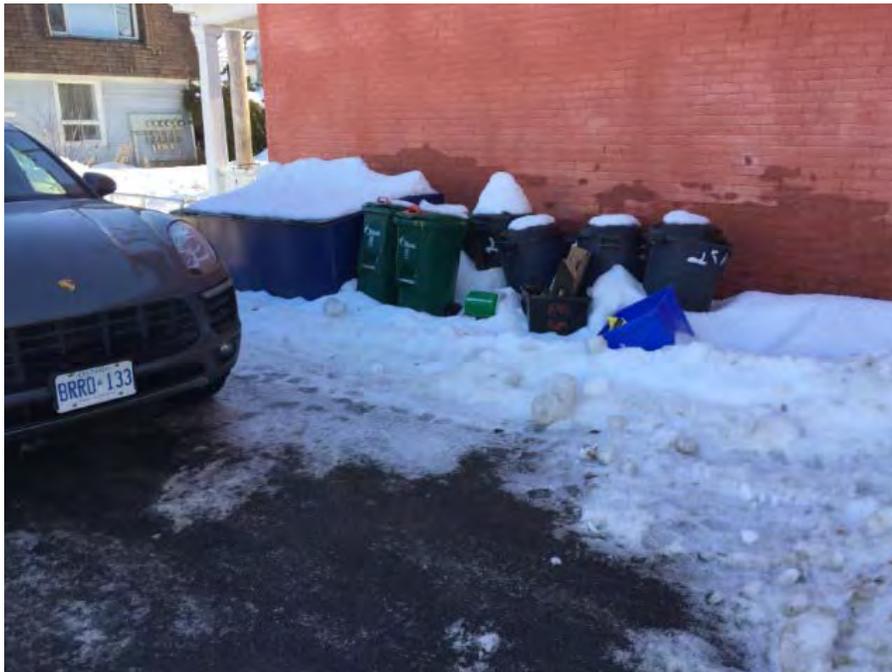
Photo 6: Waste disposal and recycling bins located along the southern Site boundary.

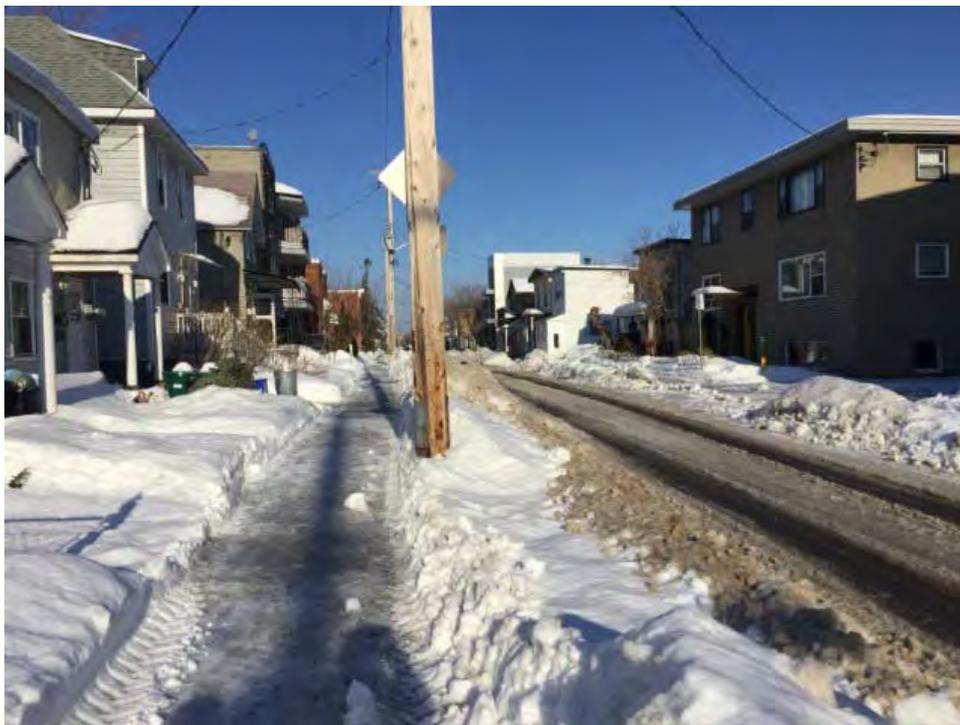
Photo 8: Looking north at residential buildings located along Carruthers Avenue on the surrounding properties north of the Site.

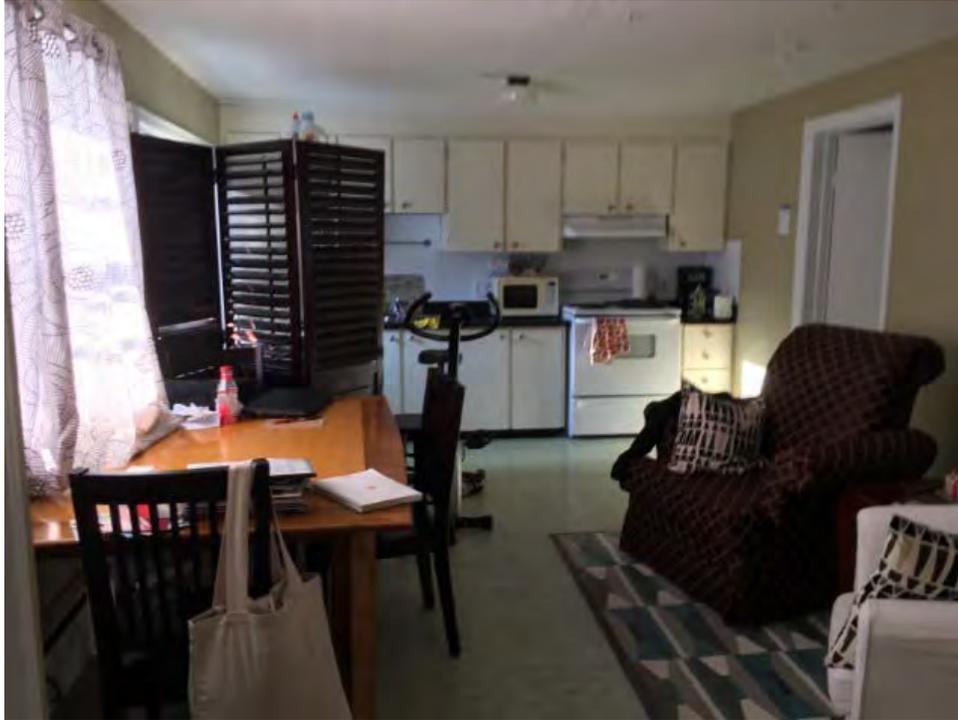
Photo 9: View of the kitchen/dining room located in one of the apartment units on the first floor of the main/northwest building. An electric baseboard heating is visible along the southern wall.

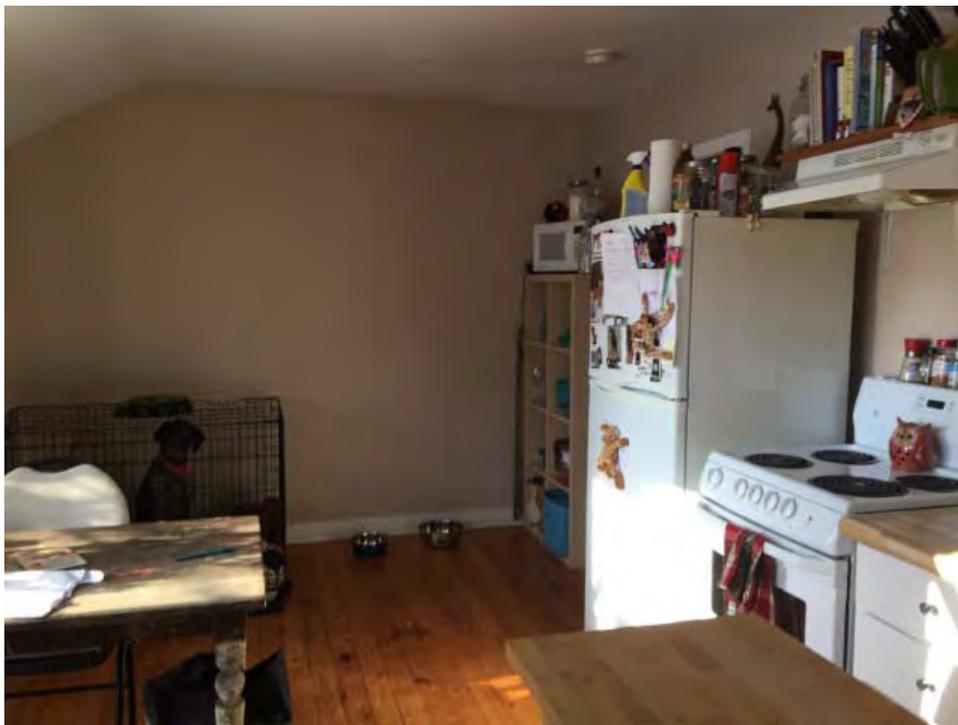
Photo 10: View of the kitchen located in one of the apartment units on the second floor of the main/northwest building. An electric baseboard heating is visible along the southern wall.

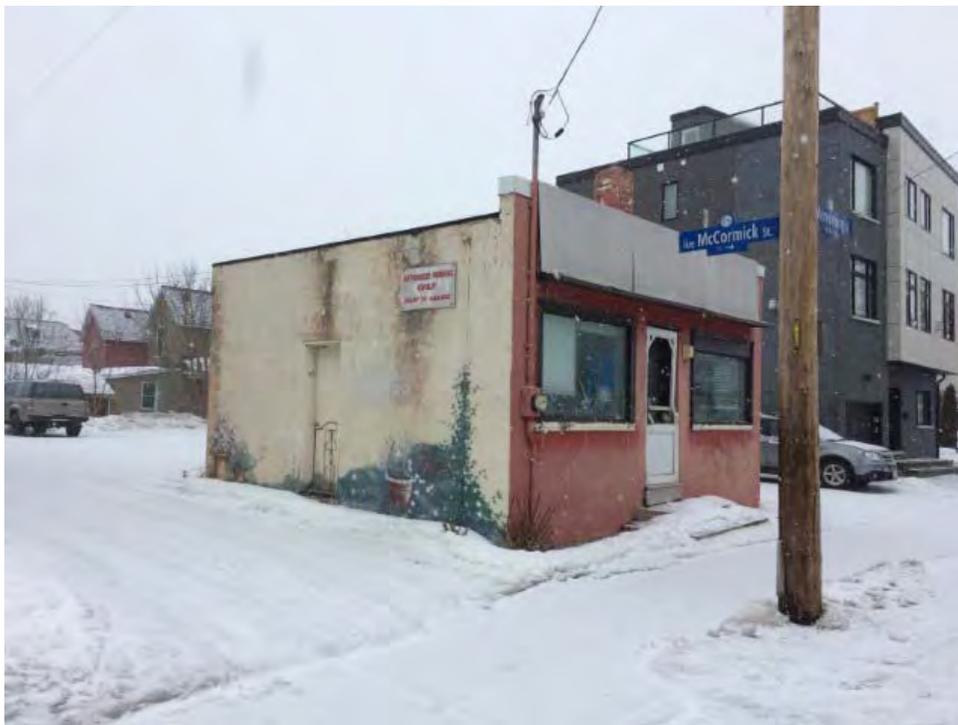
Photo 12: Looking northeast at the former "Grant Street Garage" located on the adjacent land south of the Site at 171 Armstrong Street (formerly 177 Armstrong Street).

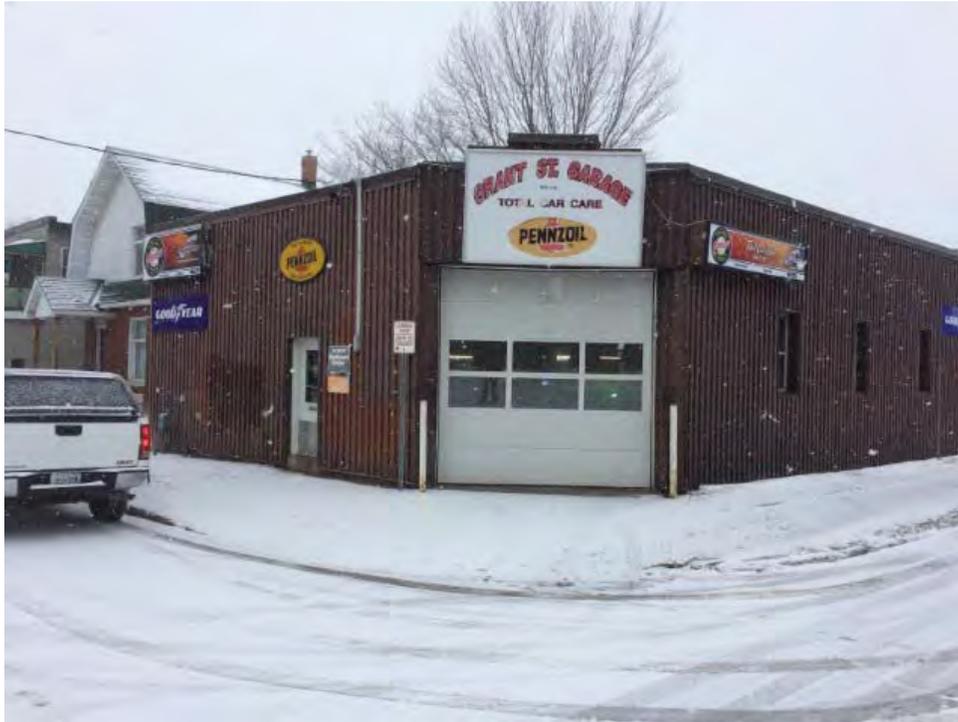
Photo 13: Photo of the current automotive garage located on the surrounding lands south of the Site at 1 Grant Street.

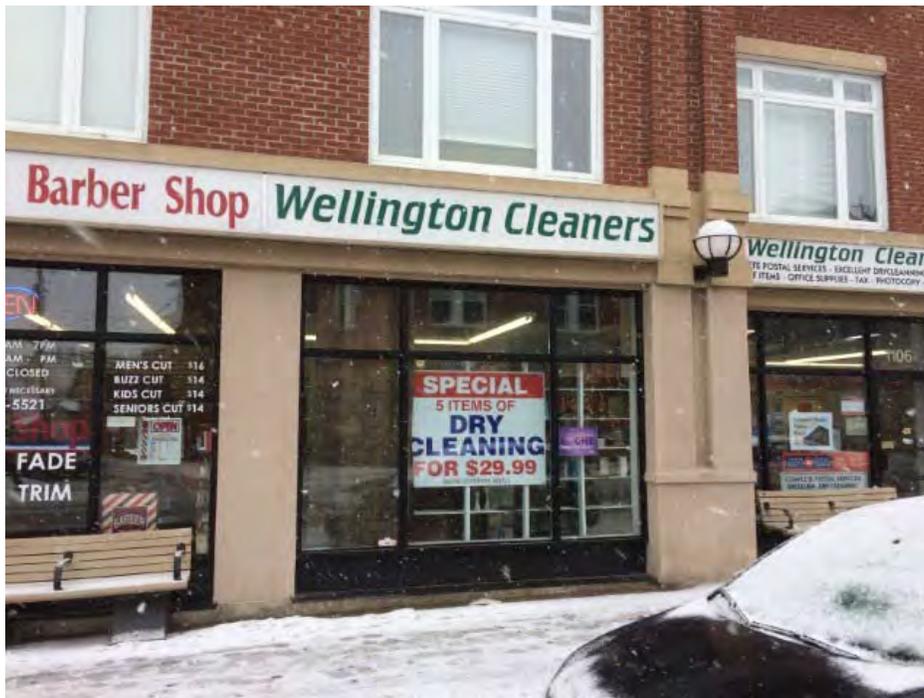
It was noted during the Site visit that a dry cleaning facility was located approximately 155 m southeast of the Site at 1106 Wellington Street West. This facility appeared to be a drop-off depot where no cleaning takes place; however, this could not be confirmed. As such, it is considered to be an off-Site PCA. An automotive garage was also observed at 1 Grant Street (approximately 95 m south of the Site). The current presence of this automotive garage is considered to be an off-Site PCA. Additionally, an abandoned commercial building with a “Grant Street Garage” sign was located approximately 95 m south of the Site at 1 Grant Street. Fill and vent pipes were observed in the eastern exterior wall of this building and were likely pipes for a heating oil AST or the fuel UST that was identified on this property in the 1948 and 1956 FIPs. The former presence of this automotive garage and the former and/or current presence of the fuel AST or UST is an off-Site PCA.

Photo 14: Looking south at the dry cleaning facility located on the surrounding lands southeast of the Site at 4 Sherbrooke Avenue.
