Phase I - Environmental Site Assessment

Vacant Commercial Land
6130 and 6150 Hazeldean Road
Ottawa, Ontario

March 3, 2016

Report: PE3699-1R

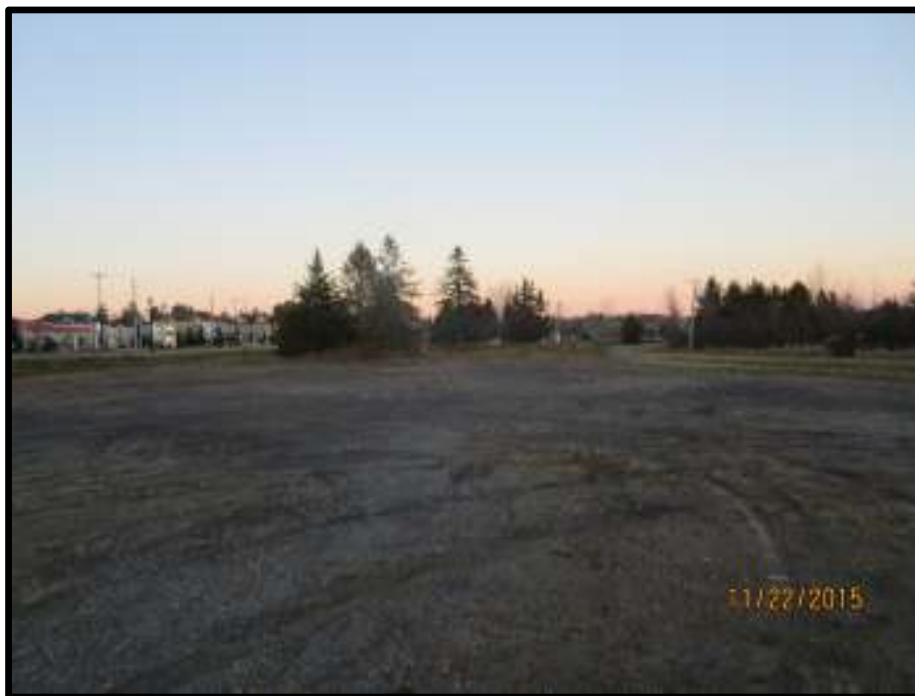
Photograph 1: View of eastern portion of the site, looking east-northeast. Picture shows retail fuel outlet located across Hazeldean Road.

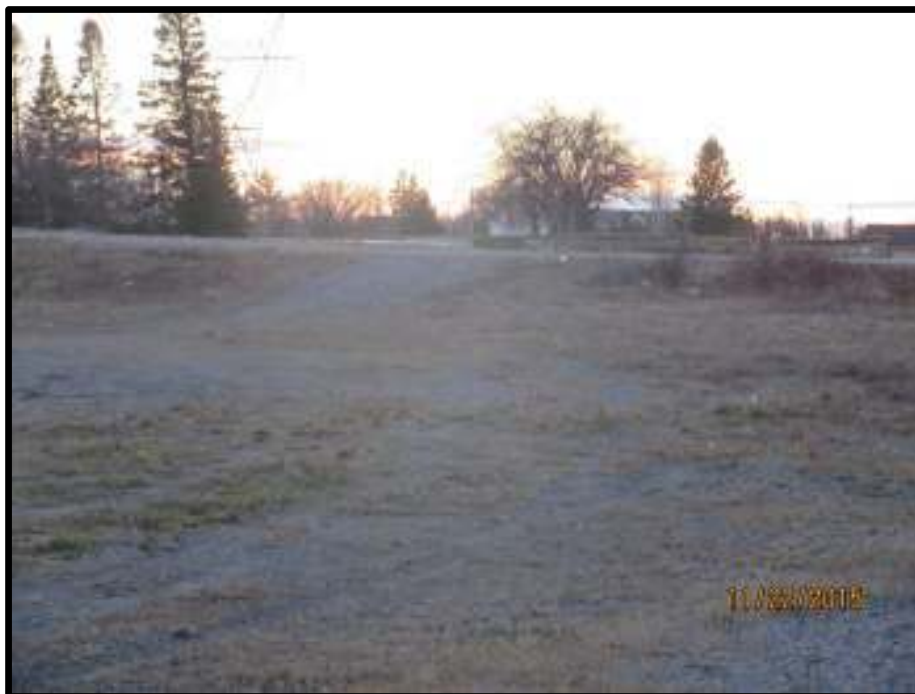
Photograph 2: View of central portion of site, looking west. Photo shows area of former MTO storage shed and the location of the former dwelling/restaurant (raised grassed areas). The foundation of the former building at 35 Neil cannot clearly be seen.

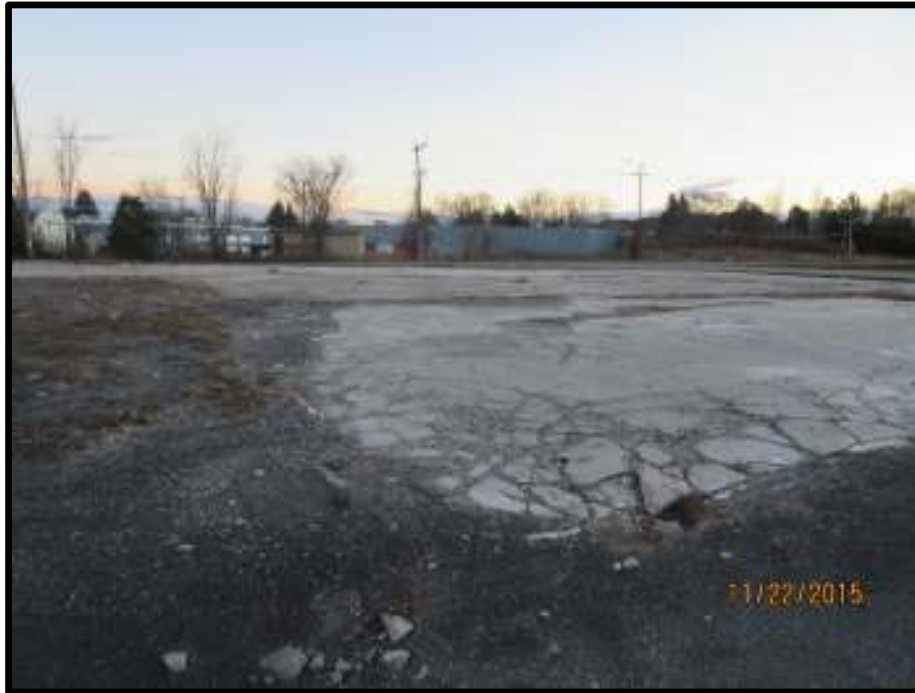
Photograph 3: Looking southwest, photo illustrates foundation of former building at 35 Neil Avenue and the Ottawa-Carleton District School Board facilities department to the south.

The central portion of land is also asphalt covered with the exception of the concrete foundation of the former building at 35 Neil Avenue. Small areas of ceramic tile and vinyl tile remain present across the foundation.

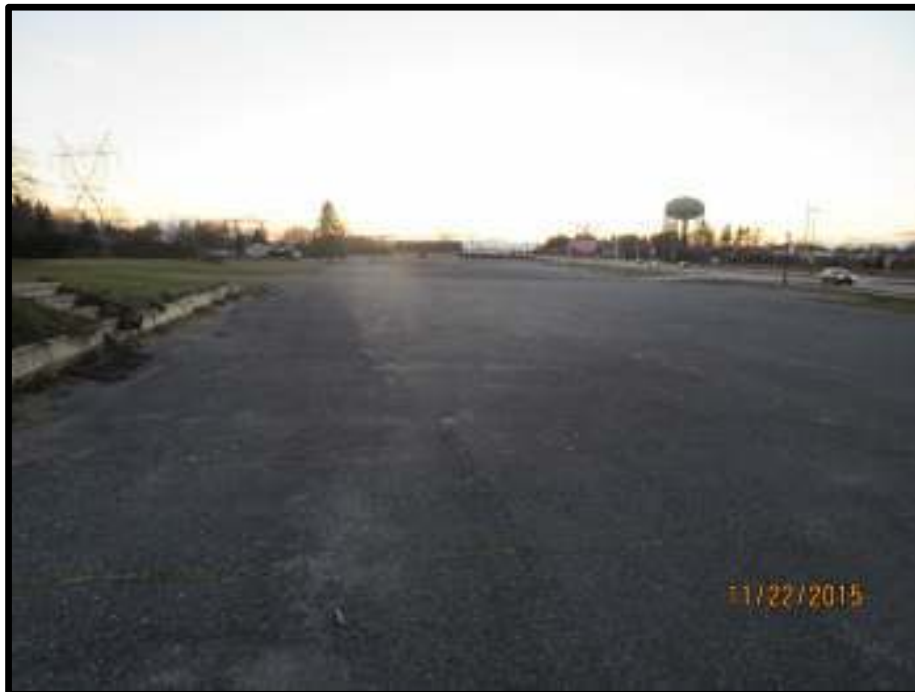
Photograph 4: Photo illustrates northwest portion of the site and the adjacent vacant commercial property to the west.

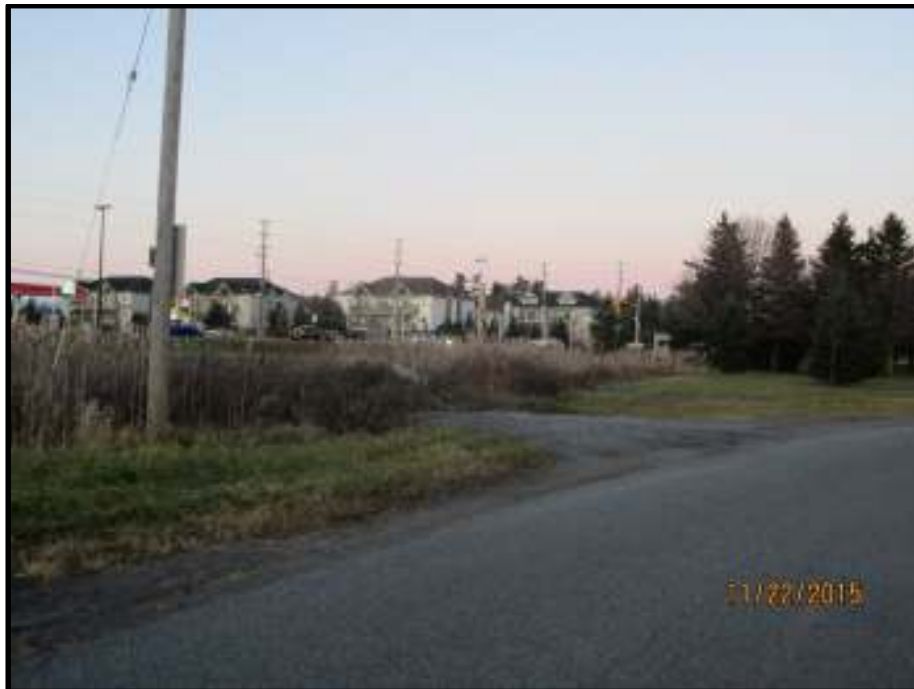
Photograph 8: Looking northeast, photograph illustrates eastern property line and adjacent landscaped land to the east.

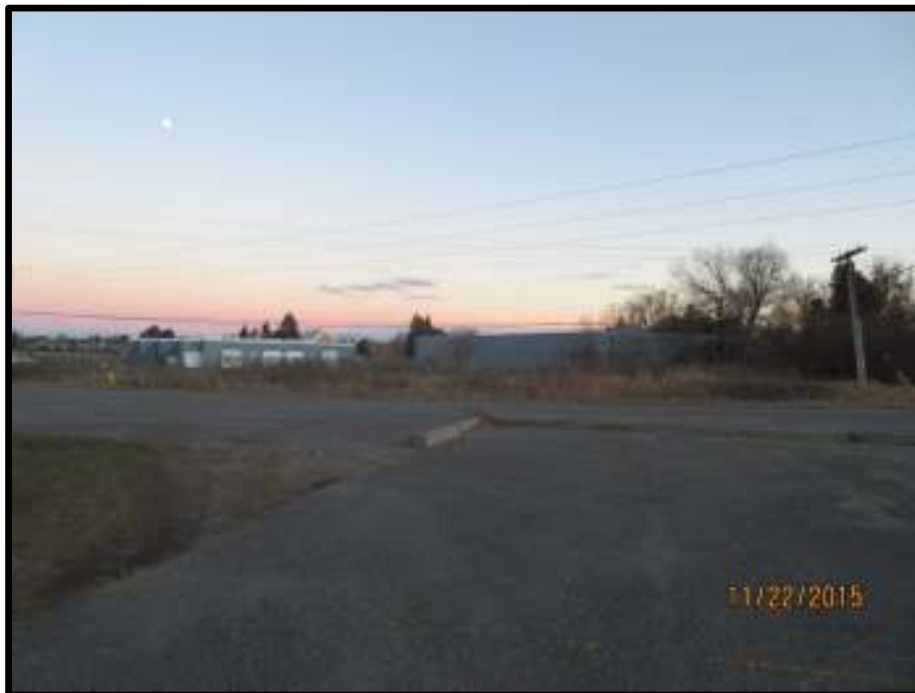
Photograph 10: View from southwestern corner of site, looking southeast at OCDSB property south of the site.

The OCDSB facilities department is considered to be a PCA, however it is not considered to represent an APEC on the subject site based on the distance of the building structures from the subject property of over 60 m. No concerns were noted on the portion of the OCDSB land situated closer to the site, during the historical portion of the assessment or at the time of the site visit.
