Phase Two Environmental Site Assessment 925 Ralph Hennessy Avenue, Ottawa, Ontario

Centre des écoles catholiques du Centre-Est 4000 Rue Labelle Ottawa, Ontario K1J 1A1

Project Number: OTT-00245869-A0

October 16, 2018

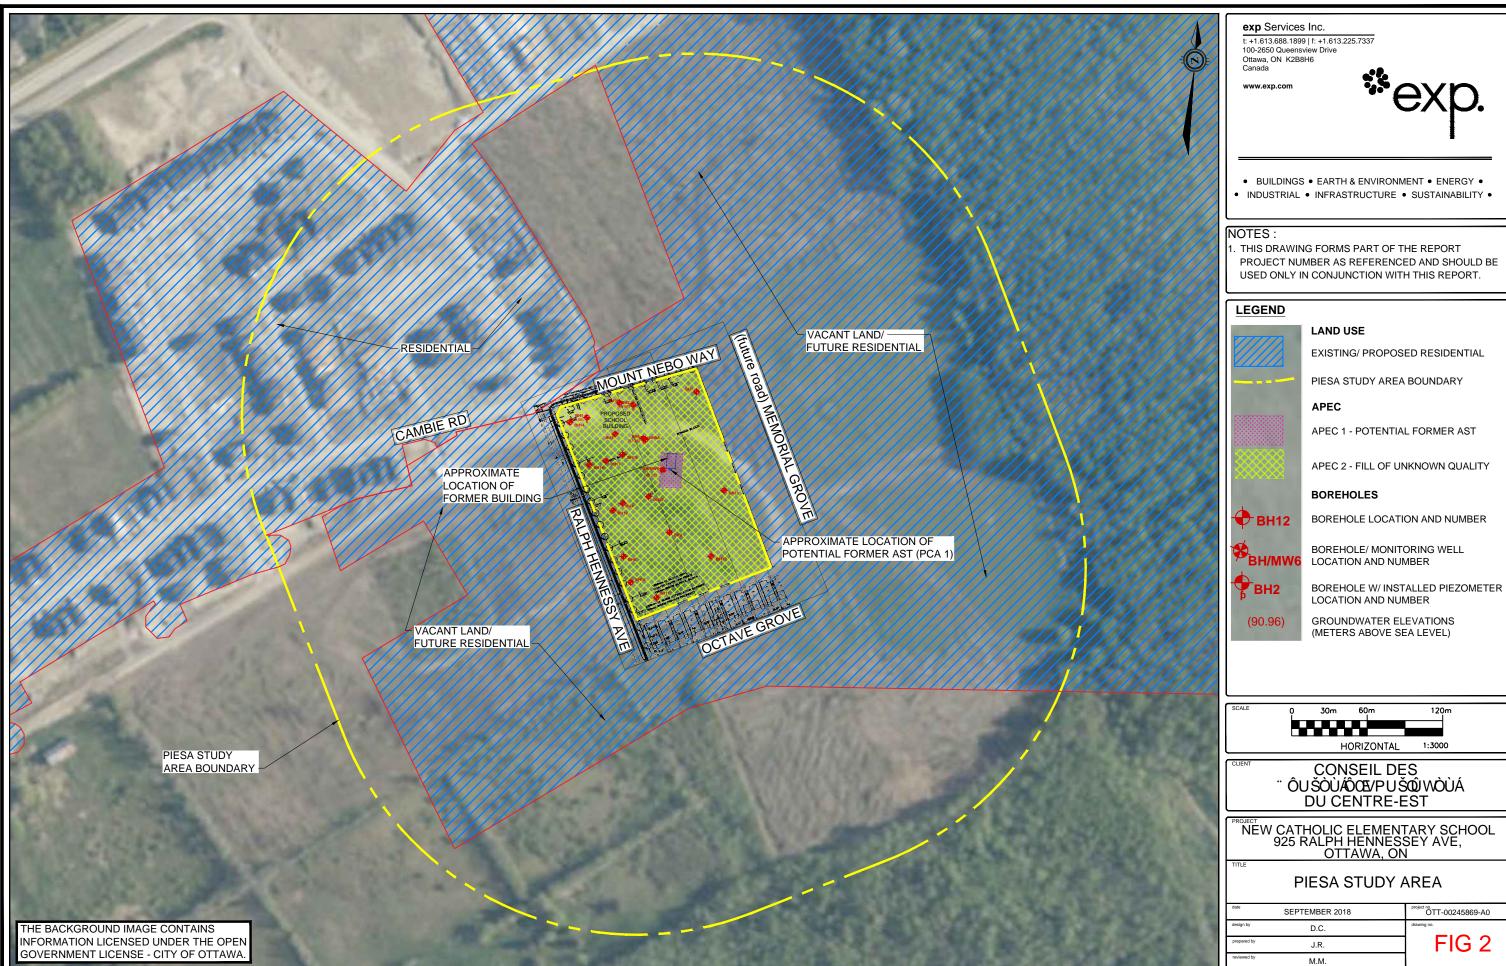
FIG 2

The Phase One Property was observed to be vacant undeveloped land and some of the surrounding area was developed with residential houses as shown on Figure 2 in Appendix B. The Phase One Property has an area of approximately 2.0 hectares and is vacant land. At the time of the investigation, the Phase One Property was owned by the Centre des écoles catholiques du Centre-Est.

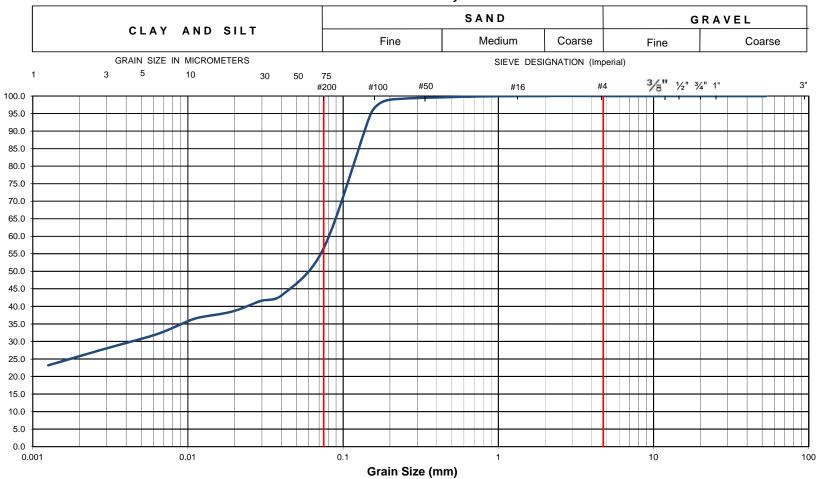
Grain-Size Distribution Curve Method of Test For Particle Size Analysis of Soil ASTM C-136/ASTM D422

EXP Project No.:	OTT-00245869-A0	Project Name :		Proposed New F	Riverside	South Catho	olic I	Element	ary School	
Client :	CECCE	Project Location	:	Ralph Hennessy	Avenue	and Mount N	lebo	Way, O	ttawa, ON.	
Date Sampled :	April 3, 2018	Borehole No:		BH1	Sam	Depth (m) :	1.5-2.1			
Sample Description :		% Silt and Clay	57	% Sand	43	% Gravel		0	Figure :	24
Sample Description : Sandy Clay (CL)								rigure .	24

The grain size analyses showed that more than 50% of the soil had a grain size of silt or finer. This indicates that the native soil is fine grained. The results of the grain size analyses are found in Appendix A.

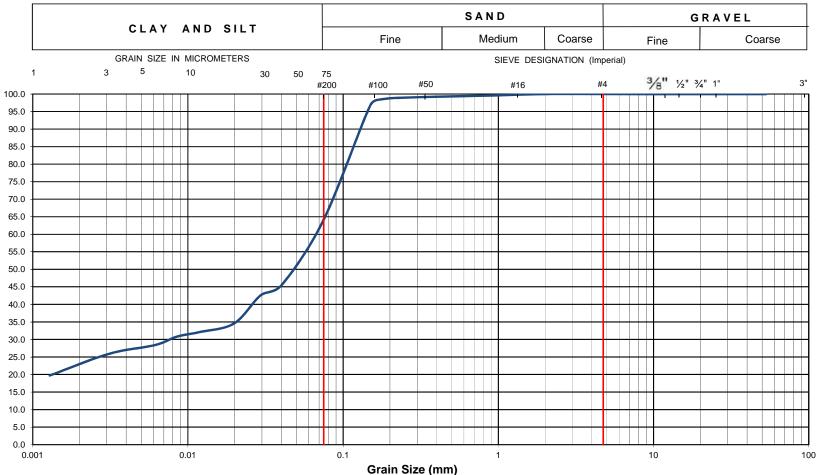
Grain-Size Distribution Curve Method of Test For Particle Size Analysis of Soil ASTM C-136/ASTM D422

EXP Project No.:	OTT-00245869-A0	Project Name :		Proposed New F	Riverside	South Catho	olic I	Element	ary School	
Client :	CECCE	Project Location	:	Ralph Hennessy	Avenue	and Mount N	lebo	Way, O	ttawa, ON.	
Date Sampled :	April 3, 2018	Borehole No:		BH2	Sam	Depth (m) :	2.3-2.9			
Sample Description :		% Silt and Clay	64	% Sand	36	% Gravel		0	Figure :	25
Sample Description :									rigure .	23

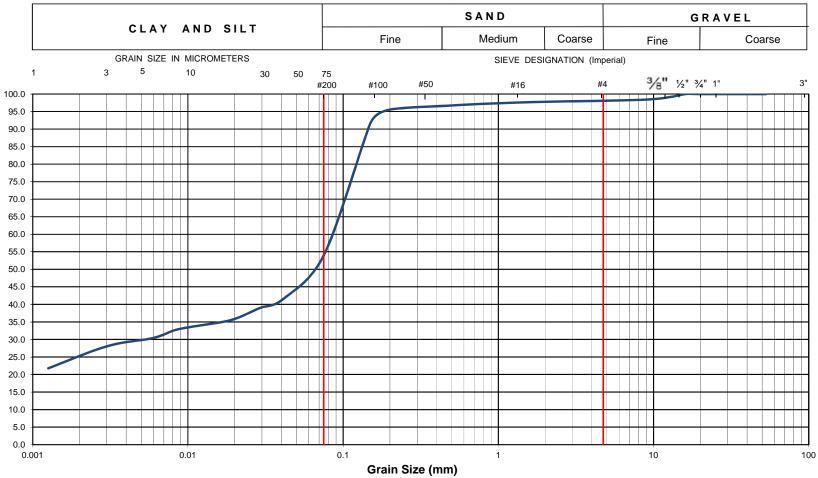
Grain-Size Distribution Curve Method of Test For Particle Size Analysis of Soil ASTM C-136/ASTM D422

EXP Project No.:	OTT-00245869-A0	Project Name :	oject Name: Proposed New Riverside South Catholic Elementary So							
Client :	CECCE	Project Location	:	Ralph Hennessy	Avenue	and Mount N	lebo	Way, O	ttawa, ON.	
Date Sampled :	April 3, 2018	Borehole No:		ВН3	Sam	Depth (m) :	0.8-1.4			
Sample Description :		% Silt and Clay	54	% Sand	44	% Gravel		2	Figure :	26
Sample Description :									rigure .	20

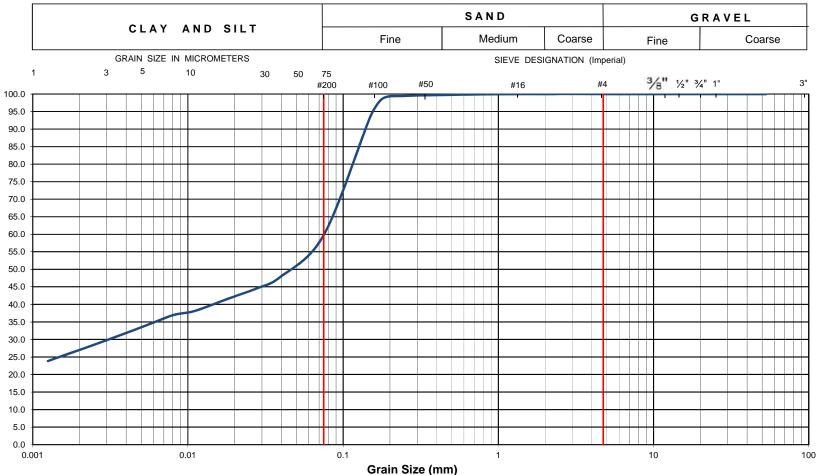
Grain-Size Distribution Curve Method of Test For Particle Size Analysis of Soil ASTM C-136/ASTM D422

EXP Project No.:	OTT-00245869-A0	Project Name :		Proposed New F	Riverside	South Catho	olic I	Element	ary School	
Client :	CECCE	Project Location	:	Ralph Hennessy	Avenue	and Mount N	lebo	Way, O	ttawa, ON.	
Date Sampled :	April 3, 2018	Borehole No:		BH4	Sam	Depth (m) :	1.5-2.1			
Sample Description :		% Silt and Clay	60	% Sand	40	% Gravel		0	Figure :	27
Sample Description :									rigure .	21

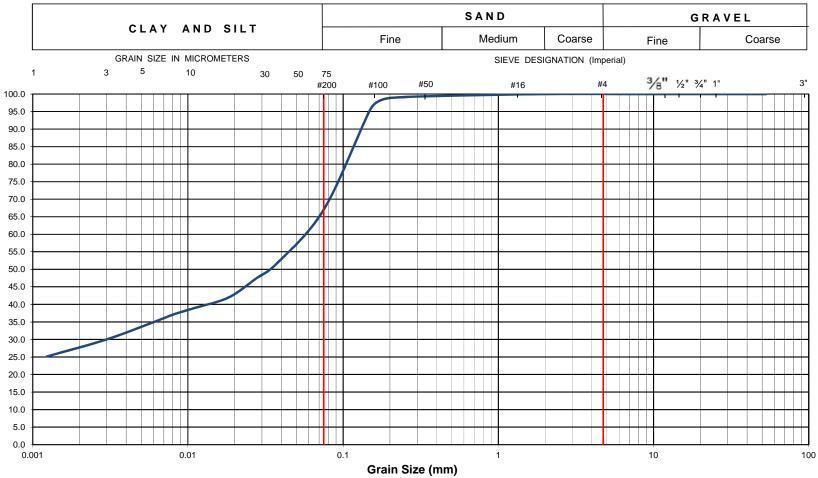
Grain-Size Distribution Curve Method of Test For Particle Size Analysis of Soil ASTM C-136/ASTM D422

EXP Project No.:	OTT-00245869-A0	Project Name :		Proposed New I	Riversid	e South Cath	olic	Elemen	tary School	
Client :	CECCE	Project Location	:	Ralph Hennessy	/ Avenue	and Mount I	Nebo	Way, C	Ottawa, ON.	
Date Sampled :	April 3, 2018	Borehole No:		BH5	Depth (m) :	2.3-2.9				
Sample Description :		% Silt and Clay	Silt and Clay 67 % Sa			% Gravel		0	-Figure :	28
Sample Description : Sandy Clay (CL)									rigule :	20

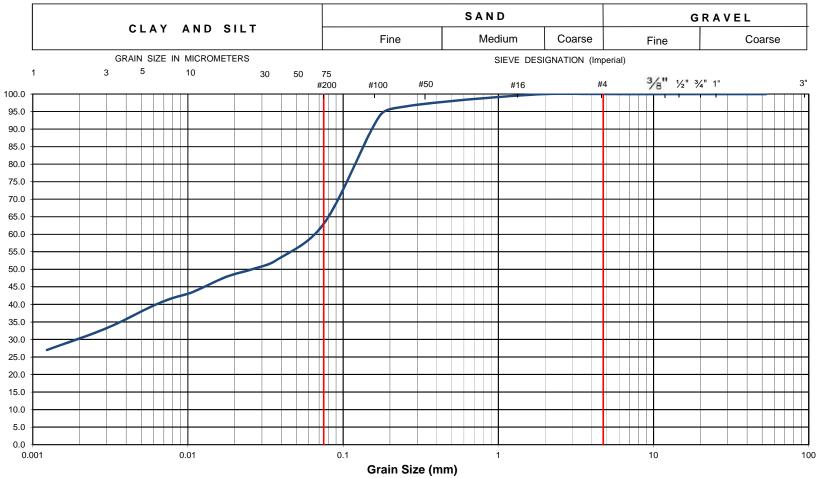
Grain-Size Distribution Curve Method of Test For Particle Size Analysis of Soil ASTM C-136/ASTM D422

EXP Project No.:	OTT-00245869-A0	Project Name :		Proposed New F	Riverside	South Eleme	nta	y Schoo	d .					
Client :	CECCE	Project Location	:	Ralph Hennessy	Avenue	and Mount N	ebo	Way, O	ttawa, ON.					
Date Sampled :	April 2, 2018	Borehole No:	orehole No: BH6 Sample No.: SS2							0.8-1.4				
Sample Description :		% Silt and Clay	63	% Sand	37	% Gravel		0	Figure :	29				
Sample Description :								rigule .	29

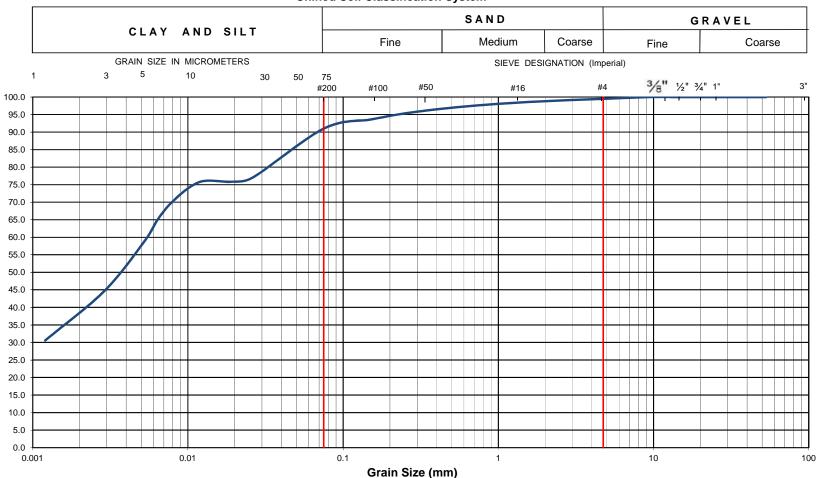
Grain-Size Distribution Curve Method of Test For Particle Size Analysis of Soil ASTM C-136/ASTM D422

EXP Project No.:	OTT-00245869-A0	Project Name :	roject Name : Proposed New Riverside South Catholic Elementa							
Client :	CECCE	Project Location	:	Ralph Hennessy	Avenue	and Mount No	ebo	Way, O	ttawa, ON.	
Date Sampled :	April 2, 2018	Borehole No:		ВН3	Sam	8	Depth (m):	6.1-6.7		
Sample Description :		% Silt and Clay	91	% Sand	8	% Gravel		1	Figure :	32
Sample Description :	iption : Clay (CL)								rigule .	32

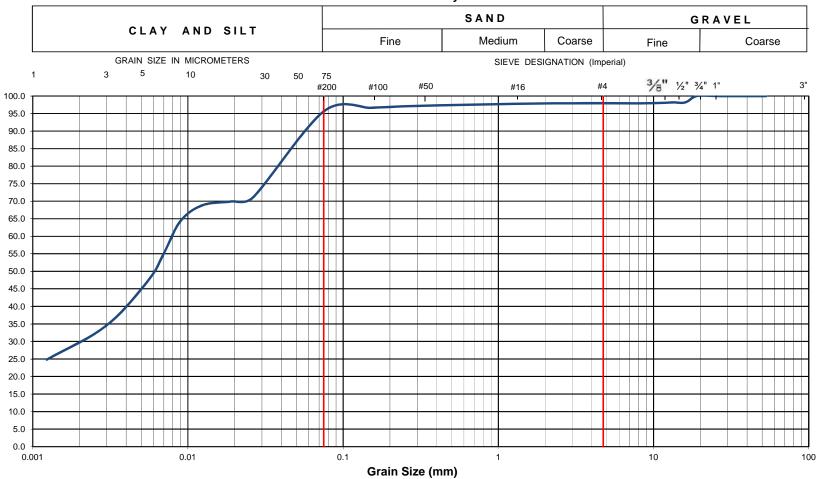
Grain-Size Distribution Curve Method of Test For Particle Size Analysis of Soil ASTM C-136/ASTM D422

EXP Project No.:	OTT-00245869-A0	Project Name :		Proposed New I	Riverside	e South Cath	olic	Element	tary School	
Client :	CECCE	Project Location	١:	Ralph Hennessy	/ Avenue	and Mount I	Nebo	Way, C	Ottawa, ON.	
Date Sampled :	April 3, 2018	Borehole No:		BH 4	Sam	Depth (m) :	7.6-8.2			
Sample Description :		% Silt and Clay	96	% Sand	2	% Gravel		2	-Figure :	33
Sample Description : Silty Clay (CL)									-Figure :	33

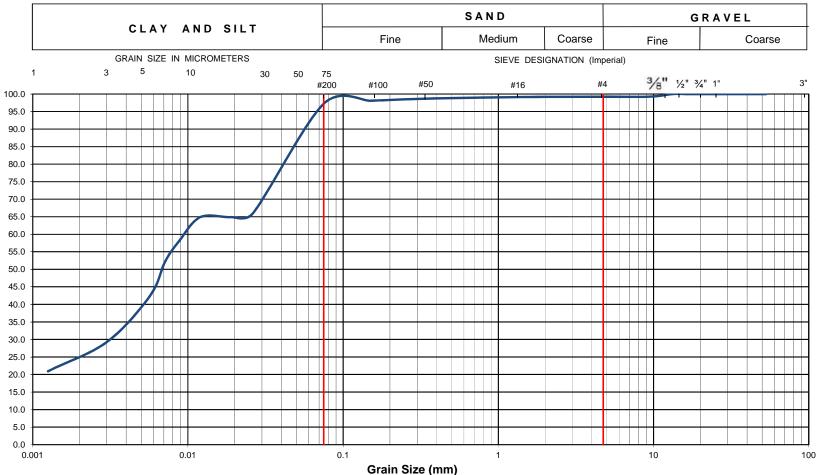
Grain-Size Distribution Curve Method of Test For Particle Size Analysis of Soil ASTM C-136/ASTM D422

EXP Project No.:	OTT-00245869-A0	Project Name :		Proposed New F	Riverside	South Catho	olic	Element	ary School	
Client :	CECCE	Project Location	ect Location : Ralph Hennessy Avenue and Mount Nebo Way, Otta					ttawa, ON.		
Date Sampled :	April 2, 2018	Borehole No:		ВН6	Sam	ple No.:	SS	88	Depth (m) :	6.1-6.7
Sample Description :		% Silt and Clay	97	% Sand	2	% Gravel		1	Figure :	34
Sample Description :	Silty Clay (CL)						rigure .	34

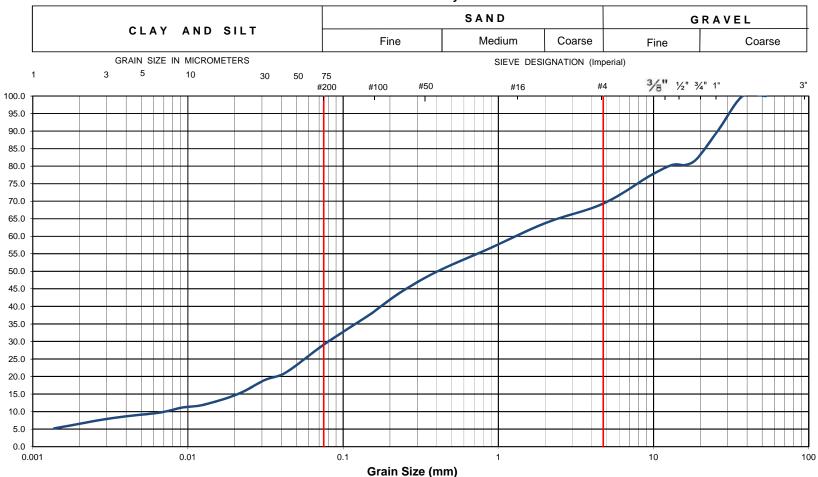
Grain-Size Distribution Curve Method of Test For Particle Size Analysis of Soil ASTM C-136/ASTM D422

EXP Project No.:	OTT-00245869-A0	Project Name :		Proposed New F	Riverside	South Eleme	enta	ry Scho	ol	
Client :	CECCE	Project Location	ect Location : Ralph Hennessy Avenue and Moutn Nebo Way, Ottawa, ON.						ttawa, ON.	
Date Sampled :	April 3, 2018	Borehole No:		BH2	Sam	ple No.:	SS	S 9	Depth (m) :	7.6-8.2
Sample Description :		% Silt and Clay	29	% Sand	40	% Gravel		31	Figure :	38
Sample Description :	Silty Sand with Gravel (SM)						rigule .	30

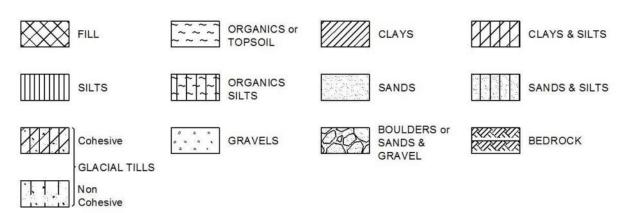
STRATA PLOT

Strata plots symbolize the soil or bedrock description. They are combinations of the following basic symbols:

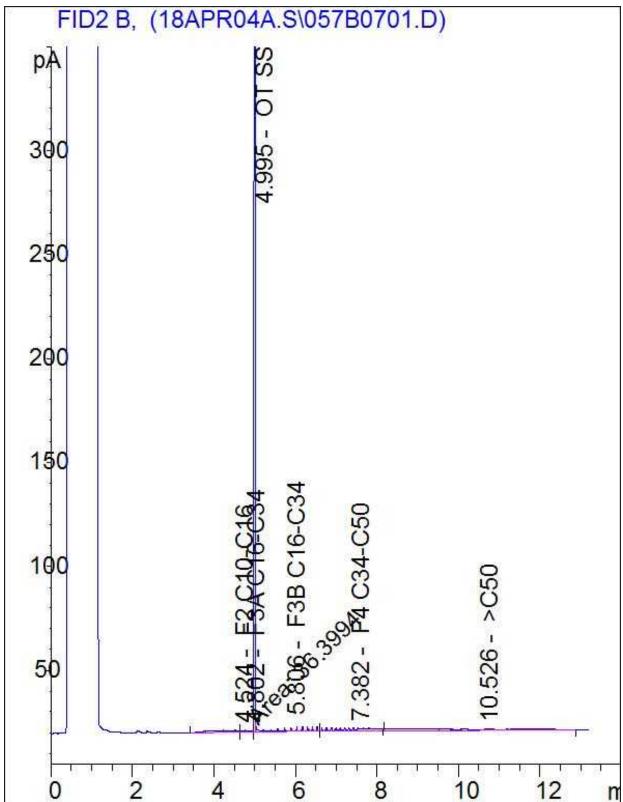
Petroleum Hydrocarbons F2-F4 in Soil Chromatogram

Client ID: BH 6-S3

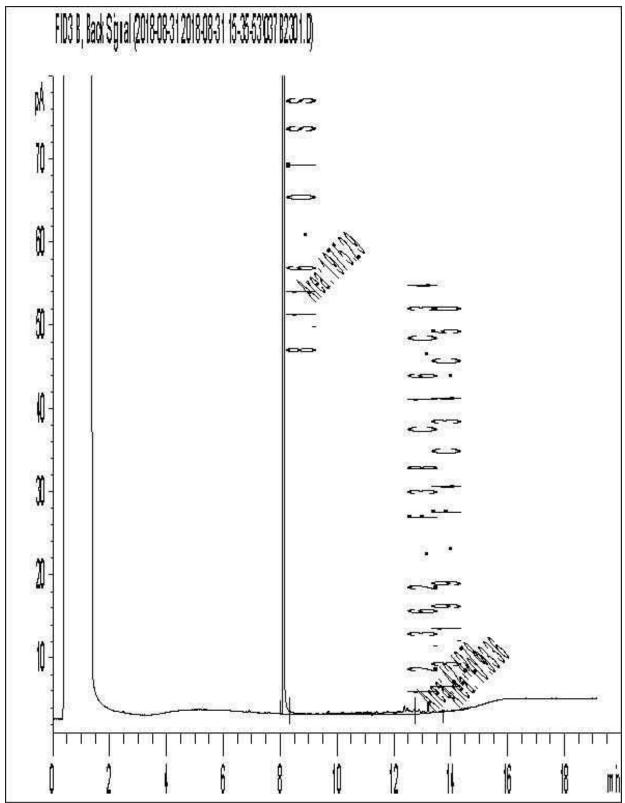
Petroleum Hydrocarbons F2-F4 in Soil Chromatogram

Client ID: BH 8-SS1

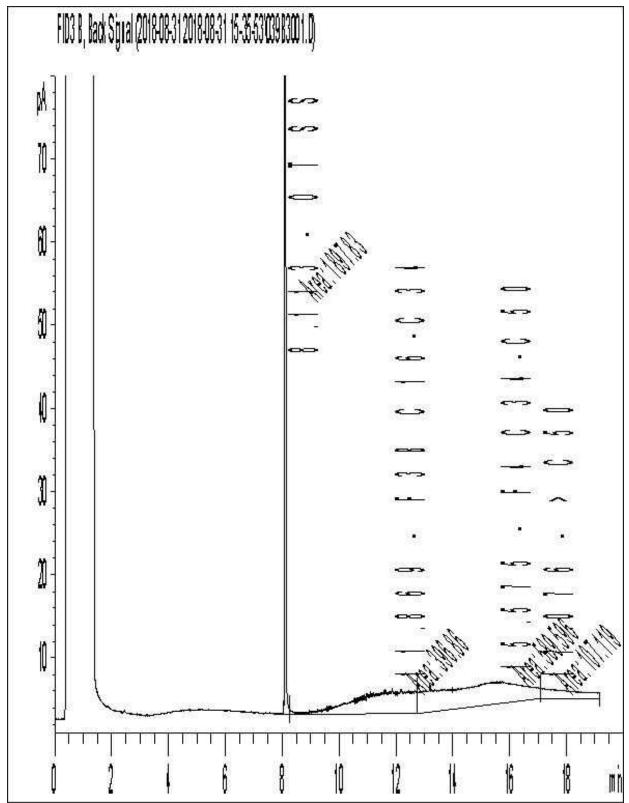
Petroleum Hydrocarbons F2-F4 in Soil Chromatogram

Client ID: BH 9-SS1

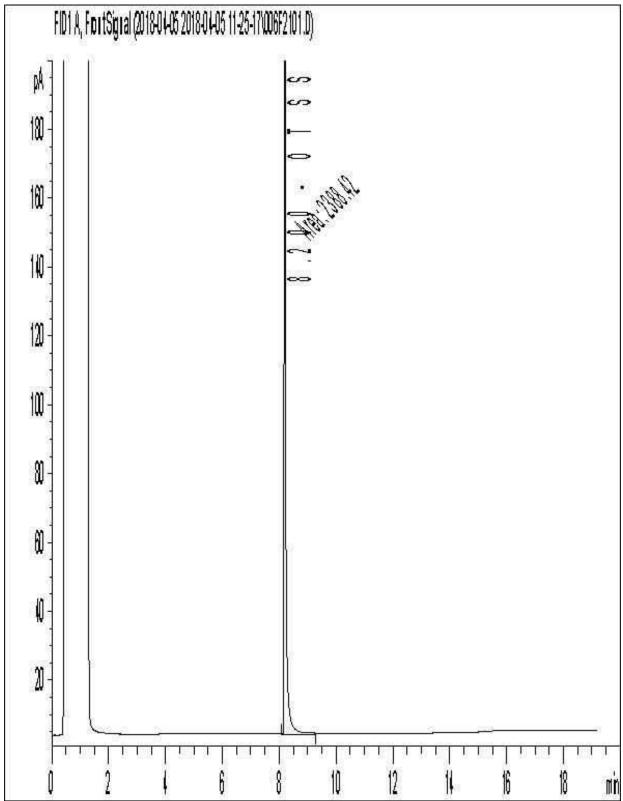
Petroleum Hydrocarbons F2-F4 in Water Chromatogram

Client ID: BH6
