Phase One Environmental Site Assessment

17, 19 & 23 Robinson Avenue Ottawa, Ontario

Robinson Village I Limited Partnership

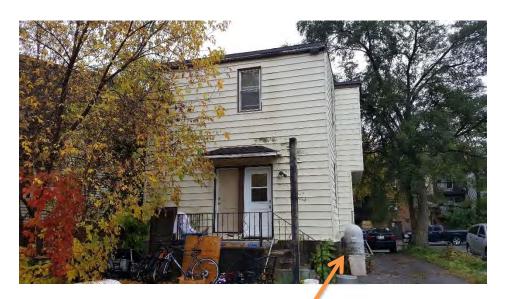
The presence of one current exterior AST was observed by GHD at the time of the Site visit; this AST was located to the northwest of the residential building at 23 Robinson Avenue. The AST was used to store furnace oil and was suspected to be actively supplying fuel to the furnace in the crawl space basement, however, confirmation of the connection could not be confirmed as access was limited in this area of the basement. The AST was approximately 905 L in size and was constructed of fibreglass reinforced plastic. A fuel odour was observed in the basement crawl space, in the room adjacent to the AST. The floors in this room appeared to consist of older concrete, which had minor cracks and also appeared to be partially wet (suspected to be associated with water infiltration). The

Olfactory observations of fuel oil odours were observed in the room adjacent to the exterior AST at 23 Robinson Avenue. It is suspected that historical spills or releases have contributed to the observed odour. The floors in this room appeared to consist of older concrete, which had minor cracks and also appeared to be partially wet (suspected to be associated with water infiltration). There was no visual evidence of staining or spills observed during the interior assessment portion of the Site visit.

Photo 4-23 Robinson Avenue – from rear, showing 900L AST (Heating Oil) – on building exterior (PCA 1, APEC 1)

There was one PCA observed at the Site at the time of inspection. The presence of an on-Site AST, with olfactory observations of fuel odours in the basement of the adjacent building, is considered a PCA and Area of Potential Environmental Concern (APEC) for the Site.

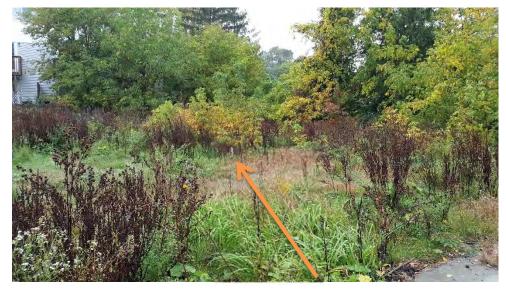
One monitoring well was observed during the Site visit in the northwest portion of the Site. This well is assumed to be associated with a limited Phase II ESA completed at the Site in 2013. The landscaped areas of the Site were overgrown with vegetation and additional monitoring wells were not observed.

Photo 5 – rear yard showing monitoring well from previous investigation
