### **Phase I Environmental Site Assessment**

24 Chesapeake Crescent and 164 Maravista Drive Ottawa, Ontario

Tel: (613) 226-7381 Fax: (613) 226-6344 www.patersongroup.ca July 16, 2018 Report: PE4346-1

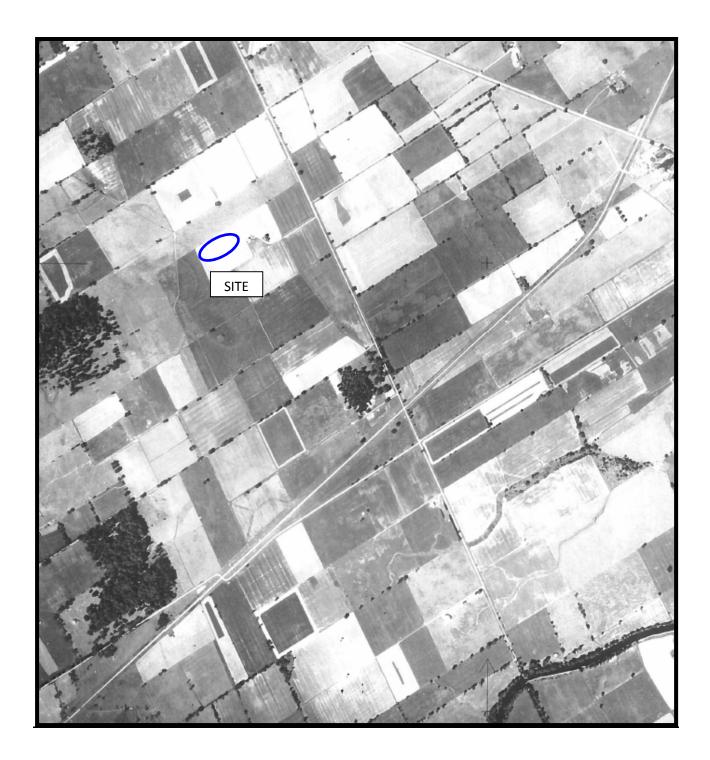
AERIAL PHOTOGRAPH 1963

- 1956 The Phase I Property and neighbouring properties within the Phase I Study Area appear to remain unchanged from the previous photograph.
- 1963 No significant changes appear to have been made to the Phase I Property or to the adjacent and neighbouring lands.

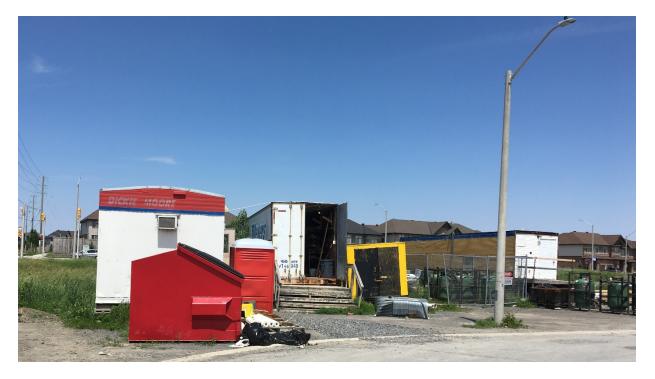
Photograph 1: View of the southwestern portion of the Phase I Property, facing northeast. The photo depicts a site office trailer, storage trailers and the propane storage area.

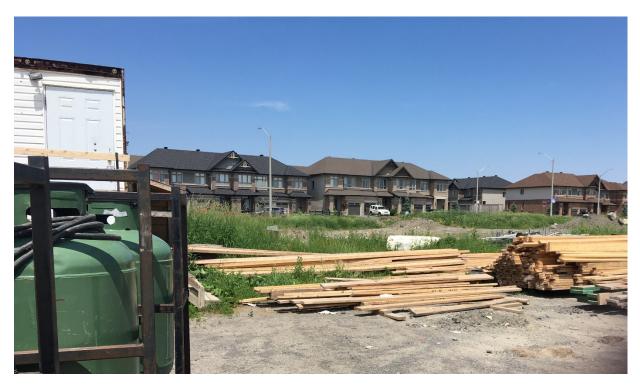
Photograph 2: View of the central portion of the Phase I Property, facing north. Photograph illustrates storage of construction materials and fill material; also depicted are residential dwellings to the north.

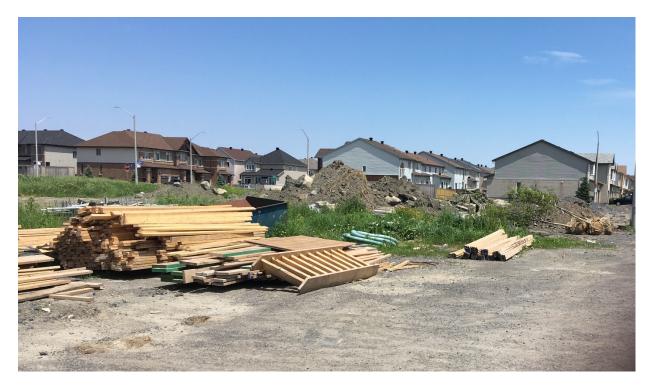
Photograph 3: View of the eastern portion of the Phase I Property, facing northeast. Photo illustrates on-site storage of construction materials and fill material, as well as residential dwellings to the east.

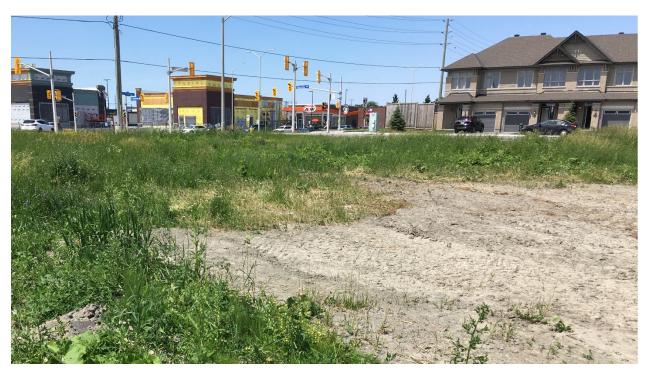
Photograph 4: View of the northwestern portion of the Phase I Property, facing northwest. Photograph illustrates commercial development to the northwest, across Strandherd Drive.
