Combined Environmental Impact Statement &  
Tree Conservation Report  
762 March Road and 335 Sandhill Road Development

December 2018  
Prepared for Minto Communities

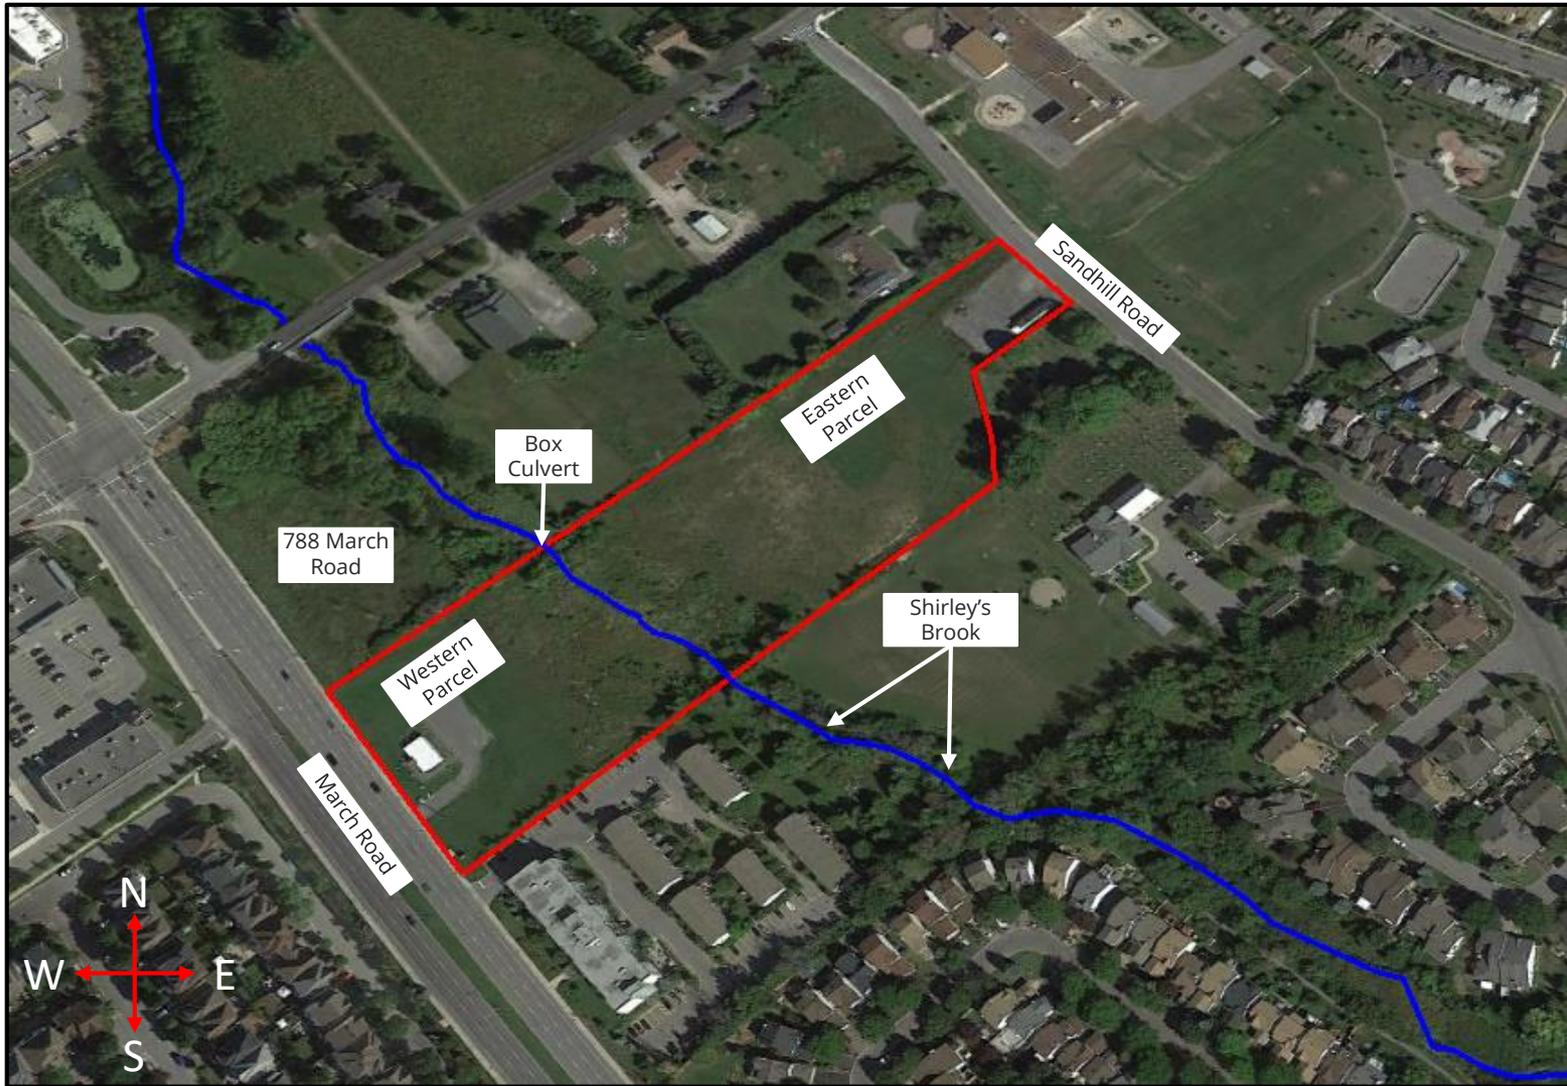
# FIGURE 1: STUDY AREA OVERVIEW

- Study Area

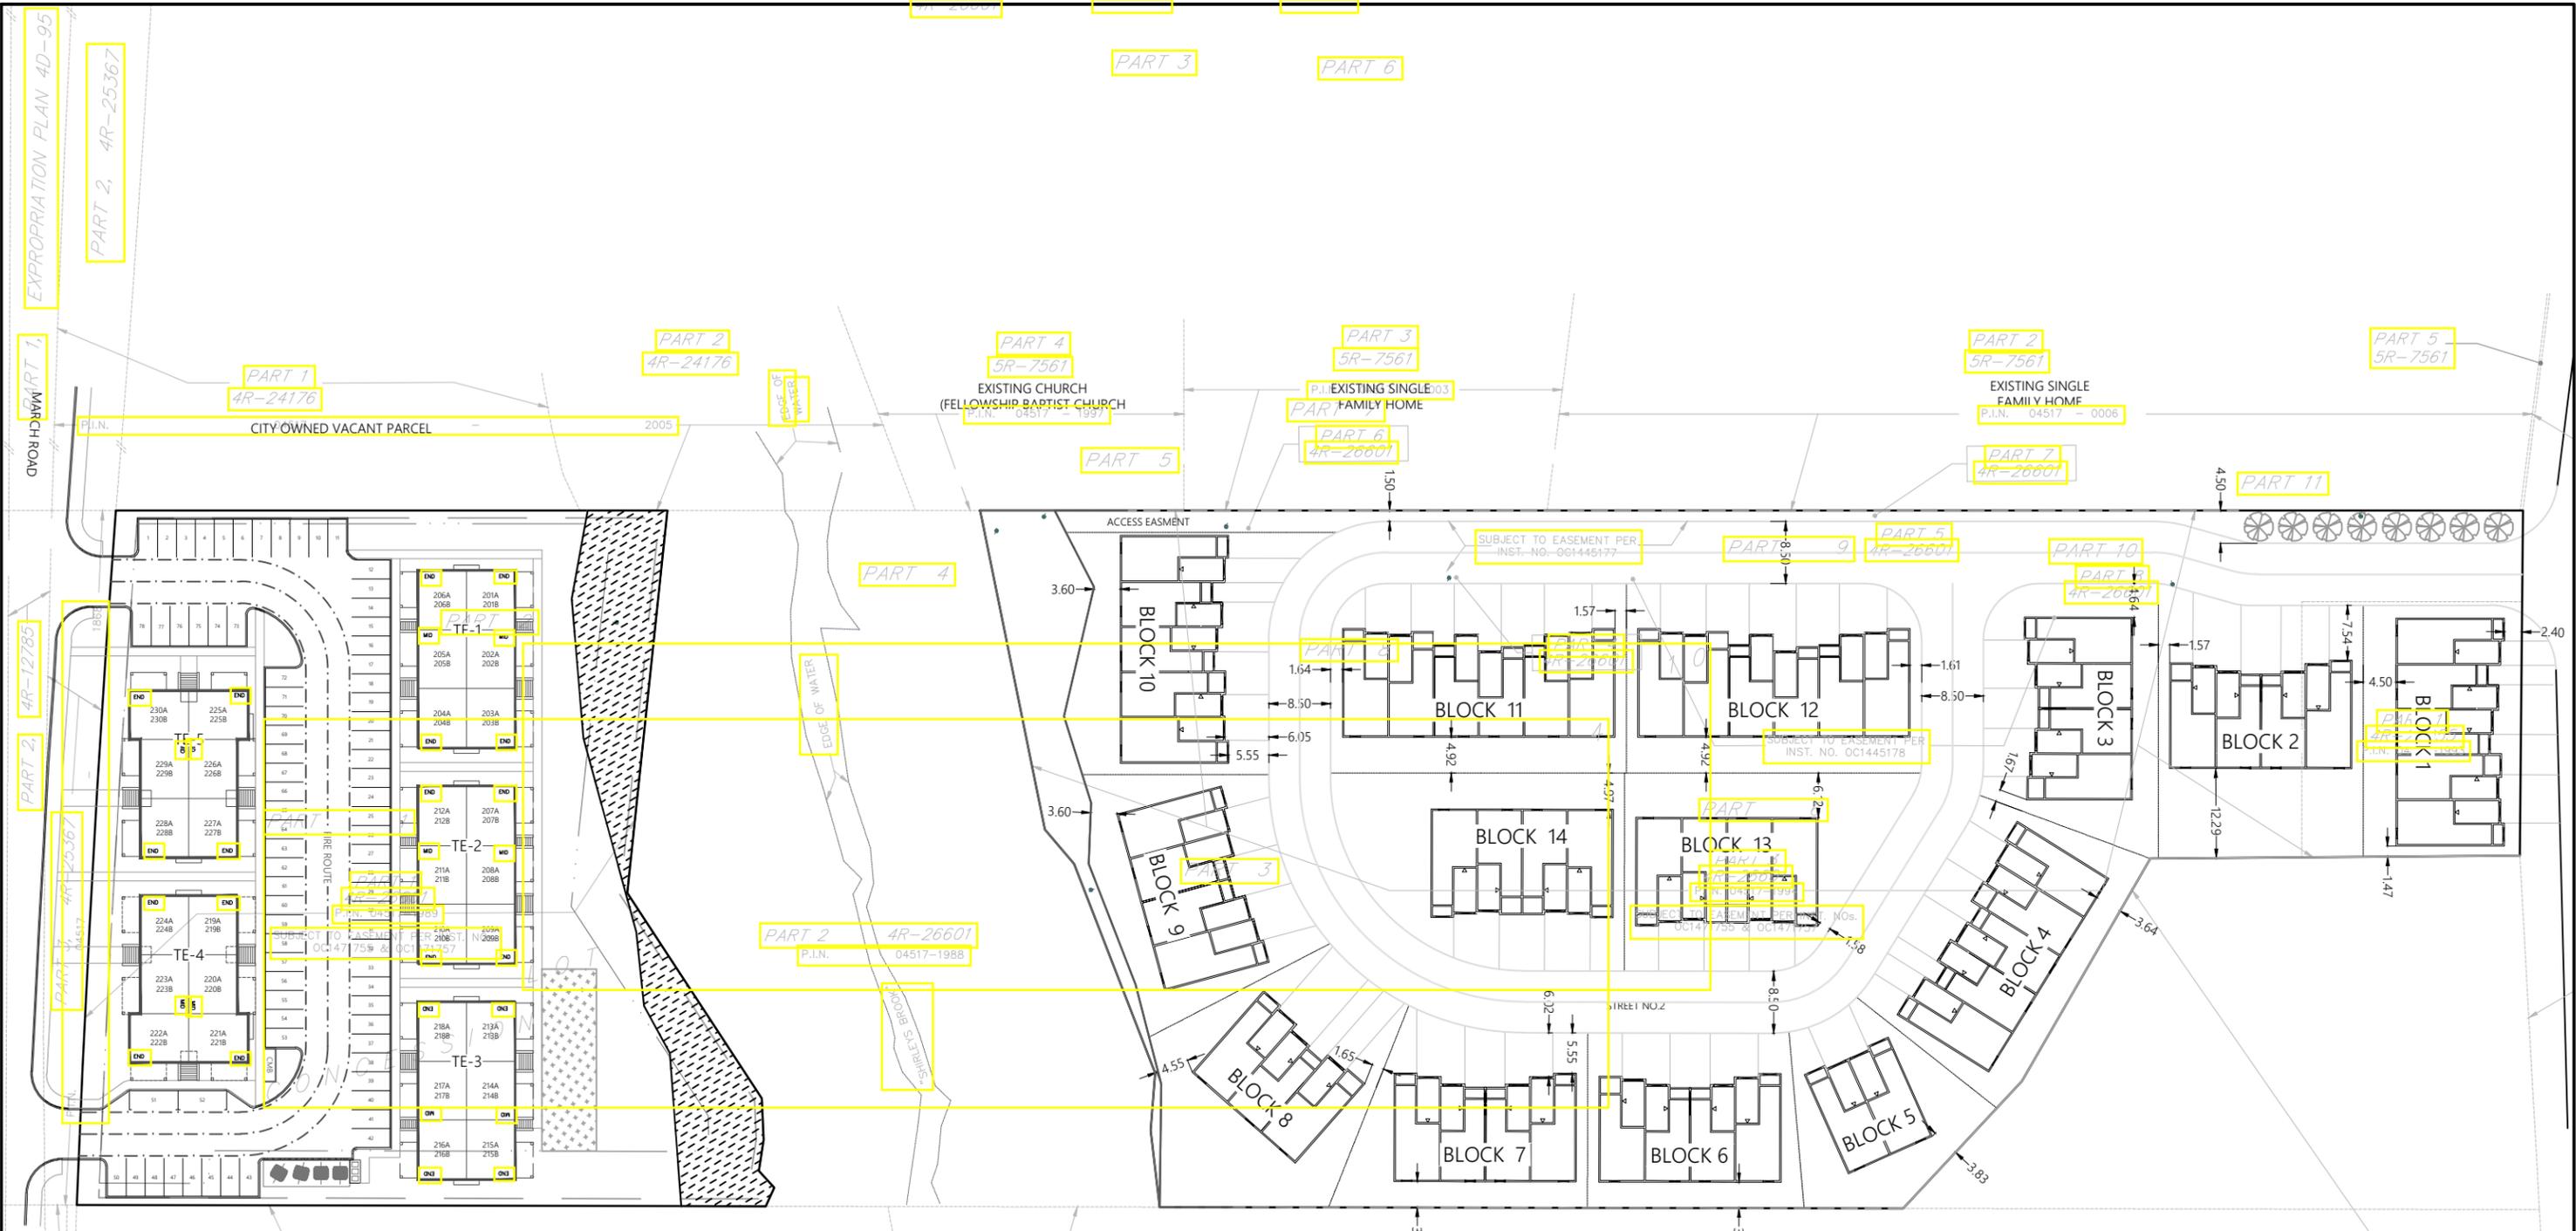
**Morgan's Creek - Stage 1**  
 60 Condominium Units

The proposed Site Plan/Draft Plan of Subdivision is included below. The western parcel will be submitted to the City of Ottawa as a Site Plan Application, whereas the eastern parcel will be submitted as a separate Draft Plan of Subdivision Application. The western parcel will be developed to include five (5) multi-level terrace residential buildings with a total of approximately 60 units. The western parcel will also include two (2) entrances from March Road, an amenity space/snow storage, and approximately 78 surface parking spaces. The eastern parcel will be developed to include approximately 60 executive townhomes. The eastern parcel will include one (1) entrance from Sandhill Road. The Site Plan/Draft Plan of Subdivision includes a 30 m setback from the normal high-water mark of Shirley's Brook on both sides of the open space corridor. Currently the open space corridor surrounding Shirley's Brook varies in width between approximately 40 m and 60 m. The setbacks included as part of the proposed development will expand the current corridor width so that it is a minimum of 60 m wide throughout the Study Area.

Stormwater from the western parcel will be directed to the existing March Road storm sewer, which outlets to the existing SWMP Pond No.1 - West (JL Richards 2011). The existing SWMP Pond No.1 - West was sized to provide quantity and quality control for the western parcel. Stormwater from the eastern parcel will be directed to the existing Sandhill Road storm sewer, which outlets to the existing SWMF Pond No.2 (JL Richards 2011). The Shirley's Brook East SWMF Pond No.2 was sized to provide quantity and quality control for the eastern parcel. Both parcels will receive municipal sewer and water. All services were shown to connect to the western and eastern parcels from March Road and Sandhill Road (respectively), and no overland or buried connections are required to cross Shirley's Brook (JL Richards 2011).

As noted above, the Site Plan/Draft Plan of Subdivision includes a minimum 30 m wide vegetated setback from the normal high-water mark of Shirley's Brook (on both sides). Currently, the open space corridor owned by the City of Ottawa that surrounds Shirley's Brook varies in width between approximately 40 m and 60 m. The setbacks included as part of the proposed development will expand the current corridor width so that it is a minimum of 60 m wide throughout the Study Area.

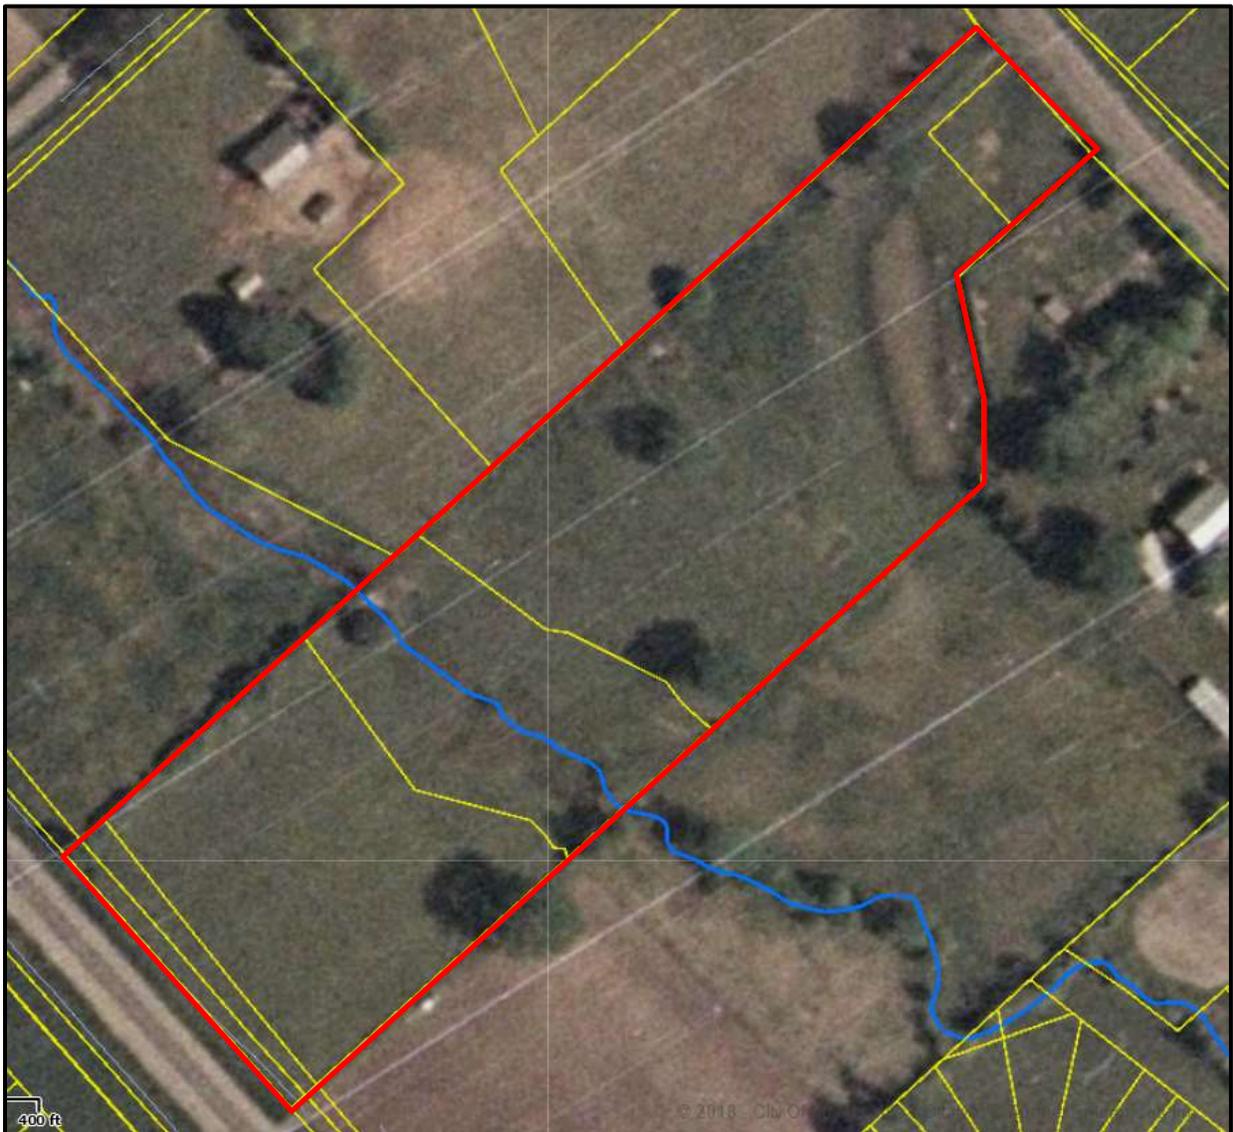
**Historic Air Photograph 1:** Historic Air Photo from 1976 (Study Area limits shown in red). Note the Study Area appears to either be farmed or open meadow/pasture. Tree cover appears to be limited to a few mature trees and hedgerows along the northern and southern Study Area boundaries in 1976. A depression is visible in the eastern parcel in 1976 (Photos from City of Ottawa 2018).

Air photos from 1976, 1991, 2005 and 2014 are included below (Photos from City of Ottawa 2018). Recent air photos are included in the report figures. The oldest available historic air photo (from 1976), shows that the Study Area was open habitat which was likely predominantly either farmed, pasture or open meadow at that time. In 1976, tree cover appears to be limited to a few mature trees and the hedgerows found along the northern and southern Study Area boundaries. The condition of the Study Area is broadly similar in 1991, 2005, and 2014, with the majority of the Study Area predominantly open meadow. By 2005, very few mature trees are visible within the Study Area, and tree cover appears limited to the hedgerows that are present along the northern and southern property boundaries. A depression is visible in the eastern parcel in the historic air photos. The depression is visible in 1976 and 2005, and appears flooded and/or a pond in 1991. The depression is visible in later air photos until 2011, after which time the depression appears to have been removed. Air photos from 2014 onwards do not show any evidence of the depression within the eastern parcel, and no standing water nor any wetland vegetation was observed in the area in 2018. The depression and any associated surface flooding and/or ponding appears to no longer exist within the Study Area from 2014 onwards.

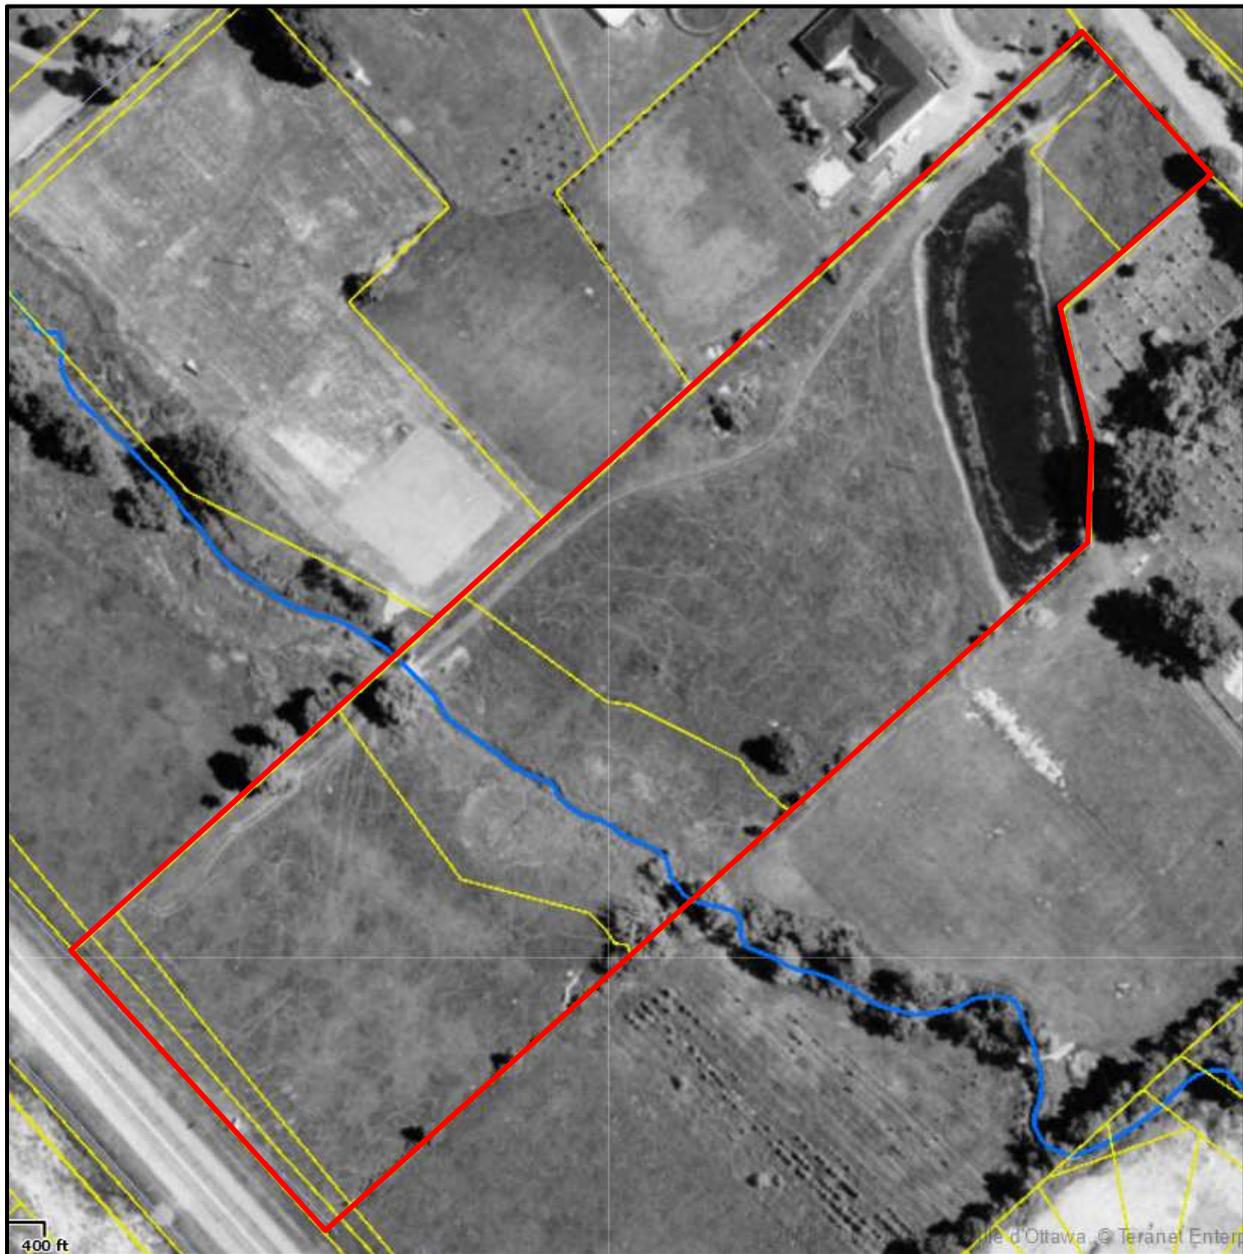
**Historic Air Photograph 2:** Historic Air Photo from 1991 (Study Area limits shown in red). Note the Study Area appears to be predominantly open meadow and tree cover appears to be limited to the hedgerows along the northern and southern Study Area boundaries in 1991. The depression that is visible in the eastern parcel appears as an open pond and/or flooded area in 1991 (Photos from City of Ottawa 2018).

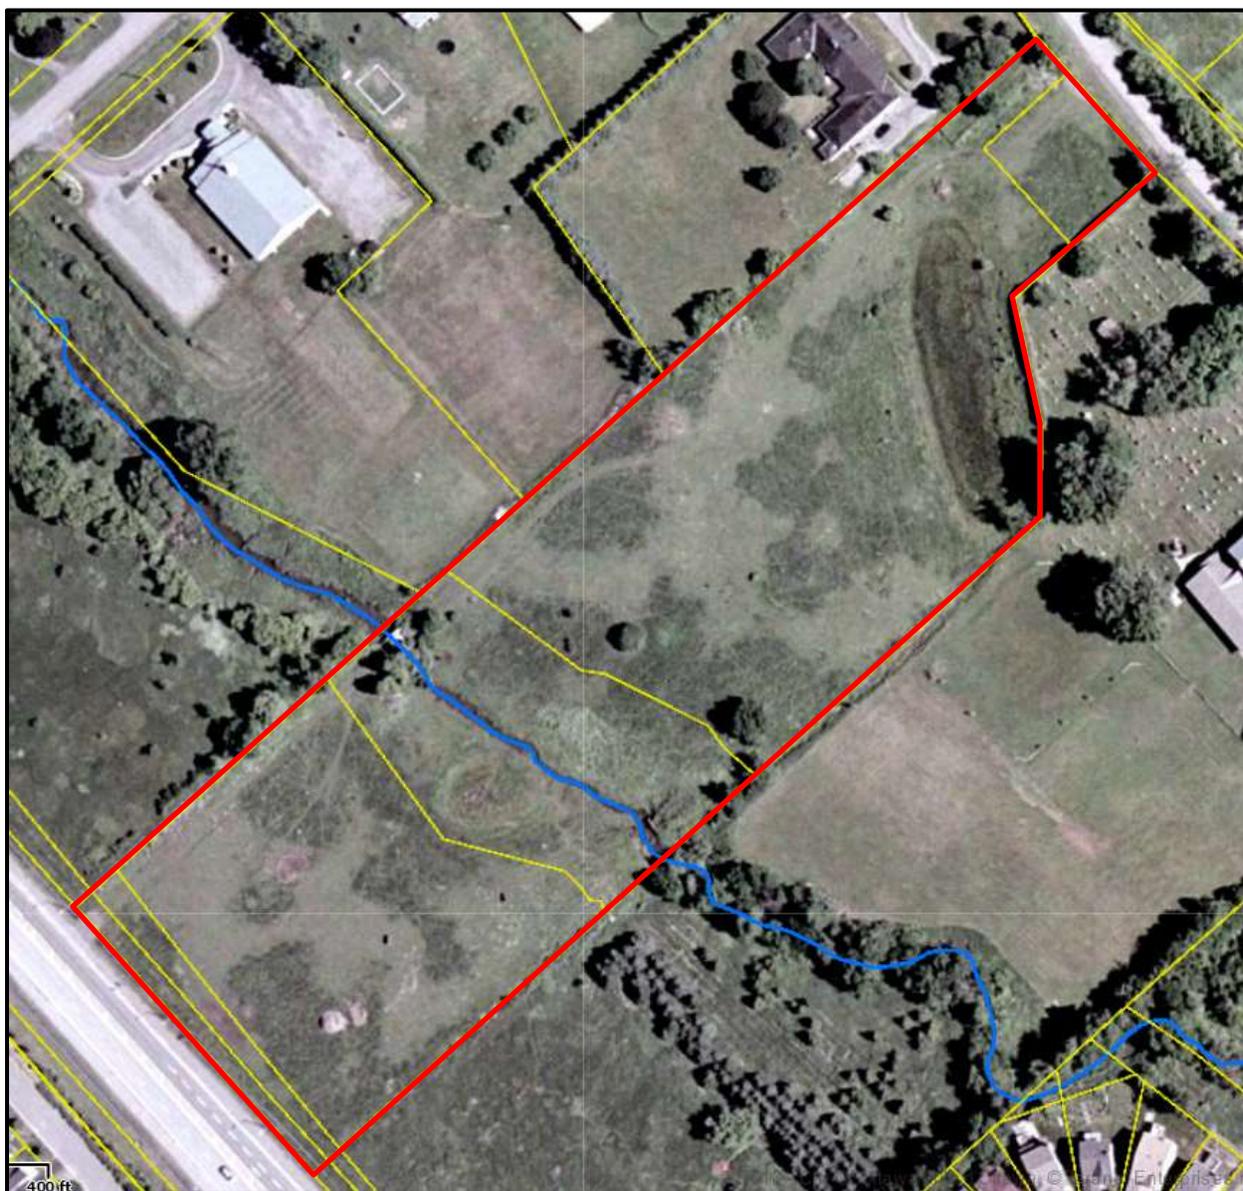
**Historic Air Photograph 3:** Historic Air Photo from 2005 (Study Area limits shown in red). Note the Study Area appears to be predominantly open meadow and tree cover appears to be limited to the hedgerows along the northern and southern Study Area boundaries in 2005. In 2005, very few mature trees are visible within the Study Area. The depression that is visible in the eastern parcel appears to be partially flooded in 2005 (Photos from City of Ottawa 2018).

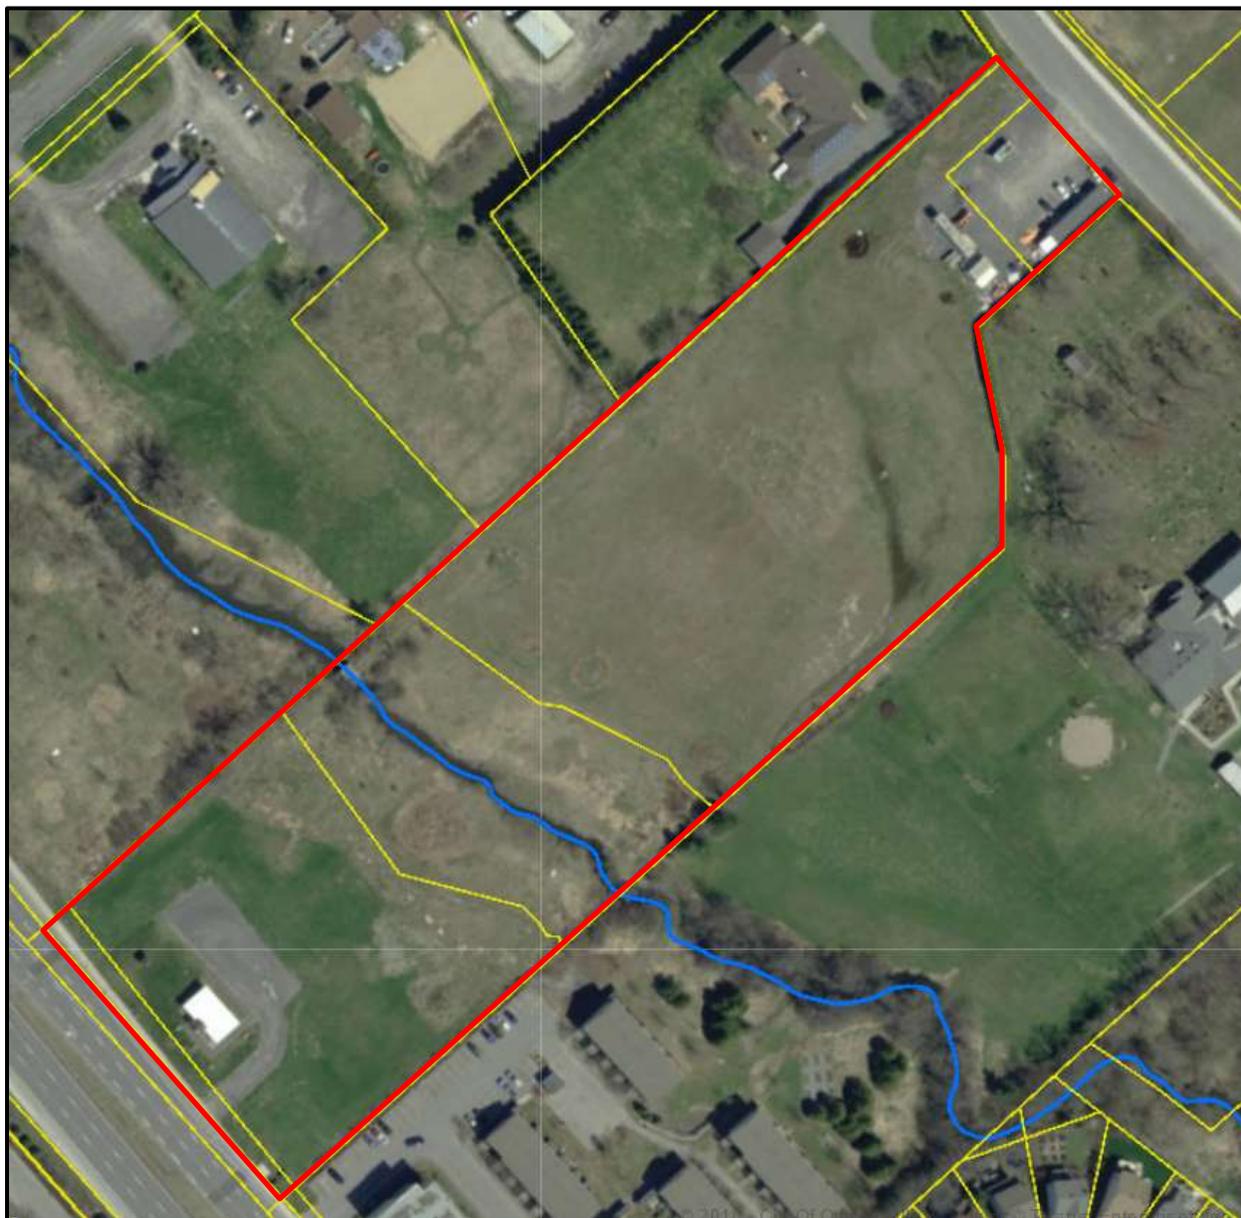
**Historic Air Photograph 4:** Historic Air Photo from 2014 (Study Area limits shown in red). Note the Study Area appears to be predominantly open meadow and tree cover appears to be limited to the hedgerows along the northern and southern Study Area boundaries in 2014. In 2014, very few mature trees are visible within the Study Area. The depression that was previously visible in the eastern parcel appears to have been filled and/or graded by 2014, and is no longer present (Photos from City of Ottawa 2018).

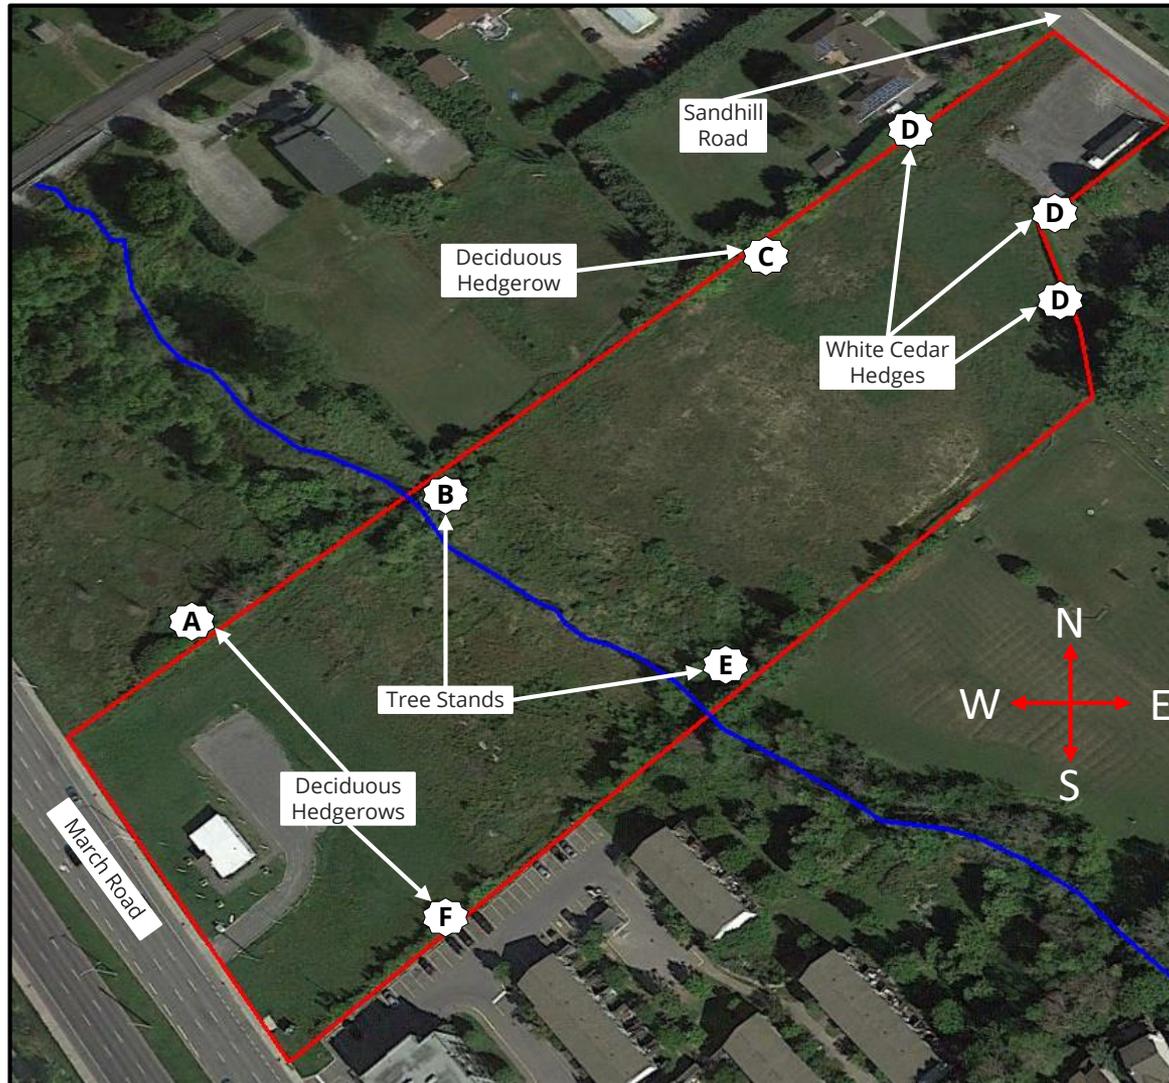
# FIGURE 3: TREE STANDS & HEDGEROWS

- Vegetation Feature Number

Vegetation communities found within the Study Area are shown in Figures 2 and 3. Refer to Appendix A for a list of plants found within the Study Area. The Study Area includes the following terrestrial vegetation communities:

- **Tree Stand (Feature B):** A Tree Stand (Feature B) is present at the north end of Shirley's Brook. The Tree Stand includes a few Crack Willow, Manitoba Maple, and American Elm between 10 cm and 40 cm dbh in size. Groundcover is similar to the adjacent Cultural Meadow. A few shrub sized Domesticated Apple trees are present.

- **Tree Stand (Feature E):** A Tree Stand (Feature E) is present at the south end of Shirley's Brook. The Tree Stand includes a few young Crack Willow, Manitoba Maple, and White/Green Ash (<15 cm dbh), as well as Slender Willow and Red Osier Dogwood shrubs.

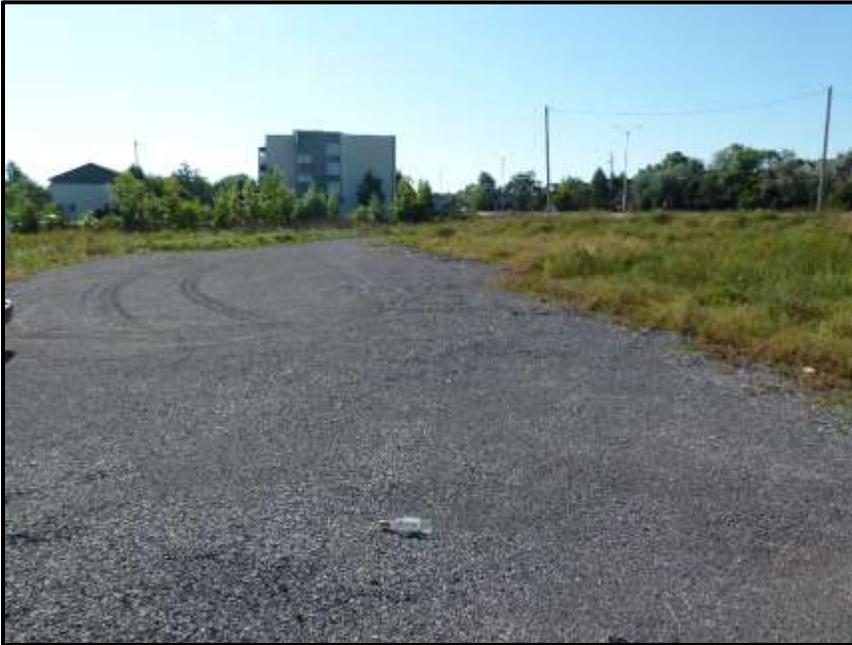
**Photograph 1:** Looking south at the Gravel Parking Area in the western parcel. March Road is visible at the right (September 14<sup>th</sup>, 2018).

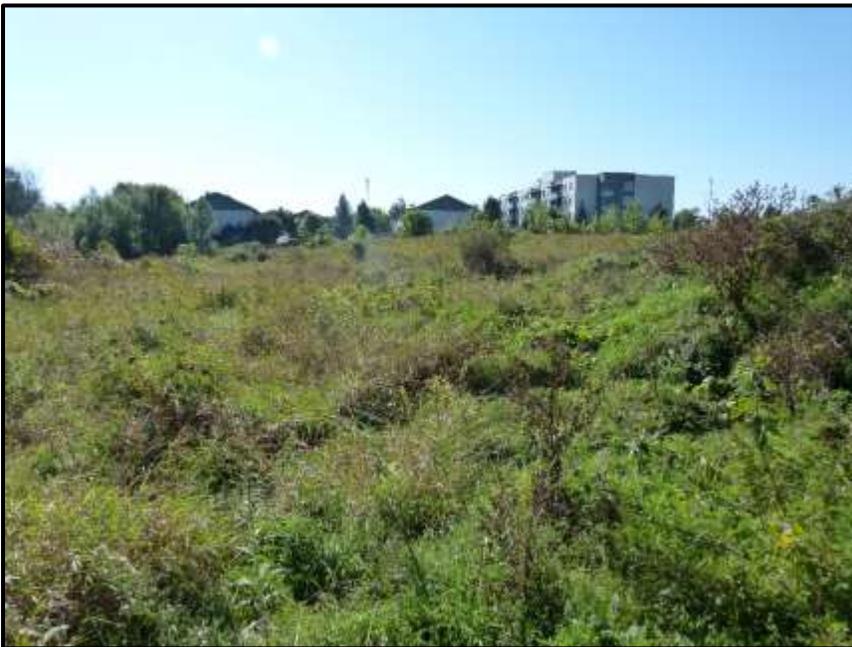
**Photograph 2:** Looking south at the forb dominated Cultural Meadow in the western parcel (September 14<sup>th</sup>, 2018).

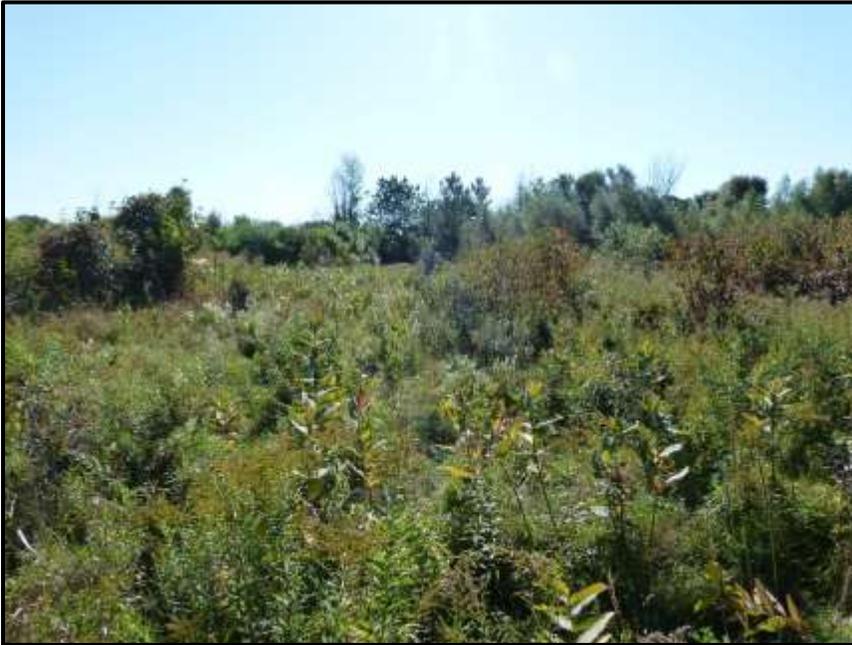
**Photograph 3:** Looking north at the forb dominated Cultural Meadow in the eastern parcel (September 14<sup>th</sup>, 2018).

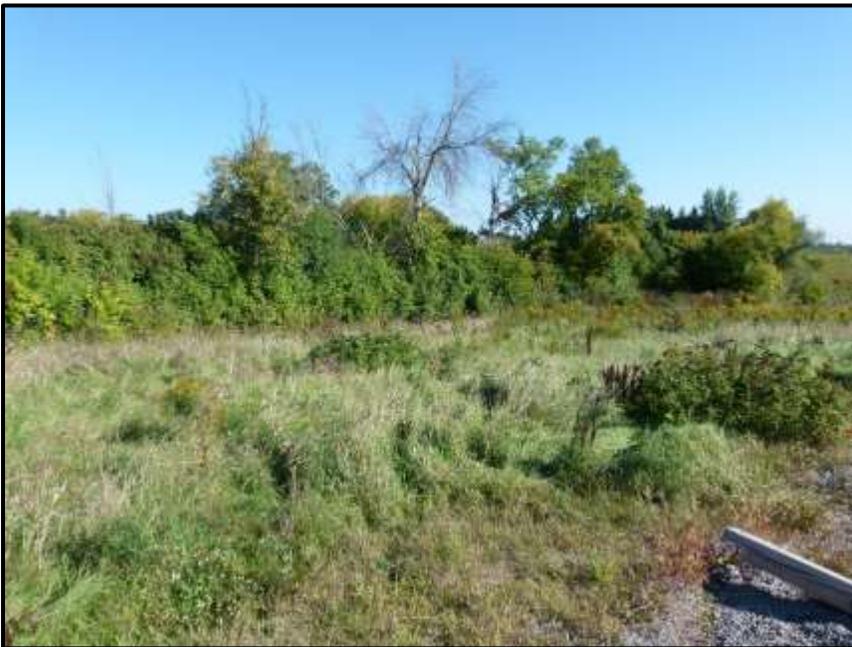
**Photograph 4:** Looking north at the Deciduous Hedgerow (Feature A) (September 14<sup>th</sup>, 2018).

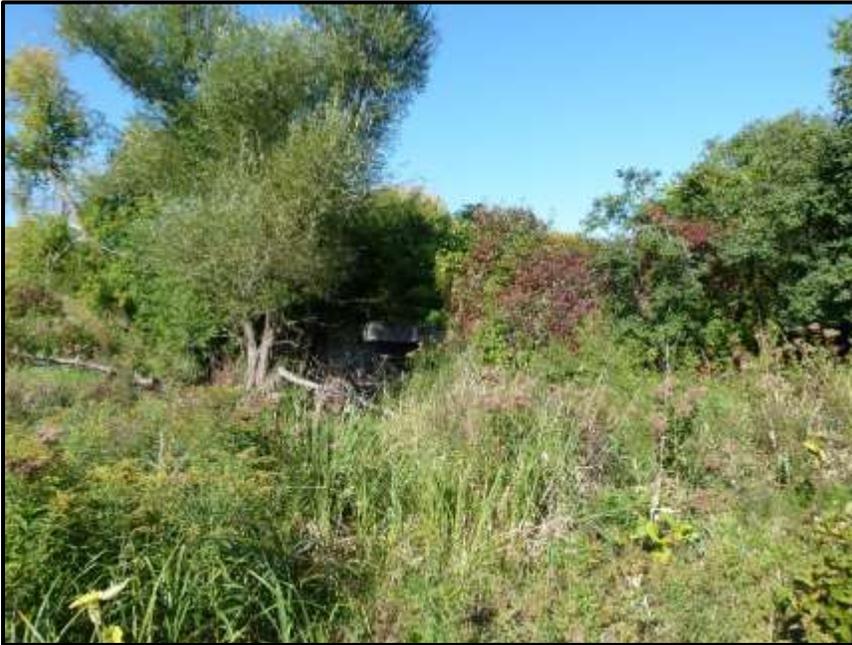
Photograph 5: Looking north at the Tree Stand (Feature B) (September 14<sup>th</sup>, 2018).

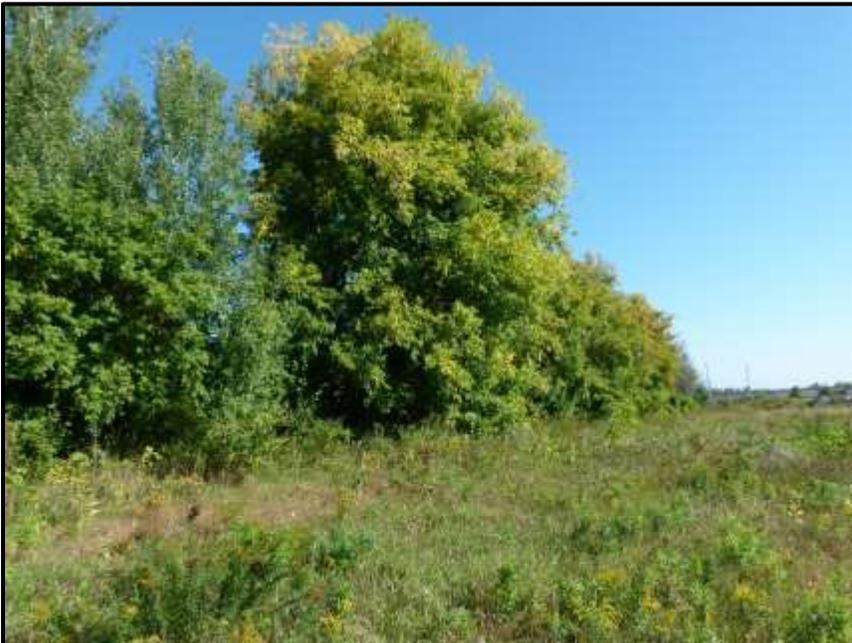
Photograph 6: Looking north at the Deciduous Hedgerow (Feature C) (September 14<sup>th</sup>, 2018).

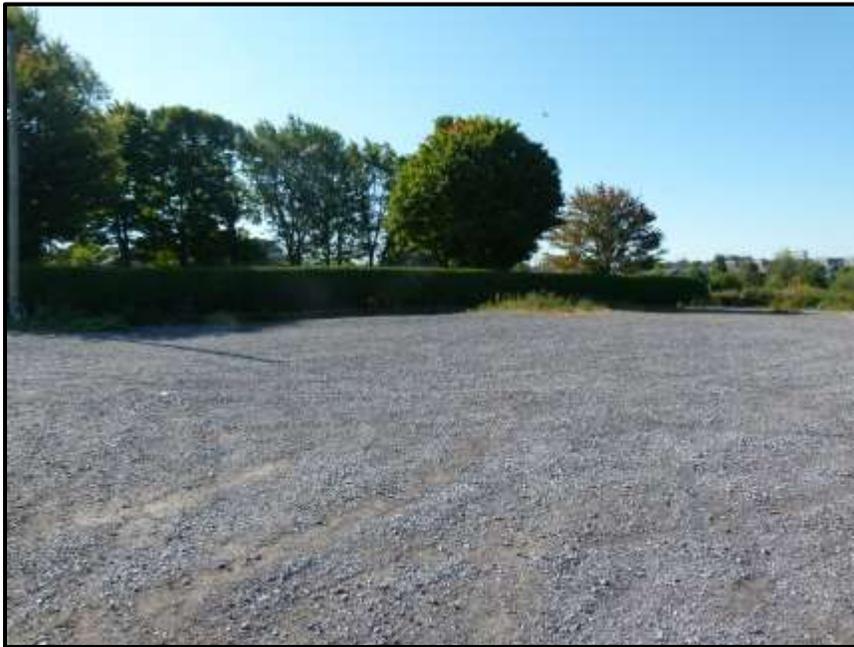
**Photograph 7:** Looking south from the Gravel Parking Area at the Coniferous Hedgerow (White Cedar Hedge) (Feature D) (September 14<sup>th</sup>, 2018).

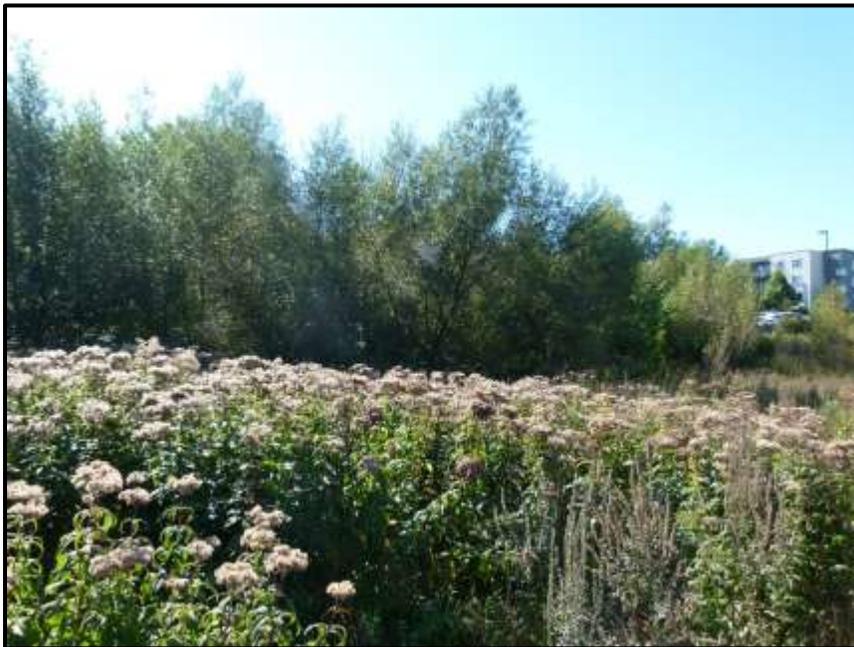
**Photograph 8:** Looking south at the Tree Stand (Feature E) (September 14<sup>th</sup>, 2018).

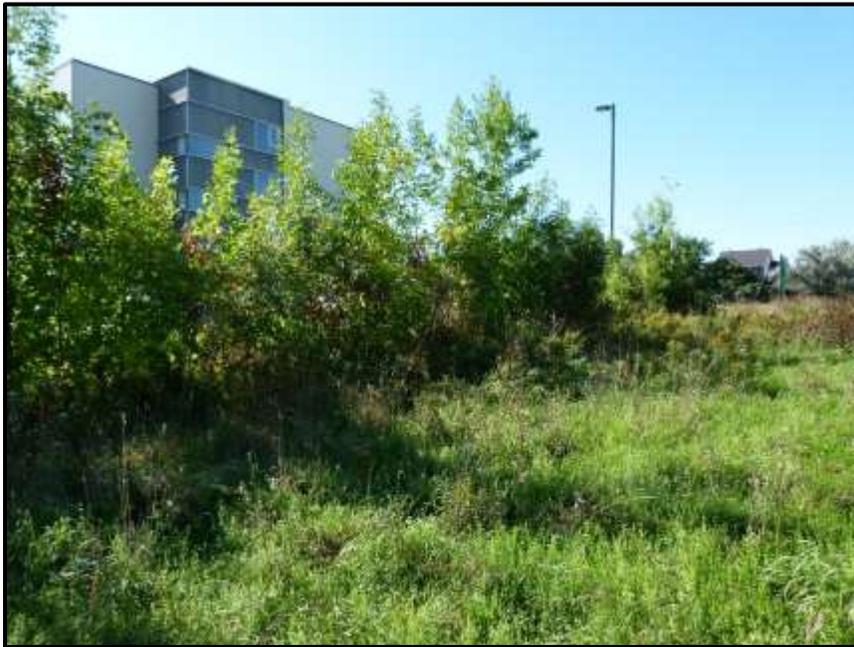
Photograph 9: Looking south at the Deciduous Hedgerow (Feature F) (September 14<sup>th</sup>, 2018).

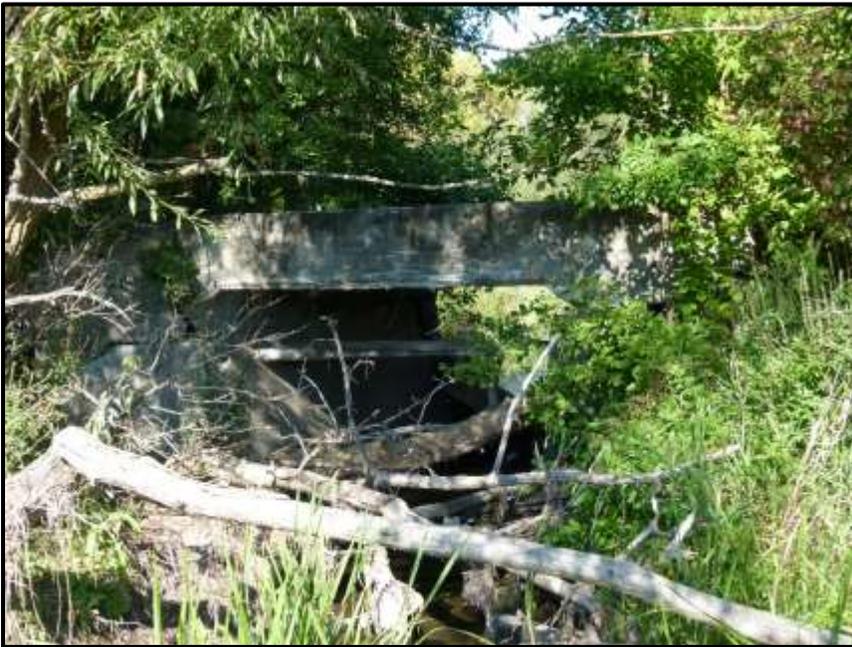
**Photograph 10:** Looking north at the Box Culvert at the northern edge of the Study Area (September 14<sup>th</sup>, 2018).

- **Barn Swallow:** Barn Swallows may be found nesting in many anthropogenic structures including old barns and sheds, culverts, and under bridges (SARO 2018). There are no buildings found within the Study Area at the current time, and therefore Barn Swallows are not likely to be a significant concern for future development. The box culvert that is present at the north end of Shirley's Brook was examined, and no evidence of Barn Swallow nesting was noted.

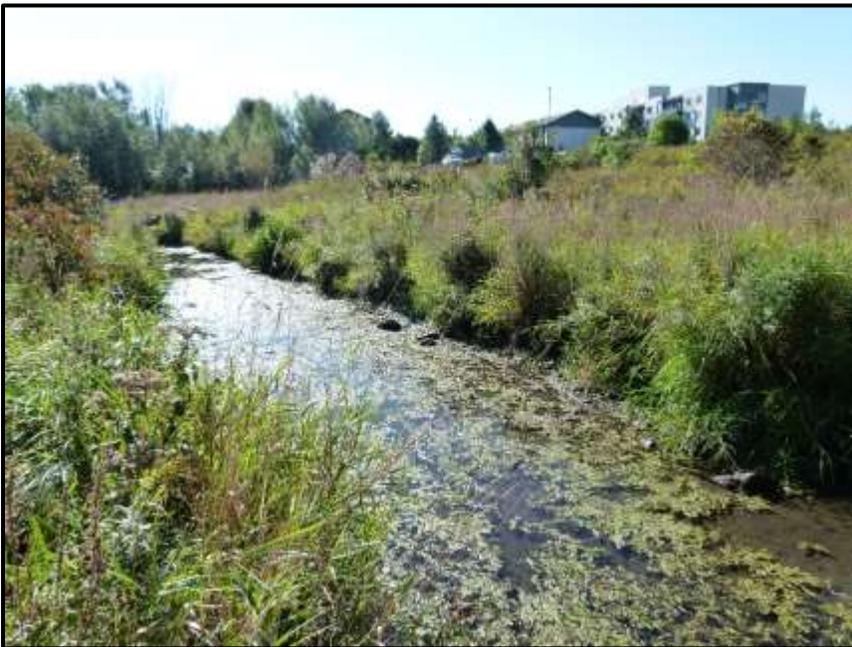
**Photograph 11:** Looking southeast at Shirley's Brook in the northern part of the Study Area (September 14<sup>th</sup>, 2018).

Shirley's Brook has a silt substrate in the northern part of the Study Area, transitioning to a sandy substrate with boulders in the southern part of the Study Area. Throughout the Study Area aquatic vegetation is present within the channel. Aquatic plants found within Shirley's Brook include Common Duckweed, Common Cattail, Tall Ironweed, and Purple Loosestrife. Plants found within the riparian corridor adjacent to the watercourse included Tall Ironweed, Reed Canary Grass, Spotted Joe Pye Weed, Spotted Touch Me Not, Purple Loosestrife, Common Cattail, Common Stinging Nettle, Boneset, and Blue Vervain. The majority of the length of the watercourse through the Study Area has little tree or shrub cover, however, tree stands are present at the northern and southern Study Area boundaries (described above). The proposed 30 m vegetated setback will maintain the existing tree cover surrounding the watercourse, including the majority of older trees found within the Study Area.

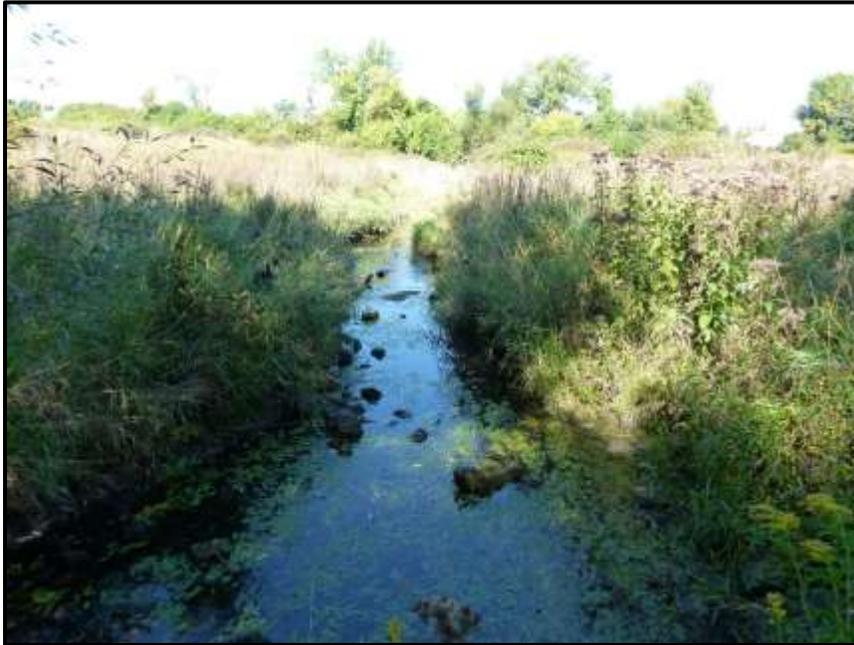
**Photograph 12:** Looking northwest at Shirley's Brook in the southern part of the Study Area (September 14<sup>th</sup>, 2018).
