August 28, 2018  
File: PE2122-LET.01

Subject: **Phase I - Environmental Site Assessment Update**  
**762 March Road and 335 Sandhill Road,**  
**Ottawa, Ontario**

Further to your request, Paterson Group (Paterson) conducted a Phase I - Environmental Site Assessment (ESA) Update for the aforementioned property. This report updates a Phase I ESA prepared by Paterson entitled "Phase I Environmental Assessment, Vacant Property, 760 March Road, Ottawa, Ontario" dated October 12, 2010. It is intended to meet the requirements for a Phase I ESA as per the MOECC standard O.Reg. 153/04 as amended by O.Reg. 269/11. This report is to be read in conjunction with the previous report.

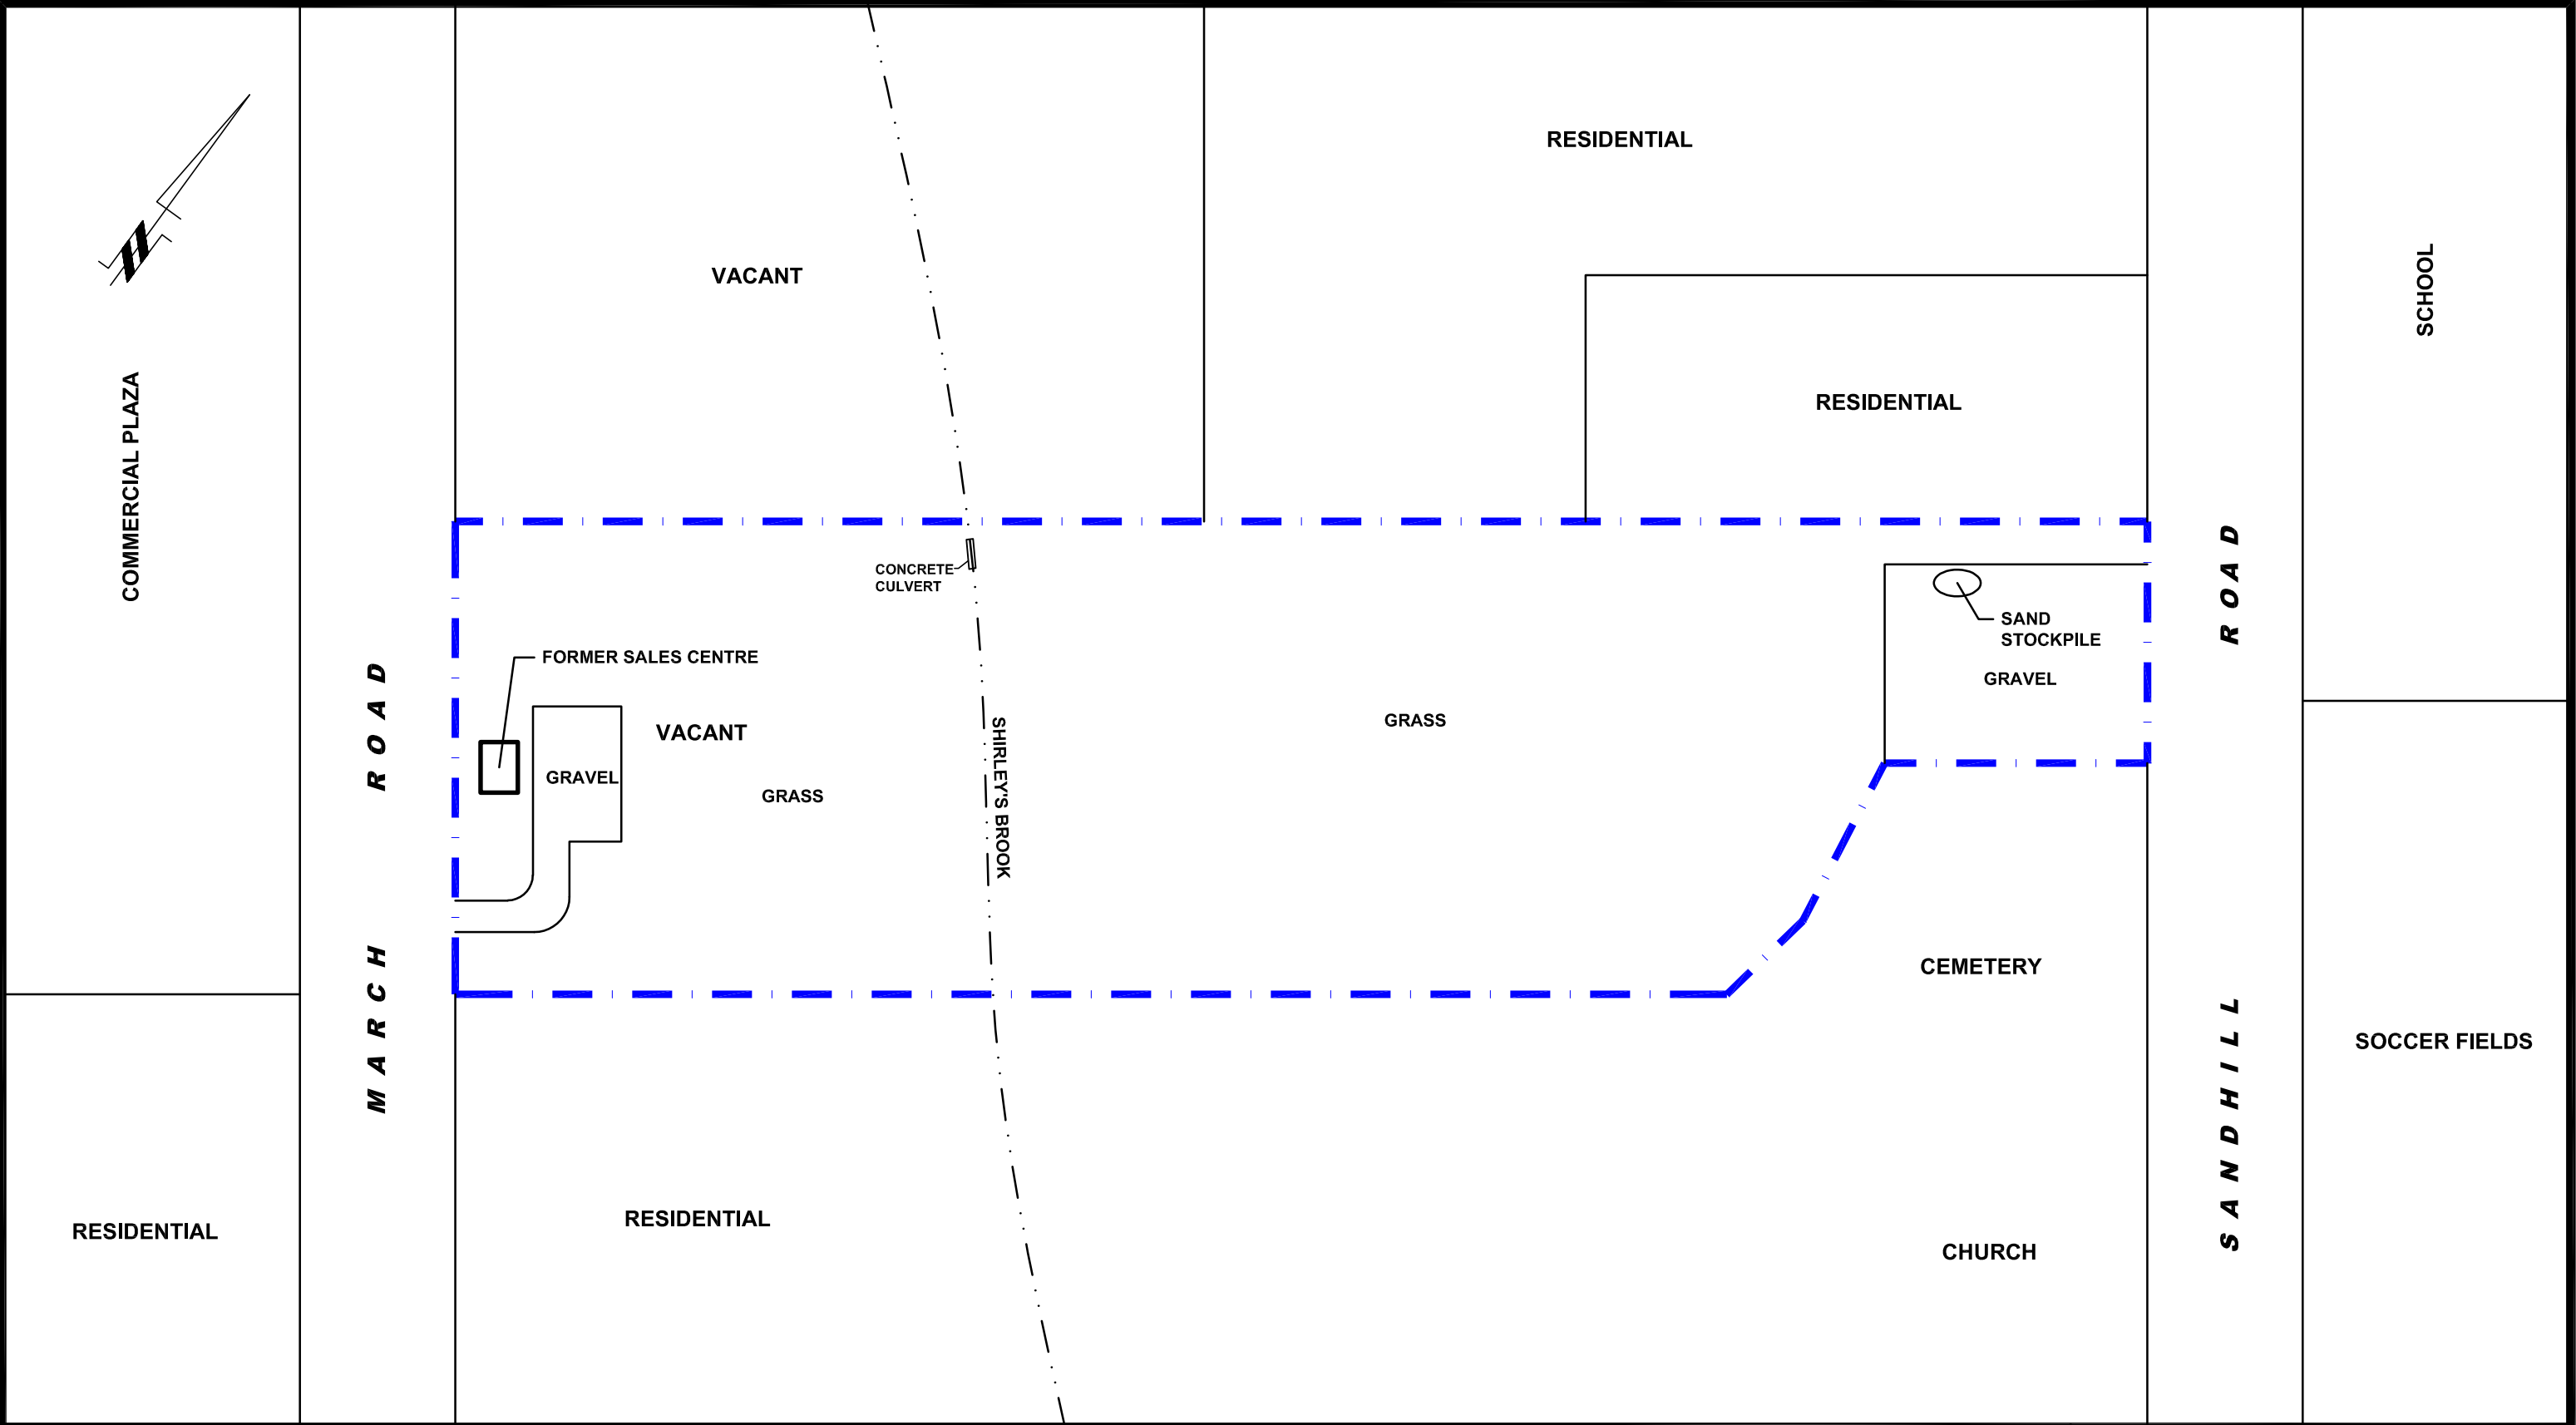
The surrounding properties were also observed during the site visit and are shown on Drawing PE2122-2 - Surrounding Land Use Plan.

Neighbouring land use in the Phase I study area is commercial, institutional and residential. Land use is shown on Drawing PE2122-2 - Surrounding Land Use Plan.

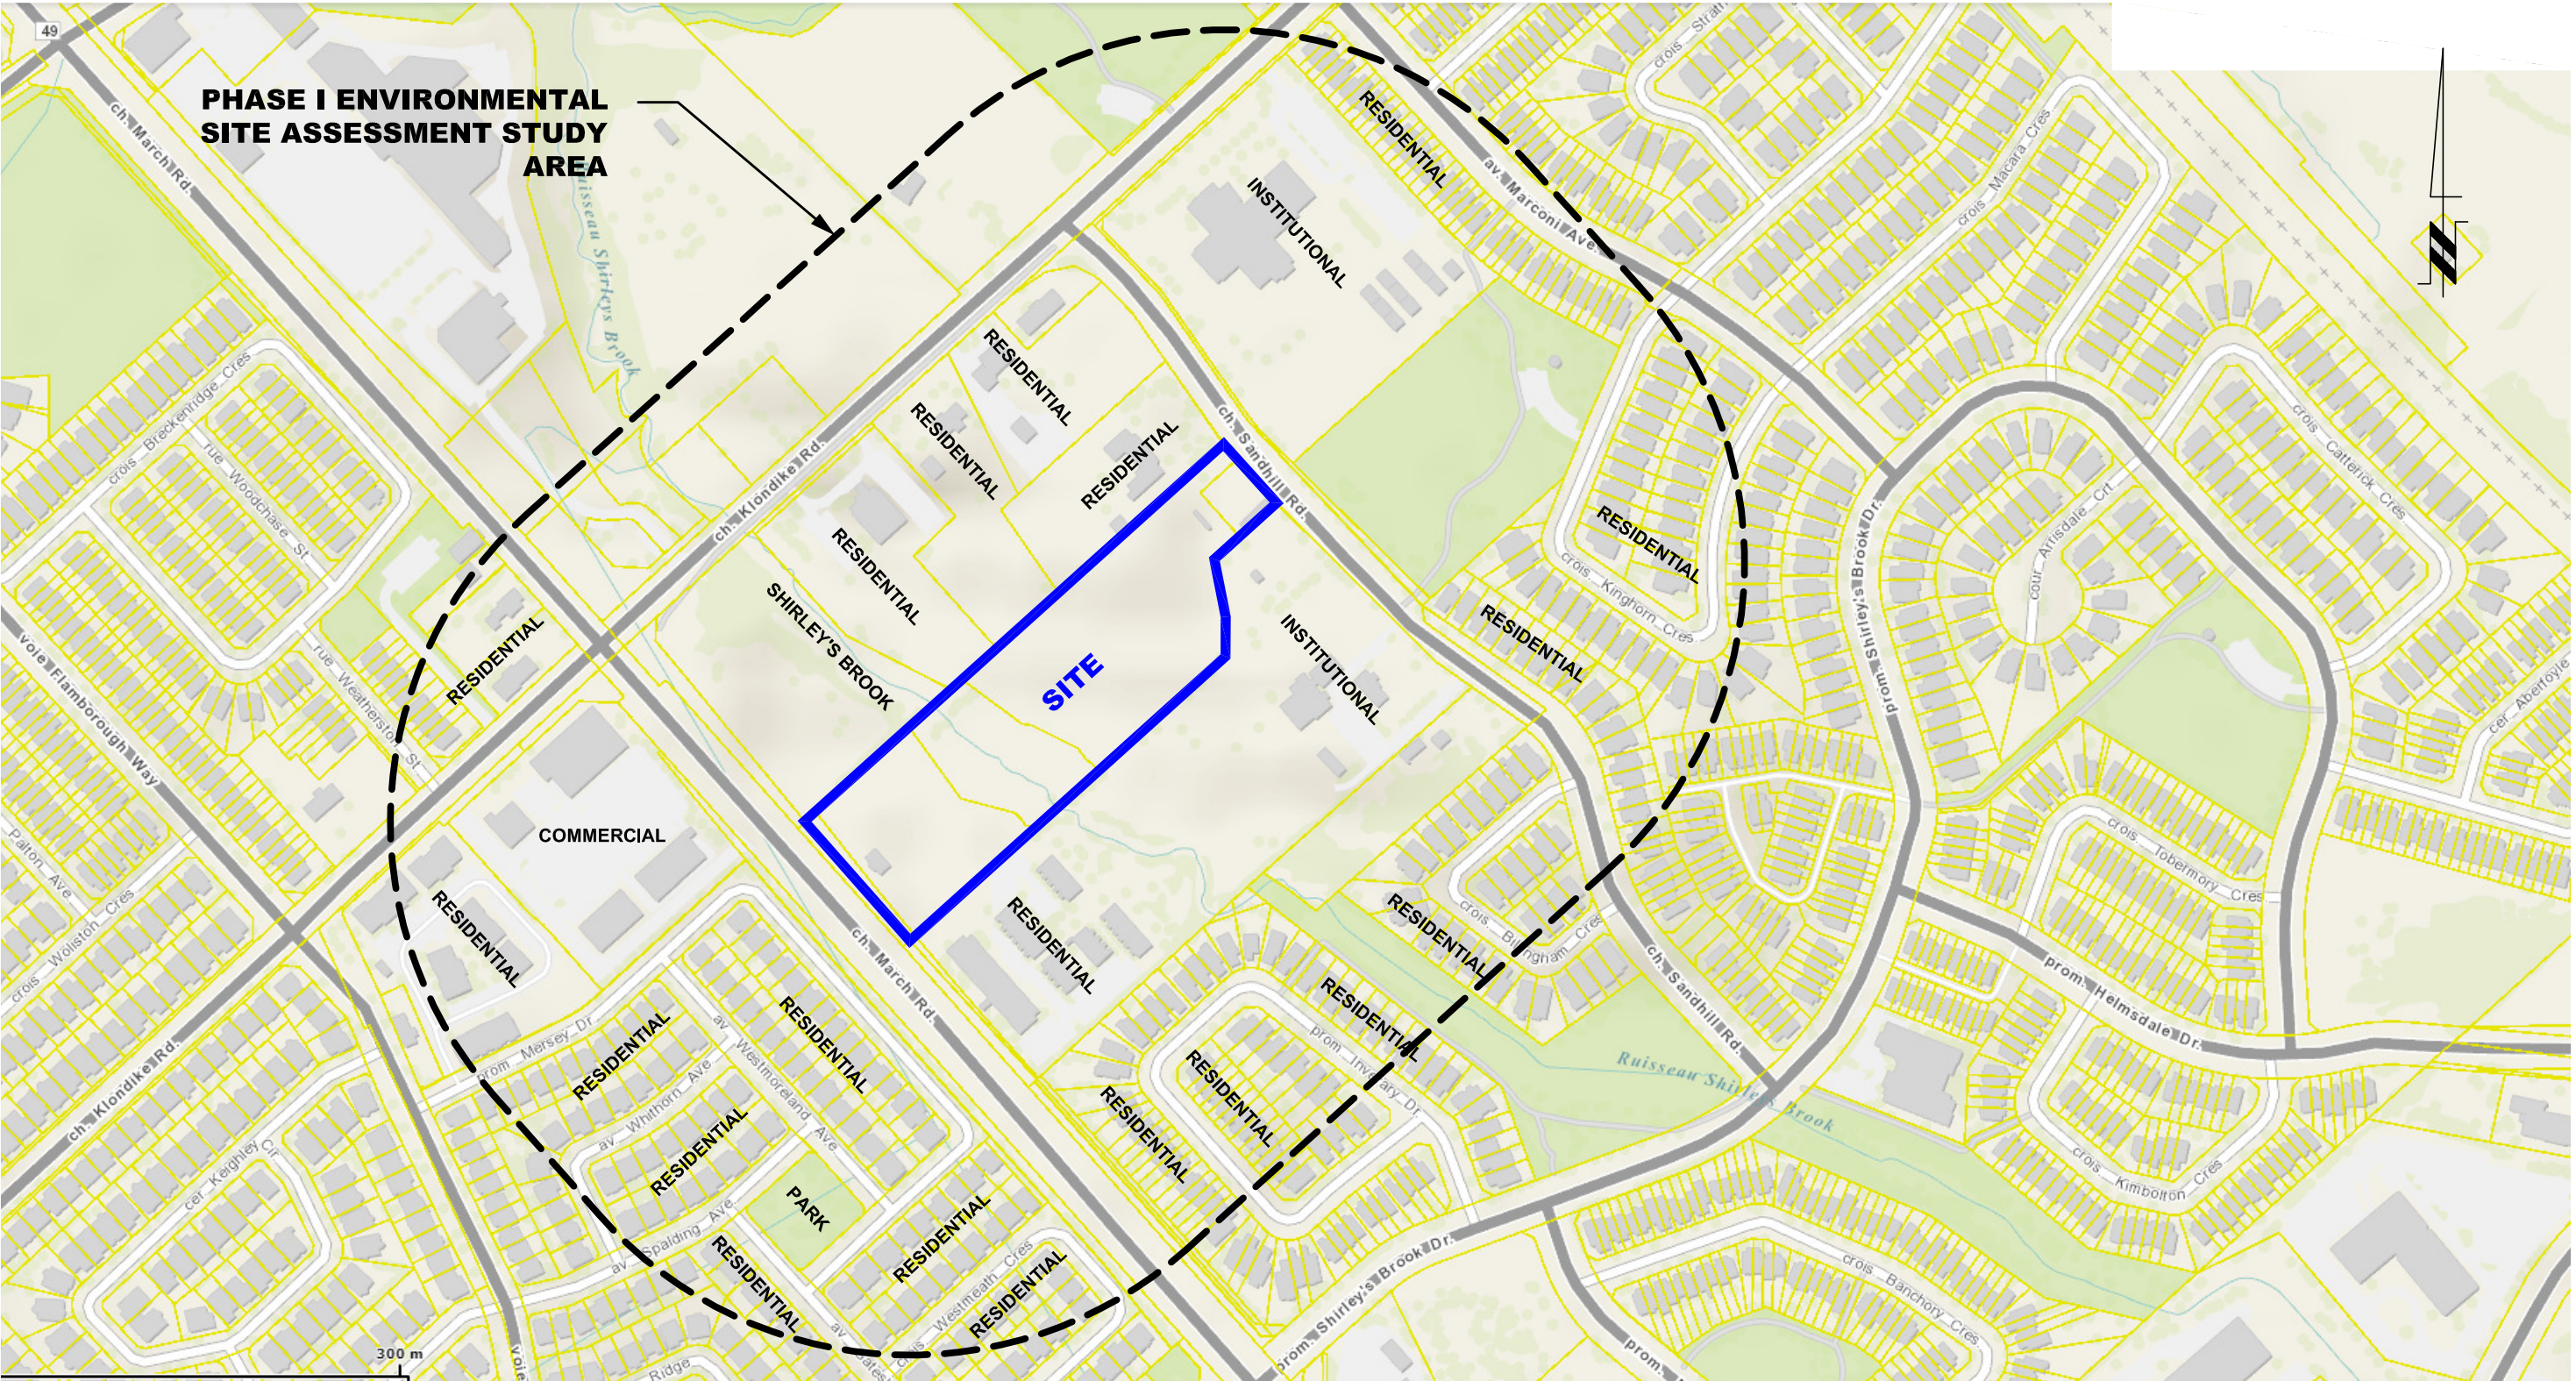
MINTO COMMUNITIES	
PHASE I - ENVIRONMENTAL SITE ASSESSMENT	
762 MARCH ROAD AND 335 SANDHILL ROAD	
OTTAWA,	ONTARIO
Title: SURROUNDING LAND USE PLAN

No potentially contaminating activities (PCAs) were identified at the subject site. PCAs outside of the subject property but within the Phase I study area are shown on Drawing PE4106-2 - Surrounding Land Use Plan. These relate to electricity transformation and potential/unidentified historic fuel storage.

Potentially Contaminating Activities (PCAs) within the Phase I ESA study area are shown on Drawing PE4106-2 - Surrounding Land Use Plan. None of these PCAs were considered to have resulted in APECs on the subject site.

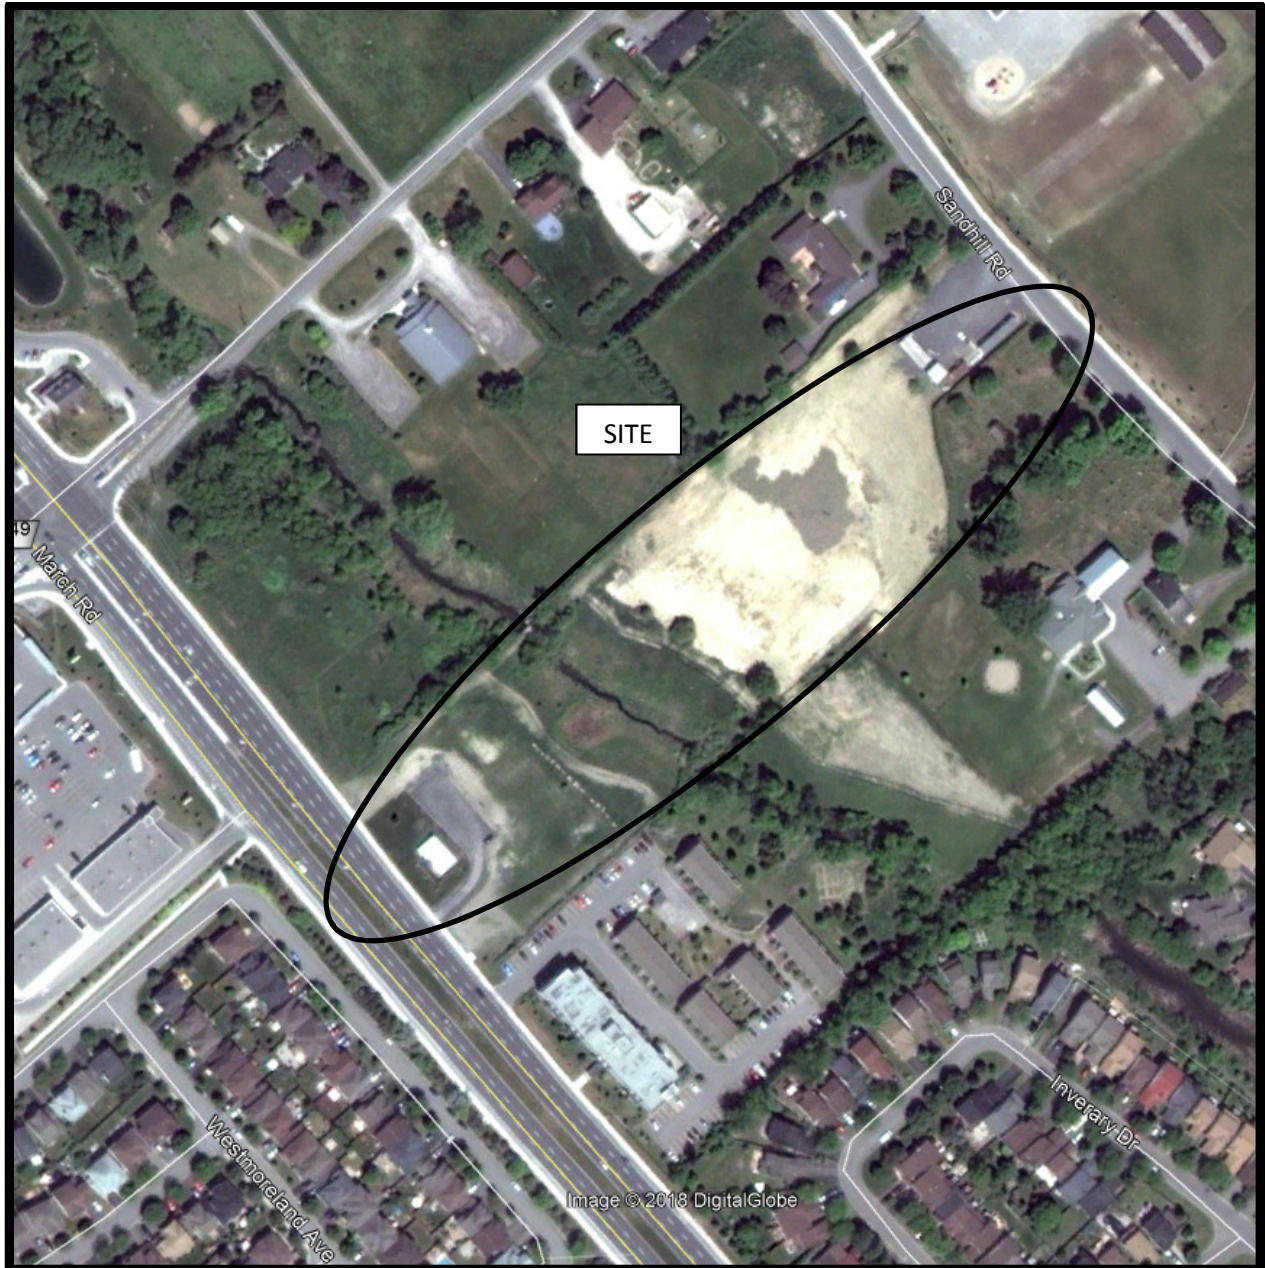
AERIAL PHOTOGRAPH  
2012

The Google Earth image dated May 2012 shows the whole site east of Shirley's Brook to be denuded of vegetation. A parking/laydown area is shown to the east of the subject site, fronting on to Sandhill Road. Four intermodal containers ("sea cans") or cabins can be seen in this area of the site. To the west of the site a second parking area is visible beside a sales center, presumably associated with the proposed development.

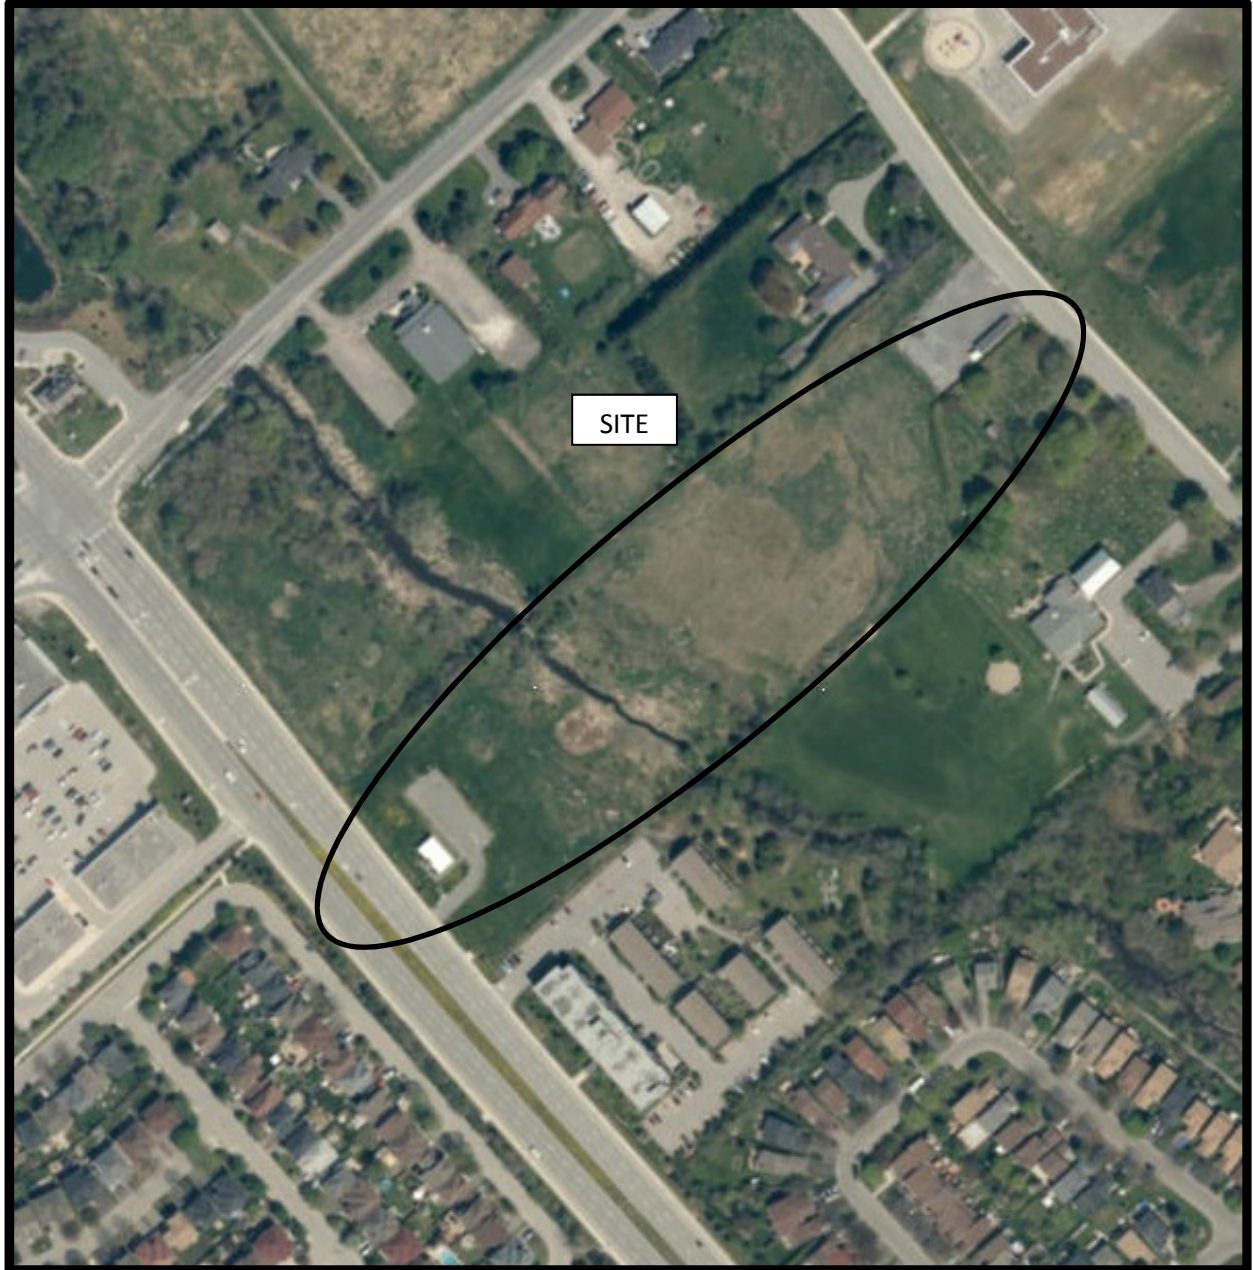
AERIAL PHOTOGRAPH  
1917

In the 2017 aerial photograph available on the City of Ottawa website, the vegetation to the east of Shirley's Brook has regrown. Only one container is shown in the laydown area to the east of the site. No other significant change can be identified on the site or in the surrounding area.
