**PHASE ONE ENVIRONMENTAL SITE ASSESSMENT (REVISED)
541 AND 545 RIDEAU STREET
OTTAWA, ONTARIO**

1912-710/171-12335-00
November 19, 2013
(Revised September 7, 2017)

Phase One Environmental Site Assessment
541 and 545 Rideau Street, Ottawa, Ontario

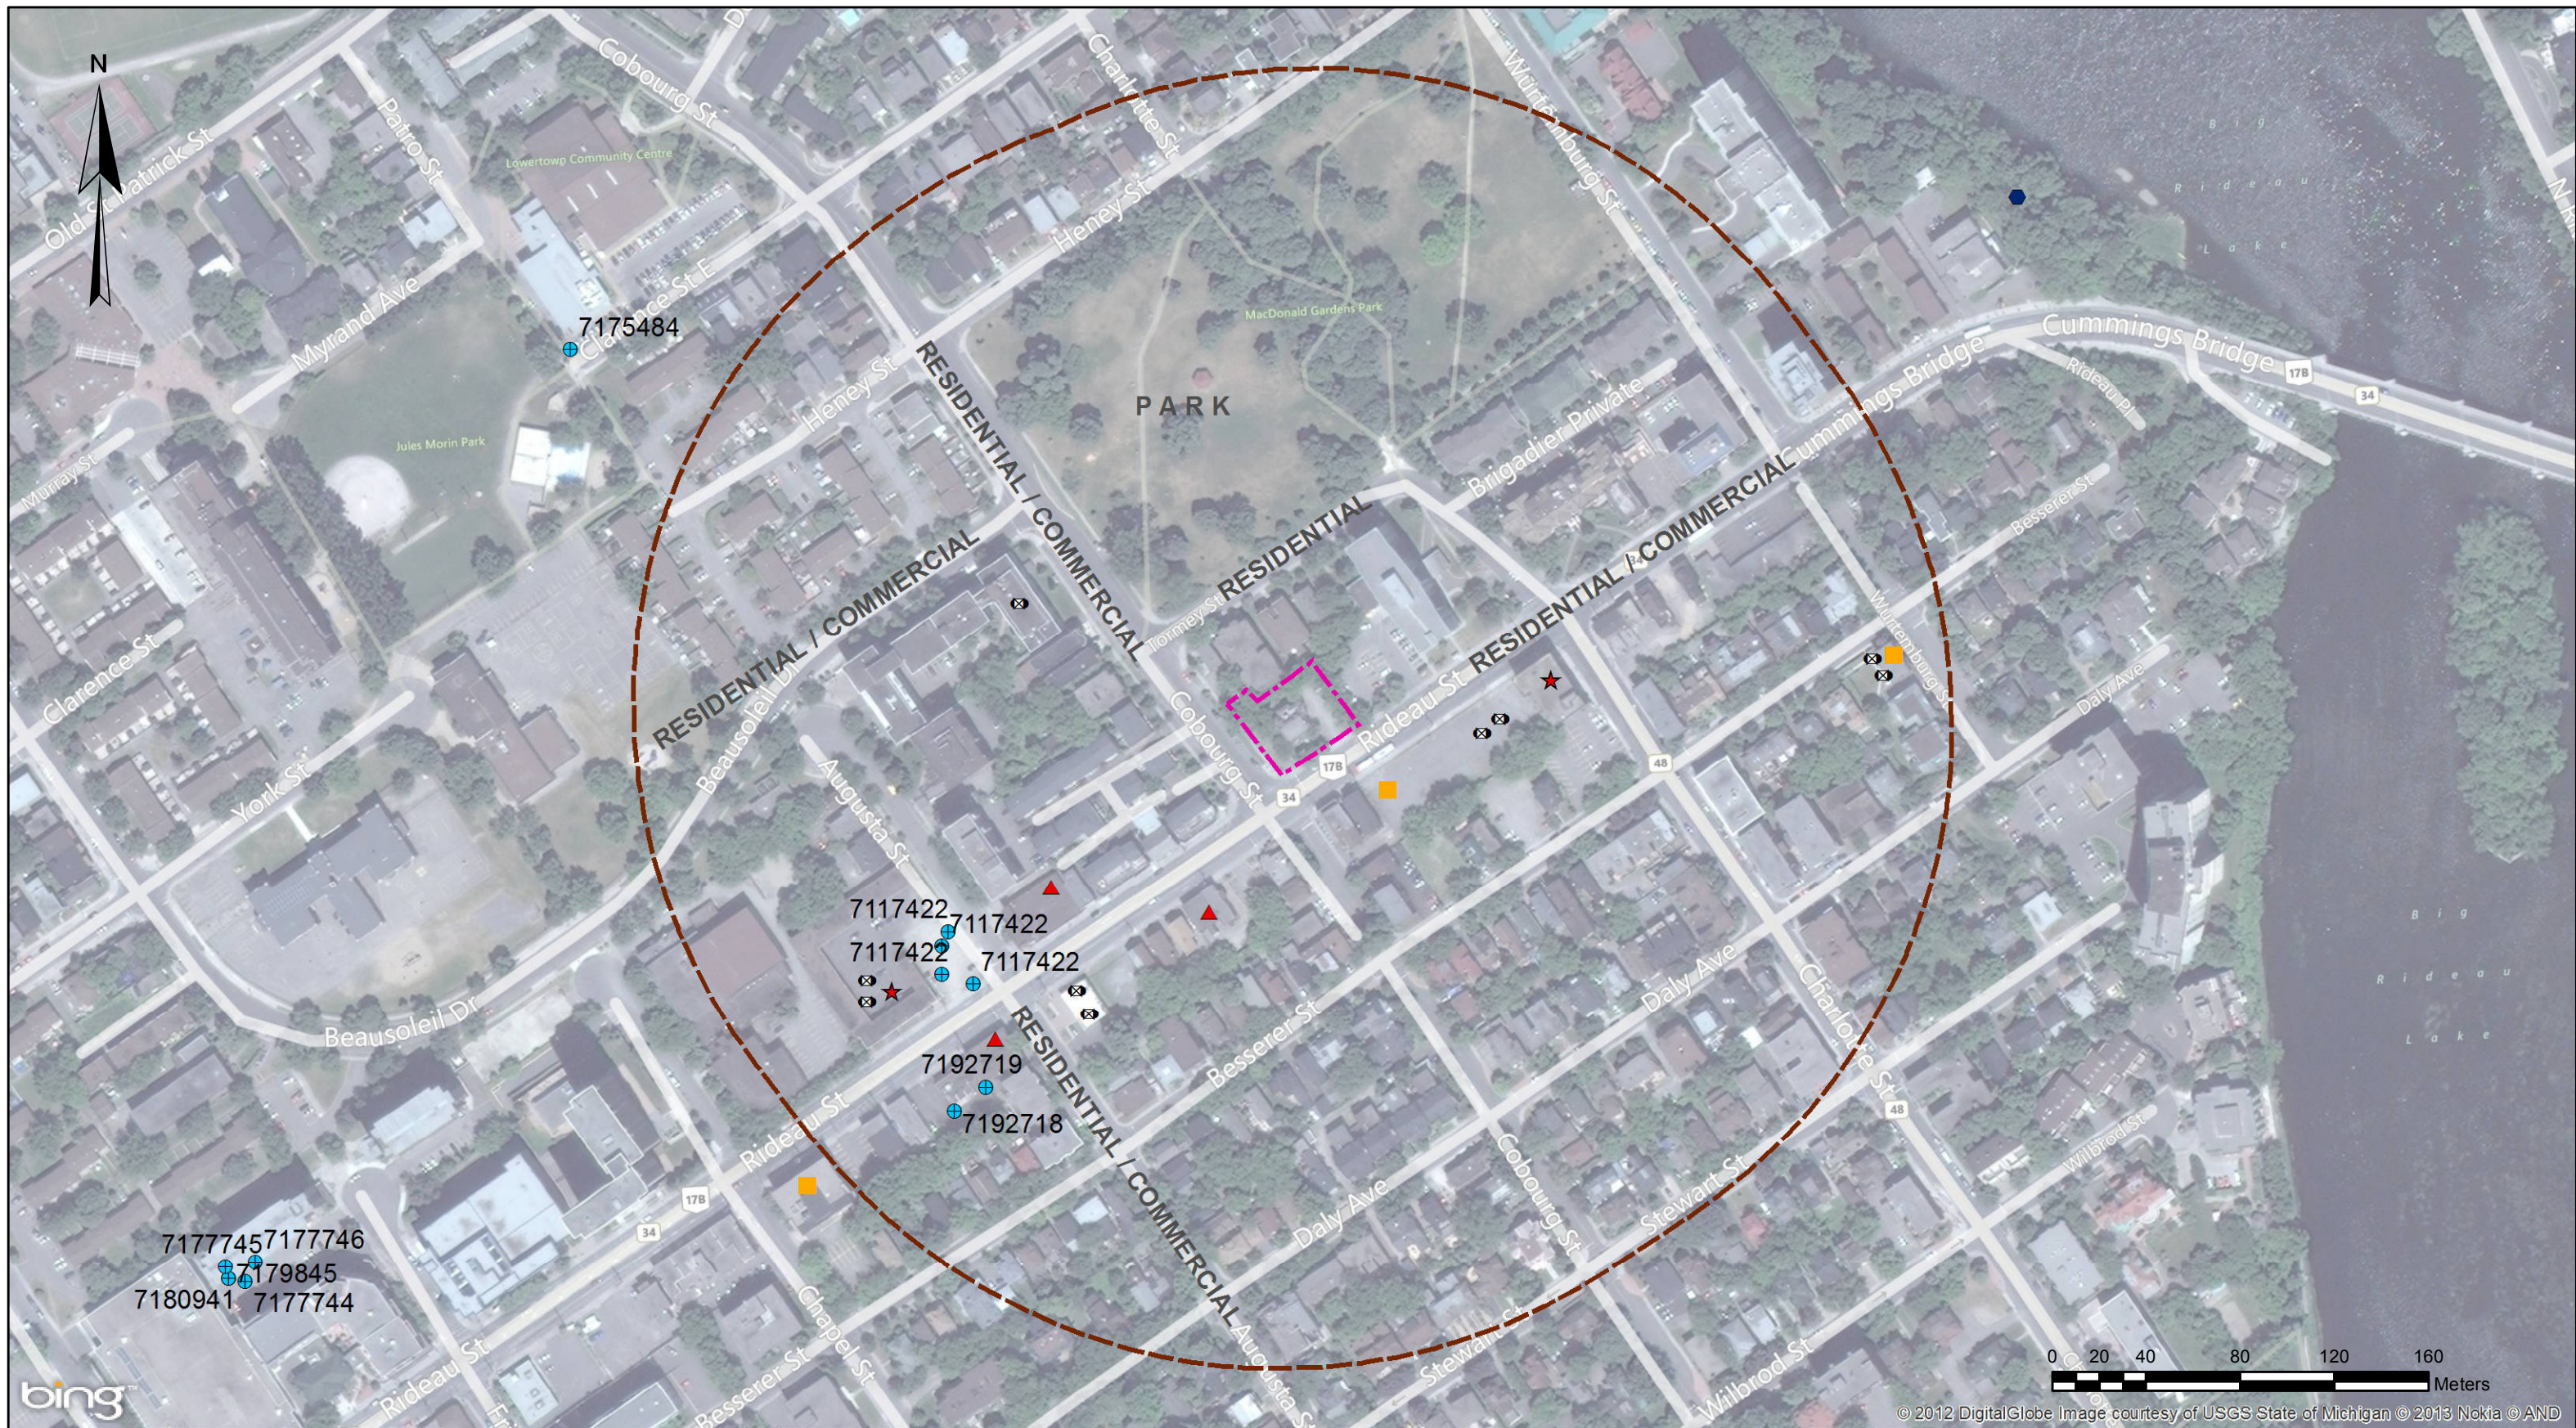
LEGEND:

-   250m Study Area
-   Phase One Site
-   HWIS
-   Waste Disposal Site
-   MOE Water Well
-   Former UST
-   Former Automotive Garage
-   Former Dry Cleaners

Information regarding the depth, date of drilling, use and materials encountered are presented in the table below. Exact locations of water wells can be found on **Drawing 2**. Bedrock was not encountered in any of the wells drilled. It is anticipated that bedrock is located approximately 15 to 20 mbgs on the Phase One Property based on the Ontario Base Map.

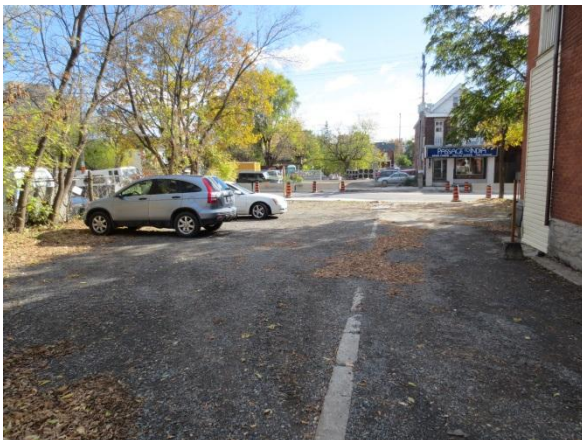
3. View of the parking area on the east portion of the Phase One Property

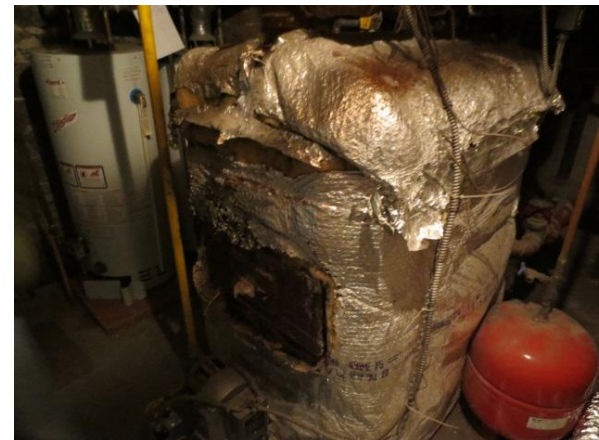
4. View of the natural gas fired boiler located in the basement of building on the Phase One Property.

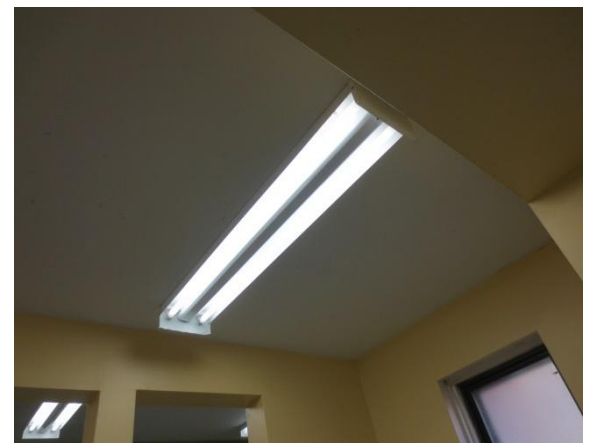
6. View of fluorescent lights observed in the building on the Phase One Property.

Fluorescent lights were observed on the ground floor of the building. Installation and production of PCB-containing electrical equipment was banned in 1980. Since the Phase One Property was built in 1910 it is possible that some of the fluorescent fixtures have PCB-containing ballasts if they have not been replaced, and some electrical equipment may contain PCB oil if present. As a Best Management Practice SPL recommends that when the fluorescent fixtures from the site are to be removed during building renovation or demolition, the ballasts should be removed from the fluorescent fixtures prior to disposal of the fixture and the ballast labels examined. The ballasts without a label indicating that they do not contain PCBs should be separated, securely stored and the serial numbers or other markings reviewed to determine if the ballast likely contains PCB. If more than approximately 40 ballasts are found to likely contain PCBs, the ballasts should be handled in accordance with federal and provincial regulations governing PCB wastes.

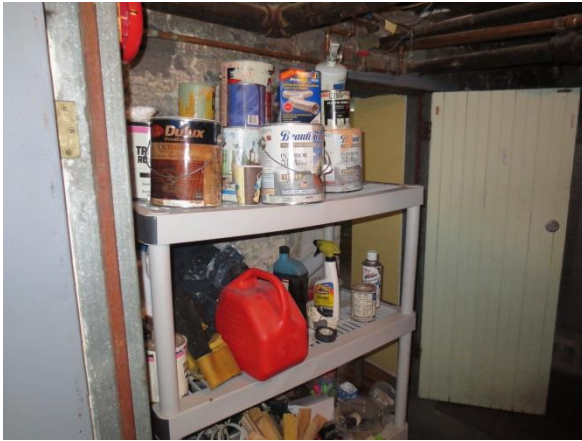
7. View of paint cans and household chemical products observed in the building on the Phase One Property.

Paint cans and household chemical products were observed in the basement of the Phase One Property. An environmental impact as a result of these substance containers is not anticipated.

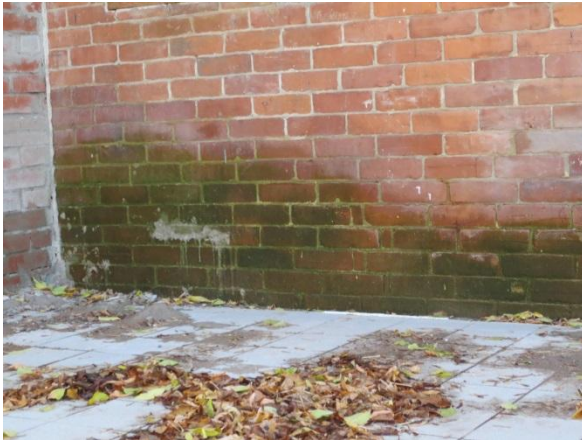
9. View of water staining observed on the exterior of the building on the Phase One Property.

Some minor water staining was observed on the exterior wall of the Phase One Property at the time of the site investigation. The cause of the stain is unknown.
