REPORT ON

Phase I Environmental Site Assessment Oblates Property, 175 Main Street Ottawa, Ontario

Report Number: 14-1122-0005 (1100)

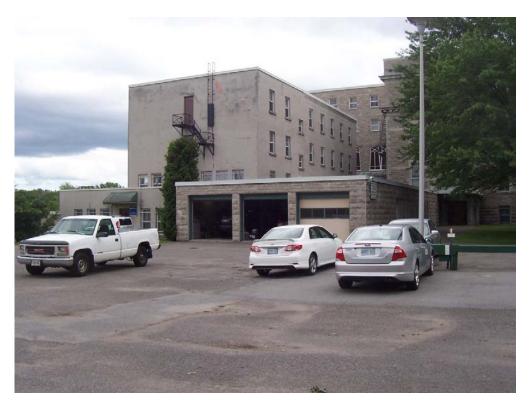
Photograph 13: View of the garage building attached to the north side of the main building looking south.

- General convent vehicle maintenance including oil changes and minor repairs is performed in the garage building attached to the northwest side of the Deschâtelets building. The garage has been in operation since the 1940s:

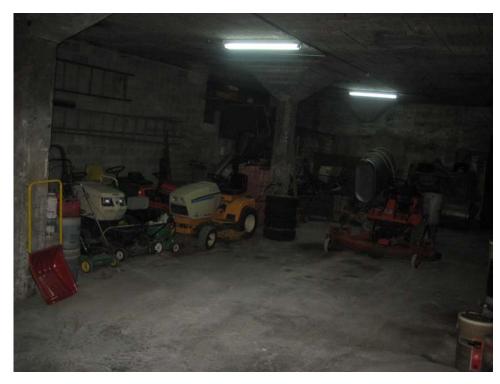
Photograph 15: View of the former coal storage room.

- Historically the Site buildings were heated with coal and associated boilers. The ash generated from the coal burning was deposited on the Site prior to the early 1950s when the Site switched to natural gas;

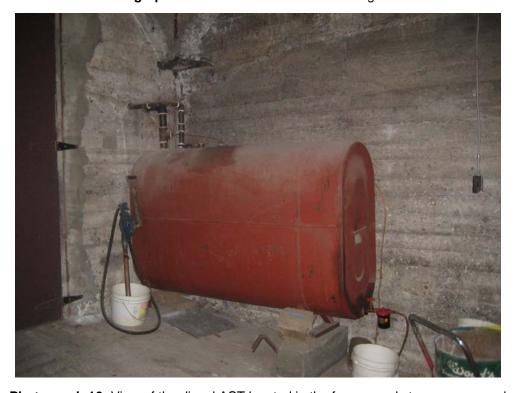
Photograph 16: View of the diesel AST located in the former coal storage room and used to fuel the backup generator.

Two diesel-containing ASTs were noted on the Site at the time of the Site visit. One of the ASTs is located at the northeast corner of the former coal storage room and is used to fuel the back-up generator located in the same area. The second AST is located in the northeast part of the laundry/woodshop building and is used to fuel the Site lawn mower. Both ASTs were installed in 1997, have a capacity of 900 L and are single walled. The ASTs were installed on the concrete floors with no secondary containment. No evidence of spills or leaks was noted in the area of the ASTs or in the area of the fill pipes. In addition, the Site Representative indicated that there were no spills or leaks on the Site associated with the presence of the two ASTs.

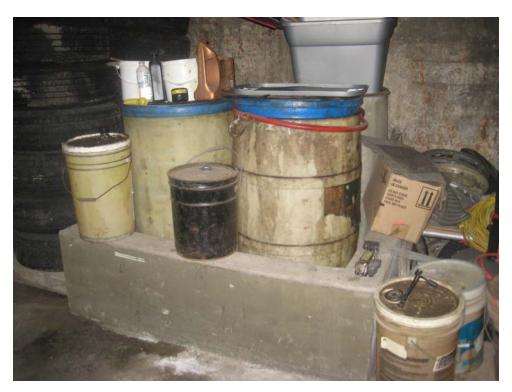
Photograph 17: View of the waste oil containers stored in the former coal storage room for pick up and off-Site disposal.

- No hazardous waste is generated or stored on the Site except for used oil from the oil changing carried out at the garage. The used oil is collected in plastic drums and pails and stored in the former coal storage area for pick up by a contracted company approximately every two years. In the 1940s, the used oil was reportedly disposed of by using it on the roads outside of the Site boundaries as a dust suppressant;

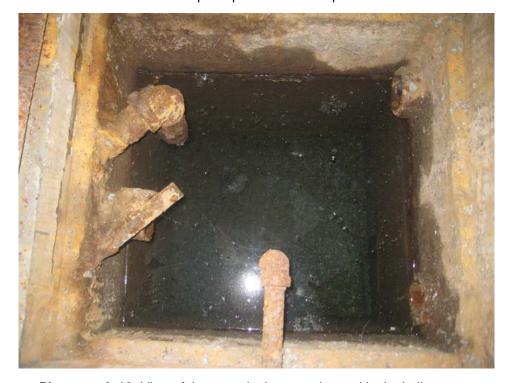
Photograph 18: View of the water in the sump located in the boiler room.

former use)	A floor drain is located in the garage. The floor drain collects wash water from the garage floor and reportedly discharges to the municipal sanitary sewer.	One representative.
	A sump is located in the boiler room. No sheen or odour was observed on the water in the sump at the time of the Site visit. The sump was reportedly cleaned up every 2-3 years by a licenced company.	
Unidentified Substances	NONE IDENTIFIED	
Stains or Corrosion Located near a Potential Discharge Location	a None	
Location of any Current and Former Wells		
Sanitary/Process Wastewater Receptor	No process water is generated at the Site. Wash water generated from washing of the garage floor is discharged to the municipal sanitary sewer.	Site observations, Site Representative.
	The domestic wastewater from the buildings is discharged to the municipal sanitary sewer.	one Nepresentative.
Sanitary Sewer Connection	Unknown.

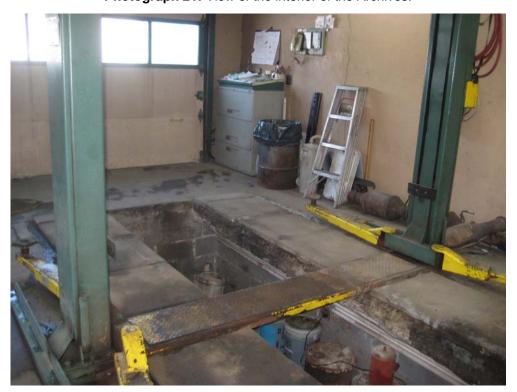
Photograph 22: View of the interior of the garage building.

The garage building annexed to the north side of the main building is used for general maintenance including oil changes and minor repairs of the Oblates' vehicles. A service pit with concrete floor and walls is located in the garage. There are no drains from the pit's floor. Some minor oily staining was observed on the concrete floor of the service pit. The floor in the garage is concrete with one floor drain which reportedly discharges to the

municipal sanitary sewer system. There was no oil/water separator in the garage. At the time of the Site visit, the garage was noted to be clean and well maintained. No staining or evidence of spills was noted in the garage with the exception of the minor oily staining noted on the concrete floor in the service pit.

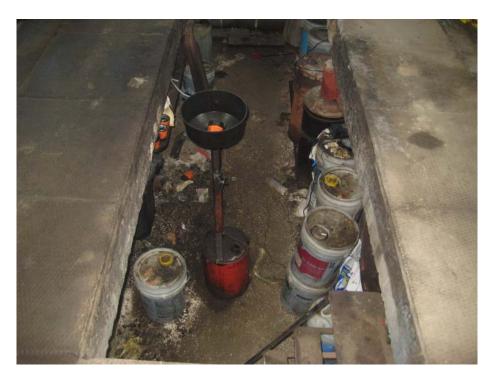
Photograph 23: View of the maintenance pit located in the garage, the staining on the concrete floor and the oils/lubricants stored in containers in the pit.

Topic	Observations	Comment/Source
Spills, staining	No evidence of discharges or upsets of chemicals were observed on-Site at the time of the Site visit with the exception of some oily staining noted on the concrete floor of the service pit in the garage building. The pit is contained and has concrete walls and floor. The walls and the floor were noted to be in good condition with no cracks and breaches. Granular absorbent material was placed in the stained areas.	Site observation.
Liquid Discharge Points	Wash water from the garage floor is collected through a floor drain that reportedly discharges to the municipal sanitary sewer.	Site observation.
Hydraulic Lift Equipment	None identified.	Site observation.
Elevators on-Site (Use and Type)	There are two cable elevators in the Main Oblates Residence.	Site observation, Site Representative.

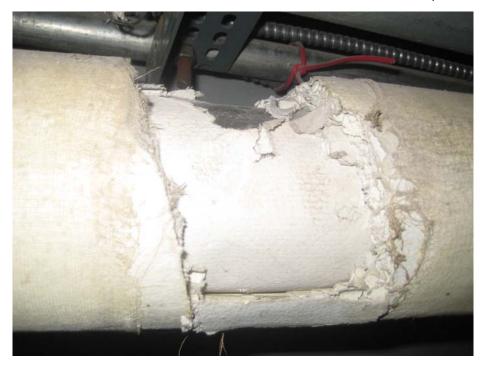
Photograph 24: View of the potential ACMs in the form of parging cement insulation on piping in the boiler room.

Topic	Observations/Findings	Source/Comment
Potential Friable ACMs and Potential Non-Friable ACMs	Based on the years of the building construction (between 1885 and 1958), it is Golder Associates' opinion that ACMs may present at the Site given that the use of friable ACMs was discontinued in the late 1970s/early 1980s. Potential asbestos parging cement insulation on the pipe elbows was noted in the boiler room. Prior to any construction/demolition activities, suspect building materials will need to be tested for asbestos according the O.Reg. 278/05 to confirm the presence/absence of asbestos in these materials. All ACMs should be abated prior to renovation or demolition activities.	Site observation.
