## Phase I Environmental Site Assessment

83 Hinton Avenue North  
Ottawa, Ontario

February 27, 2018

Report: PE4241-1

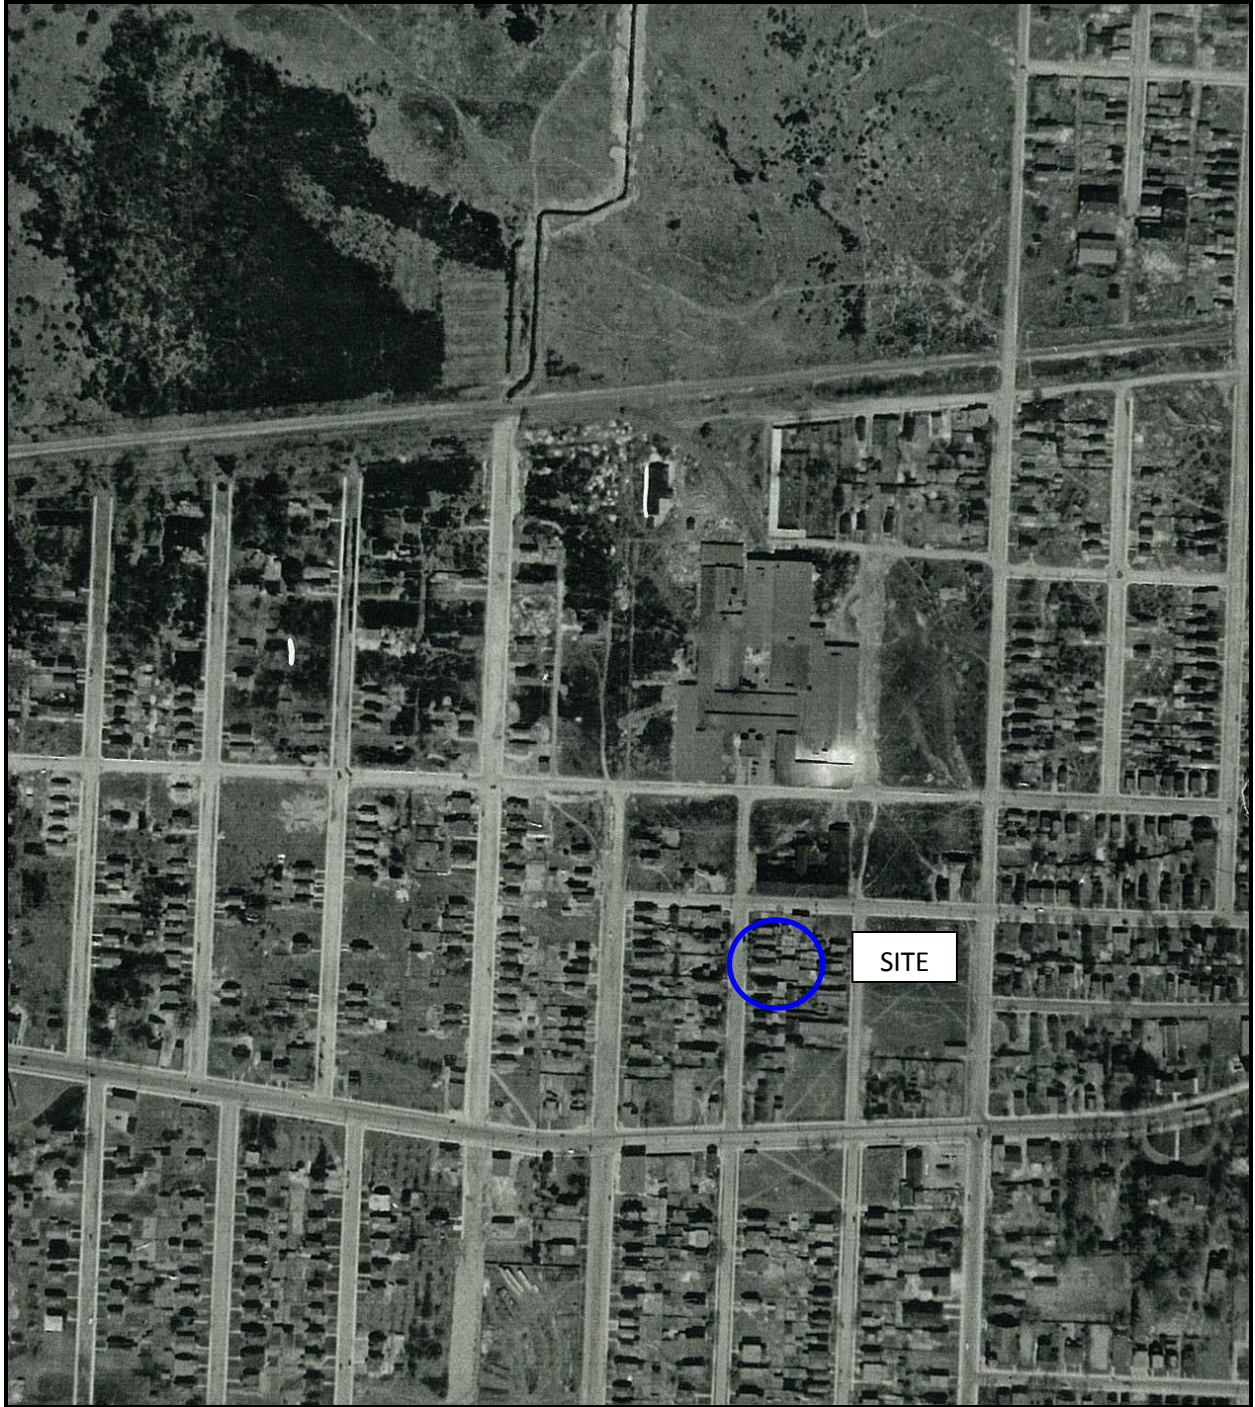
AERIAL PHOTOGRAPH  
1928

| 1928 | The subject site is occupied by a residential dwelling similar to the one present on-site today. Adjacent properties appear to be used for residential purposes as well, with the exception of an industrial structure (foundry) to the southeast. An industrial building can also be seen further to north, and a much larger industrial building beyond that. |

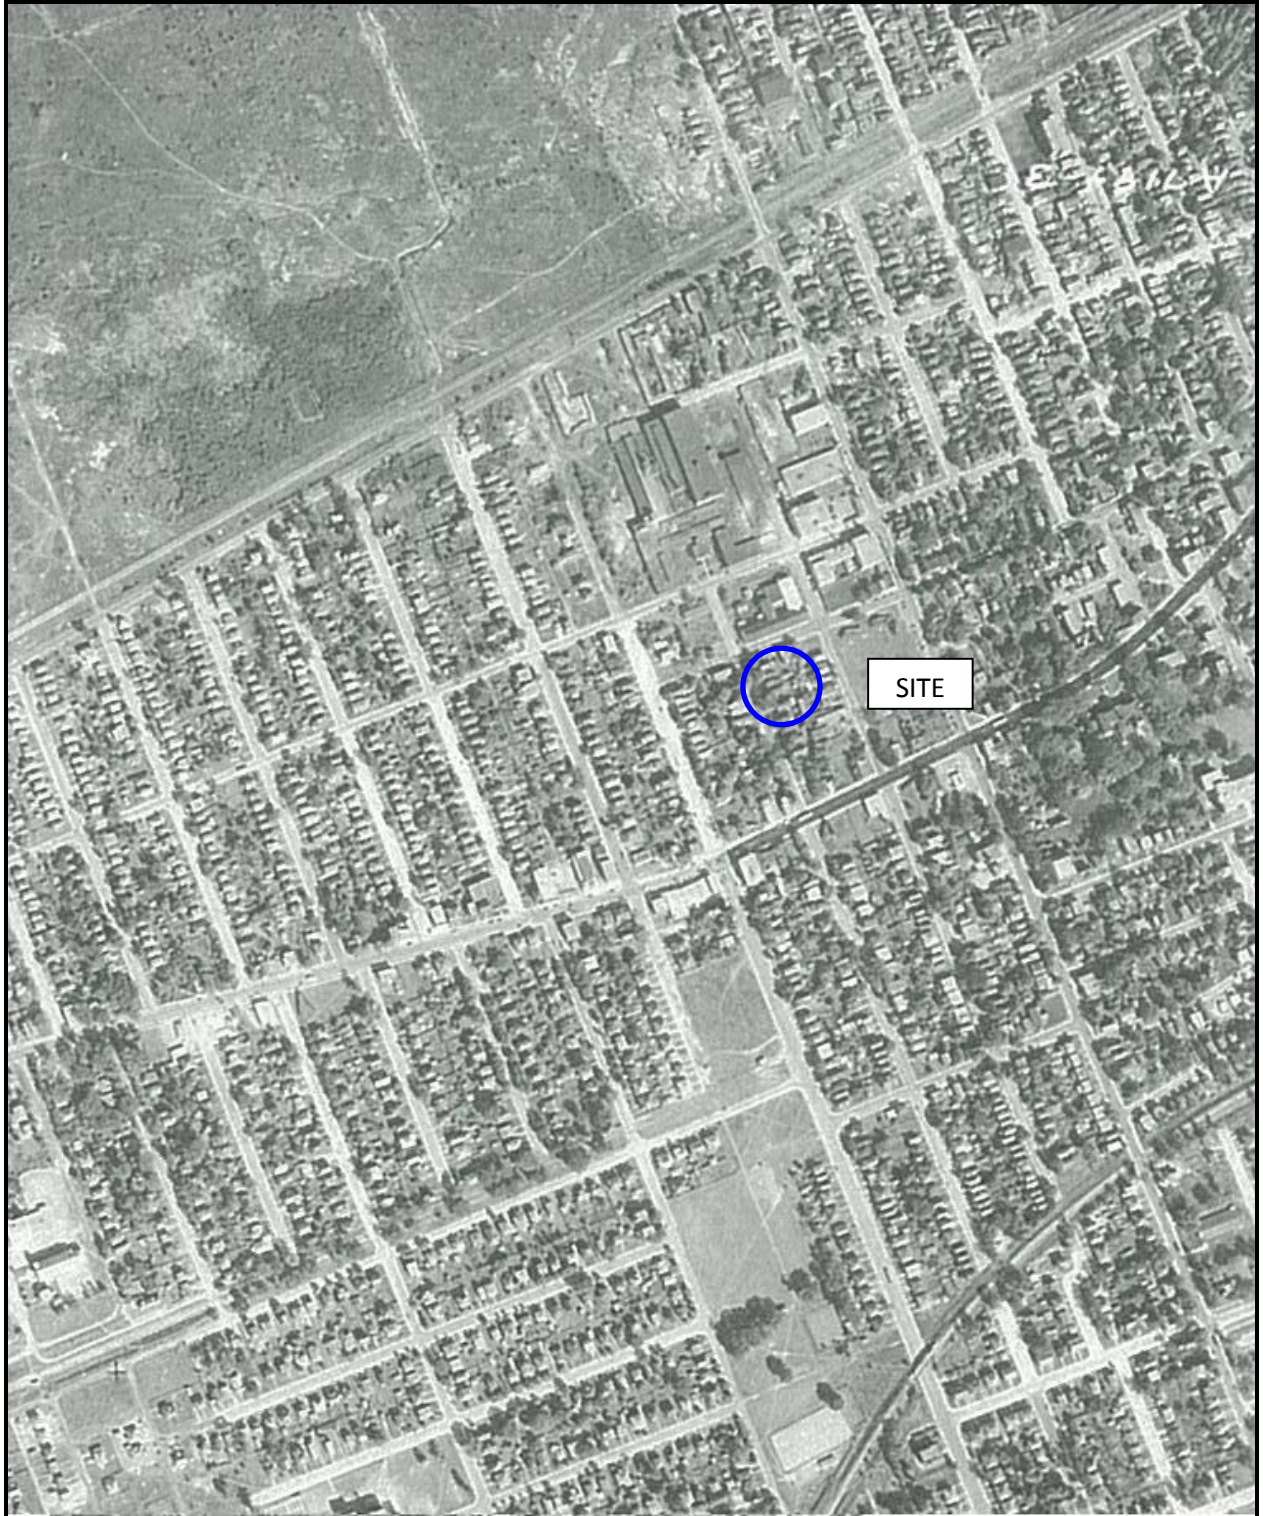
AERIAL PHOTOGRAPH  
1944

| 1944 | No significant changes can be seen on the subject property. No changes were observed on adjacent properties. Further development has occurred along Wellington Street to the south. |

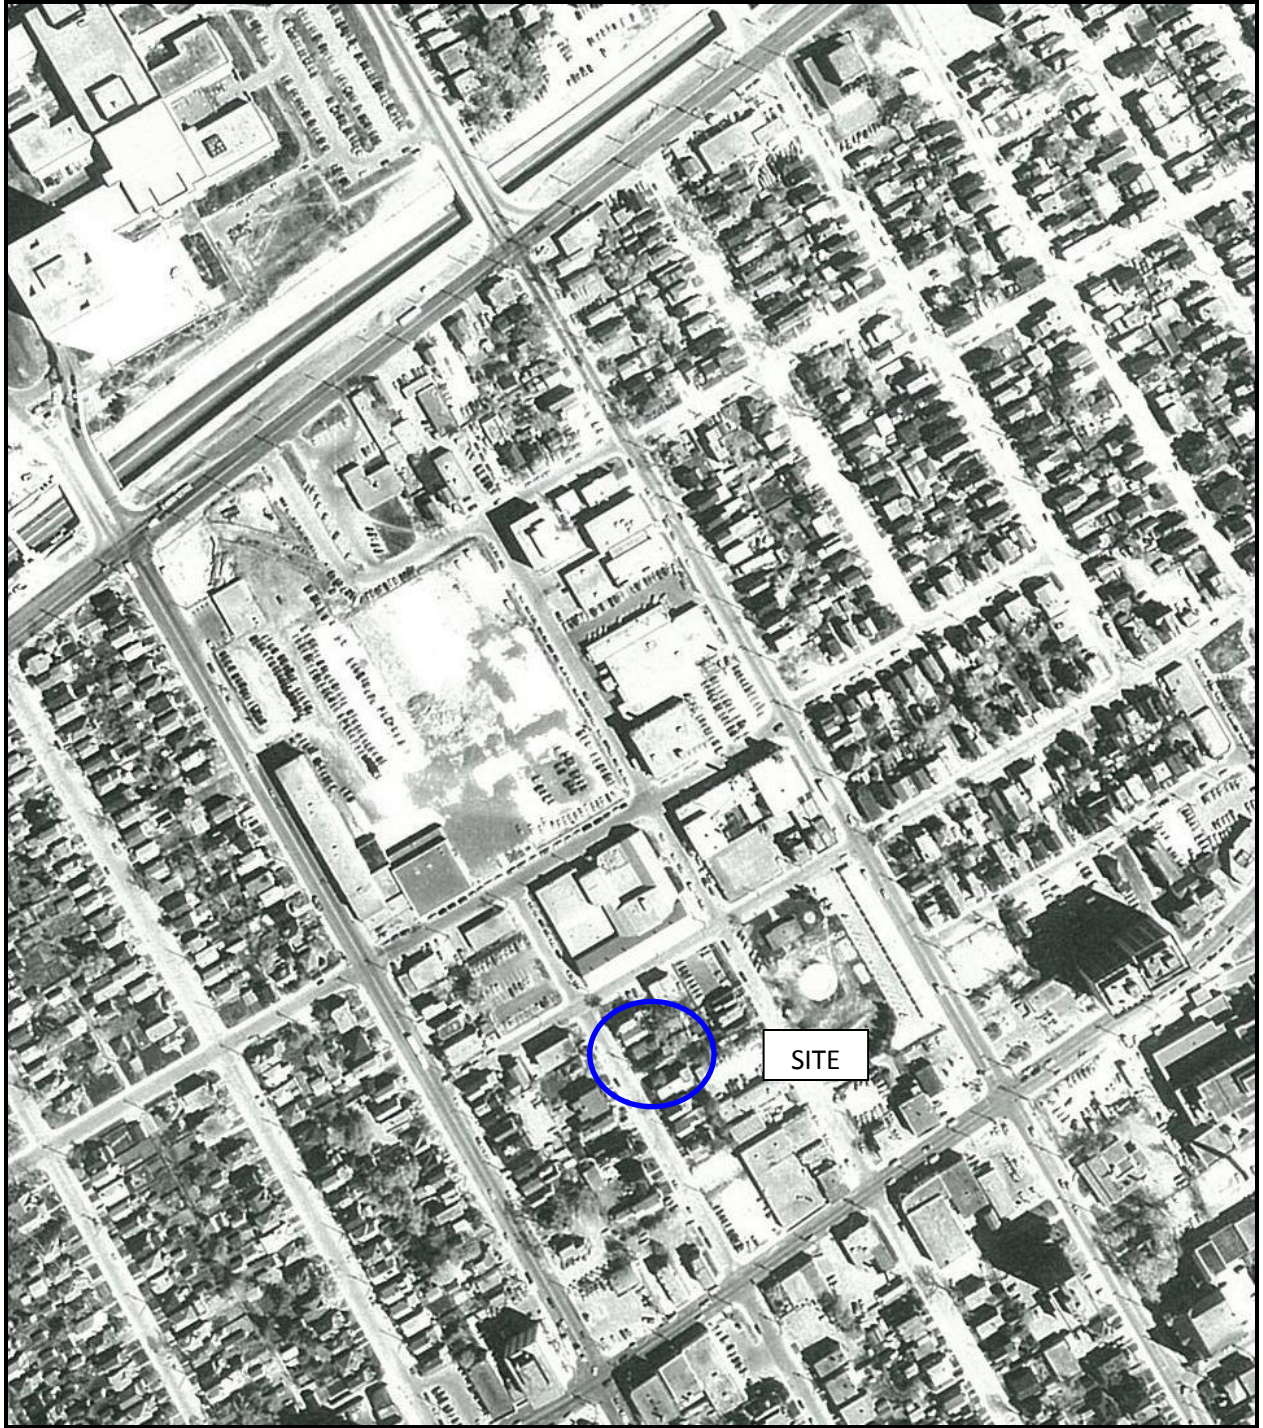
AERIAL PHOTOGRAPH  
1986

| 1986 | No significant changes appear to have been made to the subject site. No significant changes appear to have been made to adjacent properties, however, further to the north, the large foundry has been demolished, and the property is not largely vacant. |

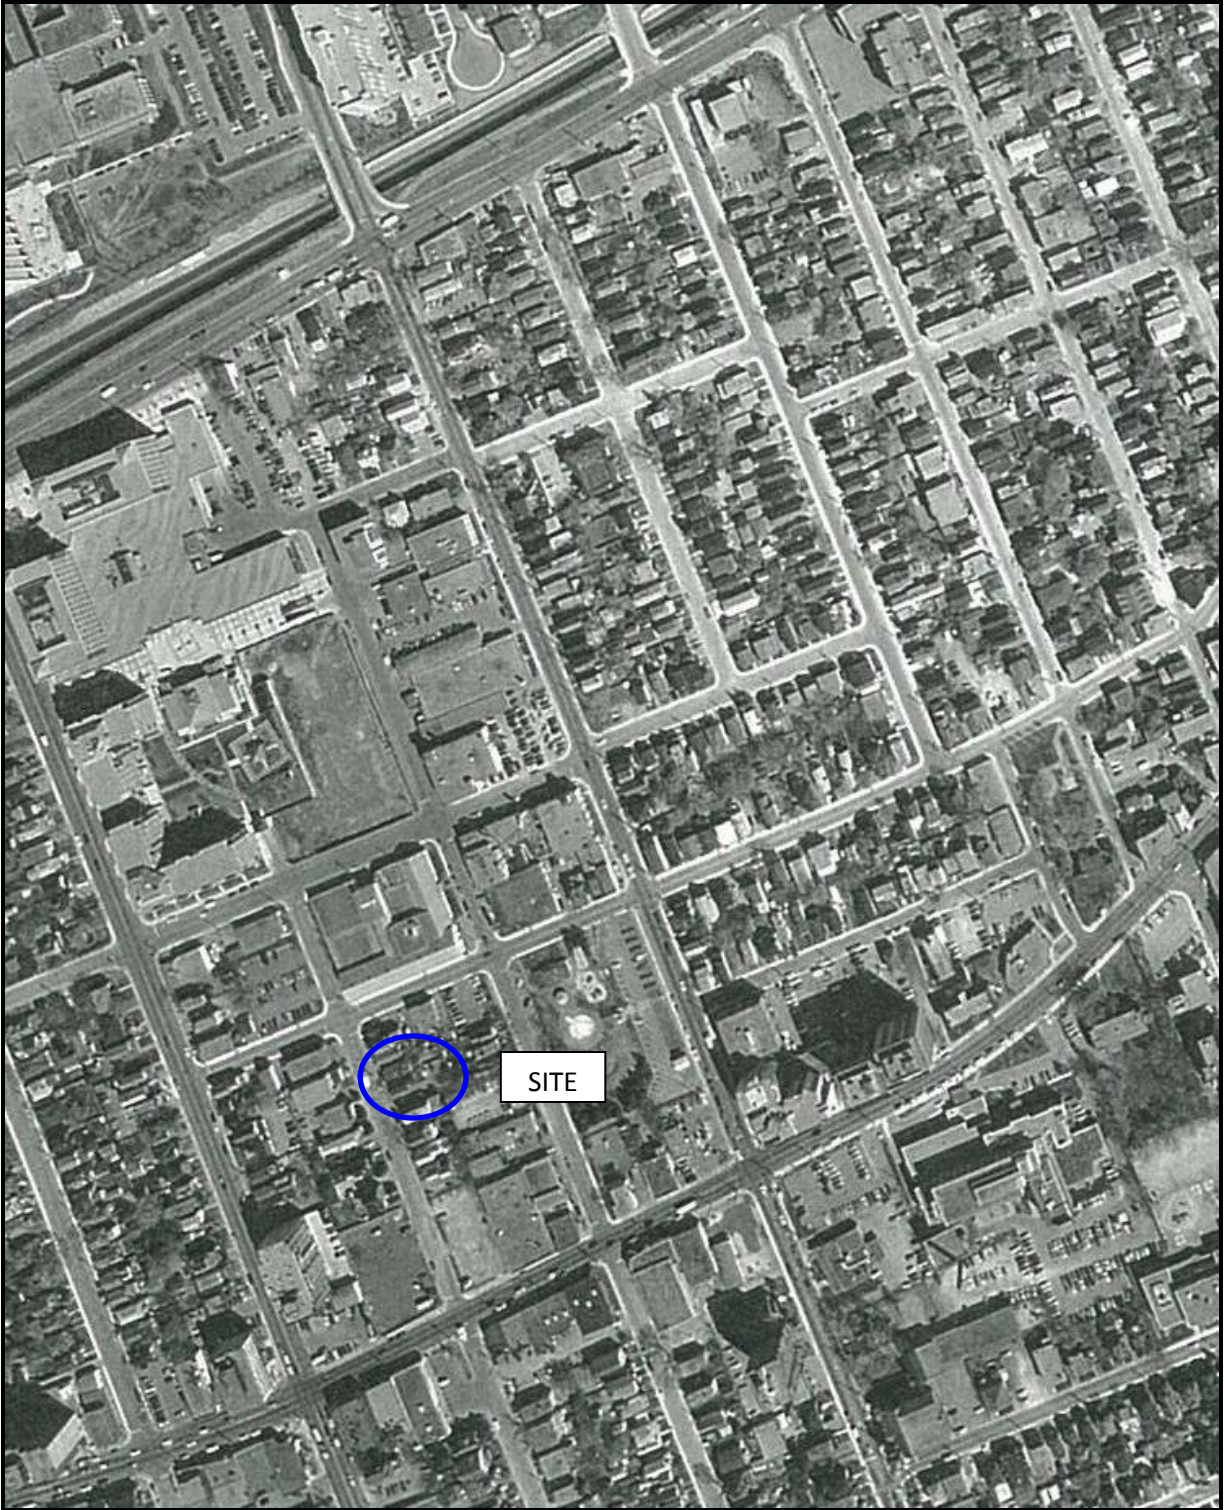
AERIAL PHOTOGRAPH  
1995

| 1995 | No significant changes appear to have been made to the subject site. No significant changes appear to have been made to adjacent properties, however, further to the north, the footprint of the former foundry has been redeveloped with a residential apartment building. |

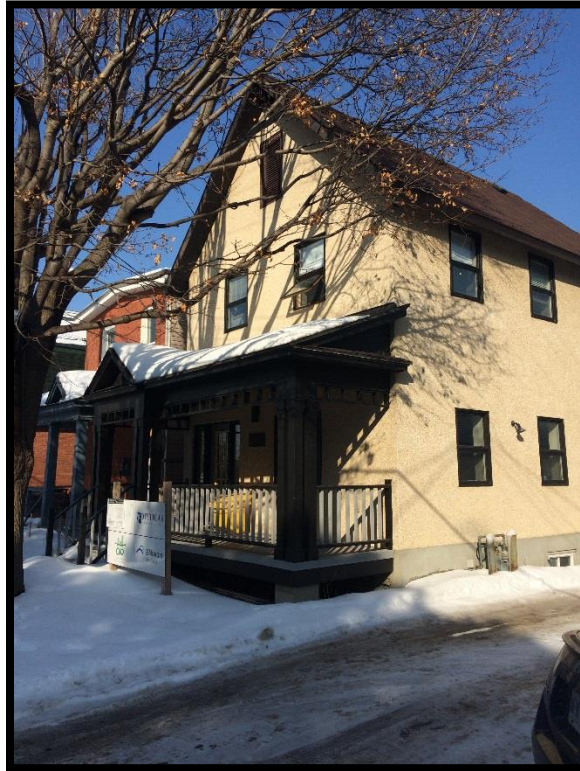
Possible asbestos-containing materials observed during the site include drywall joint compound, ceiling stipple and the exterior stucco. These materials were observed to be in fair to good condition at the time of the assessment.

Photograph 1: View of the west building face.

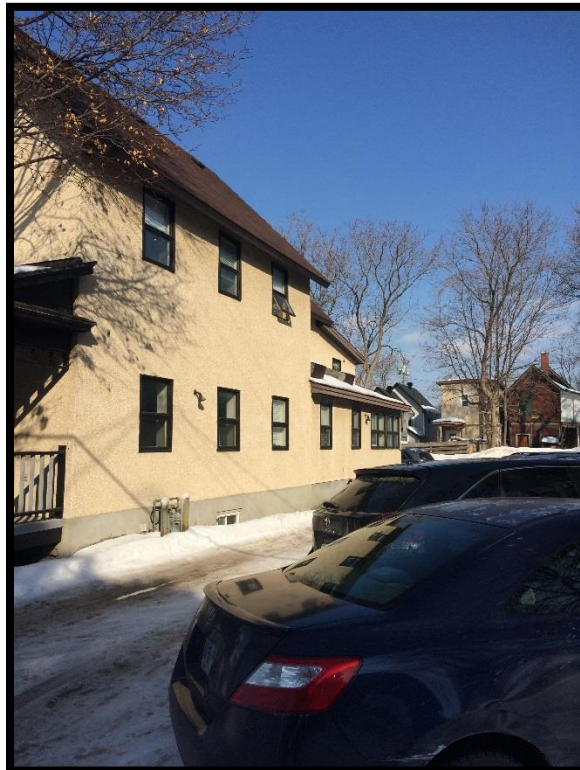
Photograph 2: View of the south building face, and parking lot.

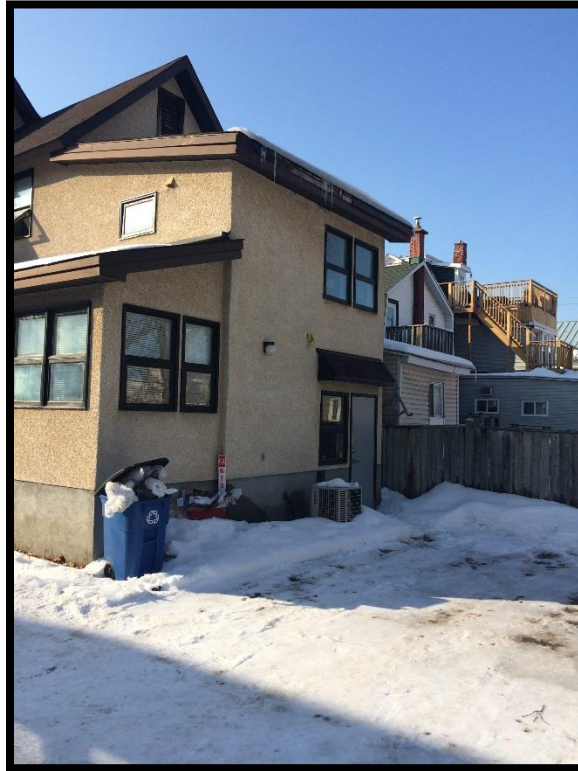
Photograph 3: View of the east building face.

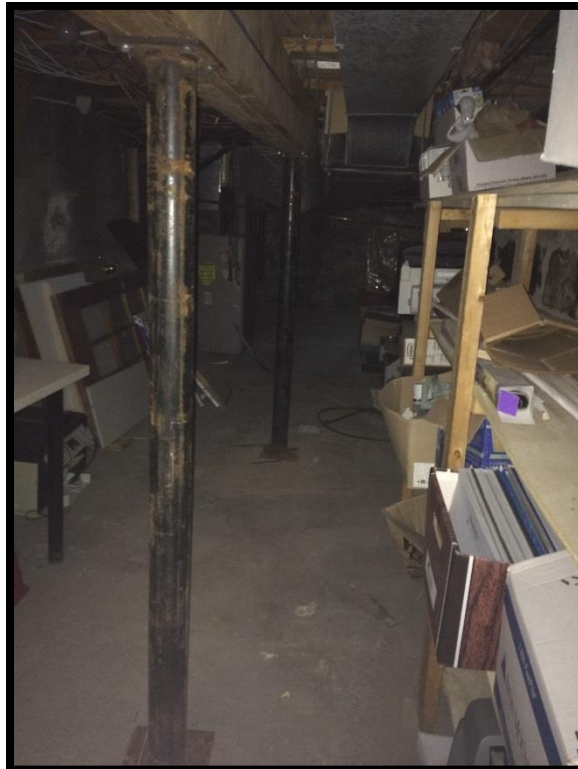
- Floors within the tenant spaces consisted of a combination of carpet, laminate flooring, and ceramic tile. The basement floor consisted of concrete.
- Walls within the tenant spaces consisted of drywall. The walls of the basement (the foundation of the building) consisted of a stone wall, with a concrete base (reinforcement).
- Ceilings consisted of drywall (some finished with stipple), or wood framing in the basement.

One drain was noted in the basement of the building. This drain likely leads to the municipal sewer system.

Photograph 4: View of the basement of the building.

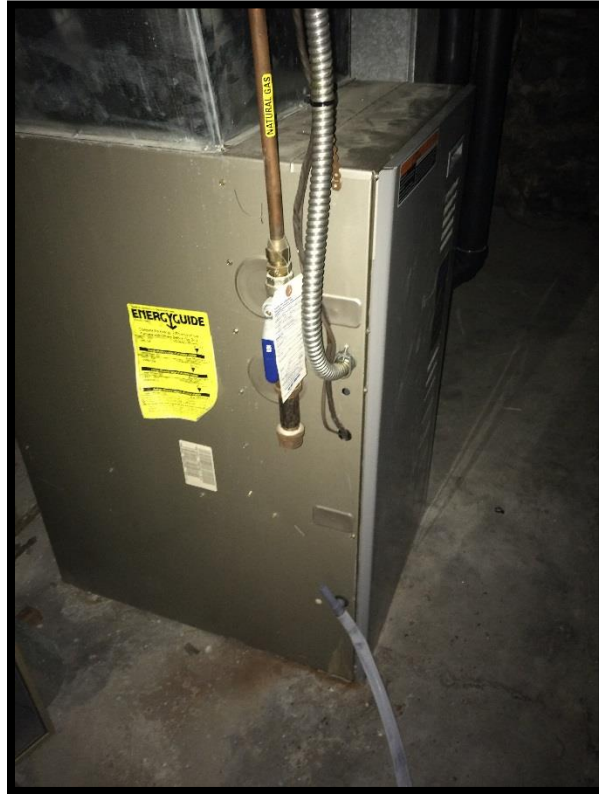
The building is heated and cooled by a forced air furnace located in the basement, and an air conditioning unit outside the east wall of the building.

Photograph 5: View of the natural gas forced air furnace.
