## **Phase I Environmental Site Assessment**

368 Chapel Street  
Ottawa, Ontario

**November 20, 2017**

Report: PE4136-1

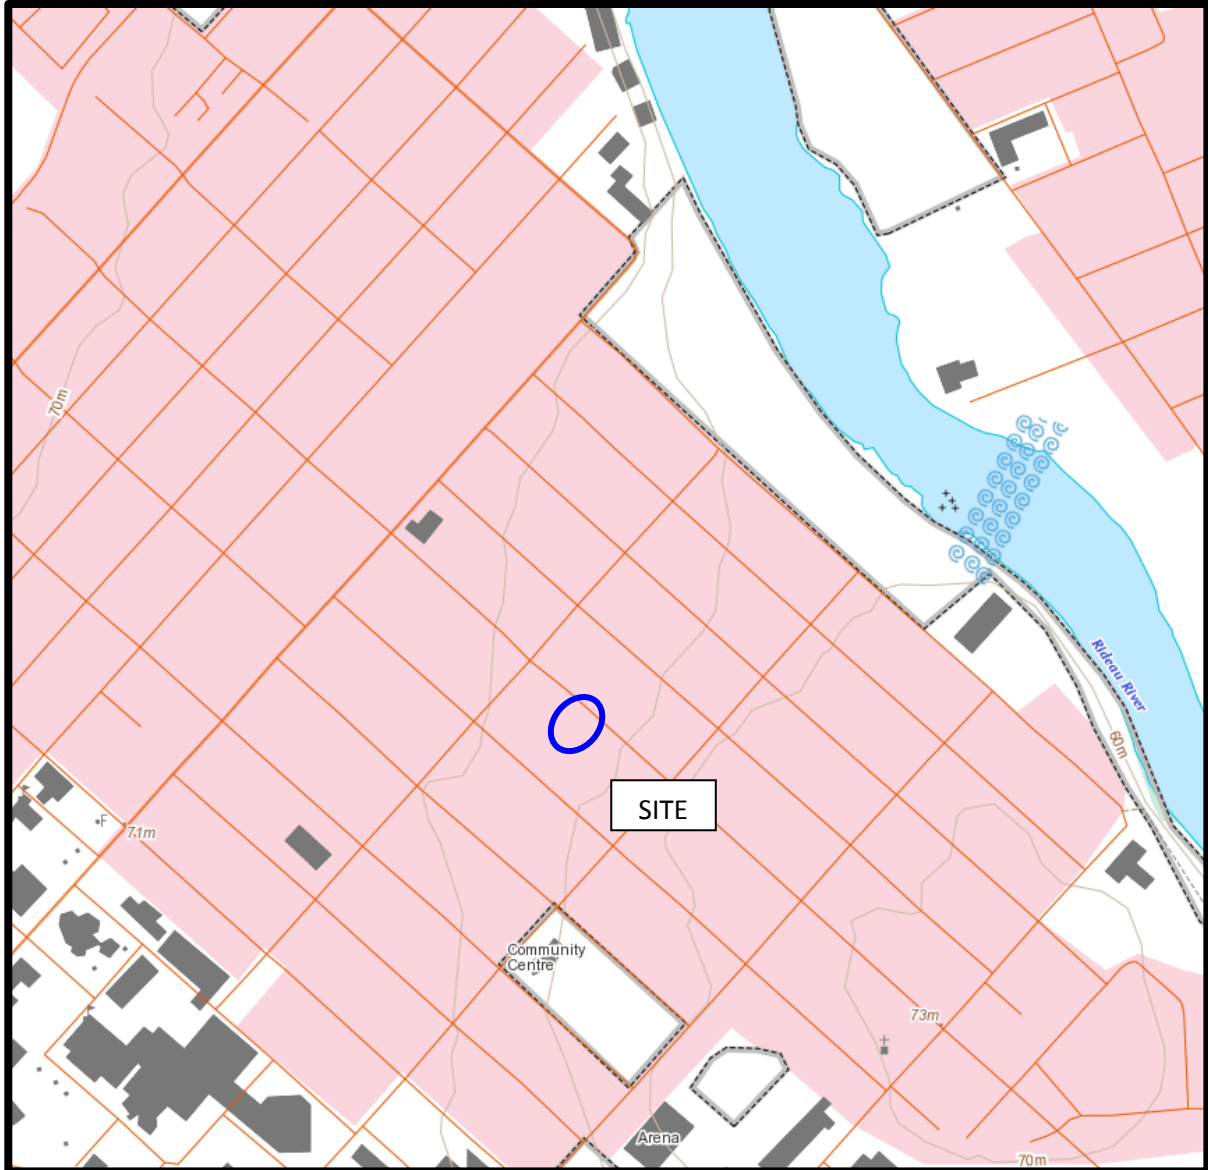
FIGURE 2  
TOPOGRAPHIC MAP

Topographic maps were obtained from Natural Resources Canada – The Atlas of Canada website and from the City of Ottawa website. Regionally, the topographic maps indicate a slope down towards the Rideau River located to the east. According to the map, the nearest water body is the Rideau River, located approximately 435 m to the east of the subject site. An illustration of the referenced topographic map is presented on Figure 2 – Topographic Map, appended to this report.

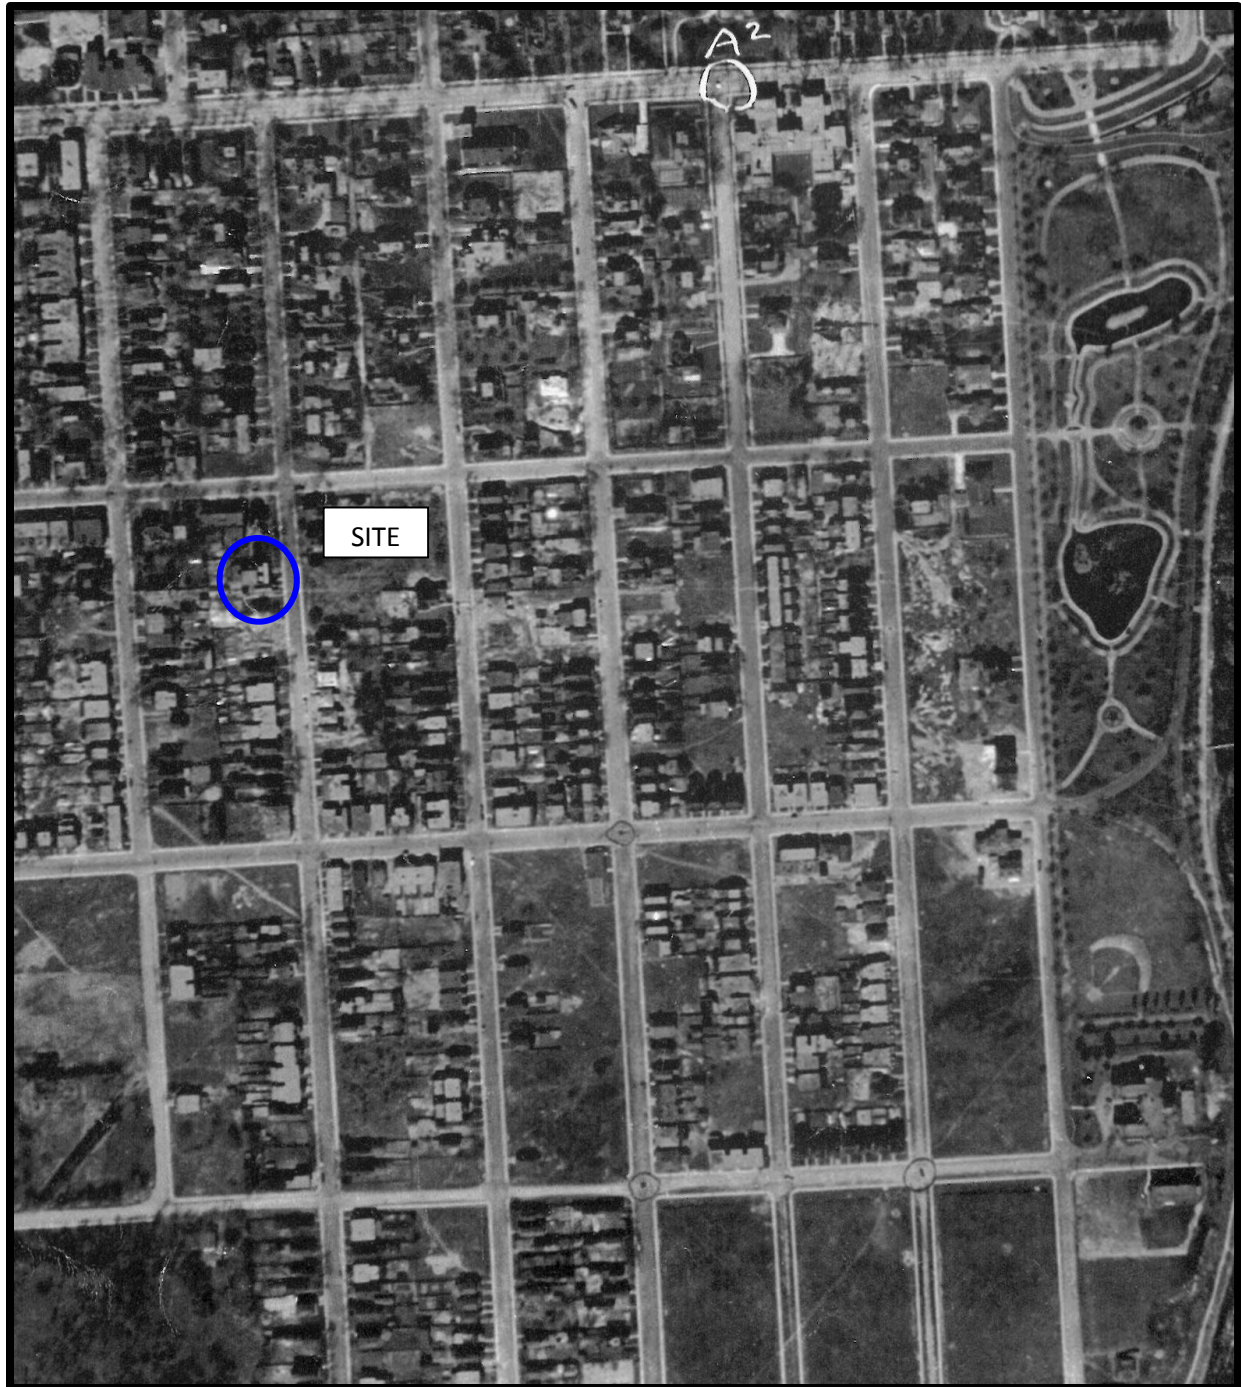
AERIAL PHOTOGRAPH  
1928

| 1928 | A residential dwelling occupies the subject site. Chapel Street appears in its present-day configuration. Neighbouring properties are used for residential purposes or are vacant. |

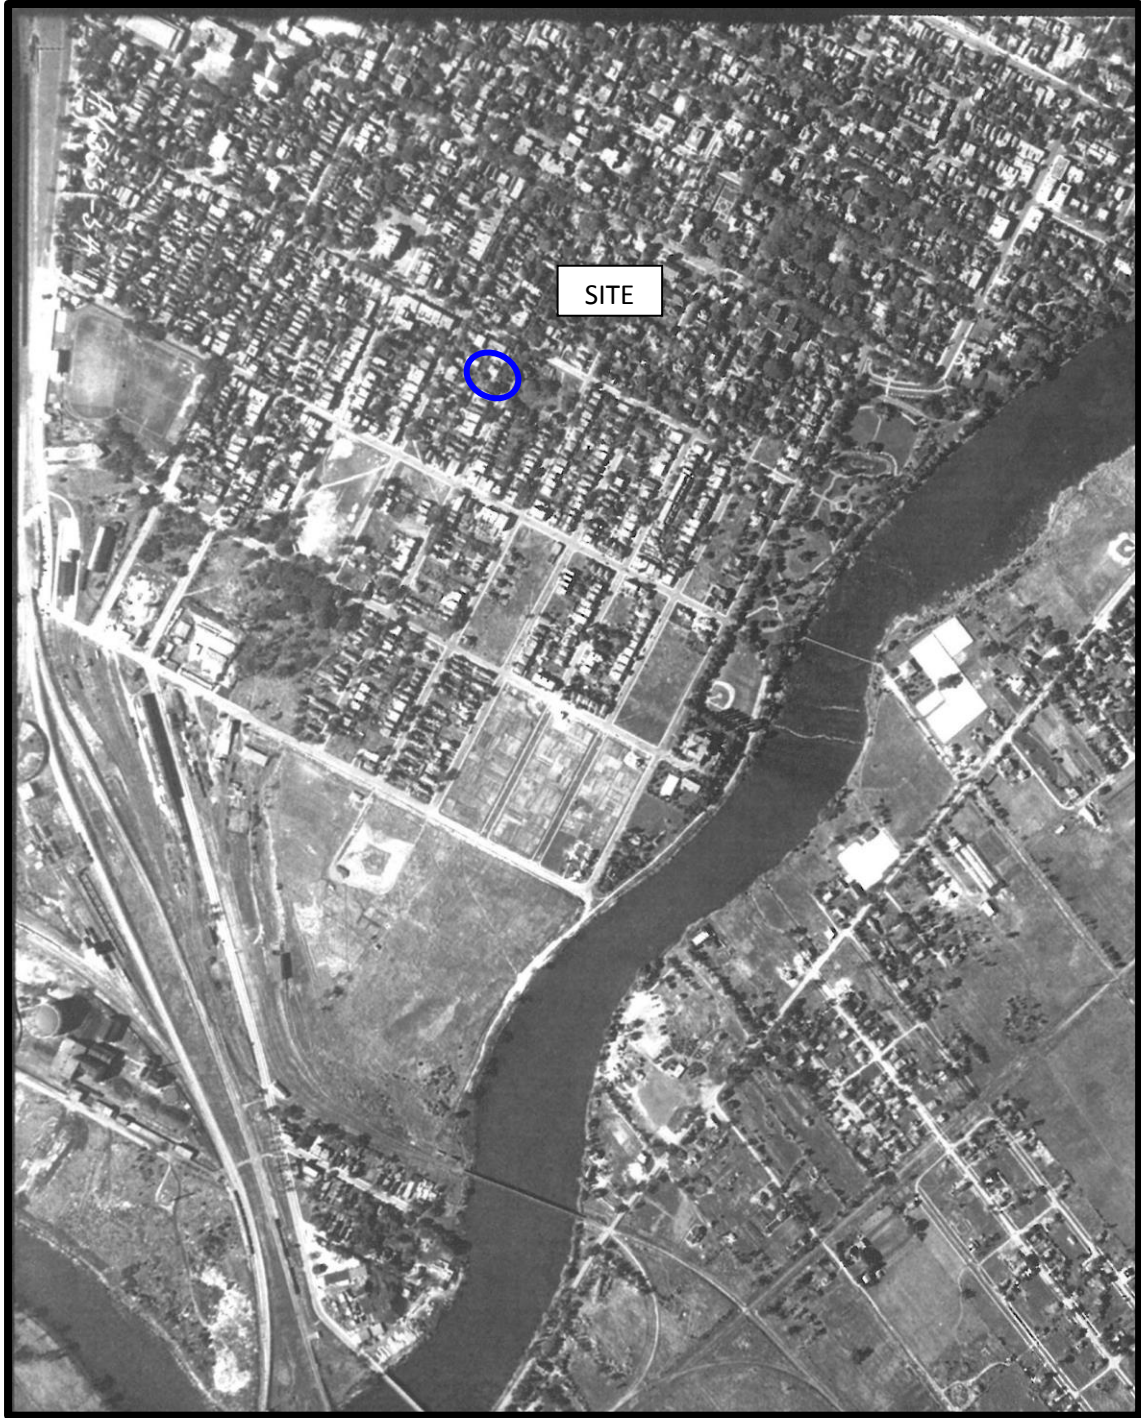
AERIAL PHOTOGRAPH  
1938

| 1938 | The scale of the photograph makes it difficult to discern details, however, it appears that no significant changes have been made to the subject site or neighbouring properties. |

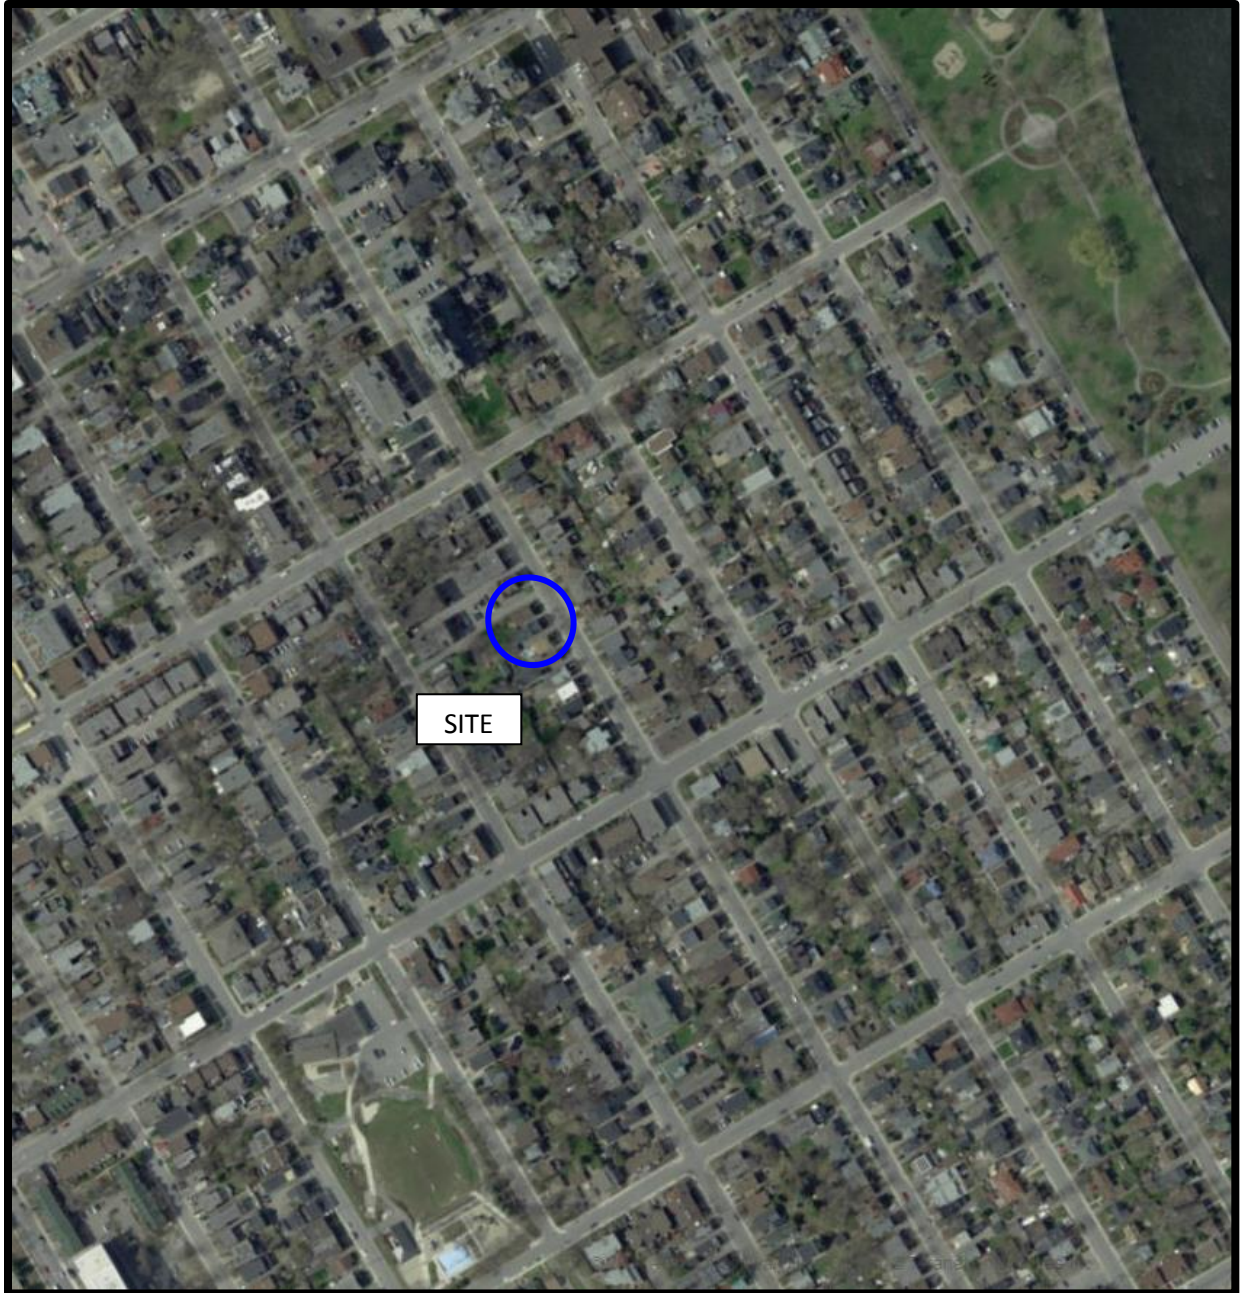
AERIAL PHOTOGRAPH  
2014

2014	(City of Ottawa, geoOttawa website) No significant changes have been made to the subject site or surrounding properties. The subject site is depicted as it appears today.

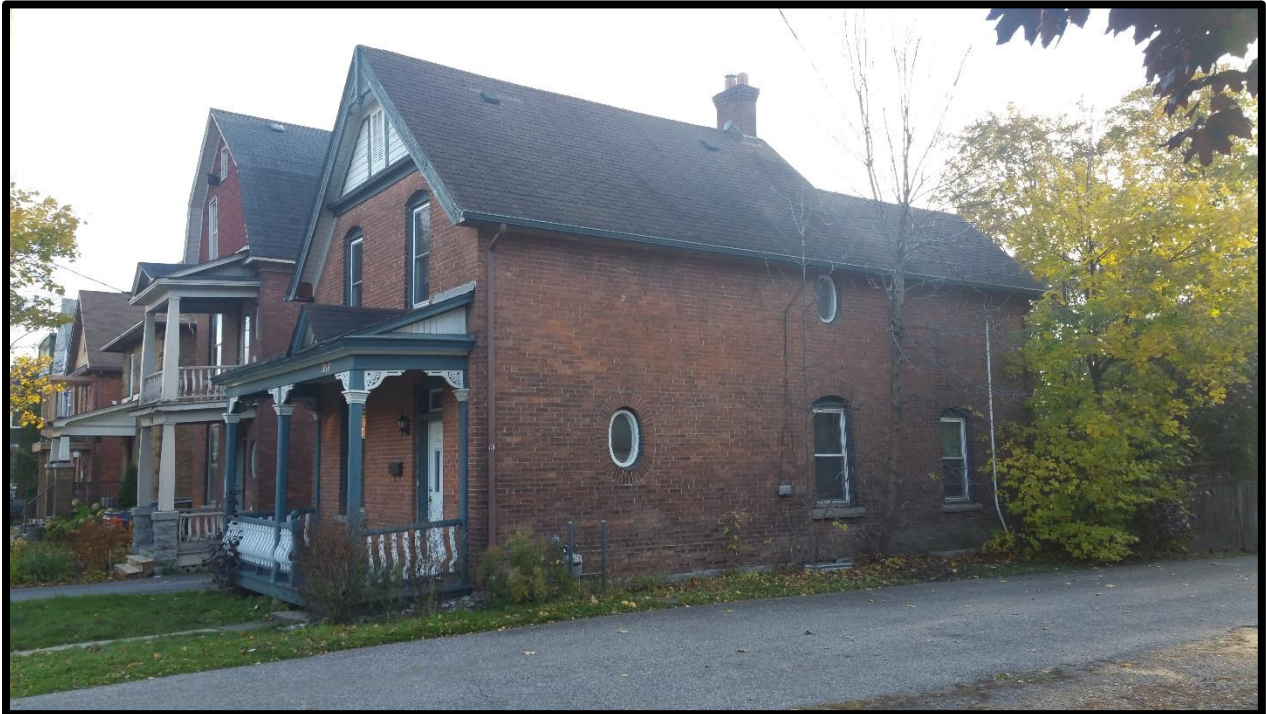
Photograph 1: View of the eastern and northern portions of the subject site. Picture taken facing southeast. Photograph illustrates the residential dwelling and a landscaped area.

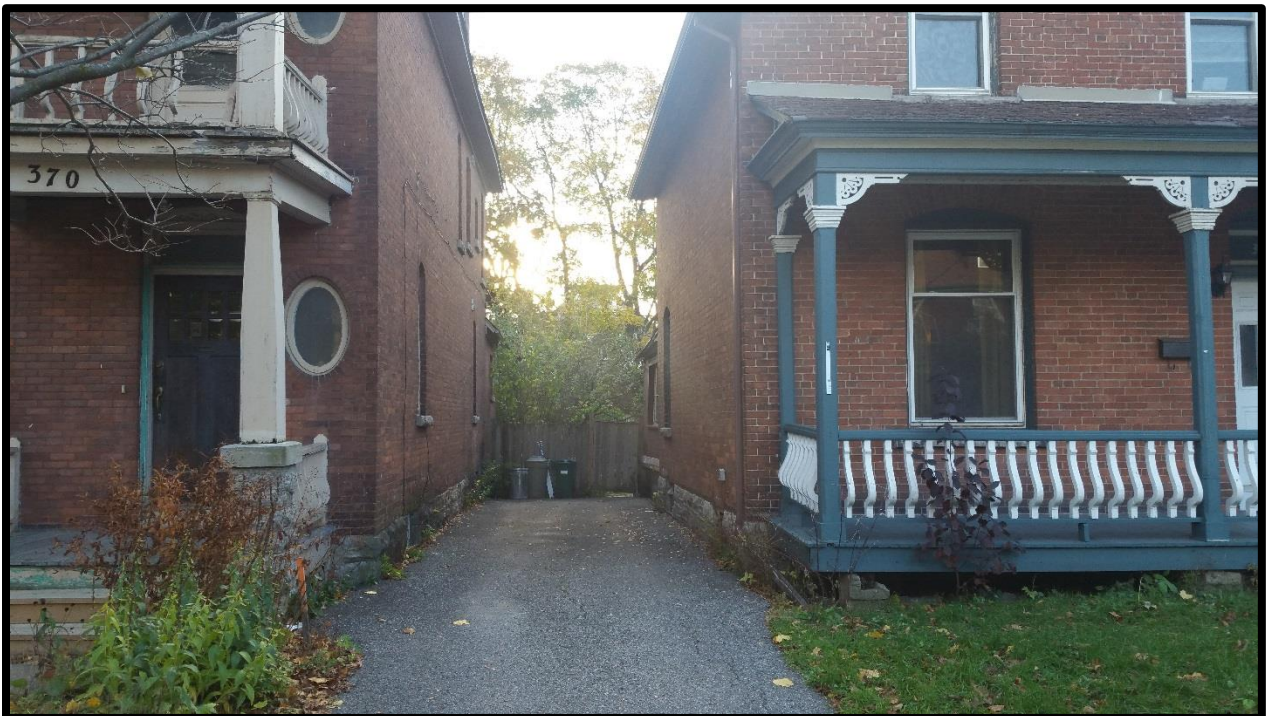
Photograph 2: View of the south portion of the subject site, facing west. Photograph illustrates an asphaltic concrete driveway.

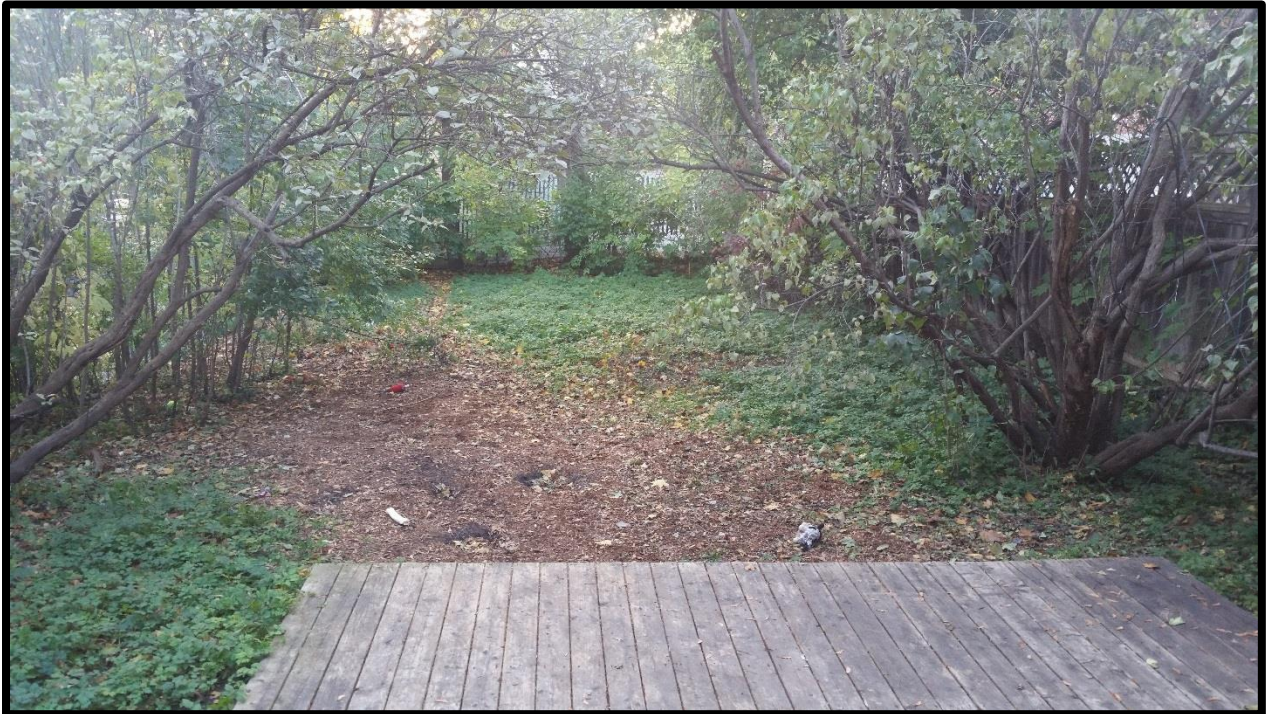
Photograph 3: View of the west portion of the subject site, facing west. Photograph illustrates a grass covered lawn and deck in the backyard. Trees are located around the perimeter of the subject site.

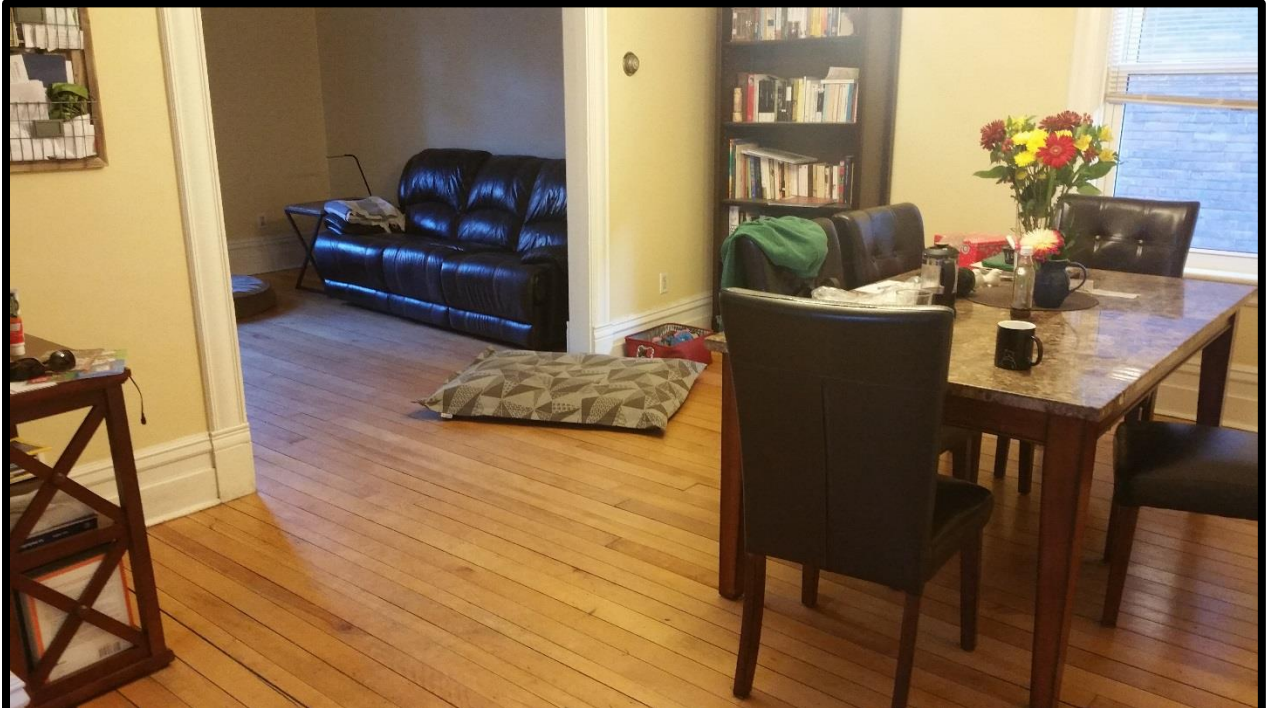
Photograph 4: Photograph of the interior of the residential dwelling on the lower level of the building.
