**Phase I-Environmental Site Assessment**

Part of 263 Greensway Avenue  
Ottawa, Ontario

Prepared For  
Manor Park Management

May 7, 2018  
Report: PE4258-1

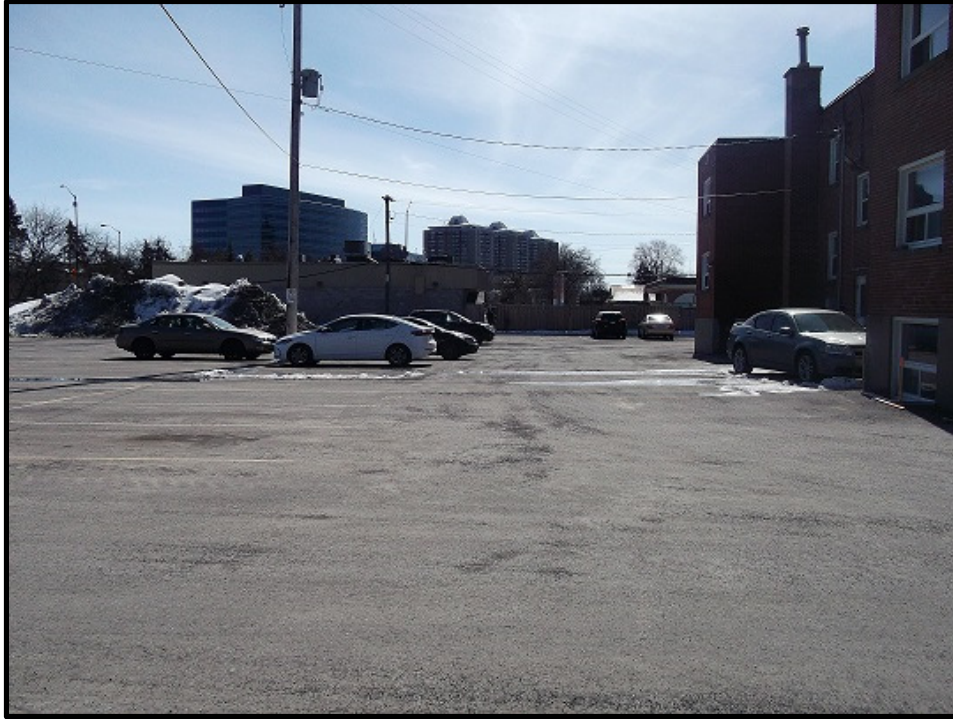
Photograph 1: Photograph illustrates central portion of the Phase I Property, facing south.

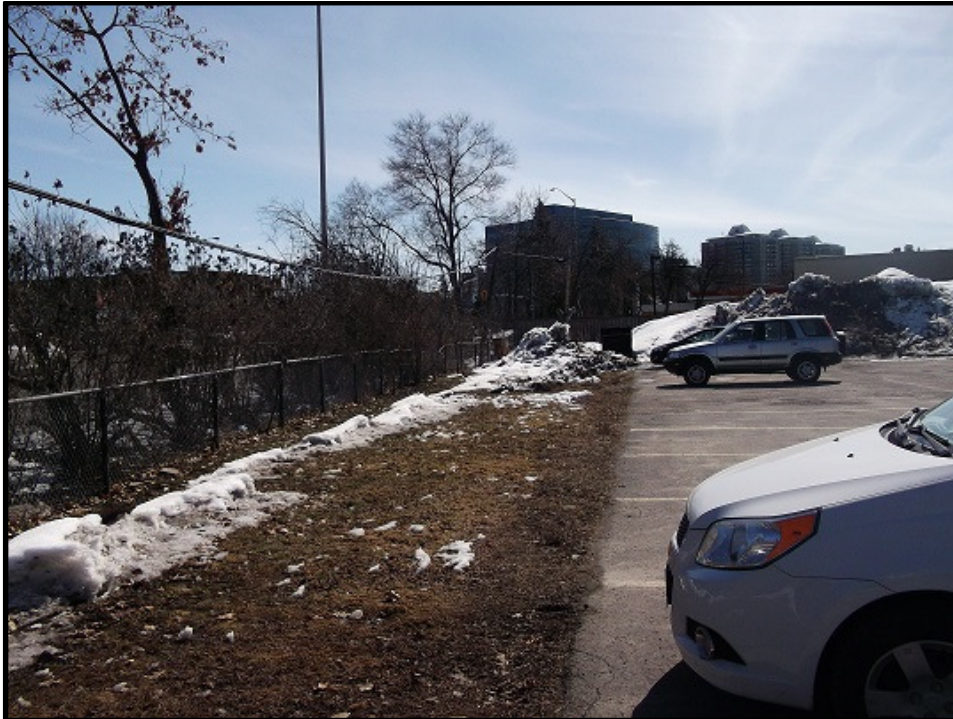
Photograph 2: View of southeastern portion of the Phase II Property; photograph illustrates the Vanier Parkway immediately east of the subject land.

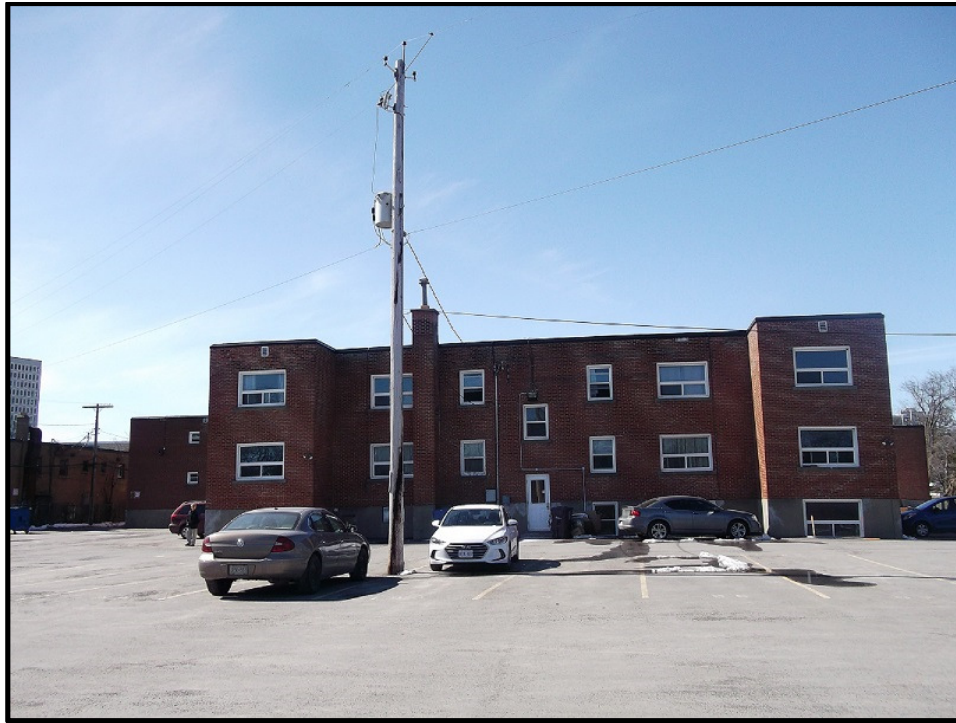
Photograph 3: View of west-central portion of the Phase I Property, facing west. Photo illustrates the east face of the adjacent apartment building (267 Greensway Avenue) to the west of the Phase II Property.

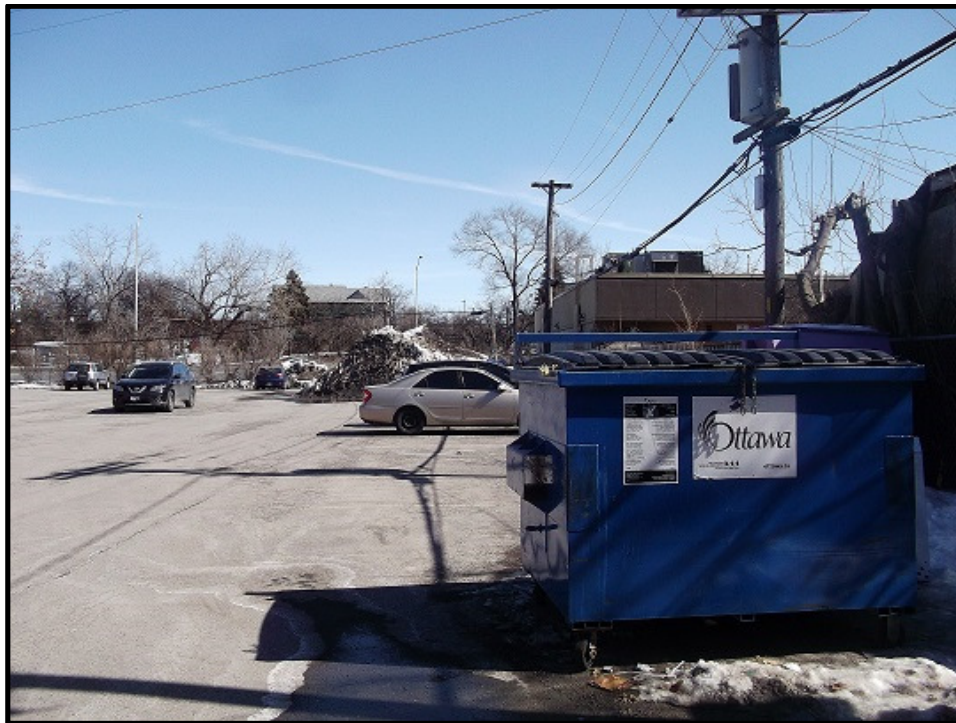
Photograph 4: View of southern portion of the Phase II Property, facing east, as well as commercial businesses to the south of the Phase II Property.

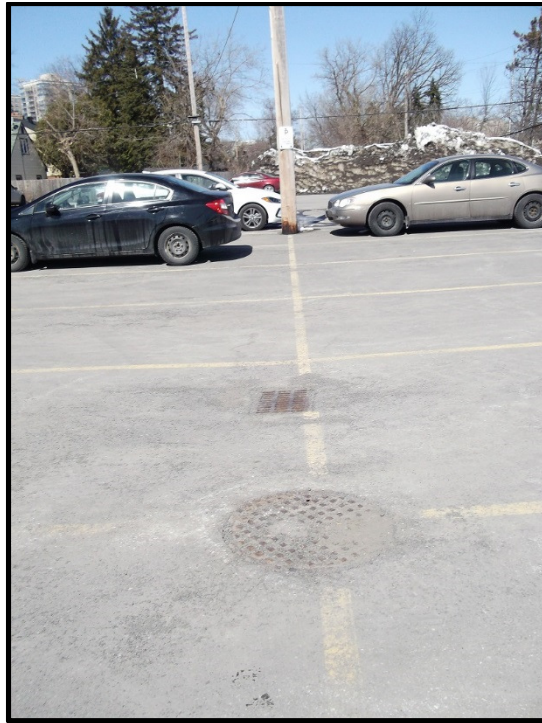
Photograph 5: View of northern portion of the Phase II Property, facing north. Photograph illustrates on-site sewers as well as the adjacent residential property to the north.
