**Phase I-Environmental Site Assessment**

20 Mark Avenue  
Ottawa, Ontario

**July 24, 2018**

**Report: PE4368-1**

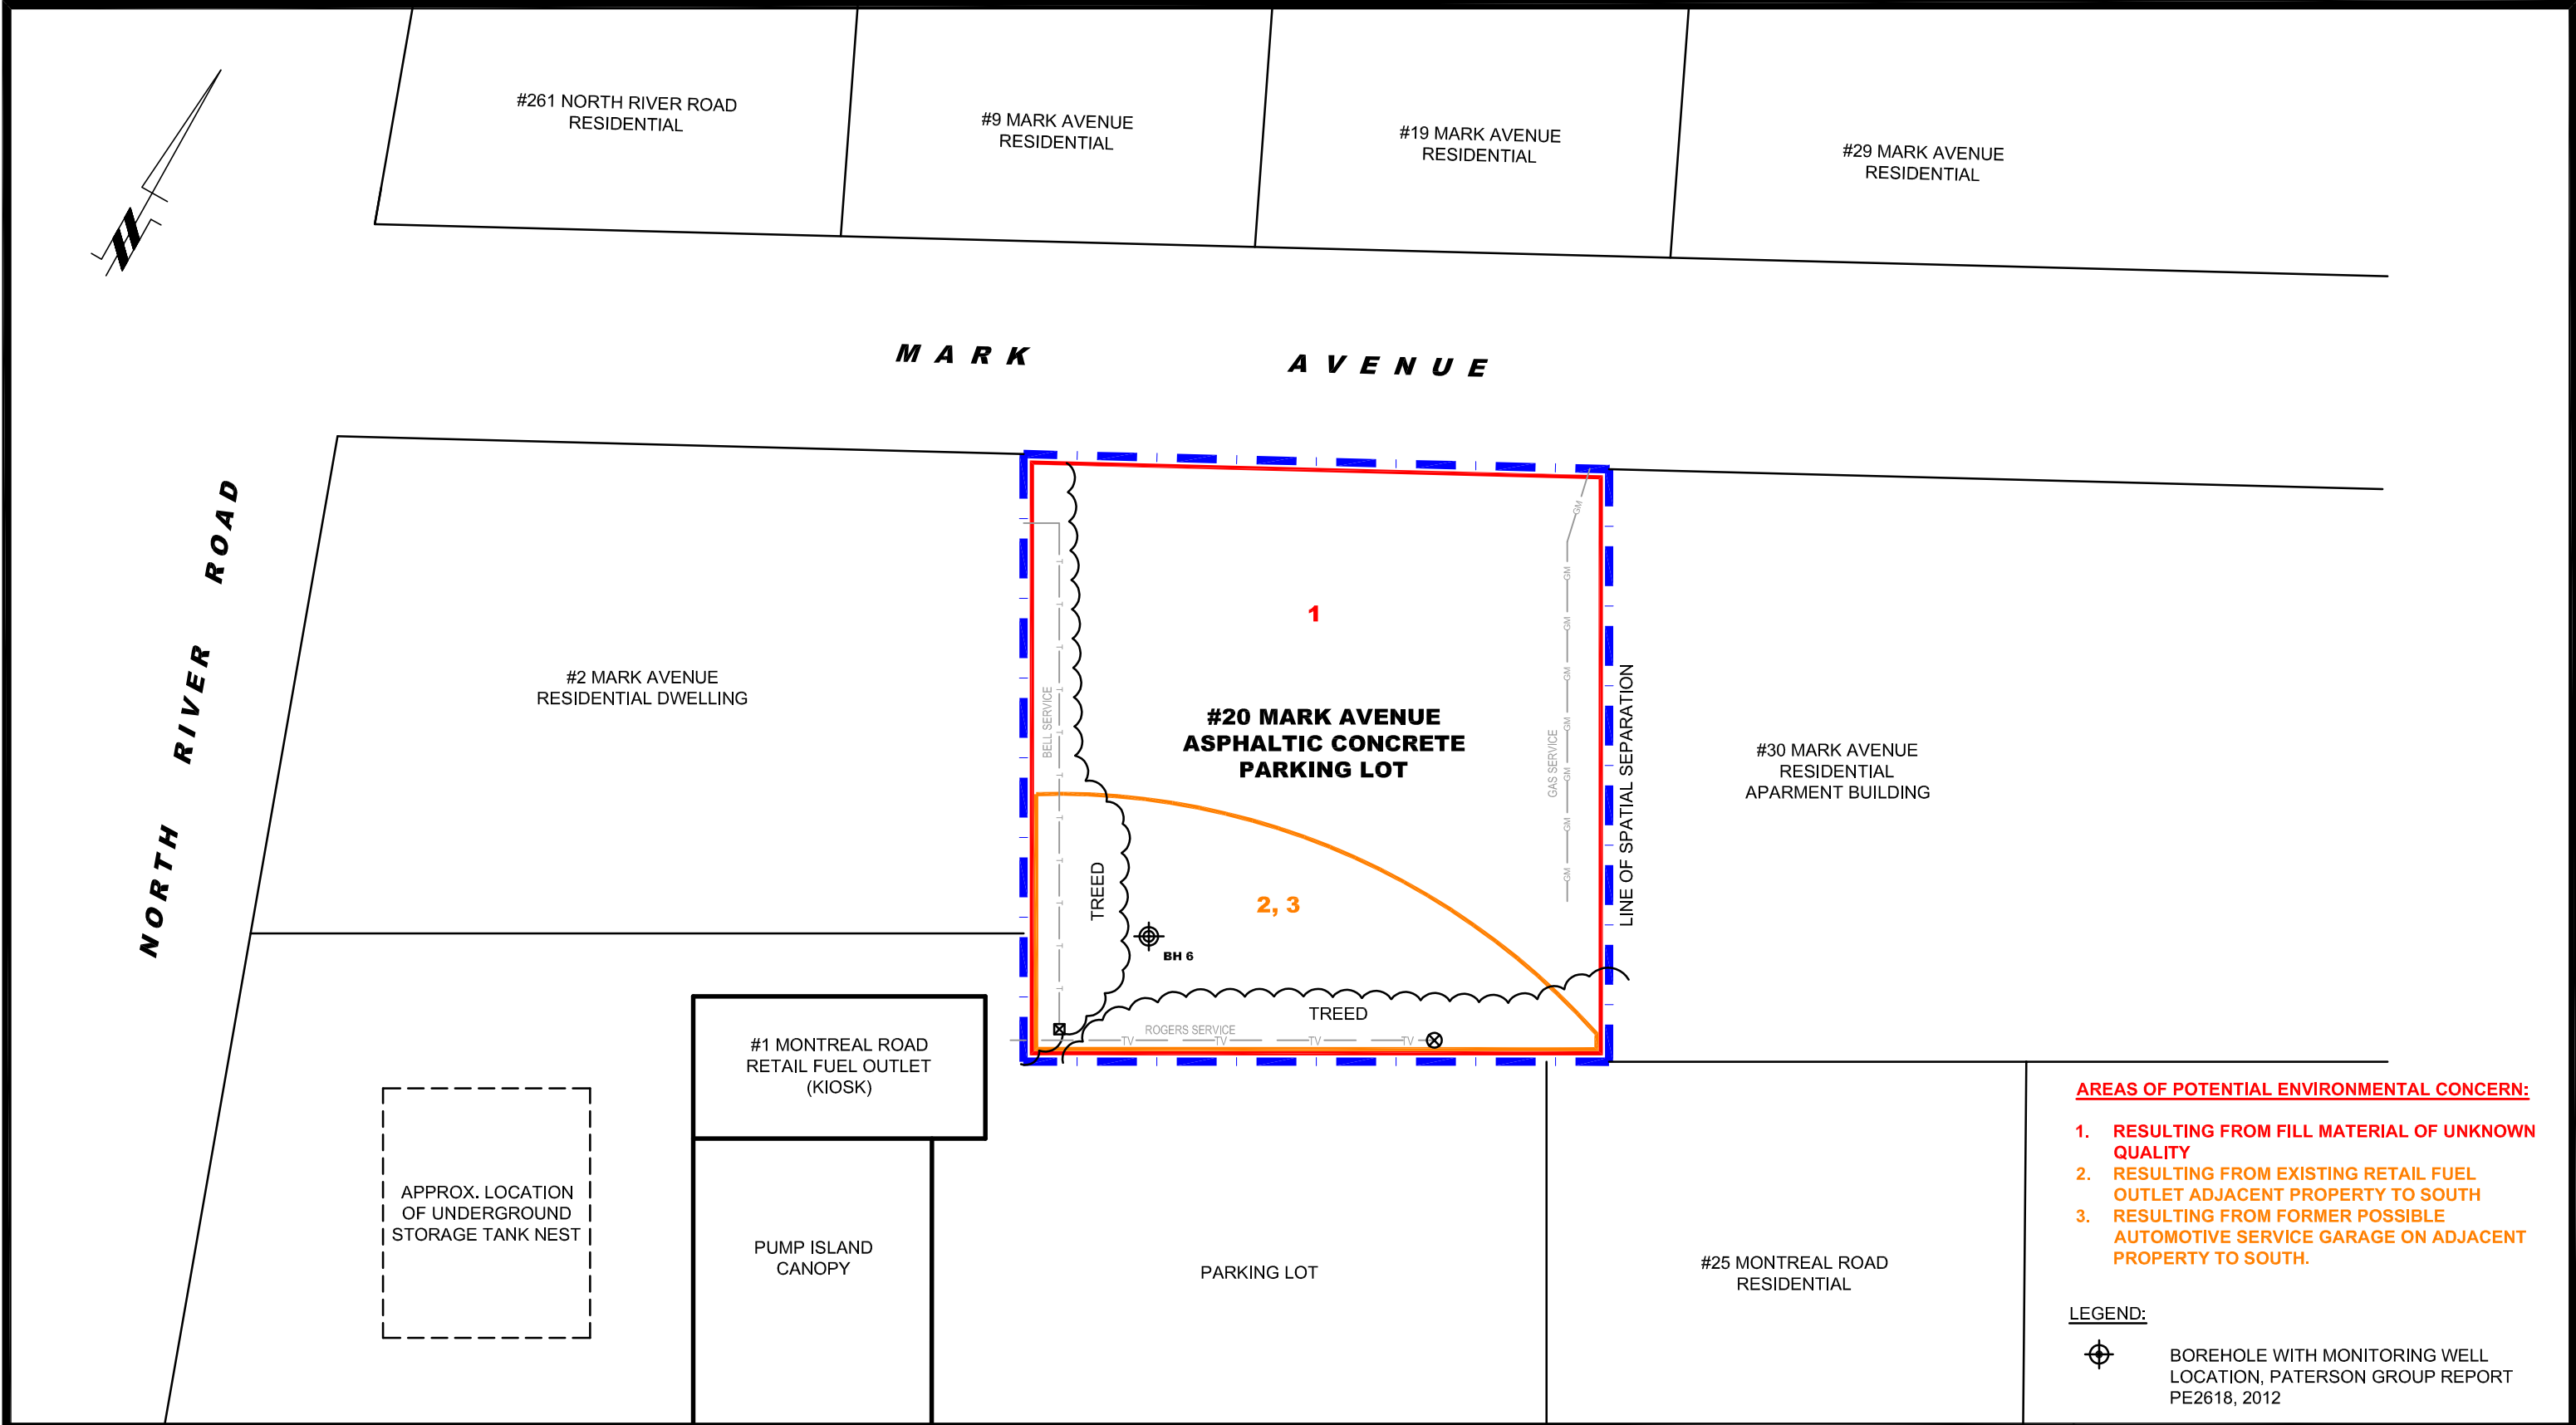
**DRAWING PE4368-1 – SITE PLAN**

**AREAS OF POTENTIAL ENVIRONMENTAL CONCERN:**

- 1. RESULTING FROM FILL MATERIAL OF UNKNOWN QUALITY
- 2. RESULTING FROM EXISTING RETAIL FUEL OUTLET ADJACENT PROPERTY TO SOUTH
- 3. RESULTING FROM FORMER POSSIBLE AUTOMOTIVE SERVICE GARAGE ON ADJACENT PROPERTY TO SOUTH.

No evidence of recent excavation was observed on the Phase I Property. No evidence of current or former railway or spur lines on the subject land were observed at the time of the site visit. There were no unidentified substances observed on the exterior of the Phase I Property. The above-noted site features are shown on Drawing PE4368-1 - Site Plan.

No obvious signs of fill material were noted at the time of the site visit. Fill material was identified on the Phase I Property during a Phase II ESA which was conducted prior to the issuance of this Phase I ESA report. The fill material generally consisted of dark brown silty sand with gravel, with fragments of brick, mortar, concrete and possible coal. The fill material is considered to represent an APEC on the Phase I Property.

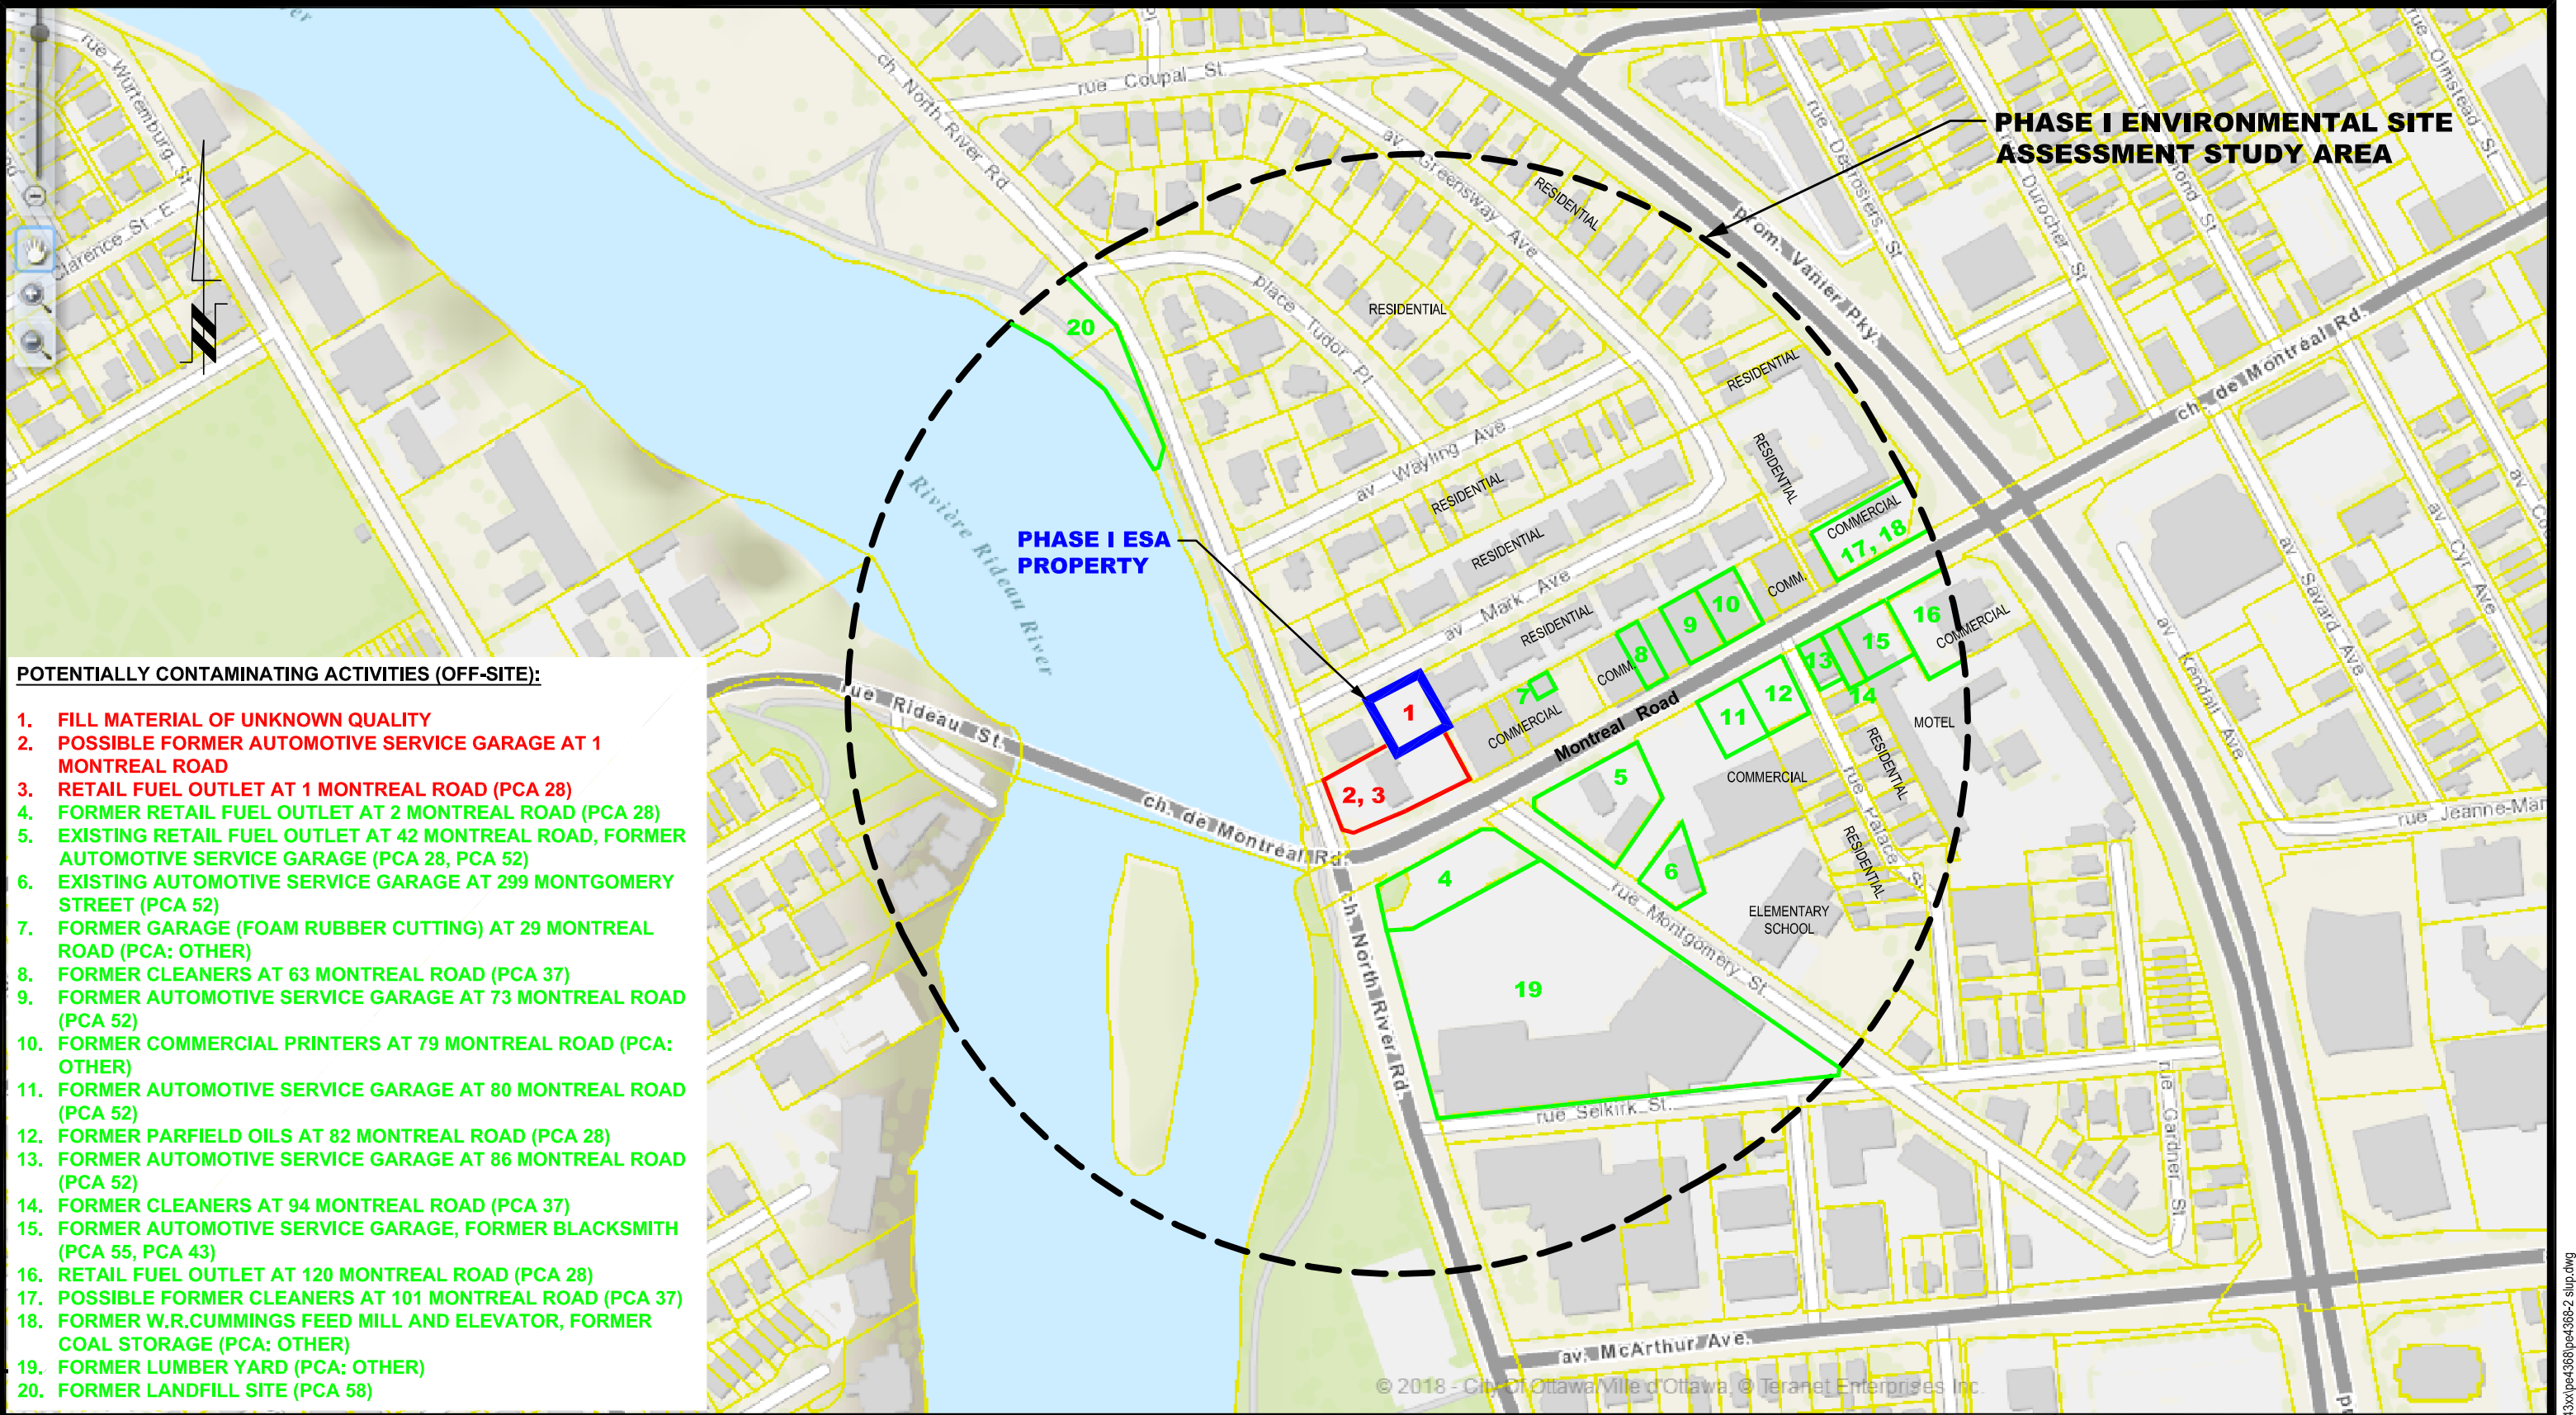
**DRAWING PE4368-2 – SURROUNDING LAND USE PLAN**

- POTENTIALLY CONTAMINATING ACTIVITIES (OFF-SITE):**
1. FILL MATERIAL OF UNKNOWN QUALITY
  2. POSSIBLE FORMER AUTOMOTIVE SERVICE GARAGE AT 1 MONTREAL ROAD

3. RETAIL FUEL OUTLET AT 1 MONTREAL ROAD (PCA 28)
  4. FORMER RETAIL FUEL OUTLET AT 2 MONTREAL ROAD (PCA 28)
  5. EXISTING RETAIL FUEL OUTLET AT 42 MONTREAL ROAD, FORMER AUTOMOTIVE SERVICE GARAGE (PCA 28, PCA 52)

Other potentially contaminating activities (PCAs) identified within the Phase I Study Area during the FIP review, include a retail fuel outlet at 4 Montreal Road, a lumber yard at 300 Montgomery Street, a garage denoted as “foam rubber cutting” at 39 Montreal Road, an automotive service garage at 42 Montreal Road, a retail fuel outlet at 120 Montreal Road, and coal storage at W.R. Cummings Feed Mill & Elevators at 115 through 125 Montreal Road. These off-site PCAs are not considered to pose a concern to the Phase I Property based on their separation distances from the subject land. All PCAs are outlined on Drawing PE4368-2 – Surrounding Land Use Plan.

Several PCAs were identified on the adjacent and neighbouring properties within the Phase I Study Area. Potentially contaminating activities identified in the city directories are presented in Table 1 and depicted on Drawing PE4368-2 – Surrounding Land Use Plan.

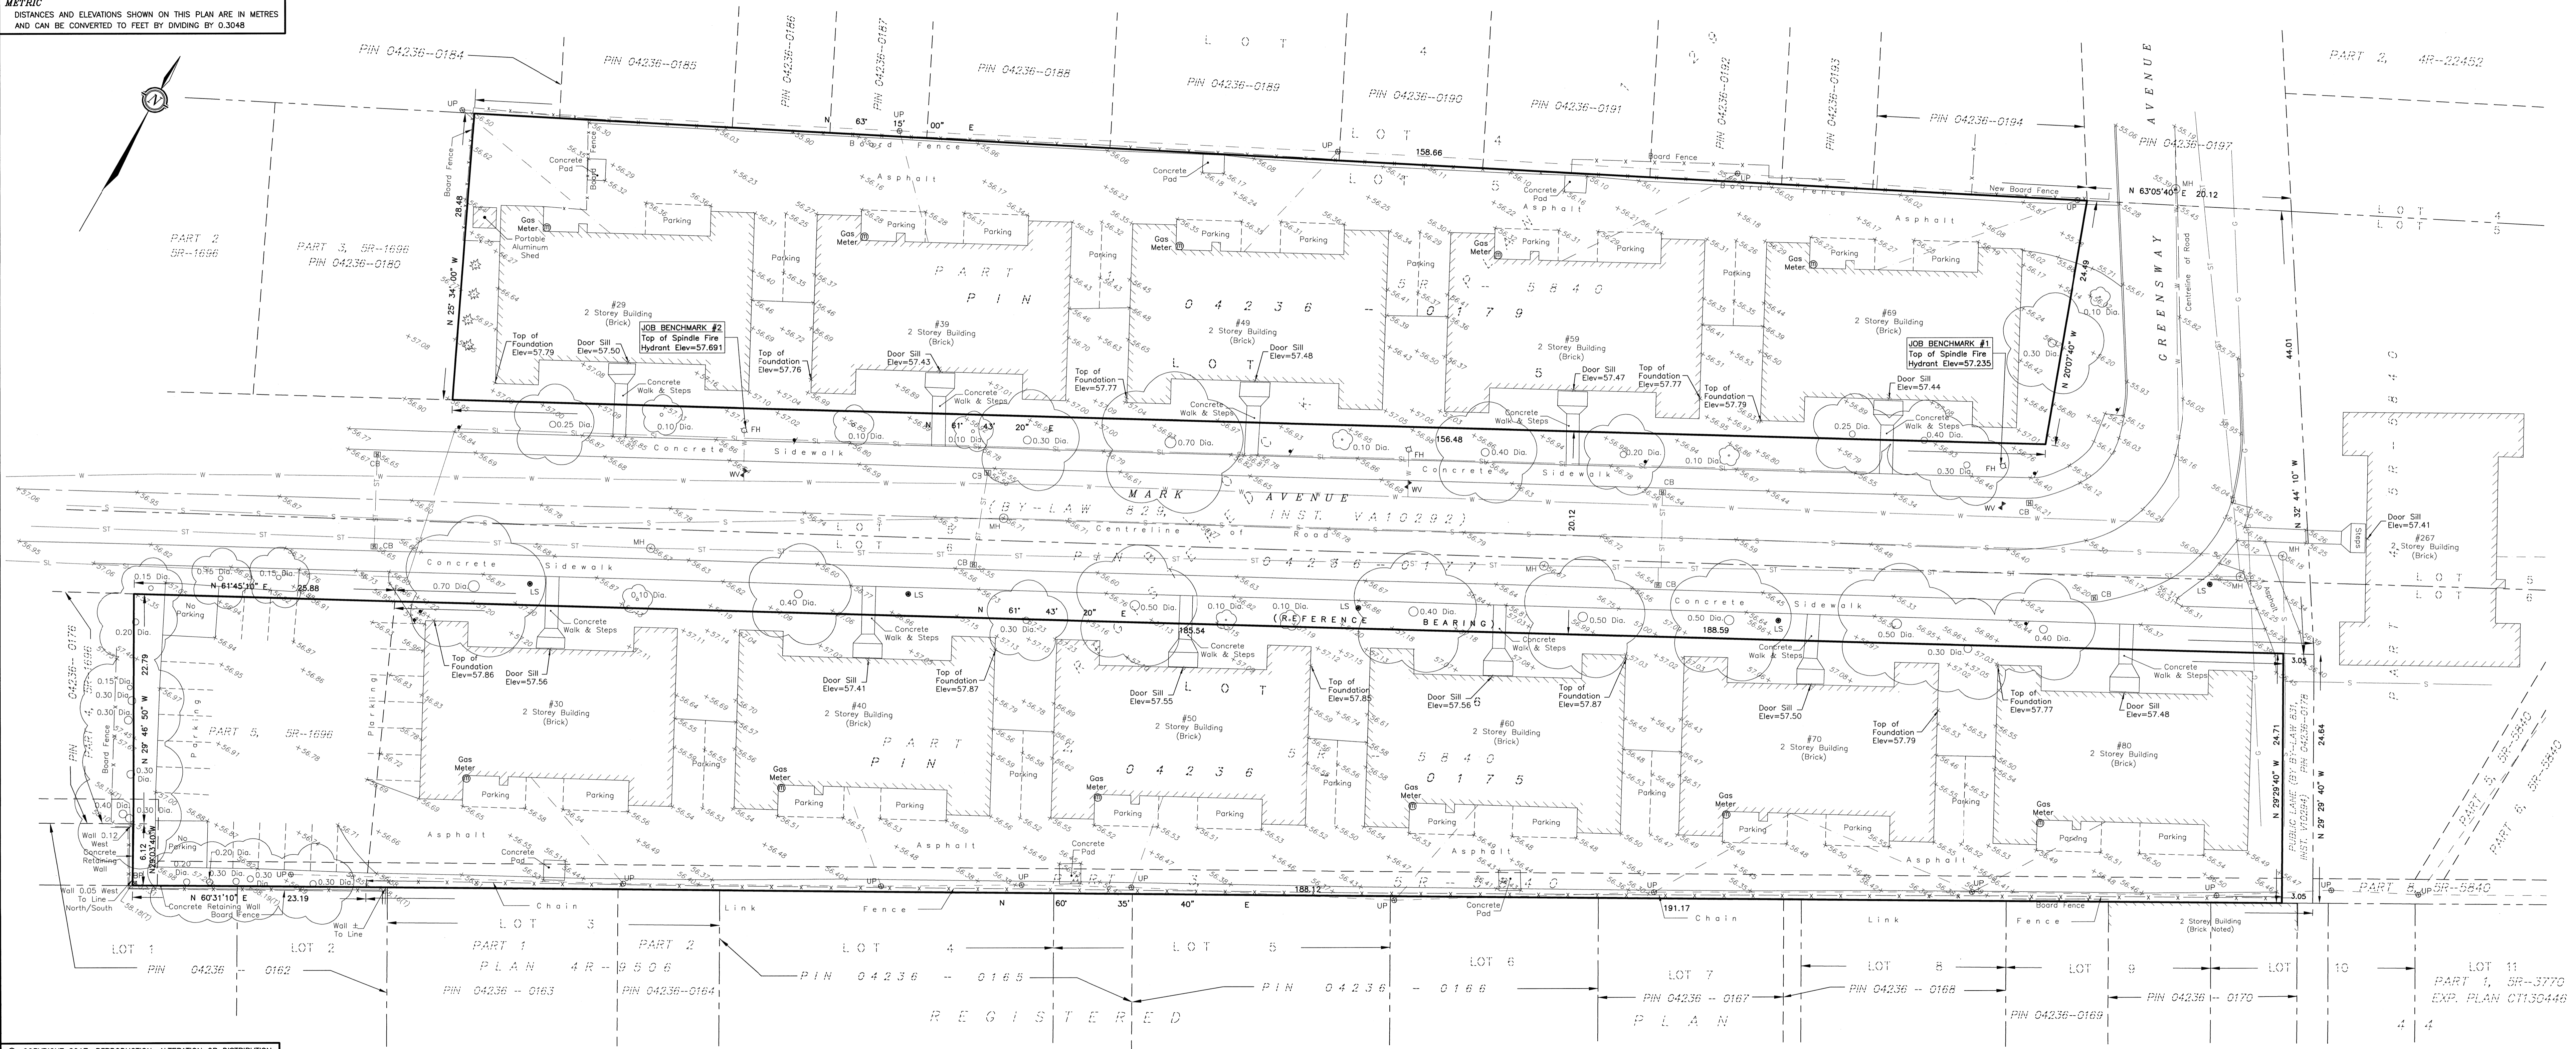
**TOPOGRAPHIC PLAN OF  
PART OF LOTS 5 & 6  
(BLOCK 1)  
REGISTERED PLAN 29  
FORMERLY CITY OF VANIER  
Now CITY OF OTTAWA**

A topographic plan, prepared by Fairhall, Moffatt & Woodland Limited and dated October 25, 2017, was reviewed as part of this assessment. The survey plan encompasses a larger parcel of land along the south side of Mark Avenue that includes the Phase I Property as well as apartment buildings addressed 30 through 80 Mark Avenue. The Phase I Property is comprised of the vacant parcel of land adjacent to the west of 30 Mark Avenue and is shown in its current configuration on the topographic plan. A copy of the topographic plan is provided in Appendix 1.

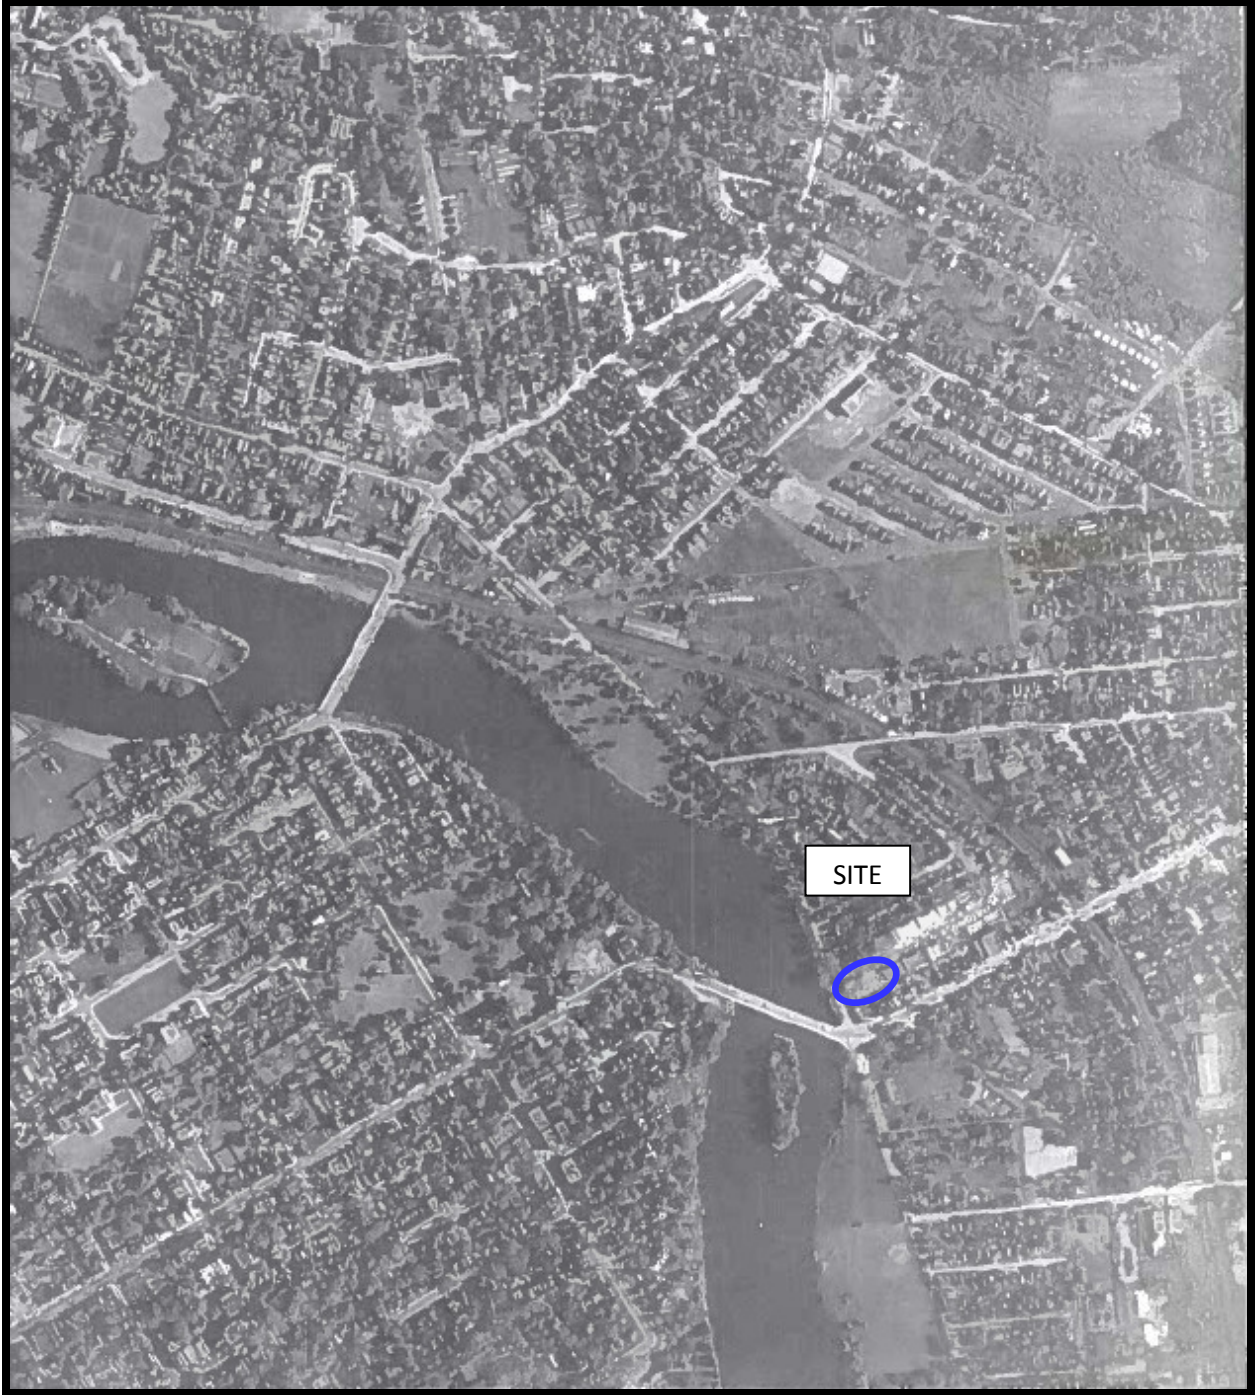
AERIAL PHOTOGRAPH  
1950

| 1950 | The Phase I Property remains unchanged from the previous photograph. The apparent commercial building structure observed in the 1928 aerial on the adjacent property to the west, is no longer present. Residential apartment buildings have been constructed along both sides of Mark Avenue, east of the Phase I Property. No other significant changes appear to have been made to the adjacent and neighbouring properties. It should be noted however, that the aerial photograph is of poor quality. |

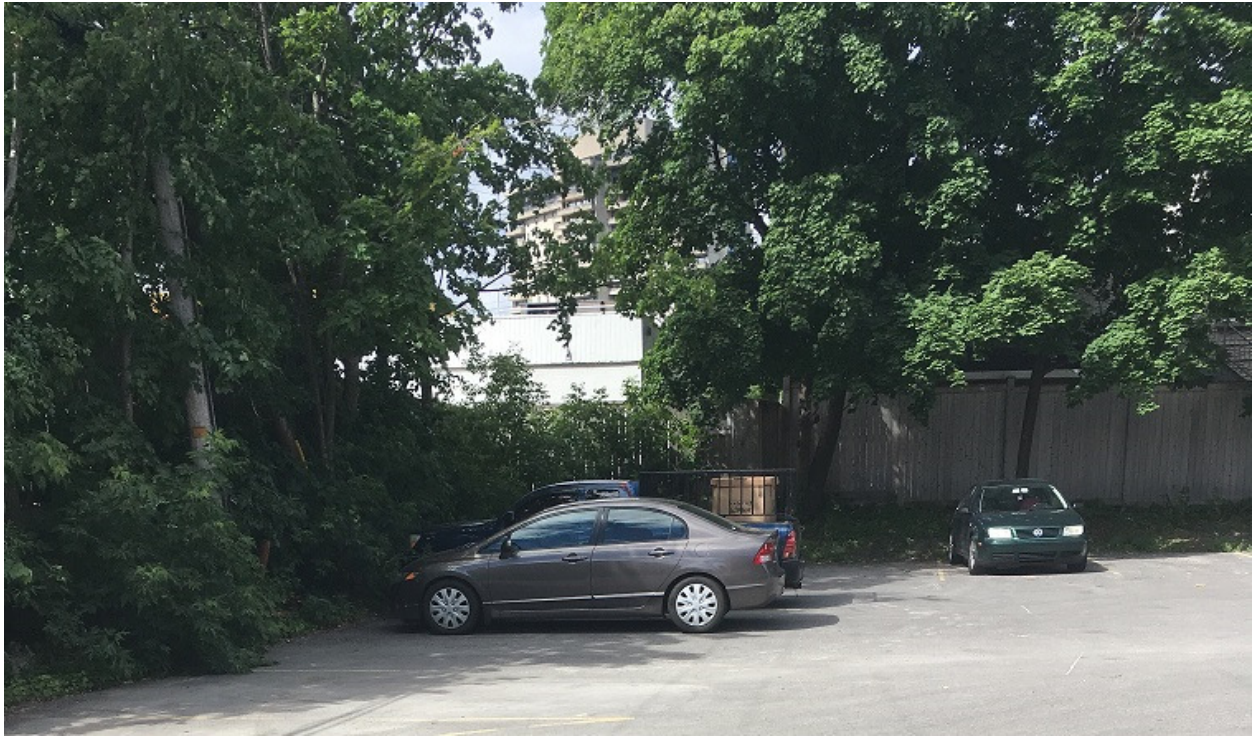
Photograph 1: Photograph illustrates southwestern portion of the Phase I Property, facing southwest. Photograph illustrates a portion of the retail fuel outlet kiosk adjacent to the southwest.

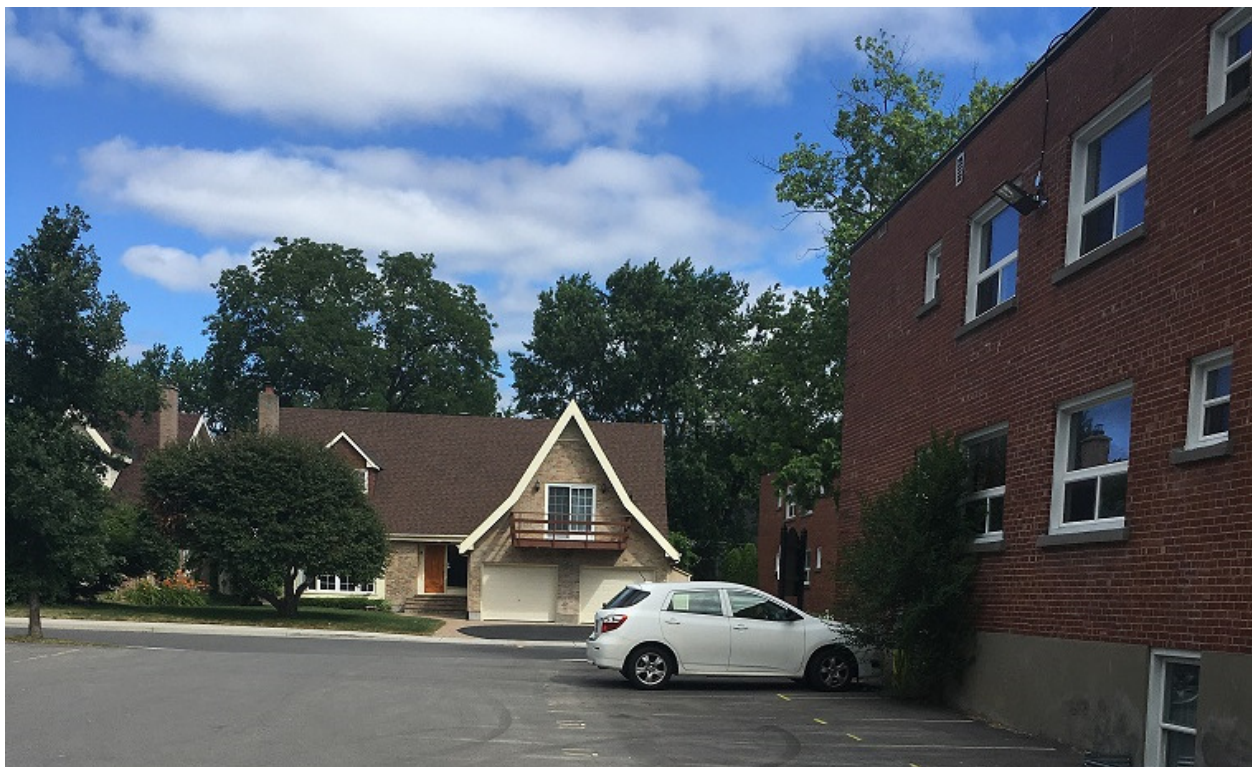
Photograph 2: View of northeastern portion of the Phase I Property, facing north. Photograph illustrates residential land use adjacent to the east.

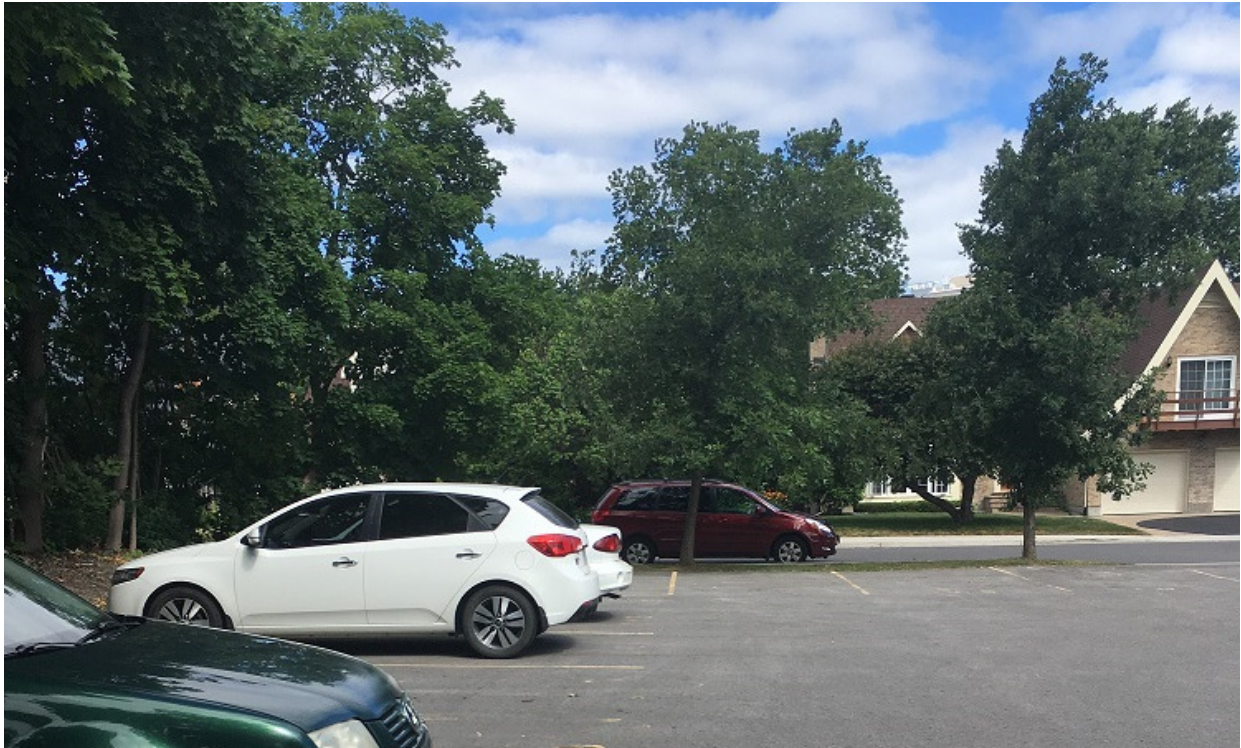
Photograph 3: View of northwestern portion of Phase I Property. Photograph illustrates residential land use to the north across Mark Avenue.

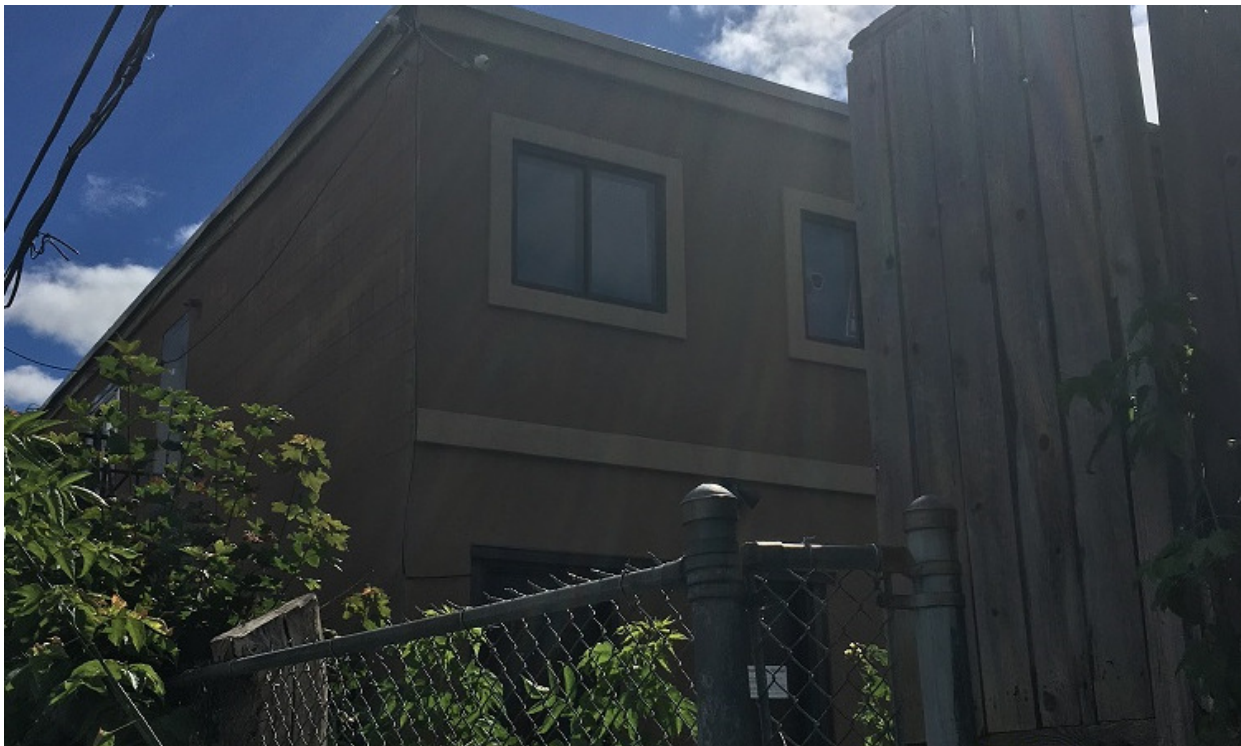
Photograph 4: View of commercial building adjacent to the southeast, facing southeast.

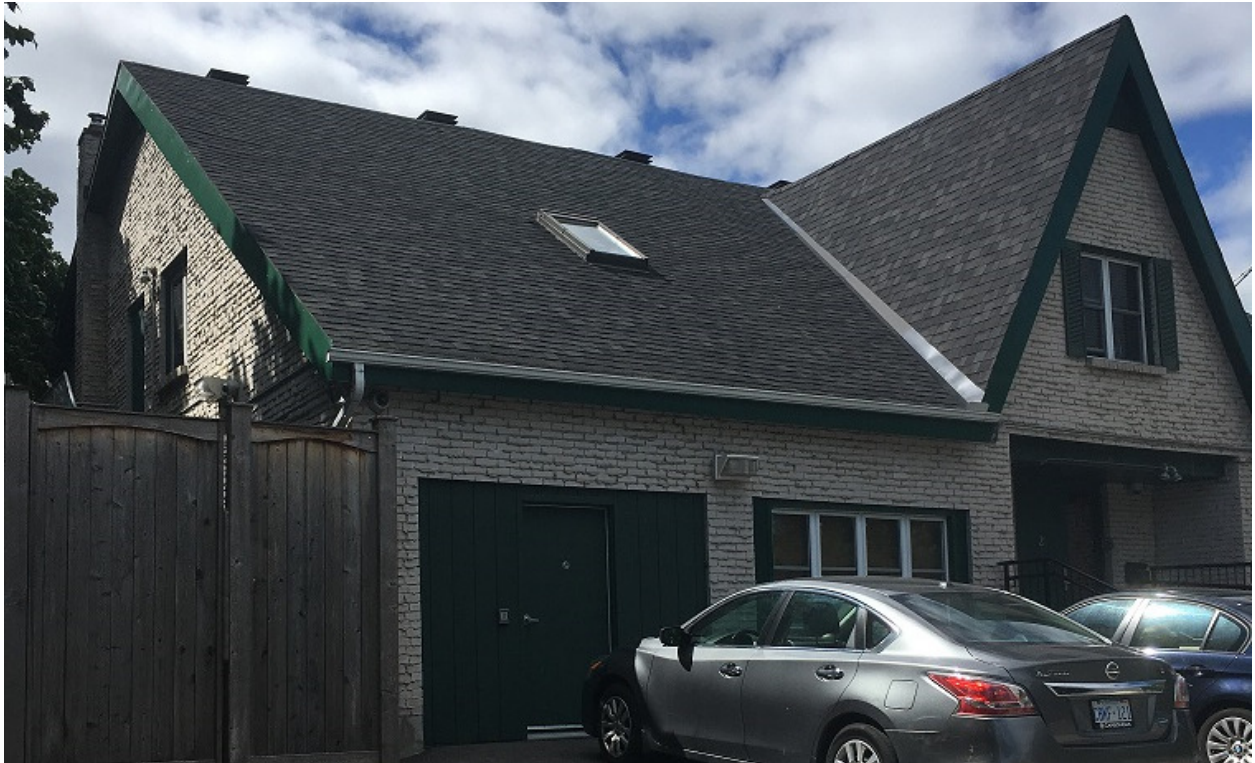
Photograph 5: View of residential property adjacent to the west, facing southwest.

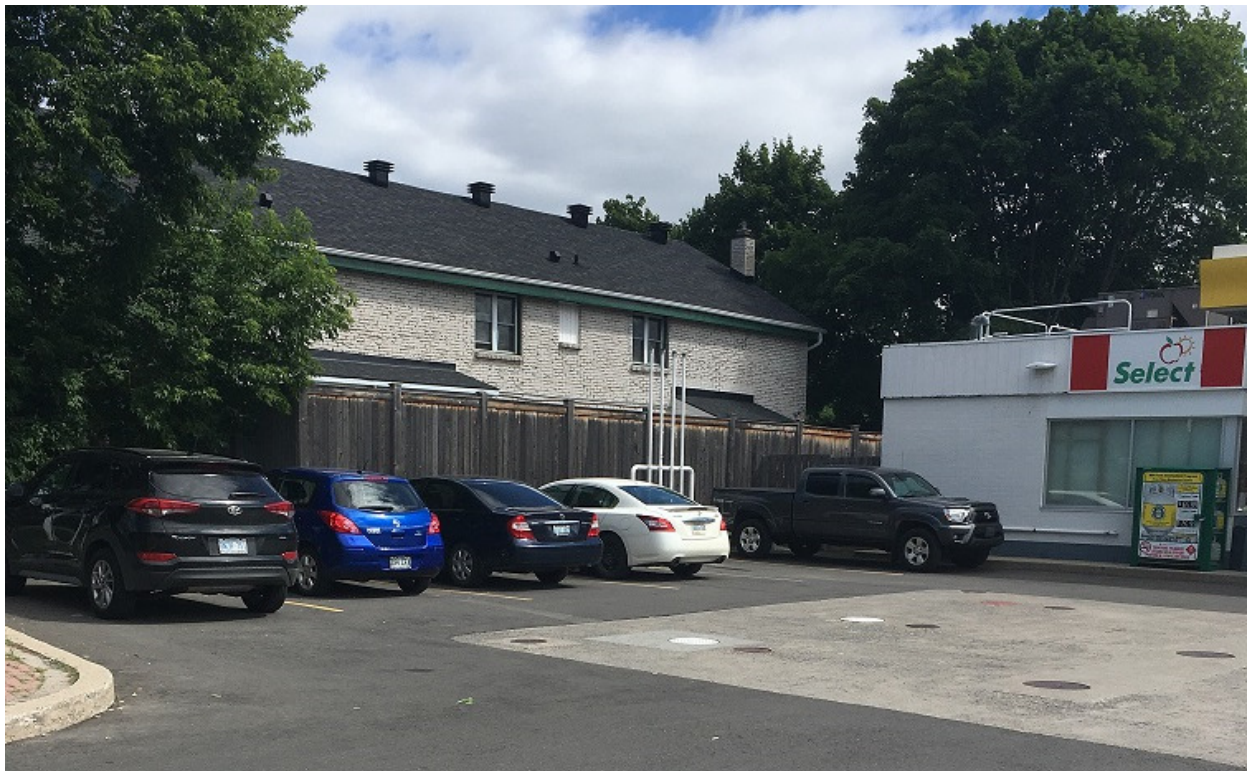
Photograph 6: View of underground fuel tank nest on retail fuel outlet property adjacent to the southwest of the Phase I Property, facing northeast.
