Phase One Environmental Site Assessment

1910 Bank Street, Ottawa, ON

Golder Associates Ltd.

November 2018

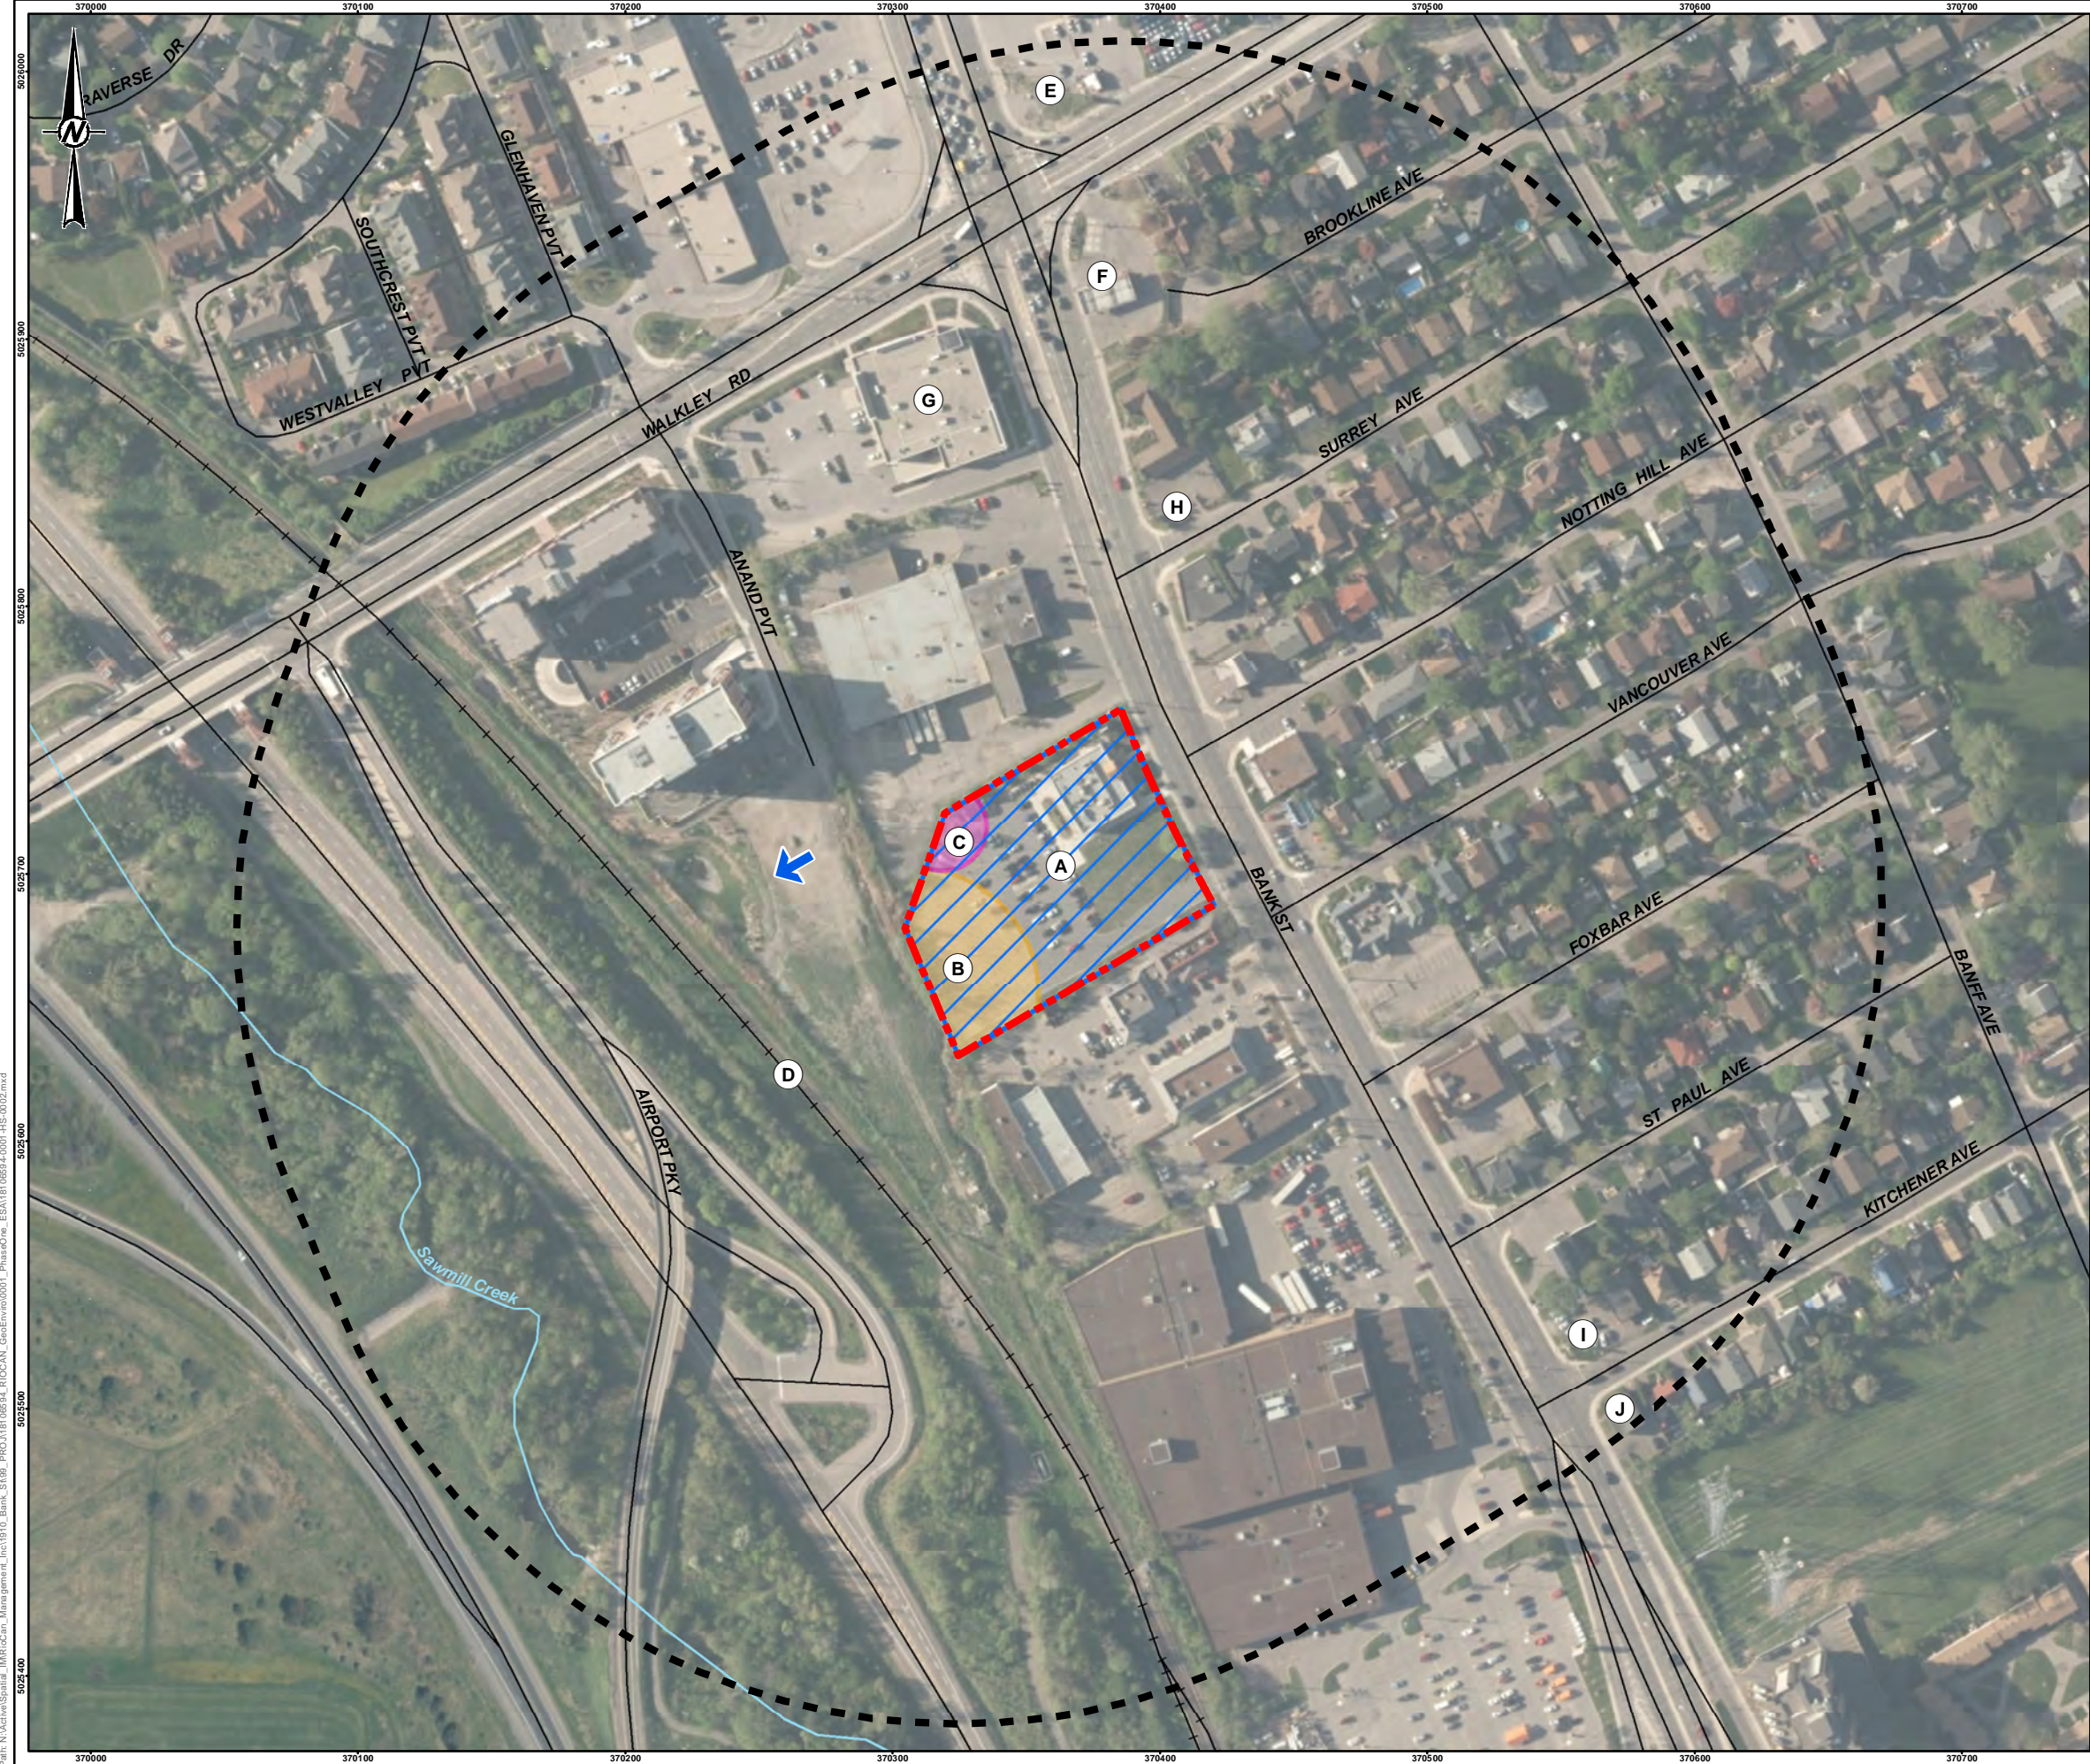
#10 Commercial Autobody Shops – A former Ford Truck sales and service centre was likely present on western portion of the Site in 1970s (shown as B on Figure 2).	Aerial Photographs, City directories	Auto service operations are considered a PCA due to potential impact to soil and groundwater due to possible spills, leaks and improper discharge. As such, it is considered to represent an APEC on the Site.

#55 Transformer Manufacturing Processing and Use – Concrete pad mounted transformer on the northwest portion of the Site (shown as C on Figure 2).	Site Observations	Use of a transformer is considered a PCA according to O.Reg 153/04, hence the pad mounted transformer is a PCA for the Site. Although no evidence of spills or stains were observed in the vicinity of the transformer, it is considered an APEC for the northwest portion of the Phase One Property given that the PCA is located on-Site.

Areas of Potential Environmental Concern ("APEC")		
APEC#	Detail	PCA#
1	Import of fill materials of unknown origin and quality	30
2	Commercial Autobody Shop (where chemicals were used and potentially spilled) on the western portion of the Site.	10
3	Concrete pad mounted transformer (potential for leakage and/or spill) on the western portion of the Site.	55

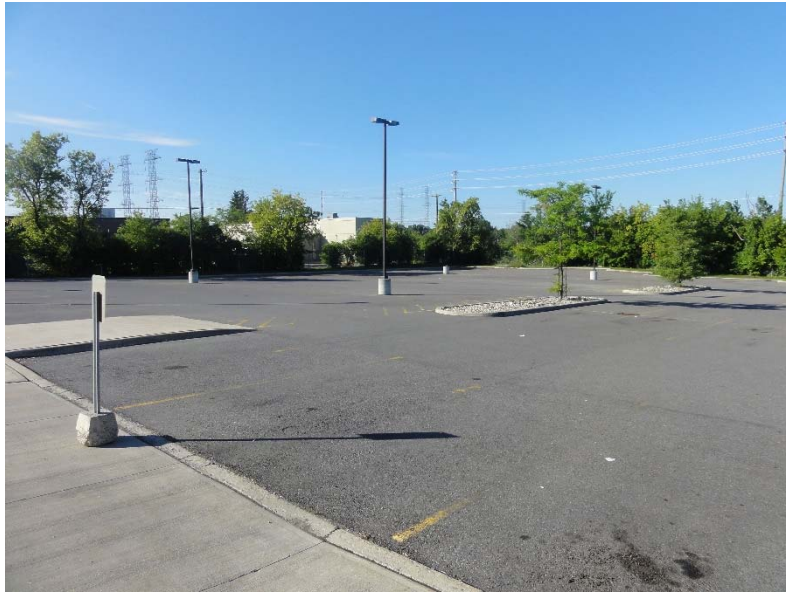
Photo 5 – General view of the asphalt paved parking area on the western portion of the Site.

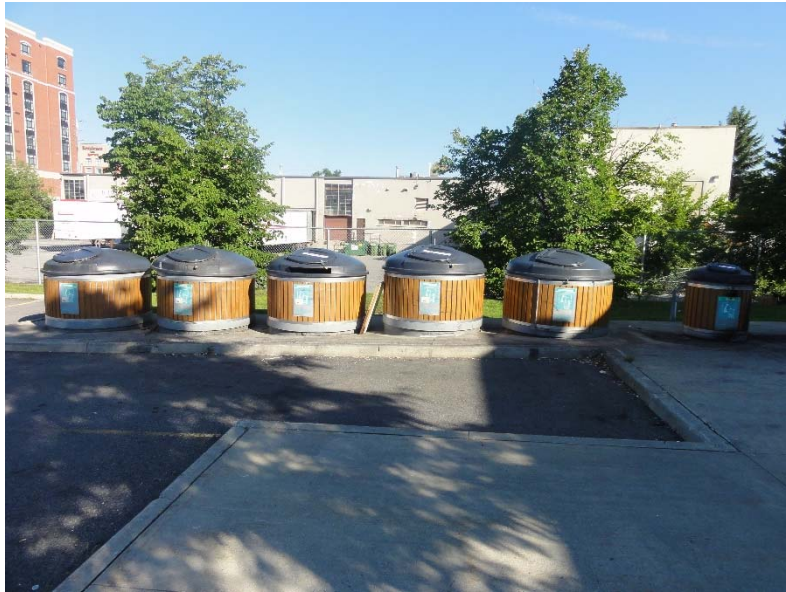
Photo 7 – View of recycling and waste collection bins located northwest of the Site Building.

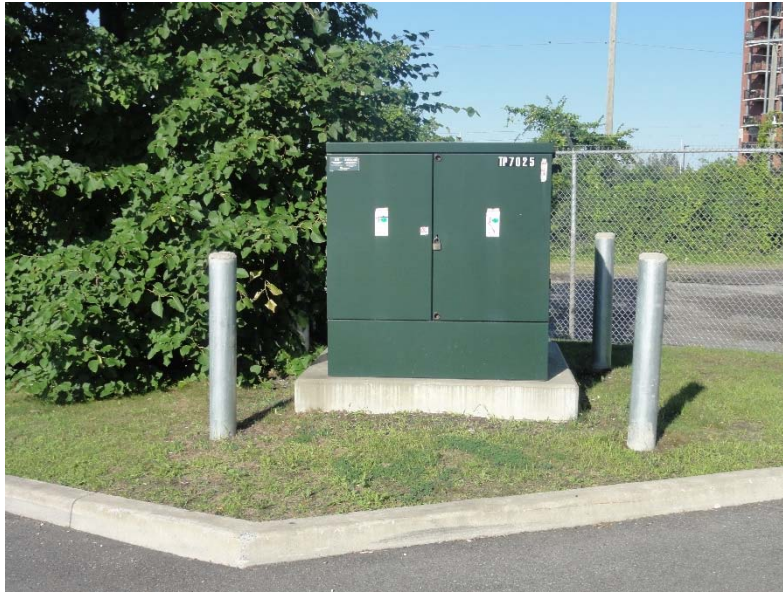
Topic	Observations	Source
Asbestos-Containing Materials (ACMs)	None observed at the time of the Site visit. Based on the age of the Site Building (constructed in 2011/2012), it is unlikely that ACMs is present at the Site.	Site observations
Polychlorinated Biphenyls (PCB) Containing Materials and Equipment	A concrete pad mounted transformer was observed on the northwest portion of the Site. In addition, two pole mounted transformers were located northeast and southeast of the Site (both across Bank Street). It could not be confirmed whether the pad mounted transformer and the two pole mounted transformers contain PCBs; however, no evidence of spills or leaks was noted in the area of the transformers. Also, no labels indicating whether the transformers are PCB-containing or not were noted on any of the transformers. However, use of a transformer is considered a PCA according to O.Reg 153/04 (PCA#55: Transformer Manufacturing, Processing and Use) and as such presence of the pad mounted transformer is considered an on-Site PCA.	Site observations

- Presence of a pad mounted transformer is considered a PCA according to O.Reg. 153/04 although no evidence of spills or stains were observed in the vicinity of the transformer at the time of the Site visit. Furthermore, given that the PCA is located on-Site, it is considered an APEC for the northwest portion of the Phase One Property due to potential subsurface impacts from leakage/spill of PCBs.

Photo 9 – View of the concrete pad mounted transformer on the northwest portion of the Site.

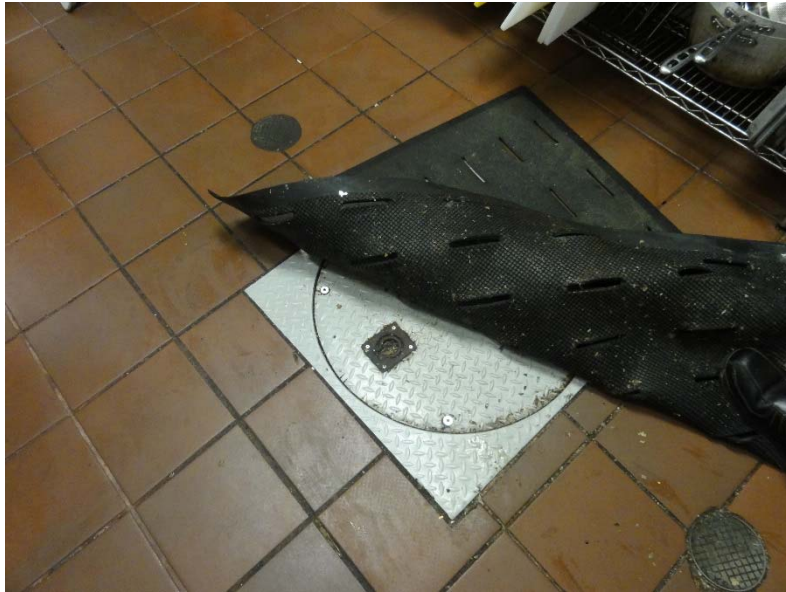
Photo 13 – View of grease trap located in the northwest portion of the Site Building.

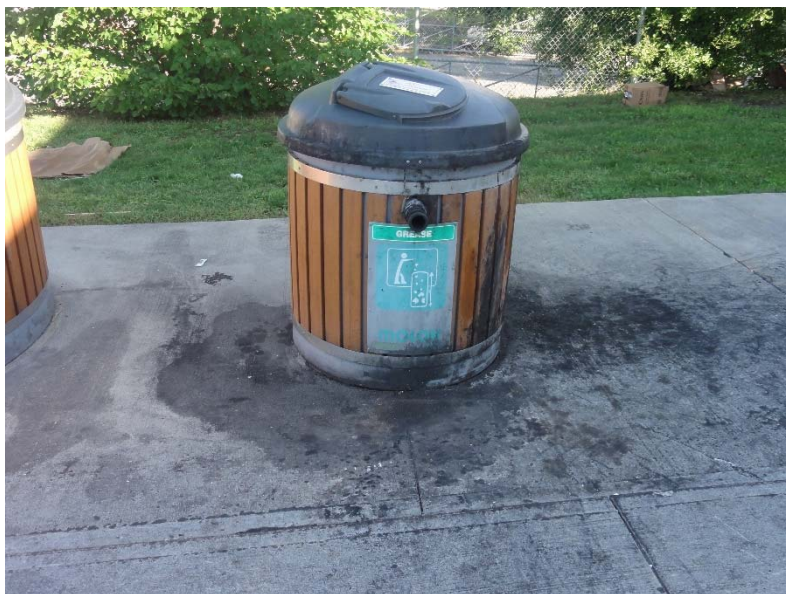
Unidentified Substances	None identified.	Site observations
Floor Stains or Corrosion Located near a Potential Discharge Location	No evidence of floor staining or corrosion were observed in the Site Building; however, some stains on concrete paved area in the vicinity of the grease bin was located northwest of the Site Building. There were no evidence of cracks on the concrete area in the vicinity of the stains that may provide access to subsurface. Given that the evidence of staining was associated with food grease/cooking oil generated from restaurant related operations at the Site and that no evidence of staining on the edge of the concrete paved areas and/or on the surrounding soil was observed at the time of the Site visit, these stains are not considered to be an issue of environmental concern for the Site.	Site observations
<u>Miscellaneous Exterior</u> Location of any Current and Former Wells	None observed on-Site; however, the Ecolog ERIS report indicated that two domestic water wells were located on the southern portion of the Site in 1949.	Site observations and Ecolog ERIS Report

Photo 14 – View of stains on concrete in the vicinity of the grease collection bin, located northwest of the Site Building.

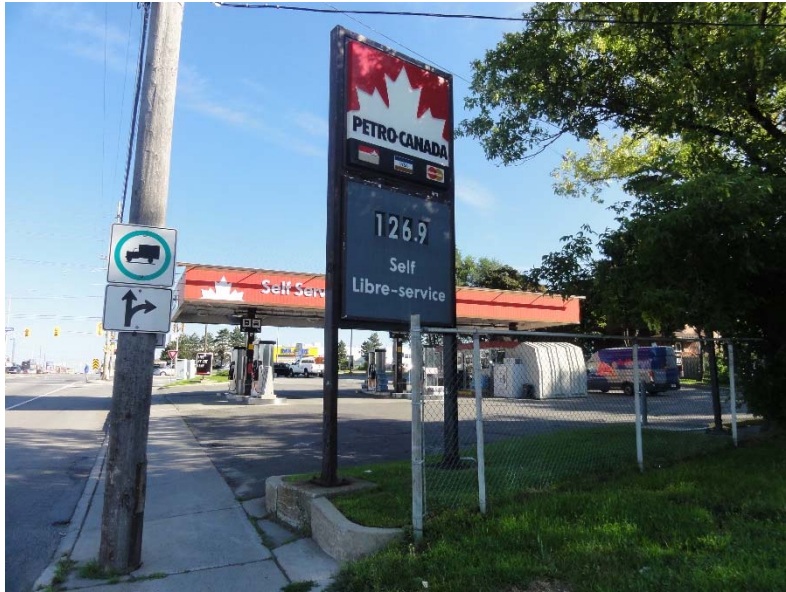
It was noted during the Site visit that a retail fuel outlet, an automotive garage and two car dealerships were located within the Phase One Study Area. The retail fuel outlet was located at 1847 Bank Street, approximately 145 m northeast of the Site. The automotive garage at 1981 Bank Street was located approximately 230m southeast of the Site. The two auto dealerships were located at 1919 Bank Street (east of the Site across Bank Street) and 1975 Bank Street (approximately 200 m southeast of Site). The presence of retail fuel outlet (1847 Bank Street) and automotive garage (1981 Bank Street) is considered to be off-Site PCAs for the Site. The car dealership at 1975 Bank Street did not appear to perform any auto servicing; however, based on historical activities at the Site including an automotive garage is considered as an off-Site PCA. Alternatively, the car dealership at 1919 Bank Street is not considered an off-Site PCA as it did not appear to perform any auto servicing operations and was not listed for any historical spills.

Photo 19 – View of a the gasoline service station at 1847 Bank Street, located approximately 145 m northeast of the Site.

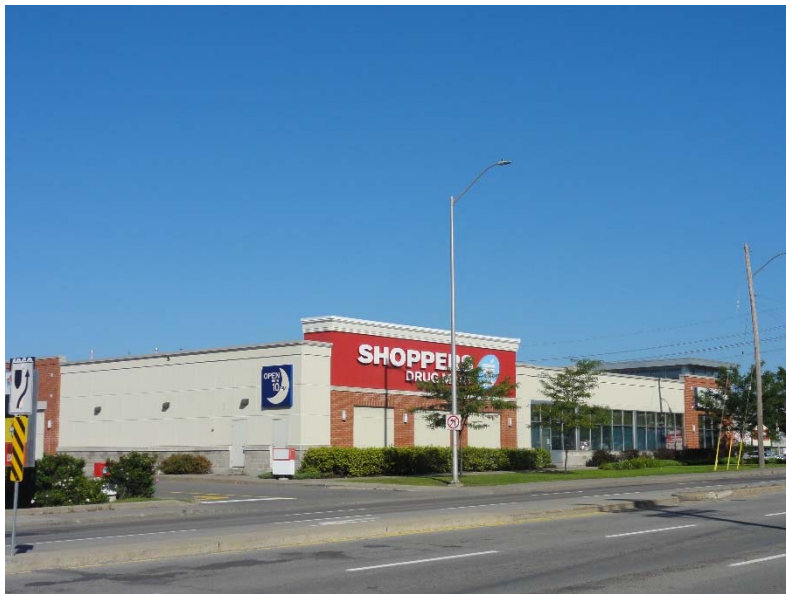
- 1850 Bank Street was listed as motor vehicle repair shops (located approximately 100 m north of the Site) between 1970 and 1999;
- 1835 Bank Street was listed as gasoline service station with three (3) associated USTs (located approximately 230 m northeast of the Site) in 1957;

Photo 20 – View of the former auto service (occupied by Nissan Walkley) at 1850 Bank Street, located approximately 100 m north of the Site.
