Combined Environmental Impact Statement &
Tree Conservation Report (Revised)
788 March Road, Ottawa, Ontario

December 2018
Prepared for 10731854 Canada Inc.

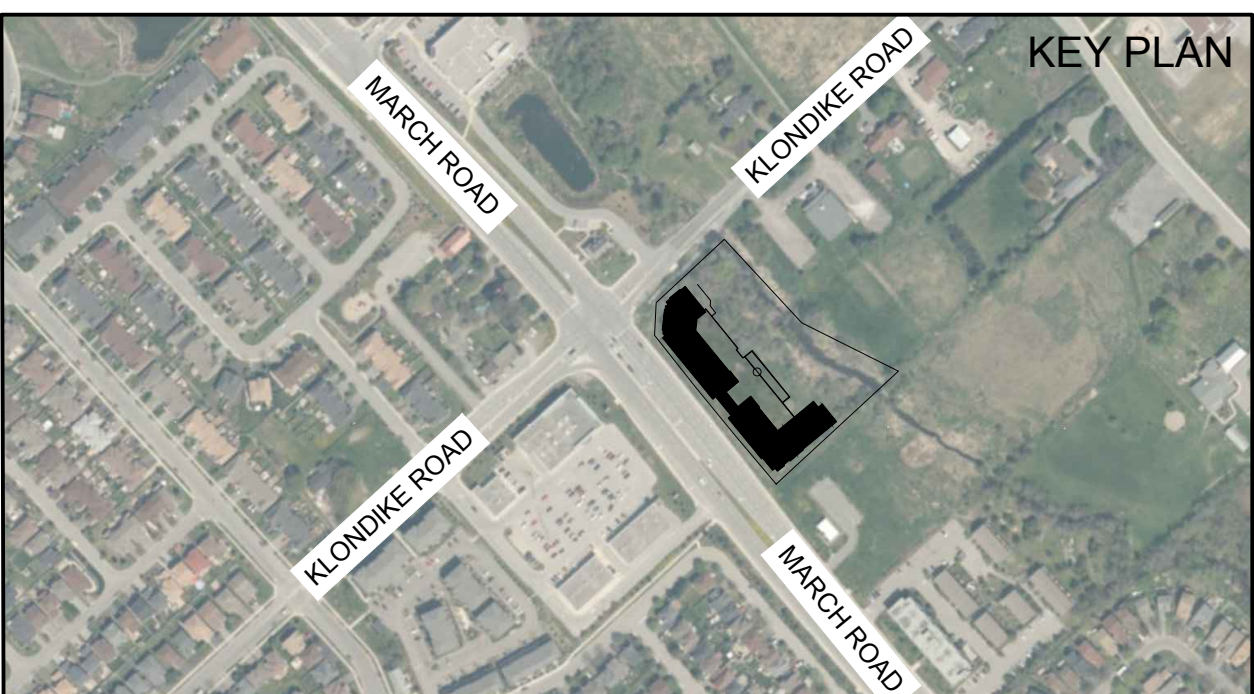
The proposed Site Plan is included below. The Site will be developed to include a six (6) storey residential building with approximately 196 units. The Site will be developed in two (2) phases, with the northern half of the Site developed first (Phase 1 – 95 units) and the southern half of the Site developed second (Phase 2 – 101 units). Phase 1 will include approximately twelve (12) surface parking spaces and Phase 2 will include approximately fourteen (14) surface parking spaces. Two (2) levels of underground parking will be included below the building. Vehicle entrances to the Site will be provided from Klondike Road and March Road, with pedestrian access from March Road. The Site Plan includes a 30 m setback from the normal high-water mark of Shirley's Brook. All existing vegetation within the 30 m setback will be retained. The Site will receive municipal sewer and water. Stormwater will be directed to the existing March Road storm sewer, which outlets to the existing SWMP Pond No.1 – West. The existing SWMP Pond No.1 - West was sized to provide quantity and quality control for the Site.

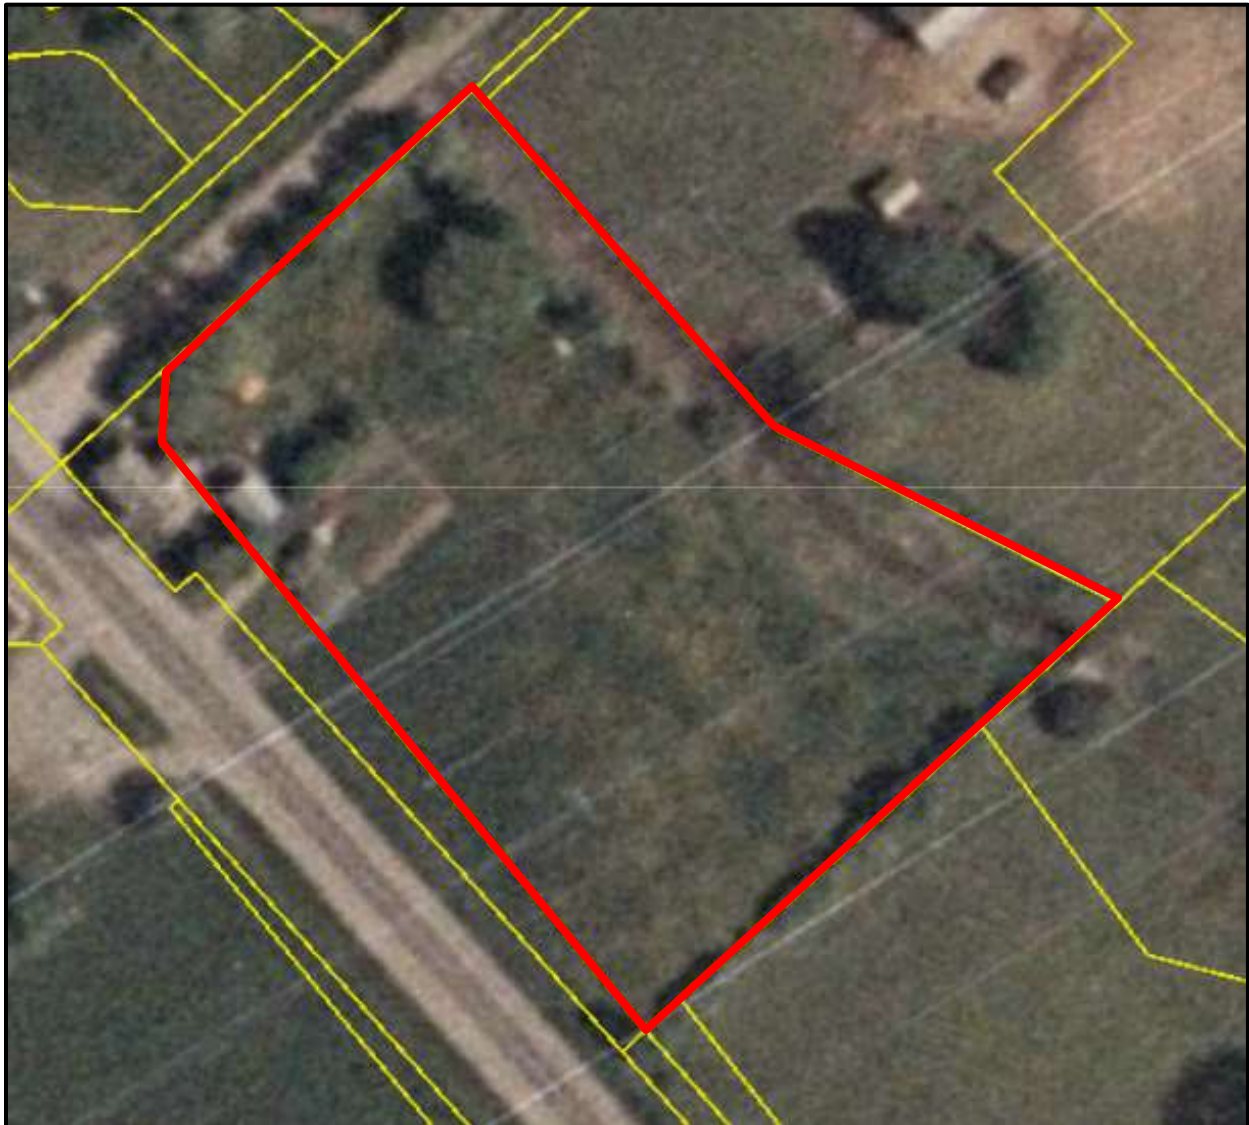
Historic Air Photograph 1: Historic Air Photo from 1976 (Site limits shown in red). Note the Site appears to be farmed and tree cover appears to be limited to hedgerows along the northern and southern property boundary in 1976. Tree cover is also present along the west side of Shirley's Brook in the northern part of the Site. The large Bur Oak found east of Shirley's Brook appears to be present in 1976. A farm house and agricultural buildings are also present in the northwest corner of the Site in 1976 (Photos from City of Ottawa 2018).

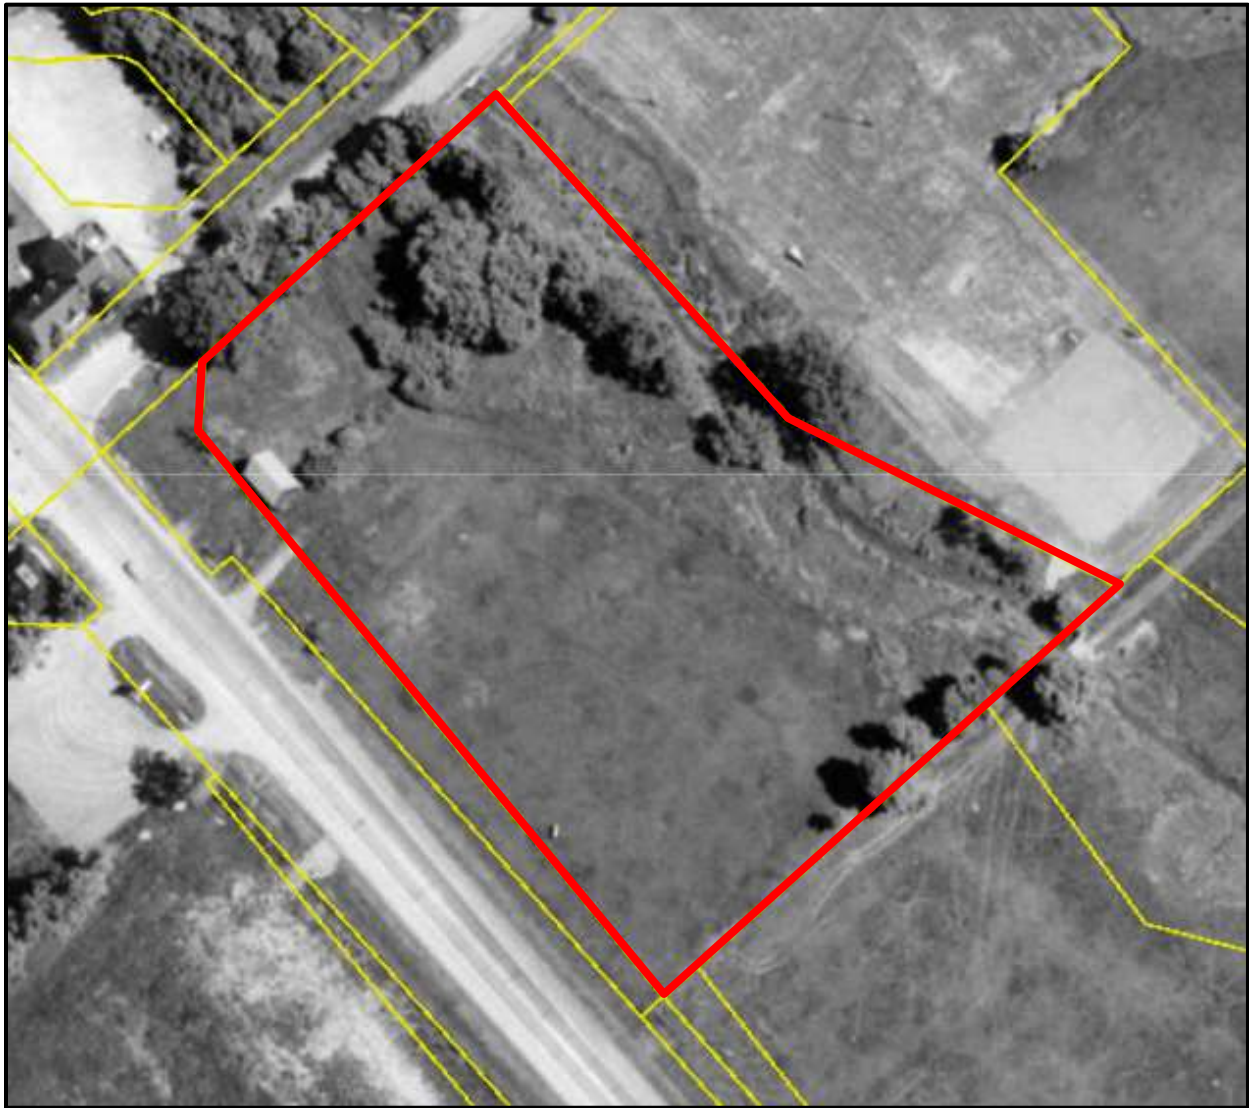
Historic Air Photograph 2: Historic Air Photo from 1991 (Site limits shown in red). Note the Site appears to be farmed and tree cover appears to be limited to hedgerows along the northern and southern property boundary in 1991. Tree cover is also present along the west side of Shirley's Brook in the northern part of the Site. The large Bur Oak found east of Shirley's Brook appears to be present in 1991. The farm house appears to have been demolished by 1991, although a barn remains (Photos from City of Ottawa 2018).

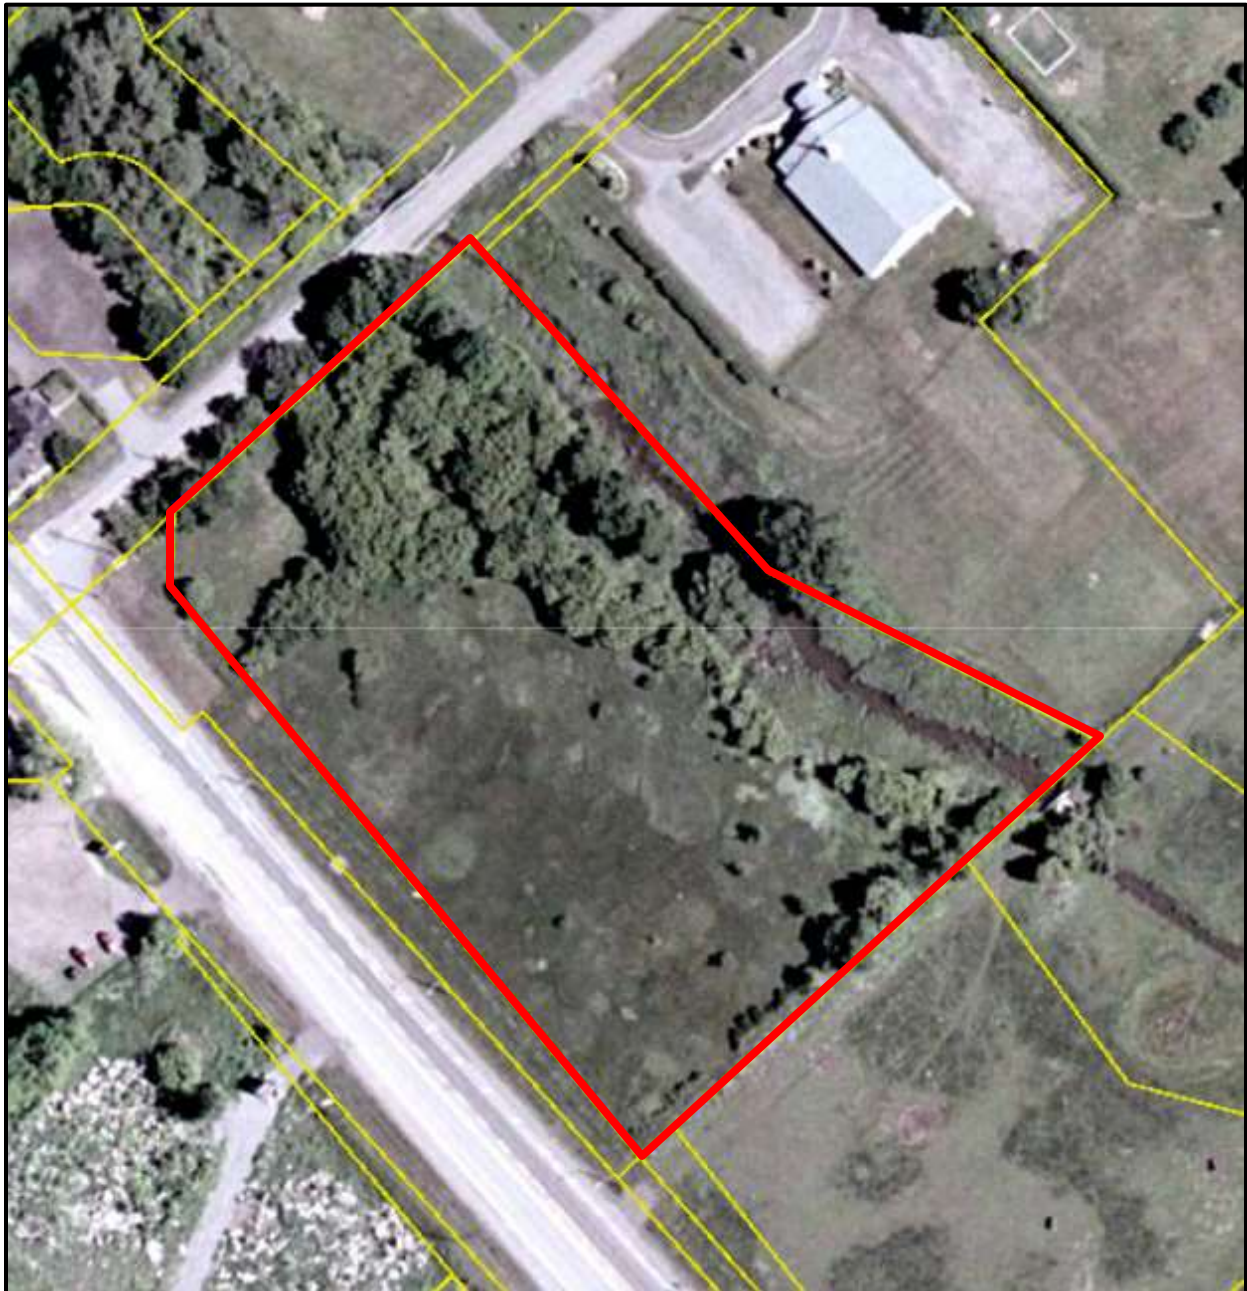
Historic Air Photograph 3: Historic Air Photo from 2005 (Site limits shown in red). Note the Site appears to be fallow and tree cover has expanded along the edge of Shirley's Brook and in the northern part of the Site. The large Bur Oak found east of Shirley's Brook continues to be present. All buildings within the Site have been demolished by 2005 (Photos from City of Ottawa 2018).

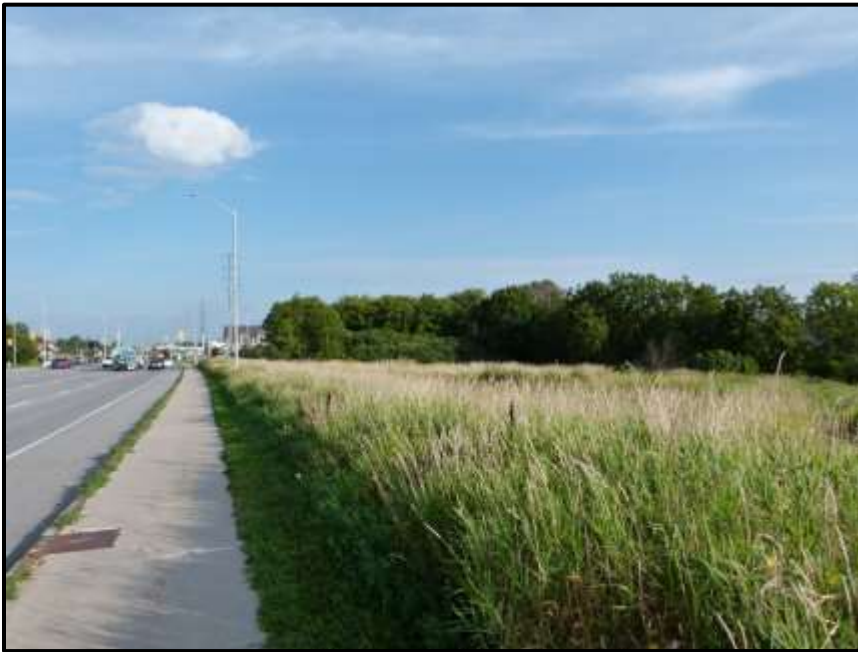
Photograph 1: Looking north along March Road (left). The Cultural Meadow (right) and the Cultural Woodlot (background) are shown (August 29th, 2017).

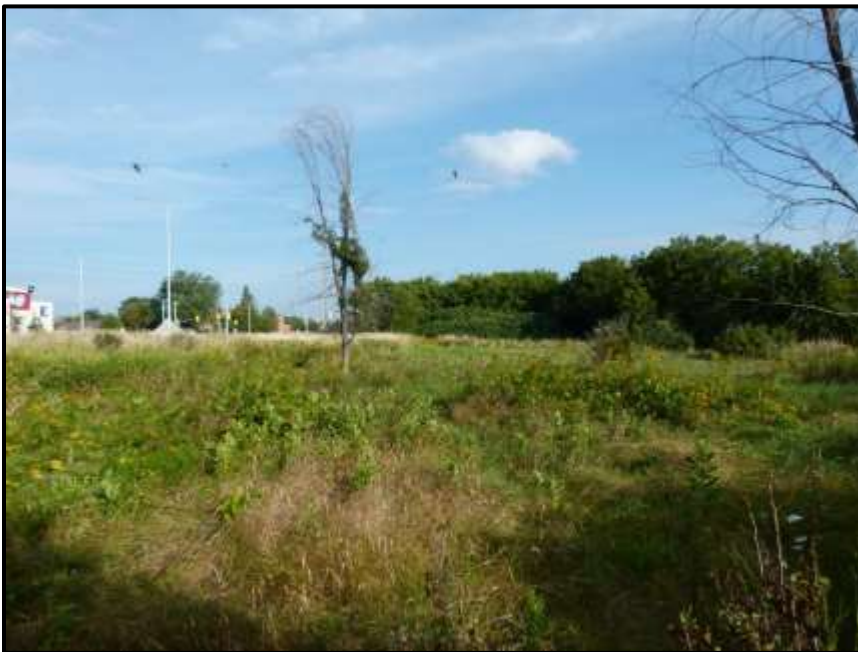
Photograph 2: Looking northeast at the Cultural Meadow and the Cultural Woodlot (background) (August 29th, 2017).

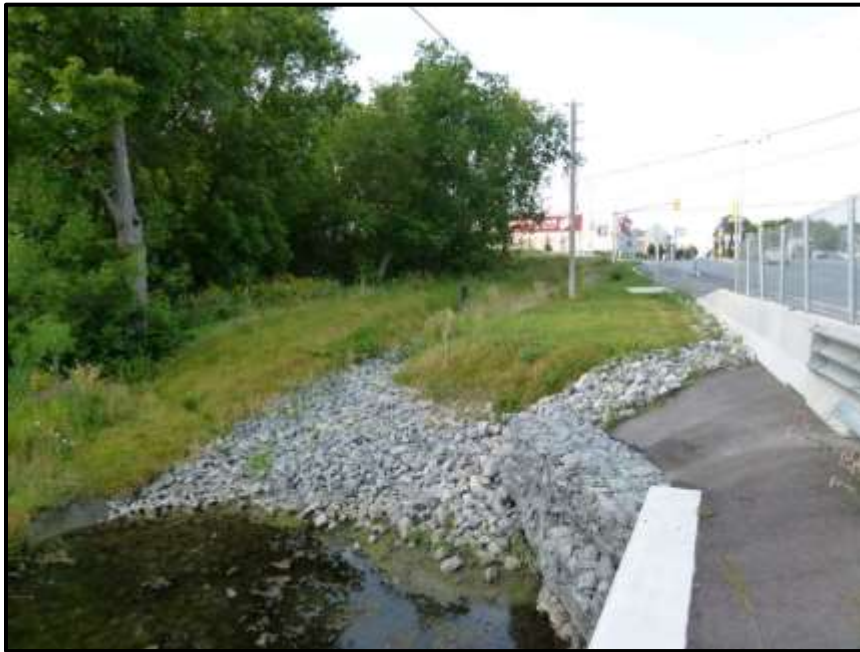
Photograph 3: Looking west from the culvert at Klondike Road (right). The Cultural Woodlot is on the left, a pool in Shirley's Brook at the Klondike Road culvert is shown in the foreground (August 29th, 2017).

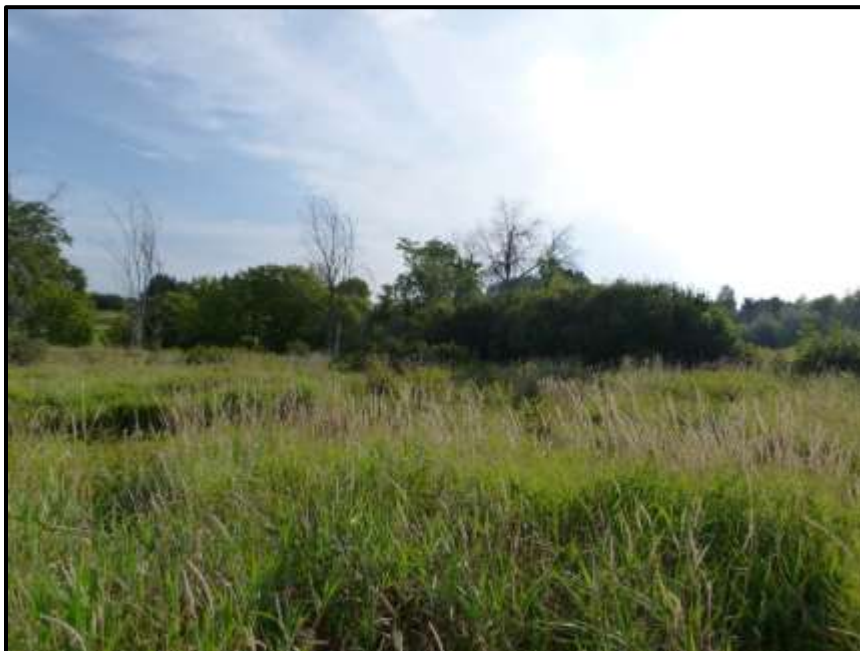
Photograph 4: Looking southeast at the Deciduous Hedgerow (August 29th, 2017).

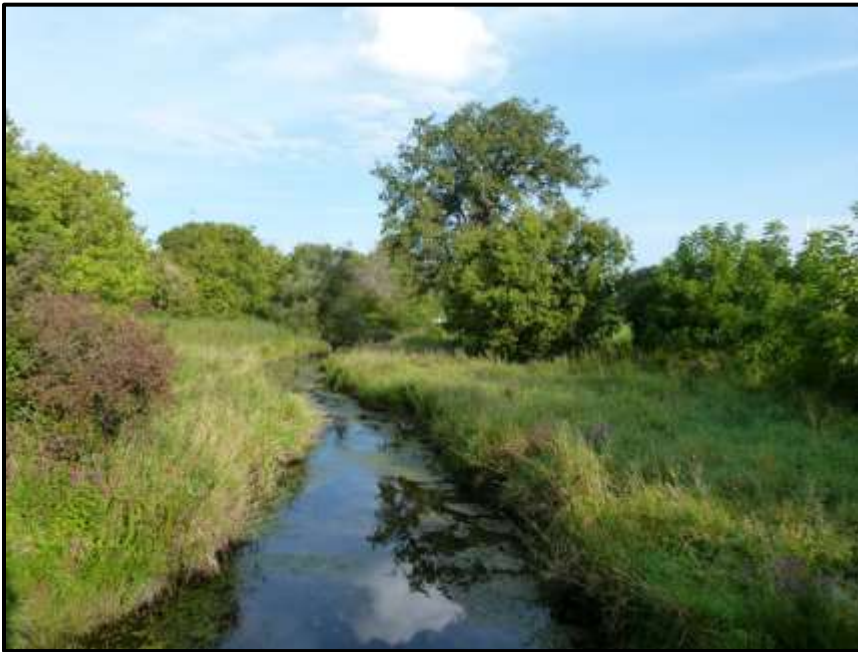
Photograph 5: Looking north along Shirley's Brook from the southern box culvert. Note the large Bur Oak on the east side of Shirley's Brook is visible on the right (August 29th, 2017).

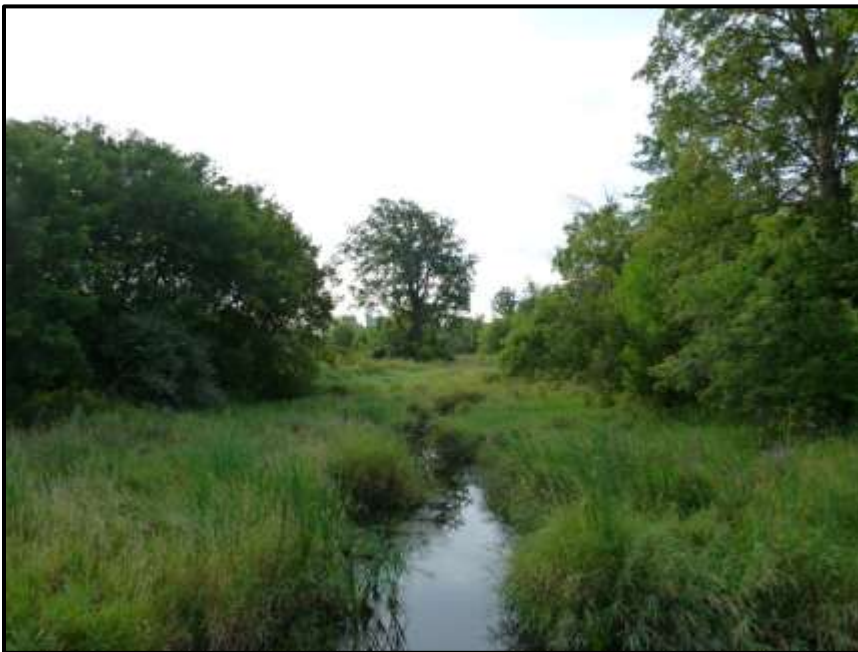
Photograph 6: Looking south along Shirley's Brook from the northern box culvert (Klondike Road). Riparian vegetation in the northern part of the Site is shown. Note the large Bur Oak on the east side of Shirley's Brook is visible in the center of the photograph (August 29th, 2017).

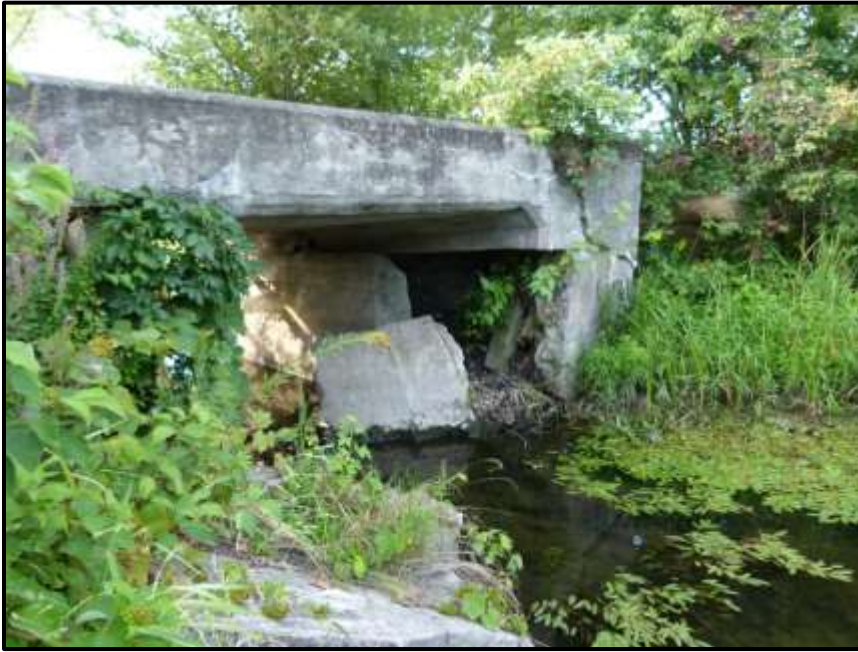
Photograph 7: The southern box culvert along Shirley's Brook (August 29th, 2017).

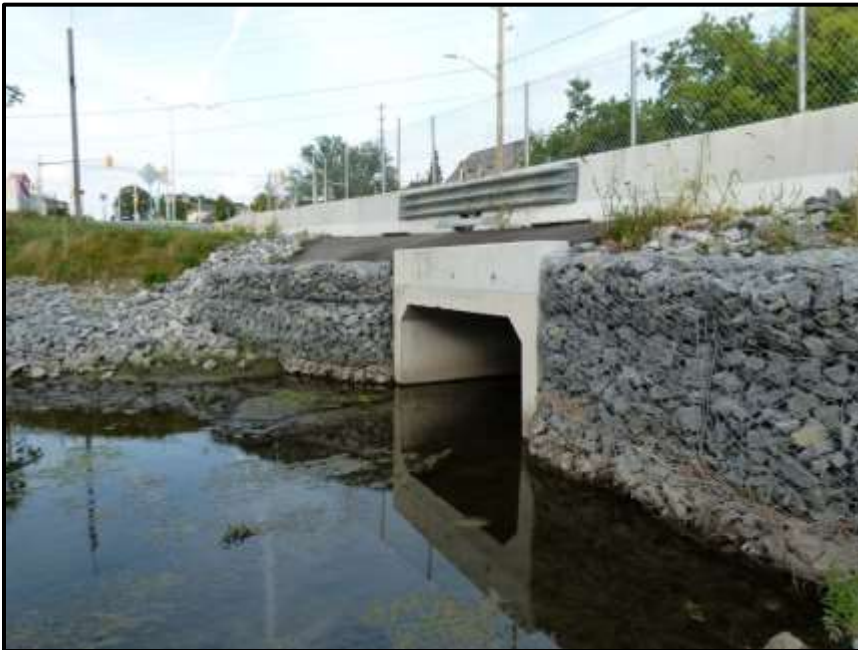
Photograph 8: The northern box culvert along Shirley's Brook at Klondike Road (August 29th, 2017).

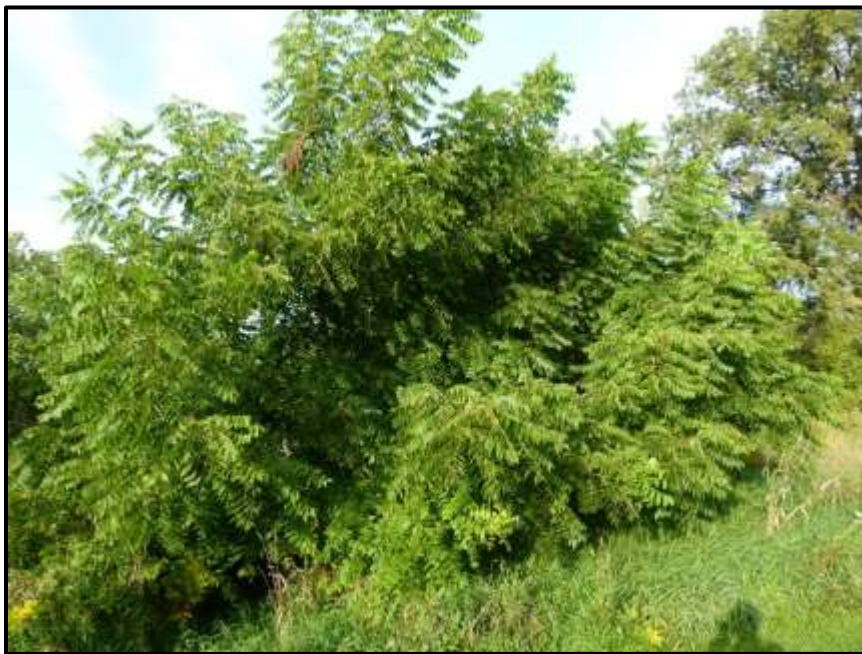
Photograph 9: Example of a Black Walnut found in the riparian corridor east of Shirley's Brook (August 29th, 2017).

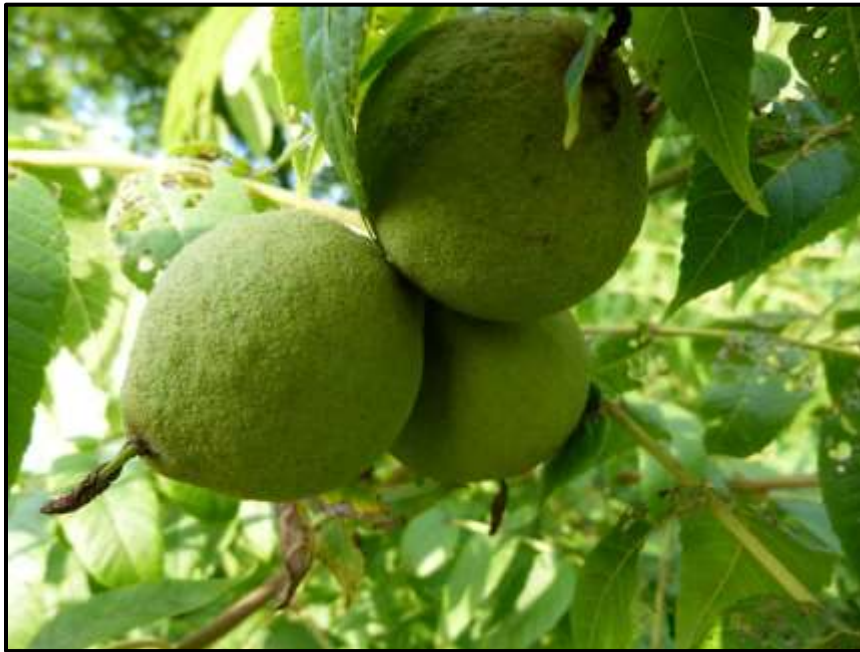
Photograph 10: Example of the Black Walnut fruit, photographed at the Site. The round shape and hairless fruit distinguishes Black Walnut from Butternut (August 29th, 2017).
