REPORT

Phase Two Environmental Site Assessment

2596 Carp Road, Ottawa, Ontario

1543767 RevA

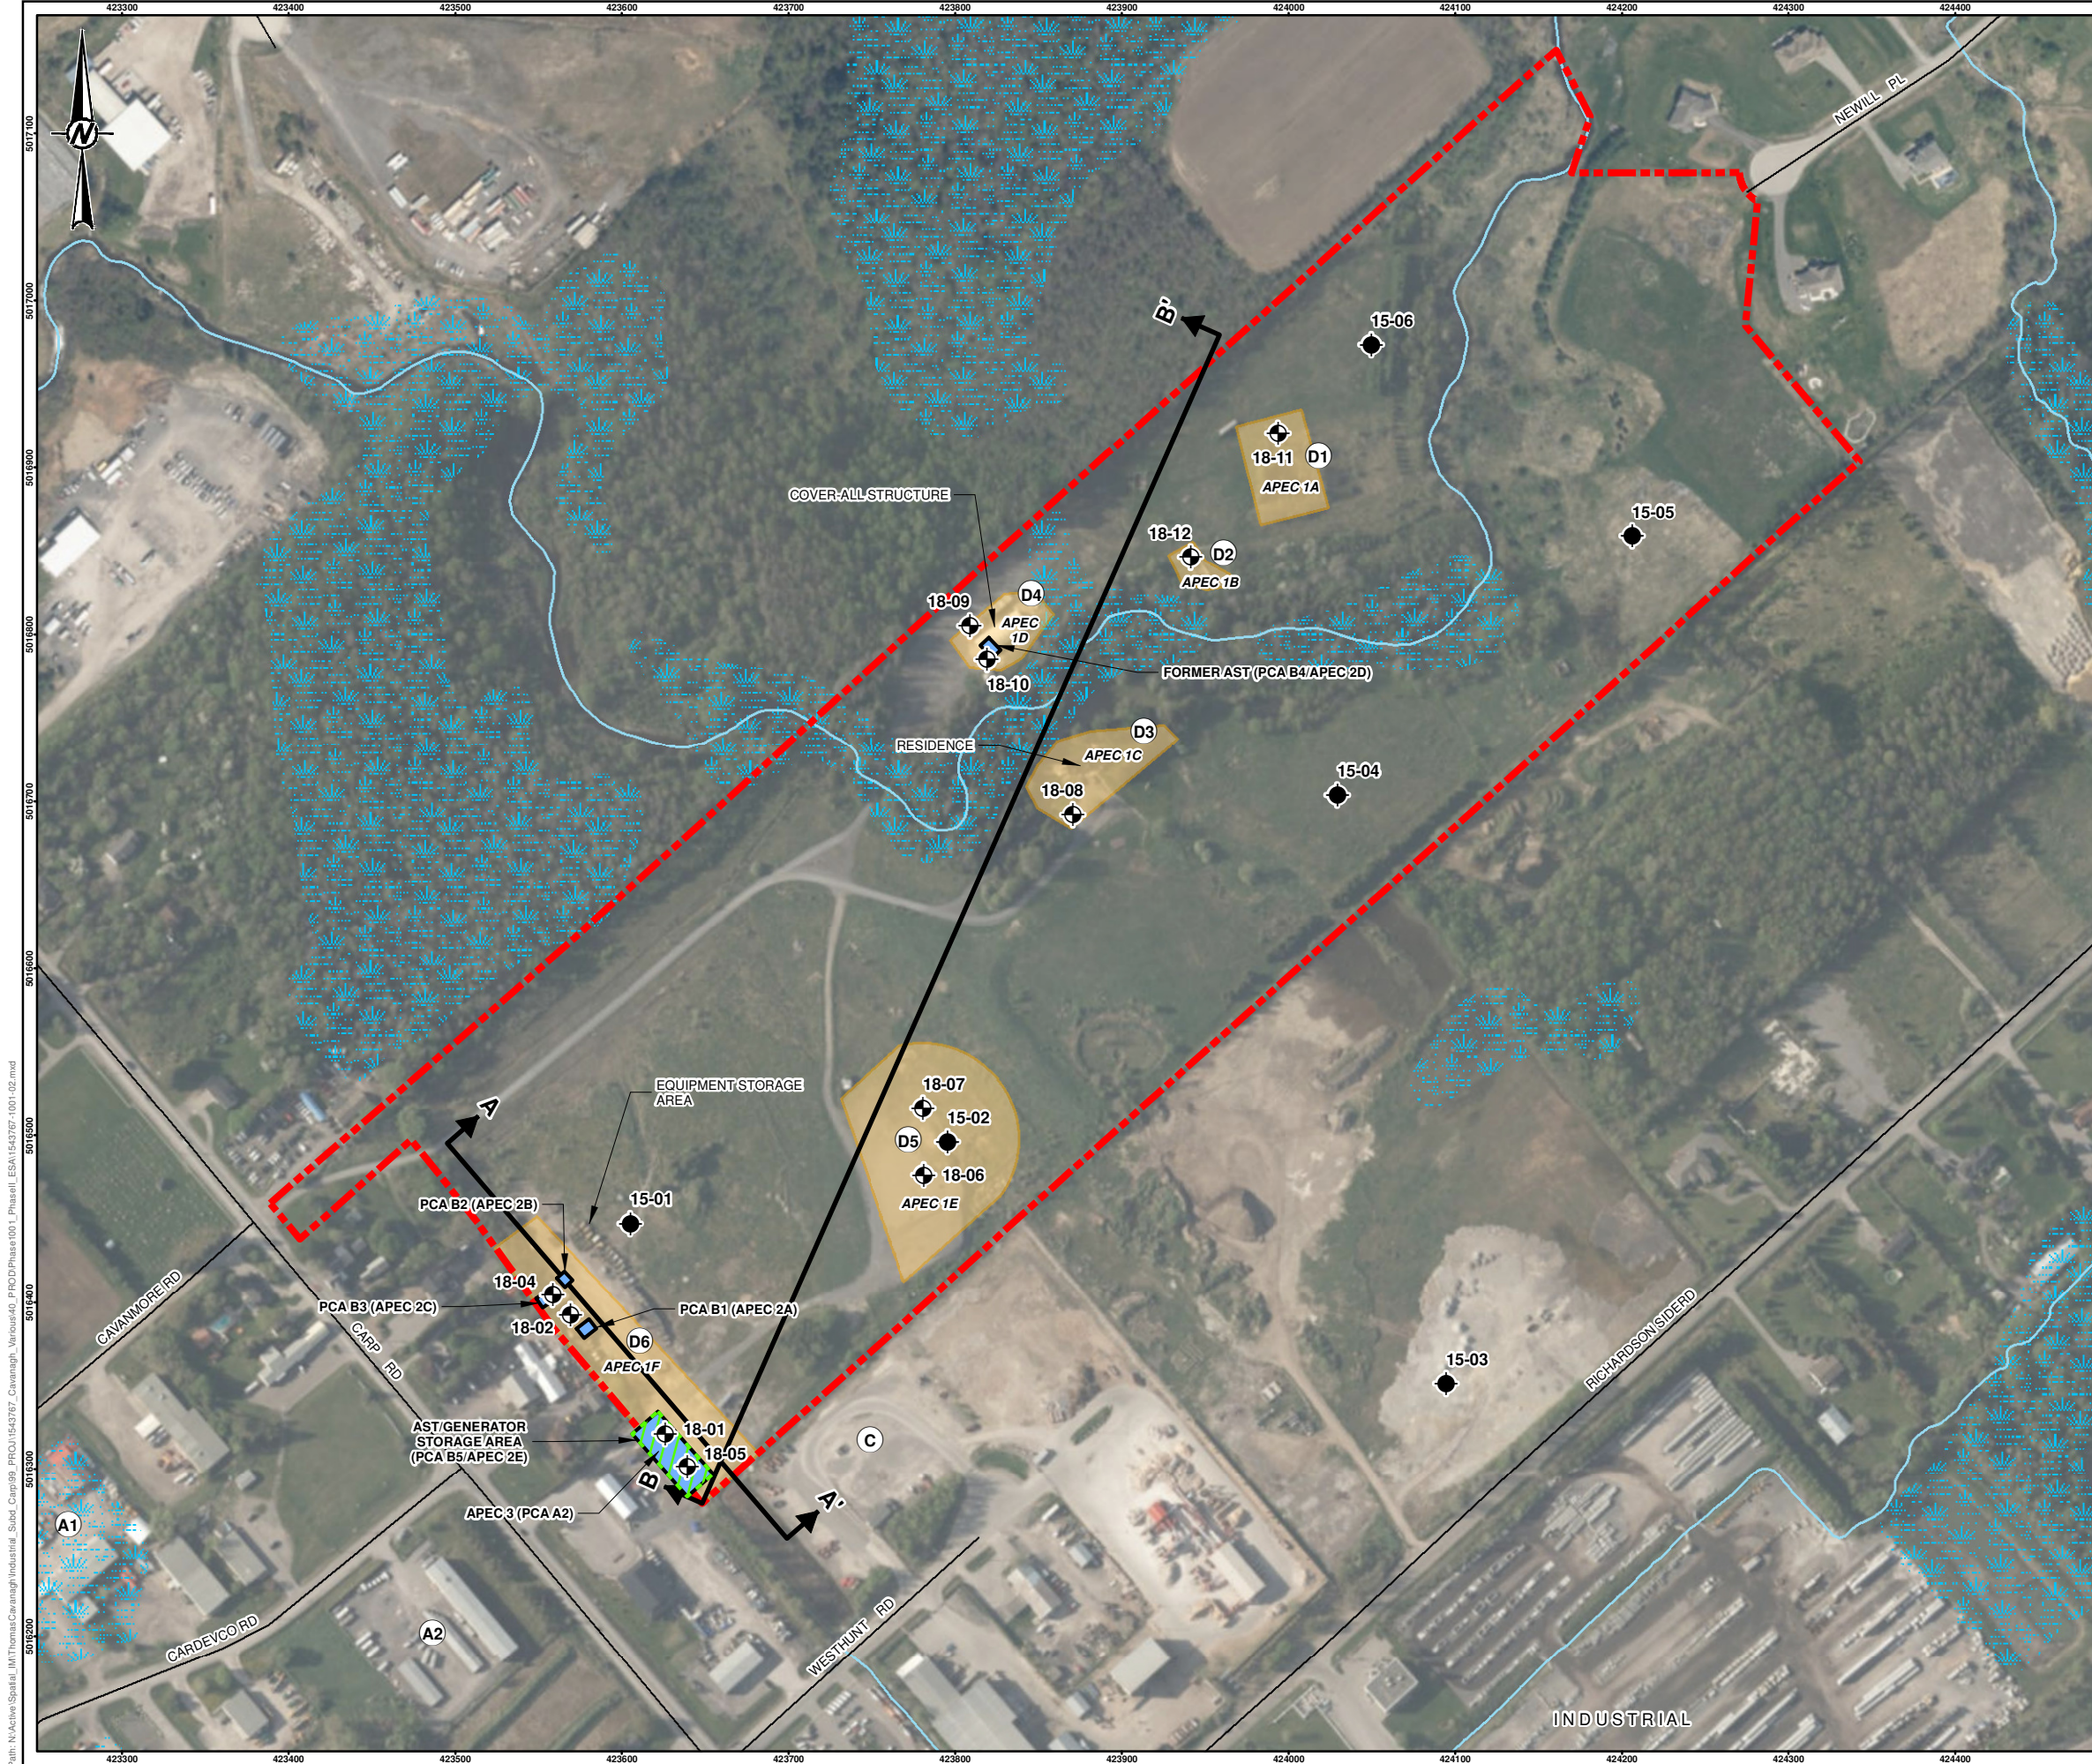
- At the time of the Site visit the surrounding properties along Carp Road include primarily commercial/industrial properties, west of which (Cardevco Road) there are additional commercial/industrial properties including automotive repair and metal fabrication. East of the Site is primarily vacant land and residential properties. South of the Site (south of Richardson Site Road) is MCon Precast Concrete products, a manufacturing property;
- PCAs were identified in the Phase One Study Area and tabulated below and are shown on Figure 2;

APEC locations are provided in Figure 2. The APECs where a contaminant is present on, in or under the Phase Two Property at a concentration greater than the applicable site condition standard, along with the contaminants present in each environmental medium, are identified in the following table.

Building structures located on the Site are shown on Figure 2. The Site residential building is constructed with a basement. The depth and location of building foundations and footings are unknown.

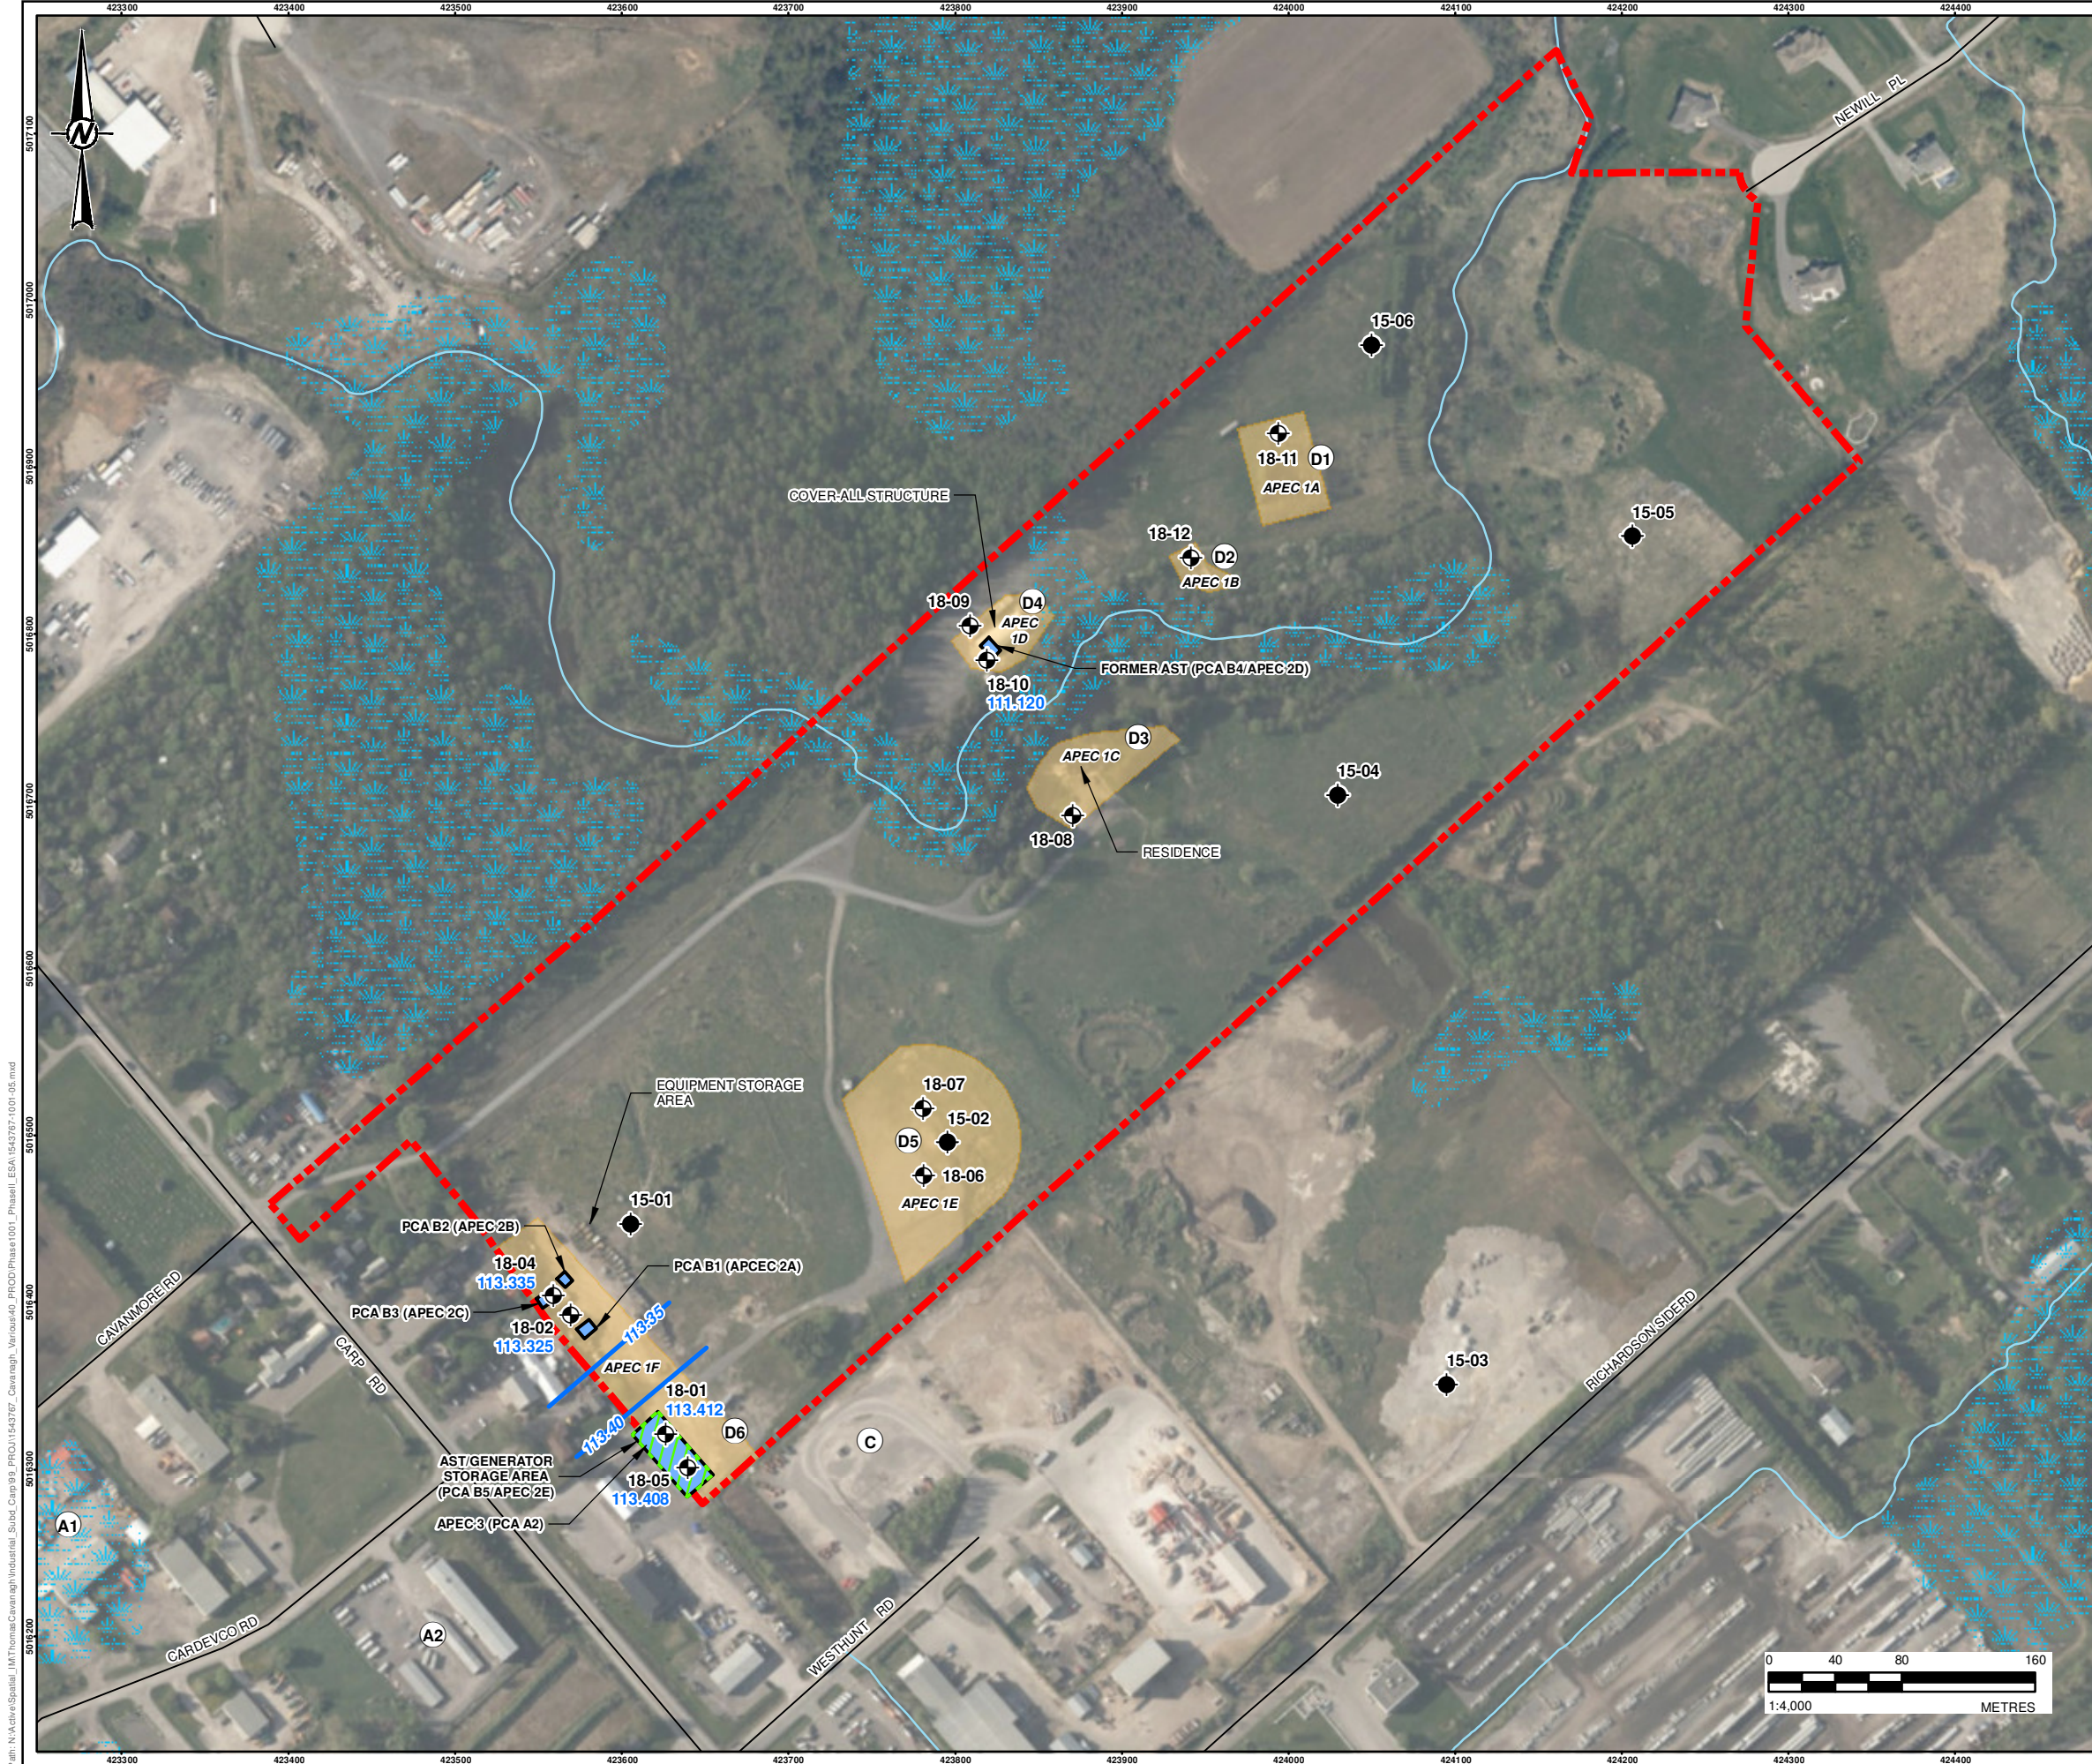
Static groundwater levels were measured in the monitoring wells located across the Site on August 27, 2018. Figure 5 shows August 27, 2018 groundwater elevations, however it is noted that monitoring wells are placed in a linear fashion in this area and a true representation of groundwater flow based on these points cannot be determined. Groundwater elevations at the Site ranged from 111.120 mald (MW18-10) to 113.412 mald (MW18-1) and were encountered at depths of 2.26 to 1.49 mbgs, respectively.

The horizontal hydraulic gradient was estimated for shallow groundwater conditions in the Equipment Storage and AST/Generator Storage Areas based on water levels collected on August 27, 2018, and the inferred groundwater contours are presented on Figure 5. The estimated horizontal hydraulic gradient for shallow groundwater conditions was calculated to be 0.001 m/m between monitoring wells MW18-5 and MW18-4.

The elevations of the potentiometric surface at each monitoring well are summarized in Table 2. Groundwater elevations at the Site ranged from 113.412 to 111.120 masl (1.49 to 2.26 mbgs) on August 27, 2018. Static groundwater levels were measured in the monitoring wells located across the Site on August 27, 2018. Figure 5 shows August 27, 2018 groundwater elevations; however, it is noted that monitoring wells are placed in a linear fashion in this area and a true representation of groundwater flow based on these points cannot be determined. Groundwater flow is inferred to be towards the southeast near the Cover-All Structure where groundwater is inferred to be flowing towards the watercourse based on local topography.

The horizontal hydraulic gradient was estimated for shallow groundwater conditions in the Equipment Storage and AST/Generator Storage Areas based on water levels collected on August 27, 2018, and the inferred groundwater contours are presented on Figure 5. The estimated horizontal hydraulic gradient for shallow groundwater conditions was calculated to be 0.001 m/m between monitoring wells MW18-5 and MW18-4.
