# Phase ONE Environmental Site Assessment

## 24 Hawthorne Avenue

## Ottawa, Ontario

*OCP-17-0197*  
*April 2017*

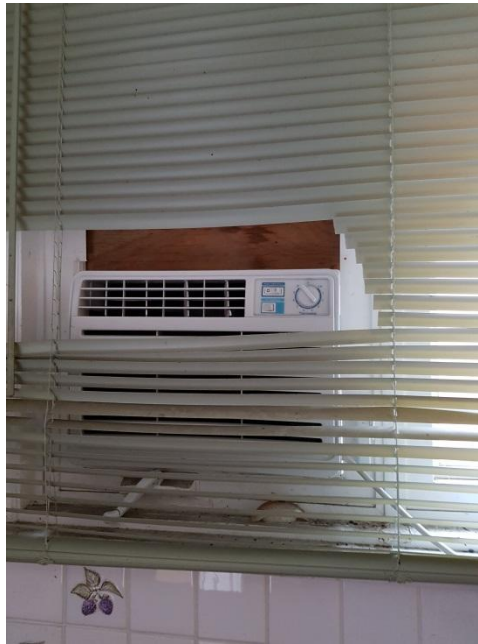
The on-site residential dwelling is cooled by two window air-conditioning units.

Photograph 5. Interior of 24 Hawthorne Ave – window-mounted air conditioning unit

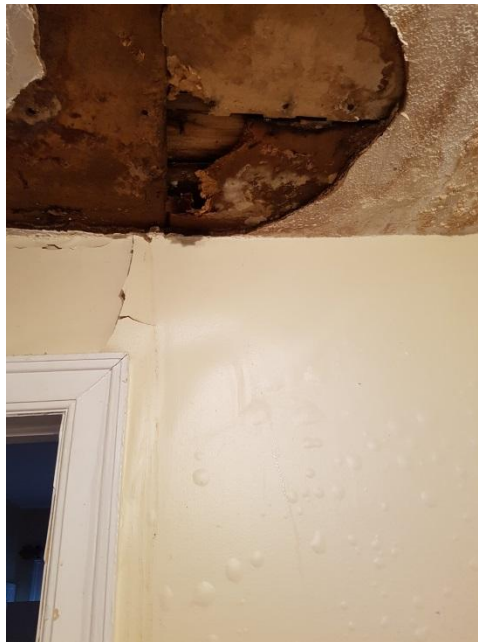
Mould or mould-like substances were observed in the basement and upper level of the residential dwelling. These areas appeared to have been impacted by water damage.

Photograph 12. Interior of 24 Hawthorne Ave – second floor water damage

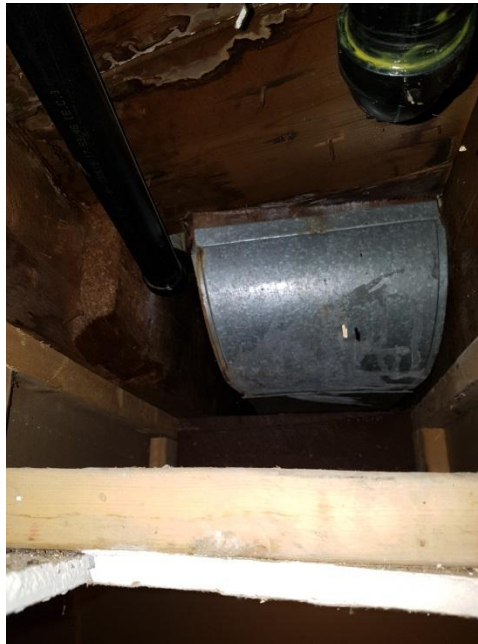
Photograph 15. Interior of 24 Hawthorne Ave – interior of basement ductwork

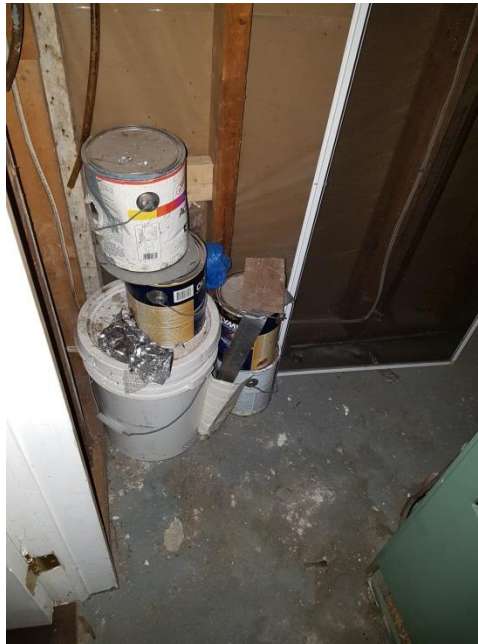
Photograph 17. Interior of 24 Hawthorne Ave – minor storage of paint in basement

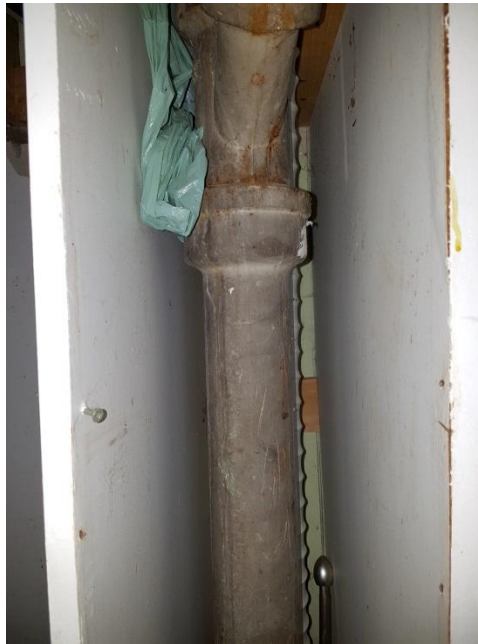
Photograph 19. Interior of 24 Hawthorne Ave – pipe in basement

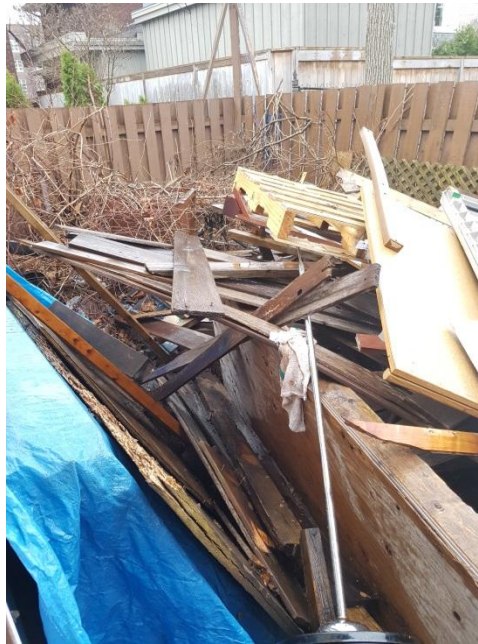
Some fill from the adjacent property (22 Hawthorne Avenue) was observed to have been placed onto the on-site driveway. A significant amount of wood and metal debris was observed in an outdoor, enclosed area immediately west of the shed/garage.

Photograph 23. Exterior of 24 Hawthorne Ave – wood and metal debris, adjacent to garage/shop

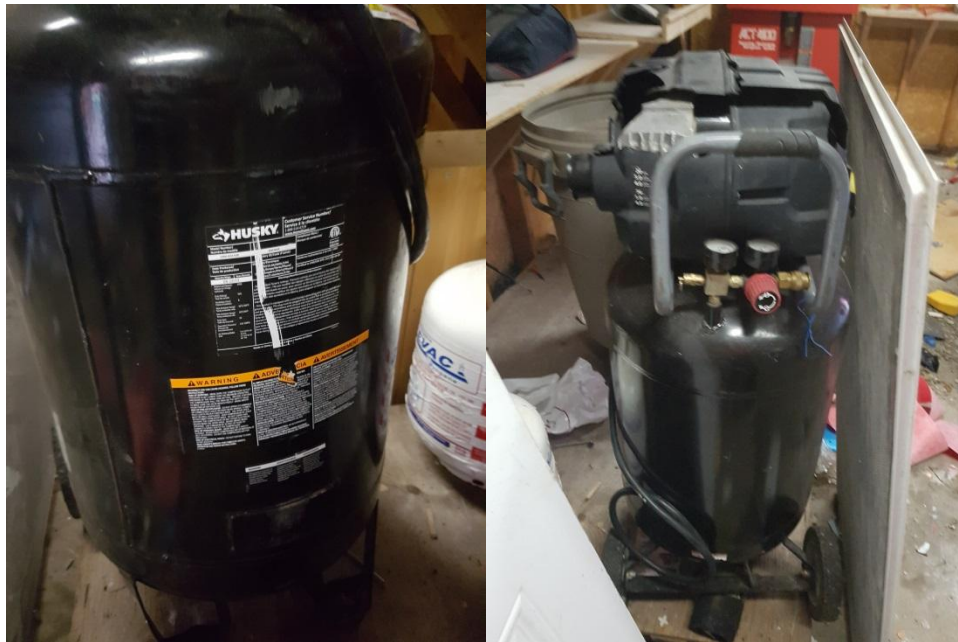
No Potentially Contaminating Activities (PCAs) were observed at the Site. In the past, the shed/garage may have been used to store automotive repair equipment (i.e. refrigerant refill station and pressurized gas canister refill station); however this storage in itself does not constitute a PCA.

Photograph 30. Interior of garage/shop – pressurized gas refill station

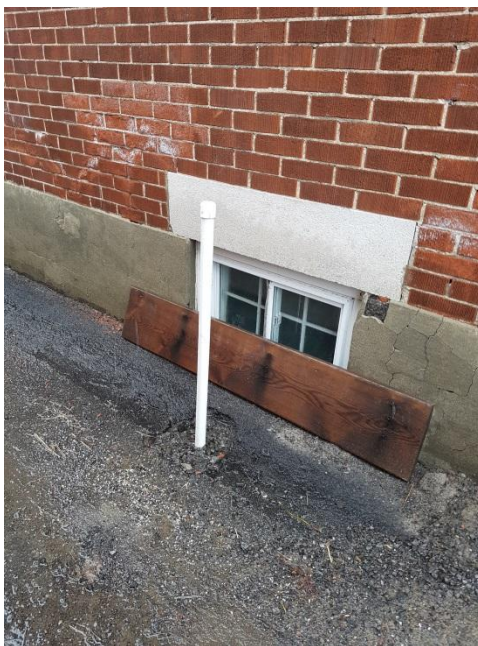
One well was observed on-site, near the southwest corner of the house, and two wells were observed near the property boundary between 22 and 24 Hawthorne Avenue. Nine additional monitoring wells were observed on 22 Hawthorne Avenue. No further information was available concerning these monitoring wells at the time of writing this report. However, it is our understanding that a Phase 2 ESA report is being completed for the adjacent property. It is recommended that McIntosh Perry be provided with this report, if possible, upon its completion.

Photograph 31. Exterior of 24 Hawthorne Ave – view of monitoring well installed by others, along southwest wall of residential structure

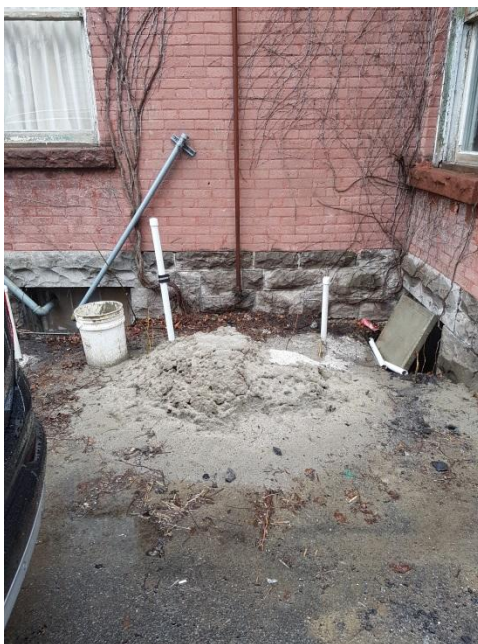
22 Hawthorne Ave	Fuel oil leak	200 L of fuel oil was leaked from an above-ground oil storage tank on November 18, 2016. It appears that subsurface investigations of soil and groundwater are currently ongoing at 22 Hawthorne Ave.  Adjacent/0 m from the Site

The above-noted APEC is indicated on Figure 6. It was noted that during the Phase One ESA Site Inspection, McIntosh Perry observed approximately eleven monitoring wells and evidence of soil investigations at 22 Hawthorne Avenue. Given TC United's relationship with the owner of 22 Hawthorne Ave, McIntosh Perry has requested that TC United obtain a copy of a Phase 2 ESA, for the observed adjacent site investigations.

Photograph 32. 22 Hawthorne Ave – view of northeast wall from 24 Hawthorne Ave asphalt driveway; possible location of former oil tank (excavation cuttings and monitoring wells present)

Based on the on-site APEC as a result of the 2016 leakage of 200 L of fuel oil from an above ground storage tank at 22 Hawthorne Avenue (adjacent to Site), McIntosh Perry recommends that,

- A scoped Phase 2 ESA be carried out to assess the condition of soil and groundwater along the southwestern property line; or
- A copy of any existing Phase 2 ESA completed for 22 Hawthorne Avenue be obtained, reviewed by a qualified third party, and be relied upon in the form of a reliance letter written by the author of the original Phase 2 ESA report.

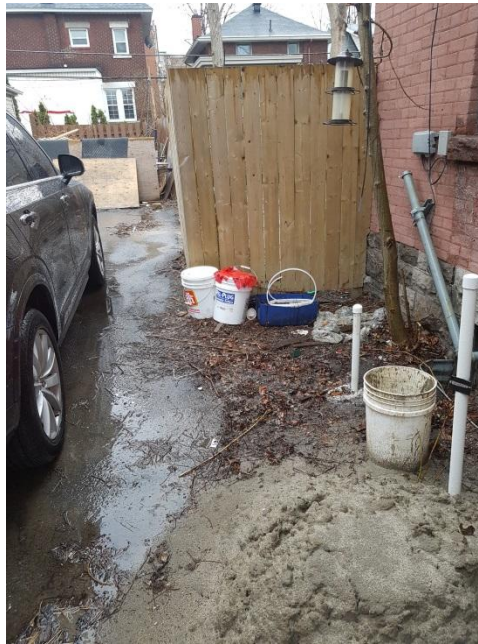
No significant fill material of unknown quality was observed at the Site. Some fill material, which appeared to have been excavated from the east wall of an adjacent property (22 Hawthorne Avenue), was present along the property line during McIntosh Perry's Site visit. Given the minor amounts of fill present at the ground surface, this material is not considered to represent a significant environmental concern to the Site.

Photograph 33. 22 Hawthorne Ave – view along northeast wall from 22/24 Hawthorne Ave property line; possible location of former oil tank (excavation cuttings and monitoring wells present)

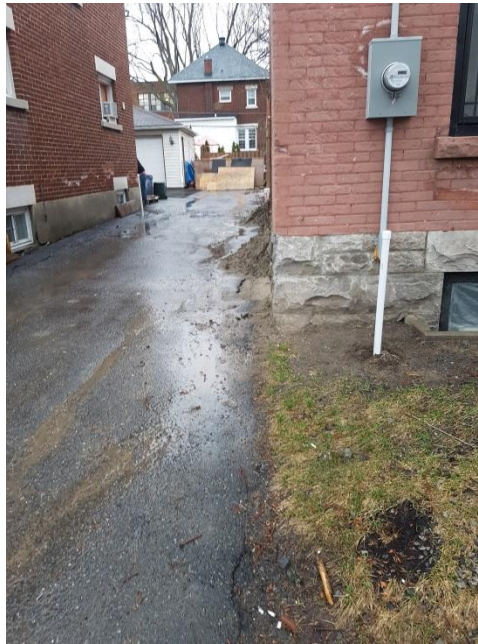
Photograph 35. 22 Hawthorne Ave – view of asphalt driveway, diving 22/24 Hawthorne Ave, with PVC monitoring well at north corner of 22 Hawthorne Ave residential structure
