Phase I Environmental Site Assessment

899, 901, and 903 Ages Drive Ottawa, Ontario

Ages Drive Development Inc.

Report: PE4405-1R

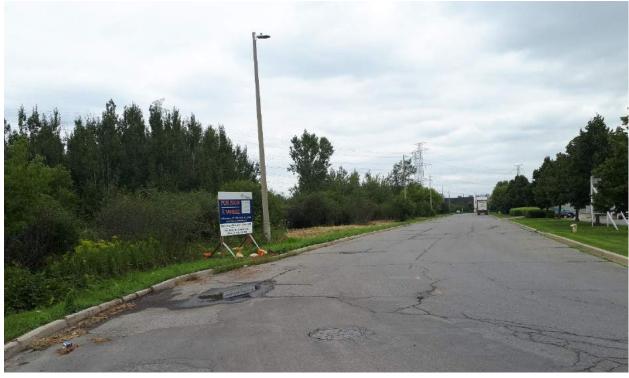
Photograph 1: View of the south end of the subject property, looking northeast up Ages Drive.

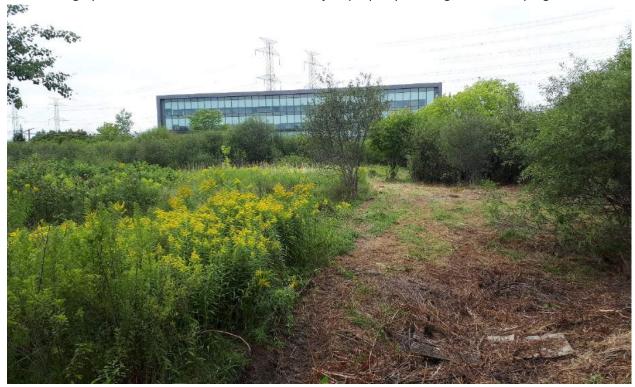
Photograph 2: View of the south end of the subject property. The building in the background is located at 1021 Thomas Spratt Place (Medical Council of Canada).

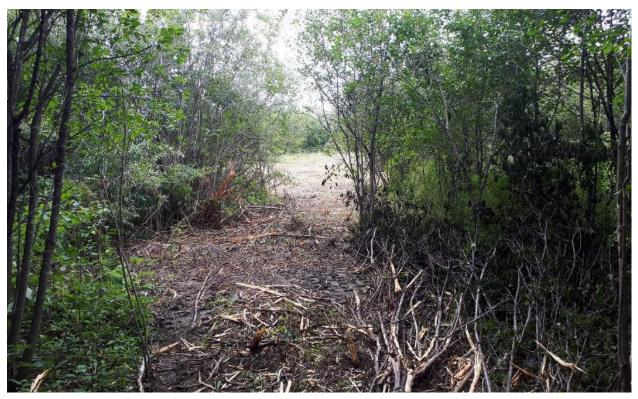
Photograph 3: One of the cleared pathways traversing the site.

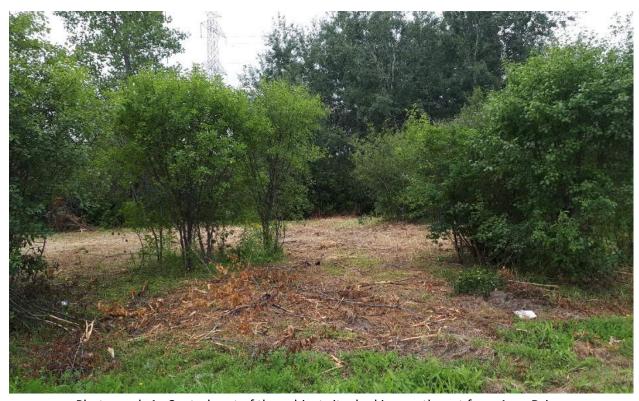
Photograph 4: Central part of the subject site, looking northwest from Ages Drive.
