REPORT ON

**PHASE II
ENVIRONMENTAL SITE ASSESSMENT
257 McARTHUR AVENUE
CITY OF OTTAWA, ONTARIO**

DATE: May 1, 2018

180140

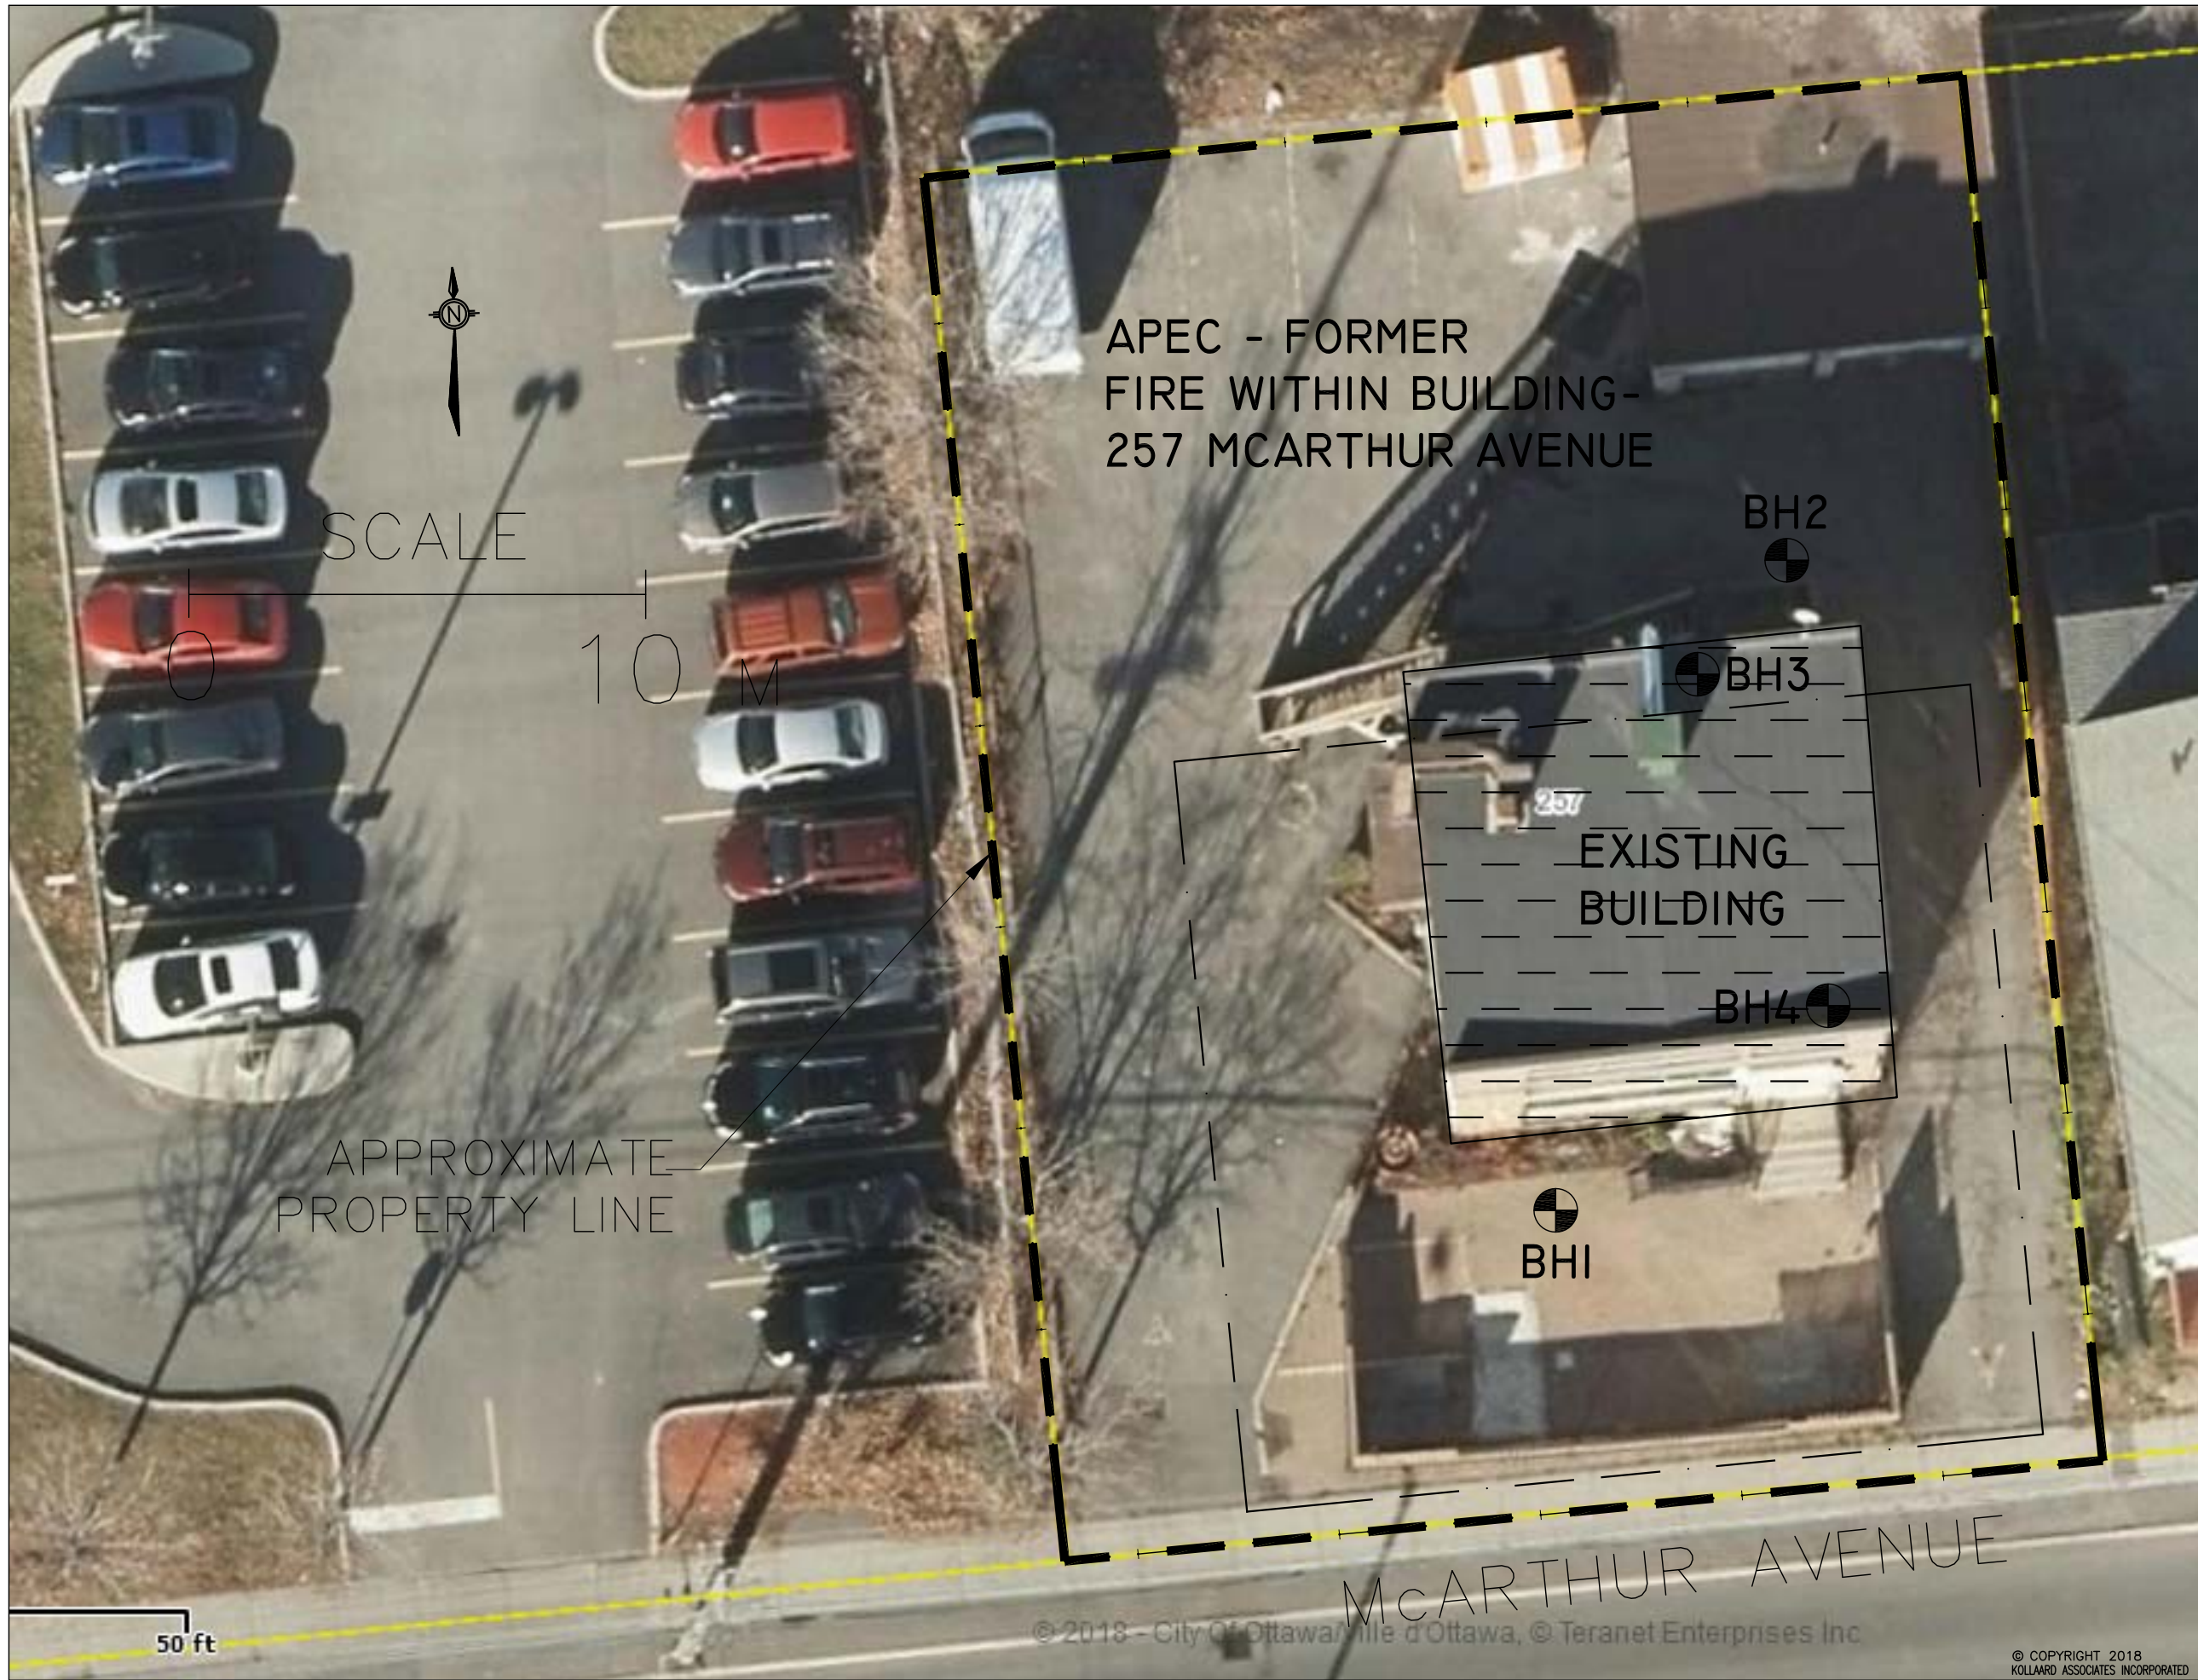
DRAWING NUMBER:
FIGURE 2

The site location is provided on Figure 1. A site plan is provided on Figure 2.

Areas of Potential Environmental Concern: Due to the PCA at the subject site, the following APEC was identified at the site in the Phase I ESA, locations as shown in Figure 2:

- APEC 1 – Fill and building debris and residues from former fire

The soil quality at the subject site was investigated at the locations shown on Figure 2 through a borehole investigation. The investigation methods are described in the following sections.
