Hydrogeological Study Report
Proposed Retail Fuel Outlet
1618, 1622 Roger Stevens Drive
Kars, Ontario K0A 2E0

June 21, 2018

DST File No.: TS-SO-032667

DST Consulting Engineers Inc.

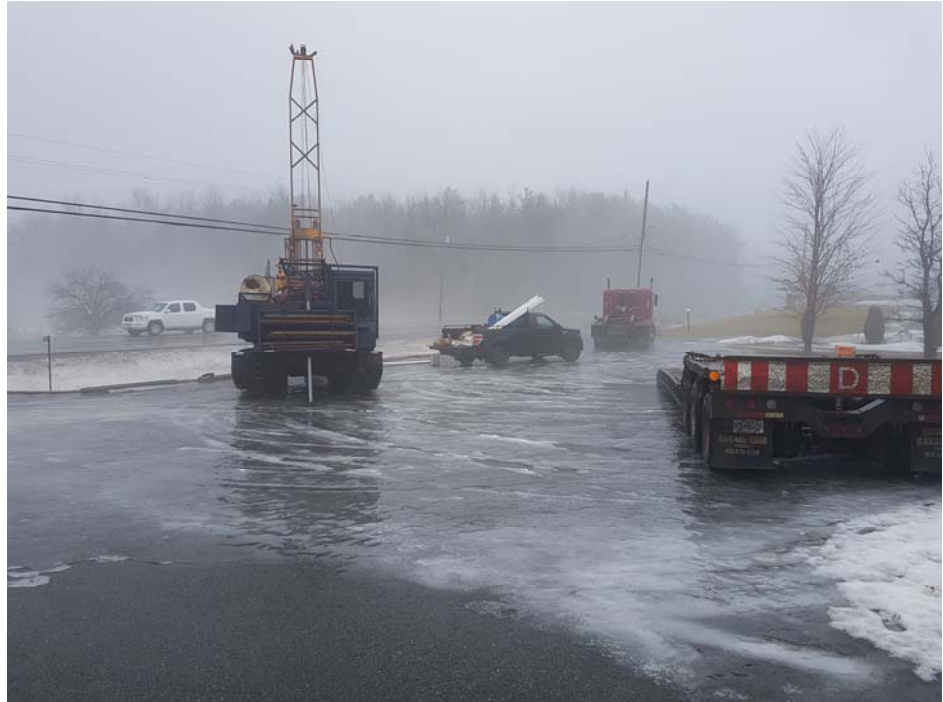
View of the track-mounted drill rig drilling monitoring well MW101.

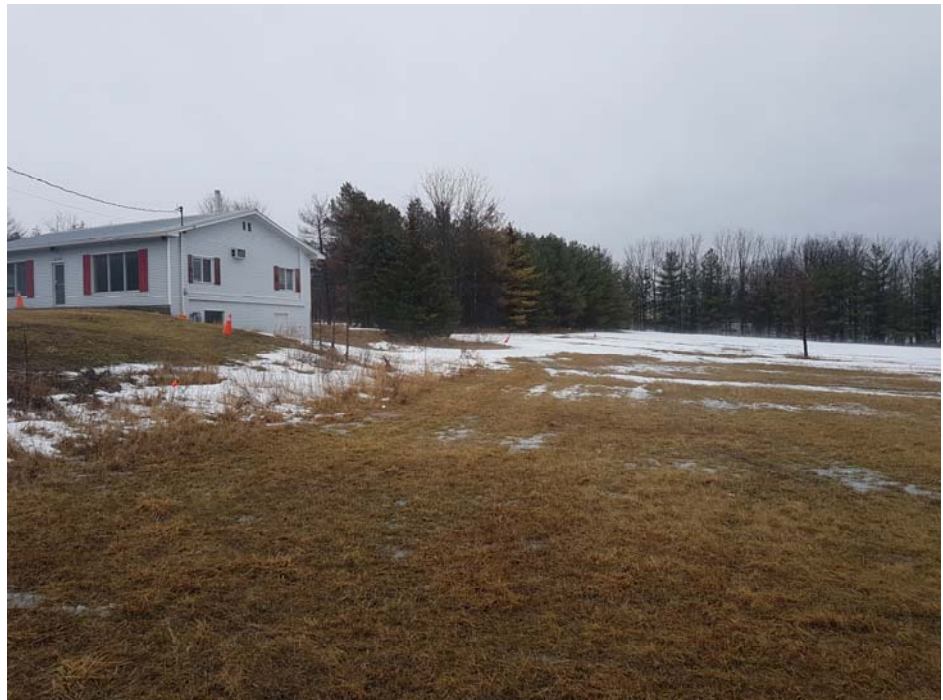
View of the slope located in the eastern portion of the Site.

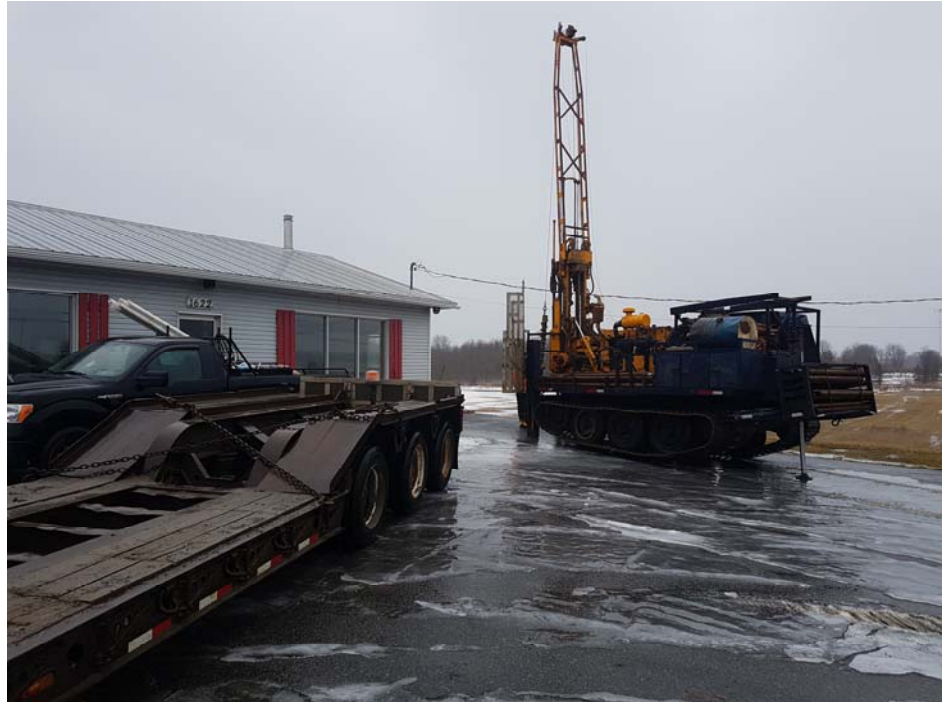
View of the track-mounted drill rig drilling monitoring well MW101.

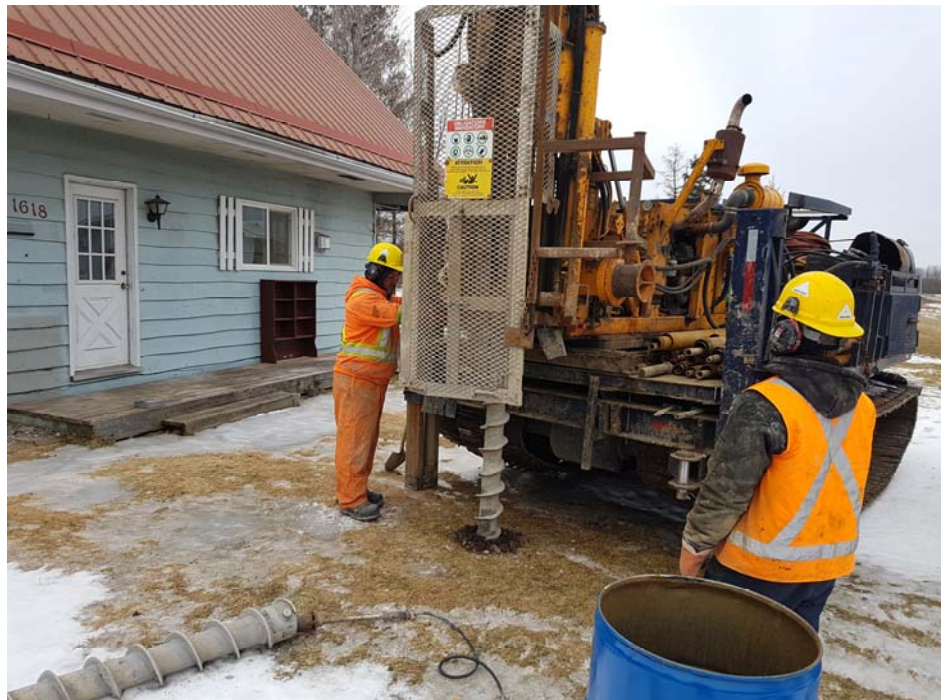
View of the drillers auguring the borehole at monitoring well MW106.

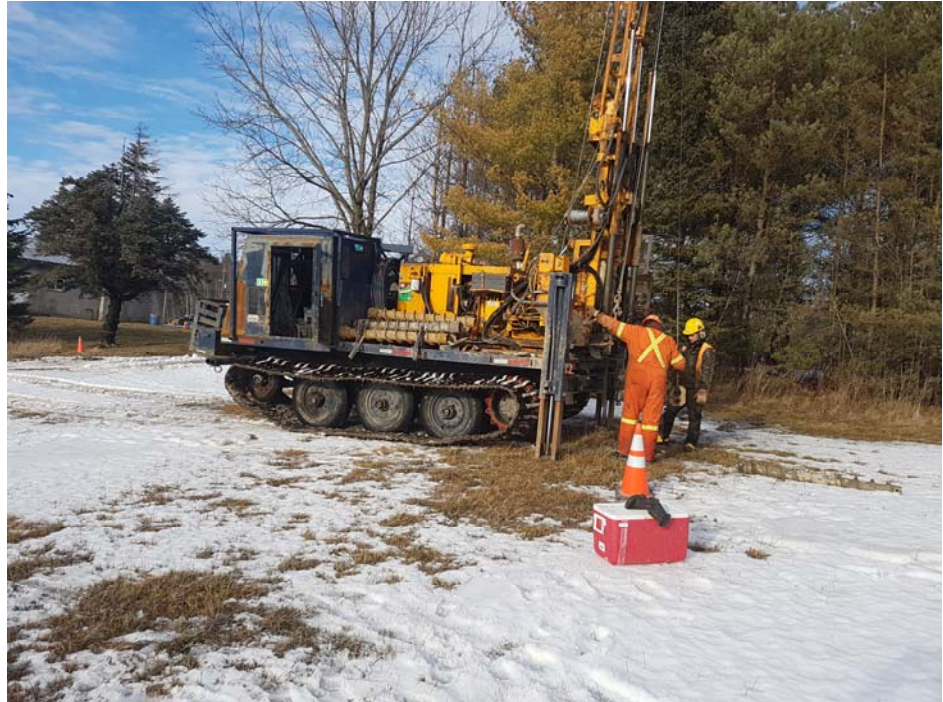
View of the drilling of borehole BH103.

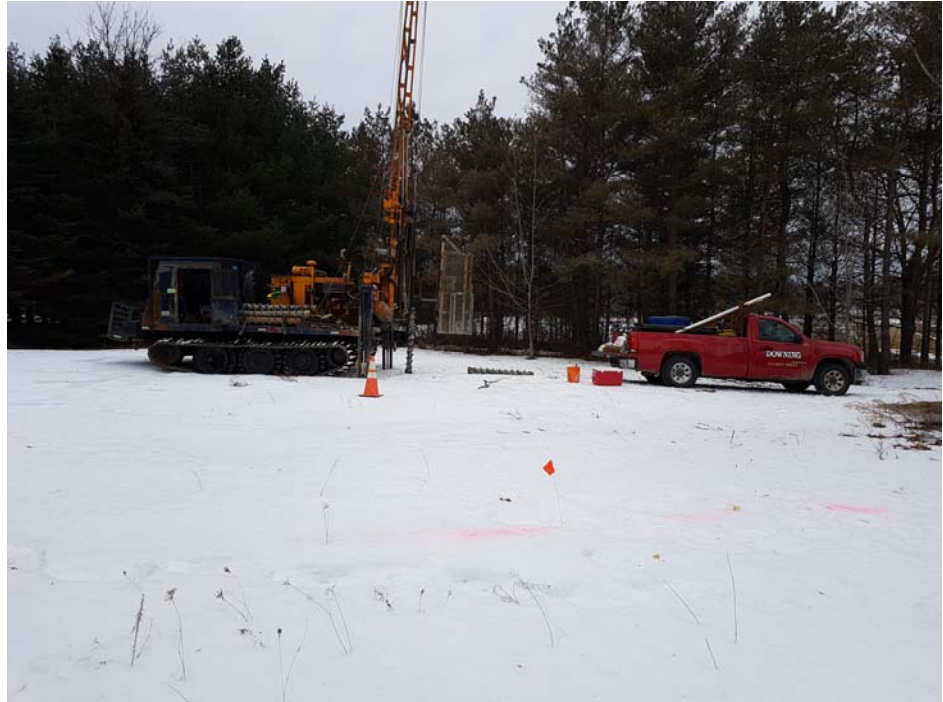
View of the drilling of monitoring well MW107.

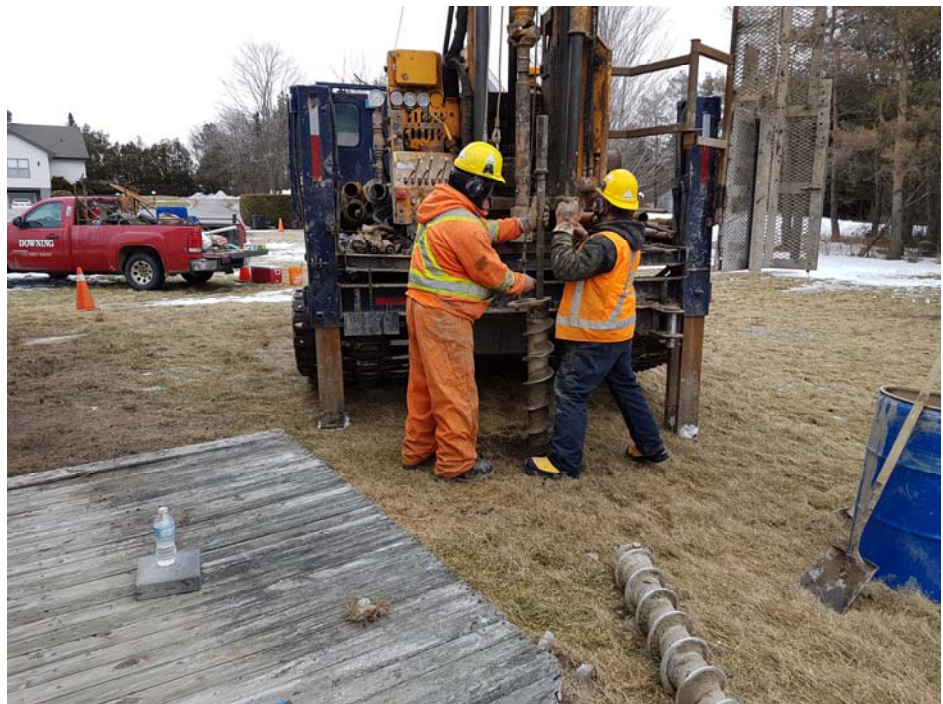
View of the drilling of the borehole for monitoring well MW108.
