**Phase One Environmental
Site Assessment
89 Richmond Road,
Ottawa, Ontario**

OTT-00240343-A0

June 21, 2017

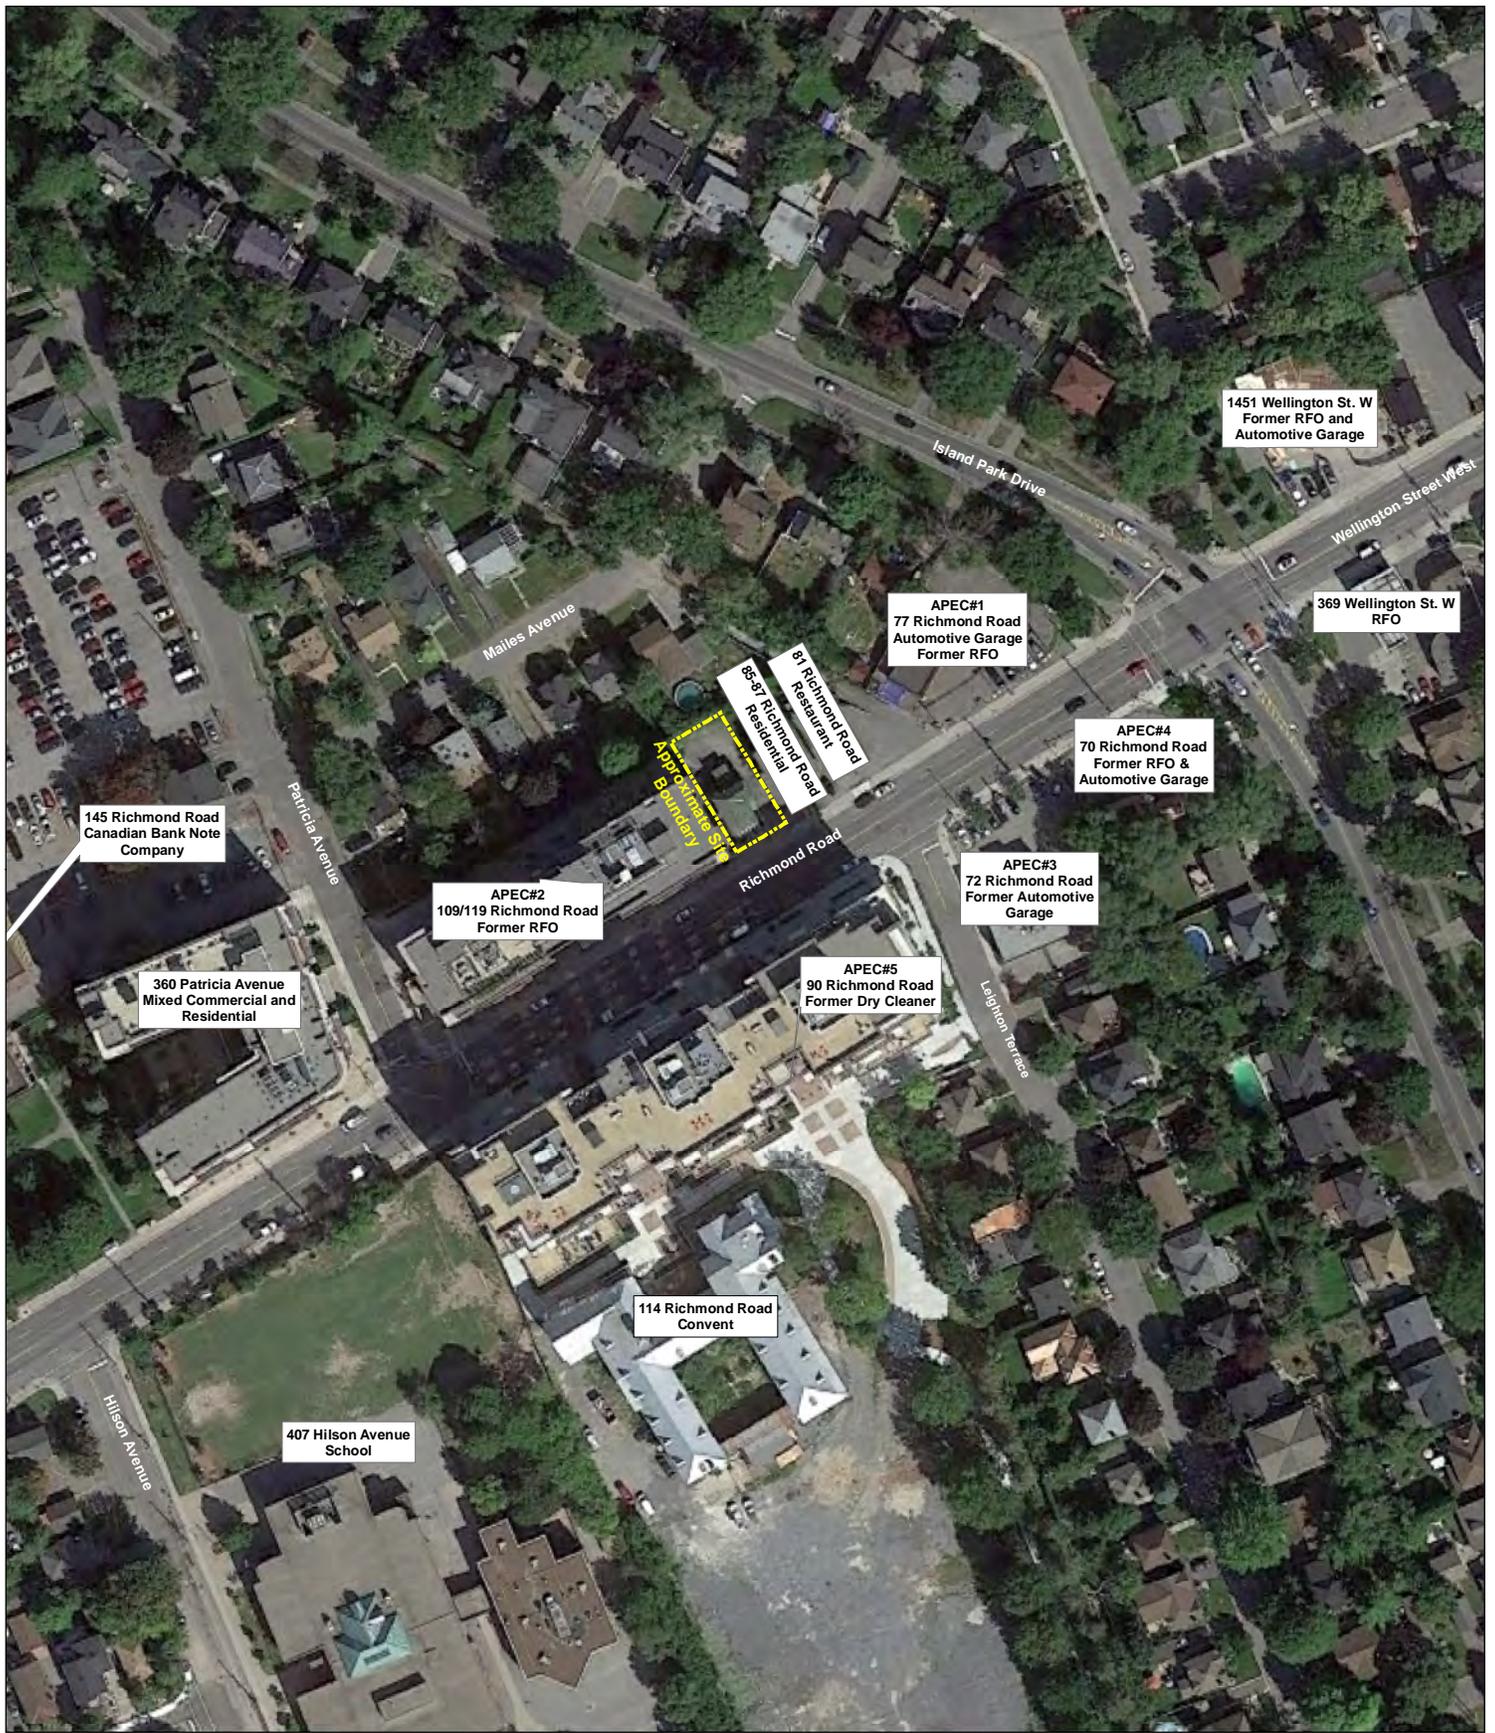
FIG. No.:
 2

The Phase One ESA study area consisted of the neighbourhood and extending a distance of 250 metres from the Site. Surrounding properties consist of mainly residential including single-family homes to the adjacent north, a low-rise mixed residential/commercial building to the adjacent west and a multi-tenant residential building following by commercial buildings to the adjacent east. There is a mixed residential/commercial building across Richmond Road to the south. It is noted that the Ottawa River is located approximately 1.2 km to the northwest of the site. A site plan is presented as Figure 2 in Appendix B.

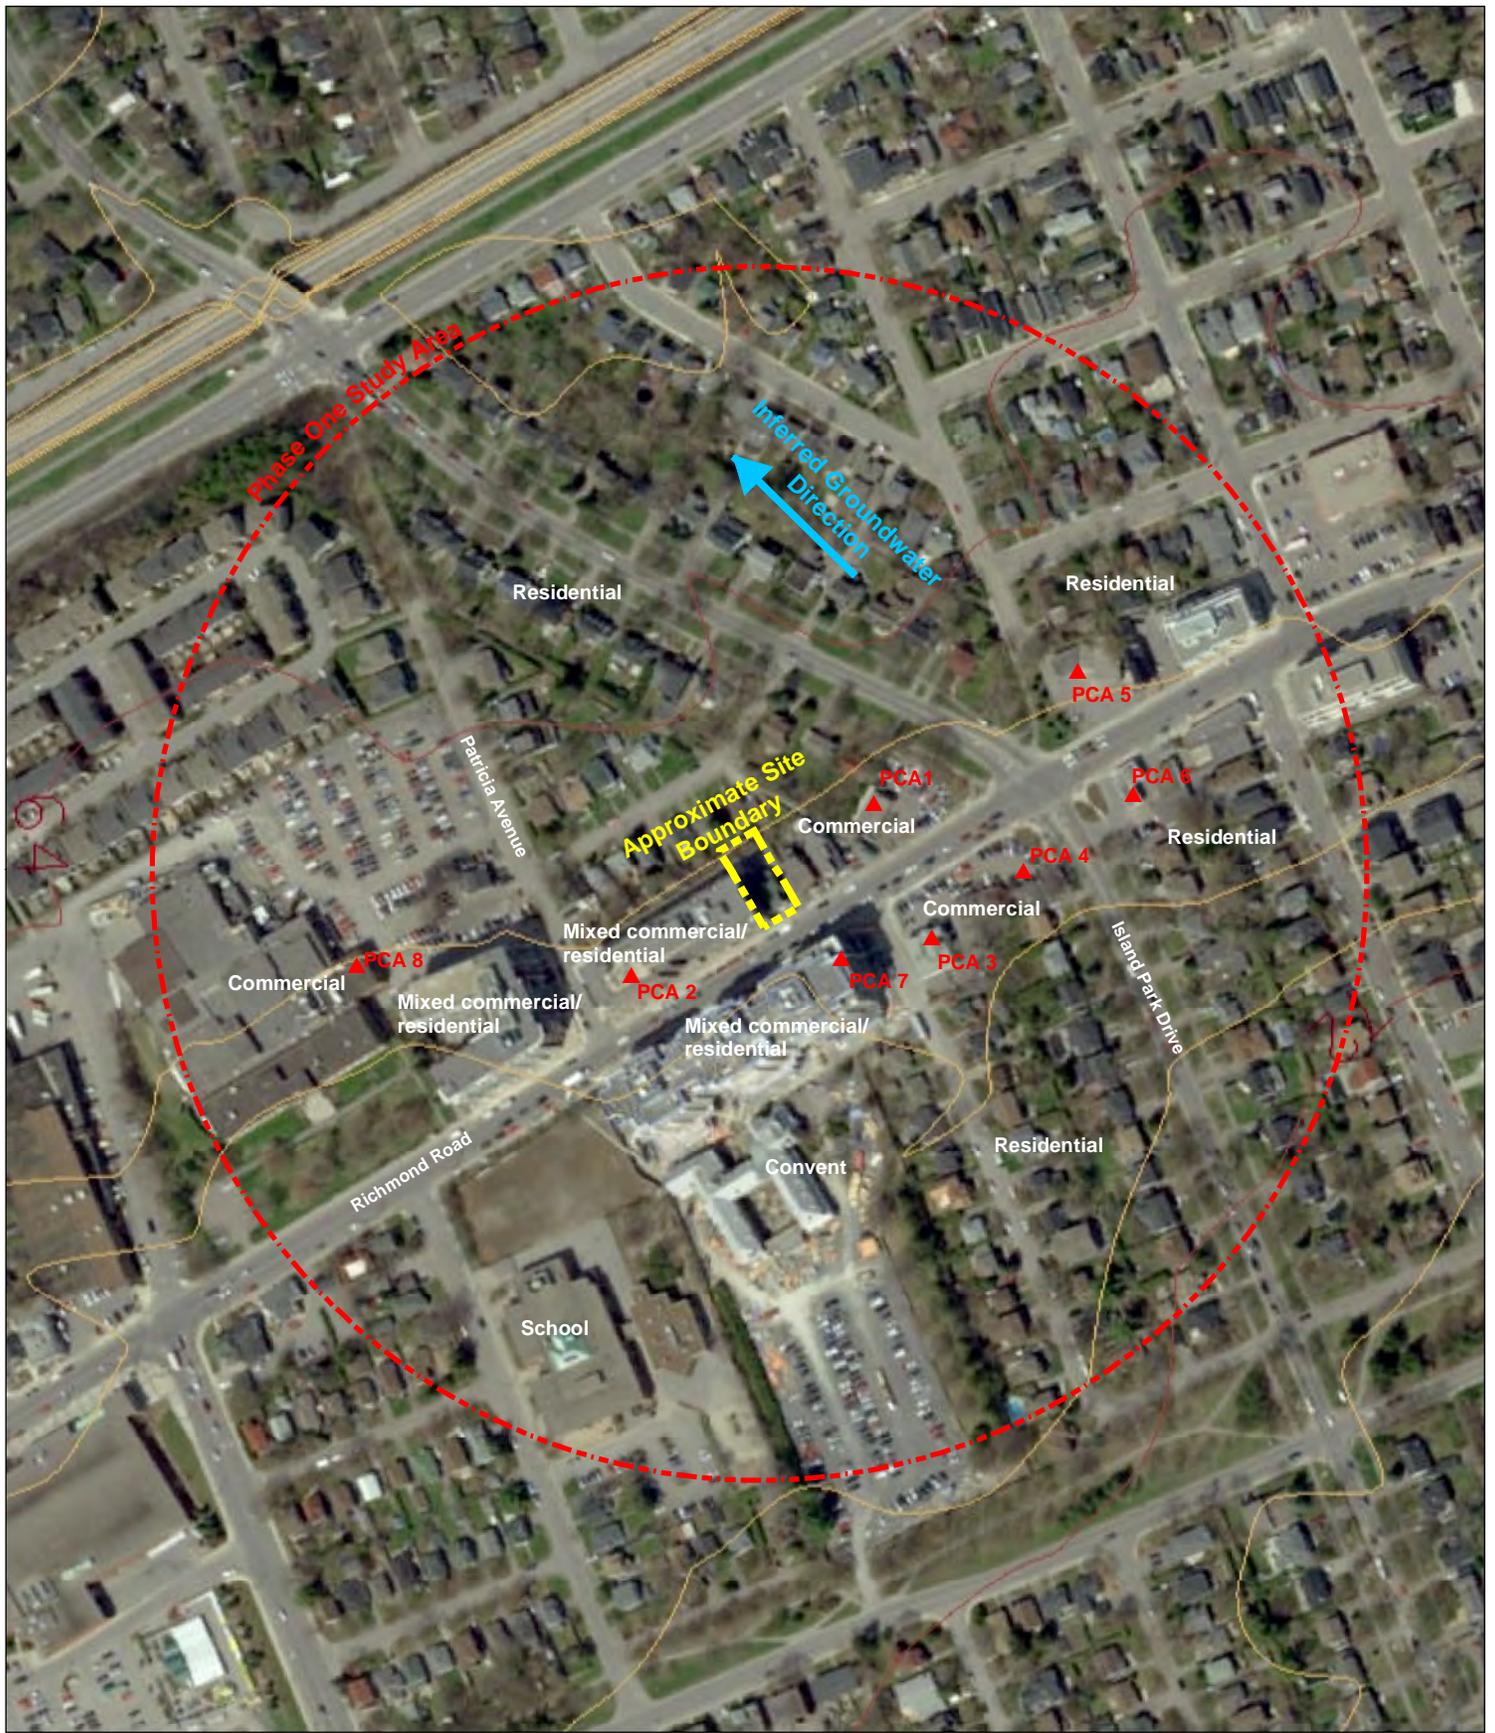
| | PHASE ONE ENVIRONMENTAL SITE ASSESSMENT 89 Richmond Road Ottawa, Ontario | CONCEPTUAL SITE MODEL | OTT-00240343-A0 | SL |

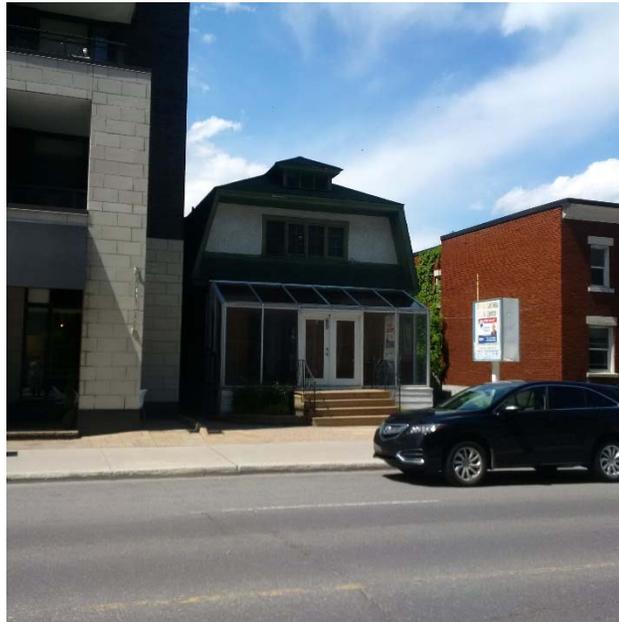
Photograph No. 1

View of site building looking north

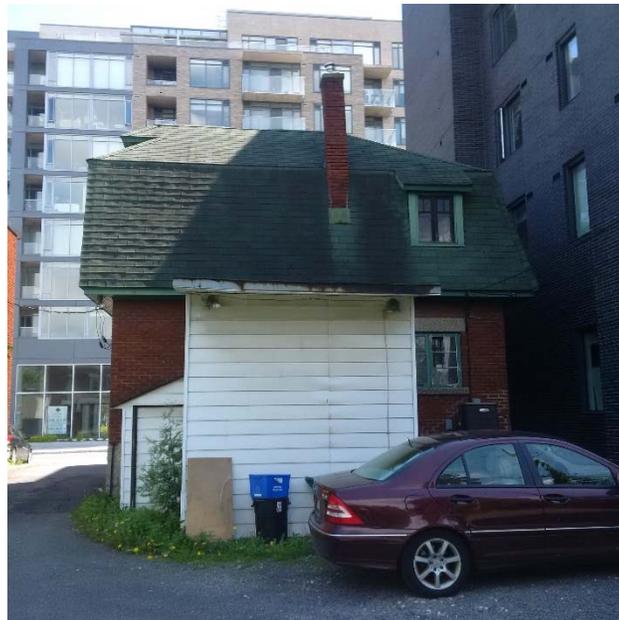
Photograph No. 2

A centralized cooling system was observed at the time of the site visit with the condenser located at the rear (north) of the building.

A view of the rear of the site building looking south

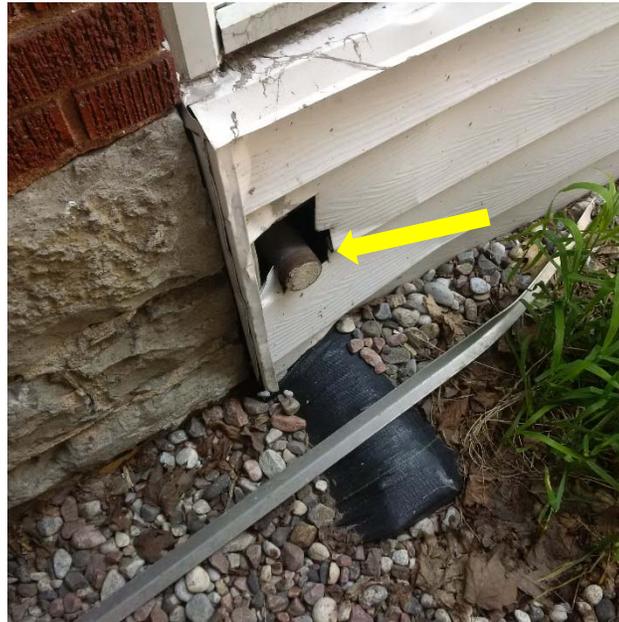
Photograph No. 5

Exp did not observe any ASTs during the site reconnaissance. Previous vent/fill pipes were visible both in the basement and from the building exterior at the southwest corner of the building. These pipes are likely associated with the previous AST that was reportedly located in the basement of the building. There was no evidence of spills or staining on the concrete slab basement floor or on the ground next to the previous pipes on the building exterior. In addition, the basement floor was observed to be in good condition and there were no petroleum odours identified in the basement. Therefore, the presence of this previous AST does not represent an APEC.

View of previous AST fill pipe at northwestern corner of site building

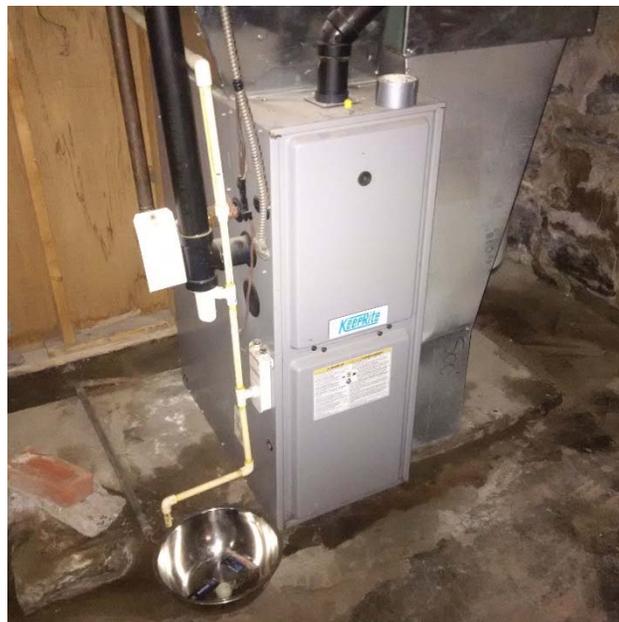
Photograph No. 6

The heating system was observed to be a natural gas fuelled forced air furnace. The current owners indicated that the heating system had been converted to natural gas from heating oil in the early 1990s. Previous vent/fill pipes were identified in the southwest corner of the building.

View of natural gas furnace located in the basement of the building

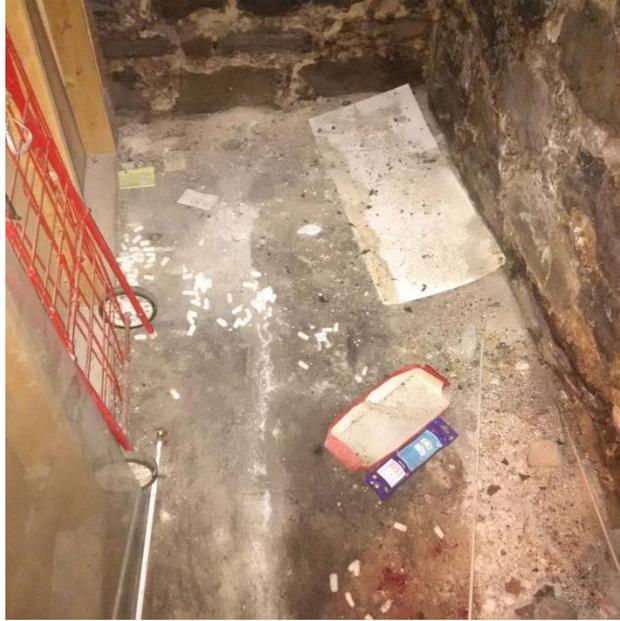
Photograph No. 7

View of previous location of furnace oil tank in the basement (no visible staining)

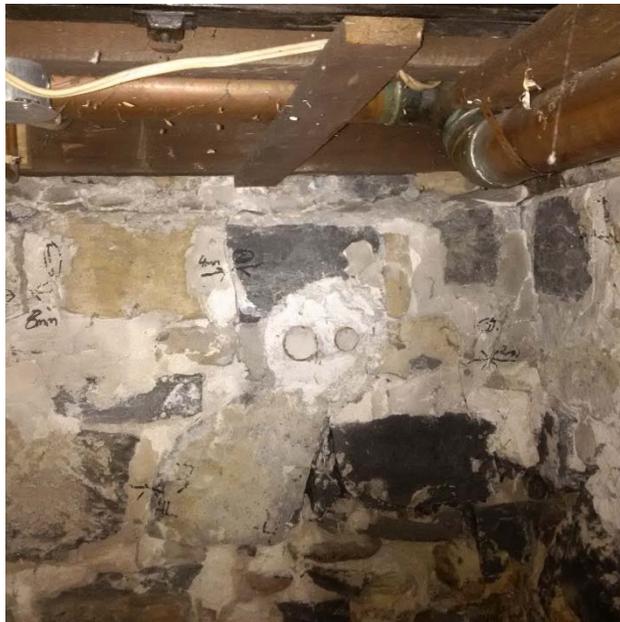
Photograph No. 8

View of previous fill/vent pipes in the basement of the building

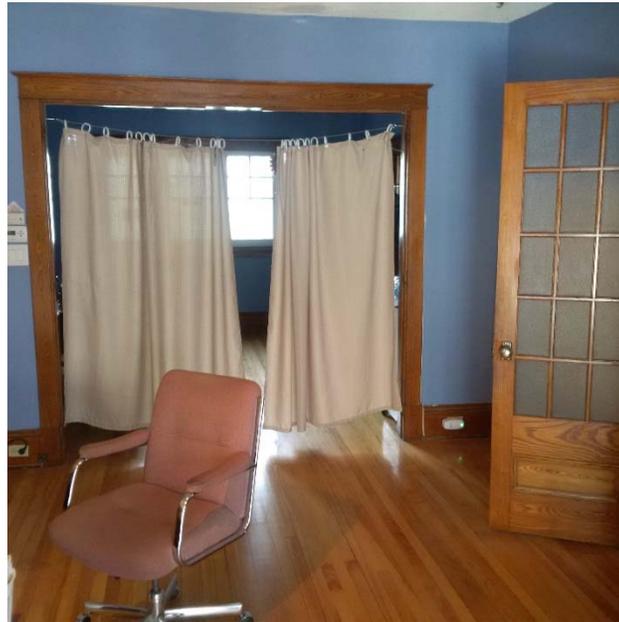
Photograph No. 9

View of typical interior construction on the ground floor
