HYDROGEOLOGICAL ASSESSMENT
HIGHLAND PARK CEMETERY VISITATION CENTER
2037 MCGEE SIDE ROAD
OTTAWA, ONTARIO

**HYDROGEOLOGICAL ASSESSMENT
HIGHLAND PARK CEMETERY VISITATION CENTER
2037 MCGEE SIDE ROAD
OTTAWA, ONTARIO**

July 2010

Our ref: 10-025

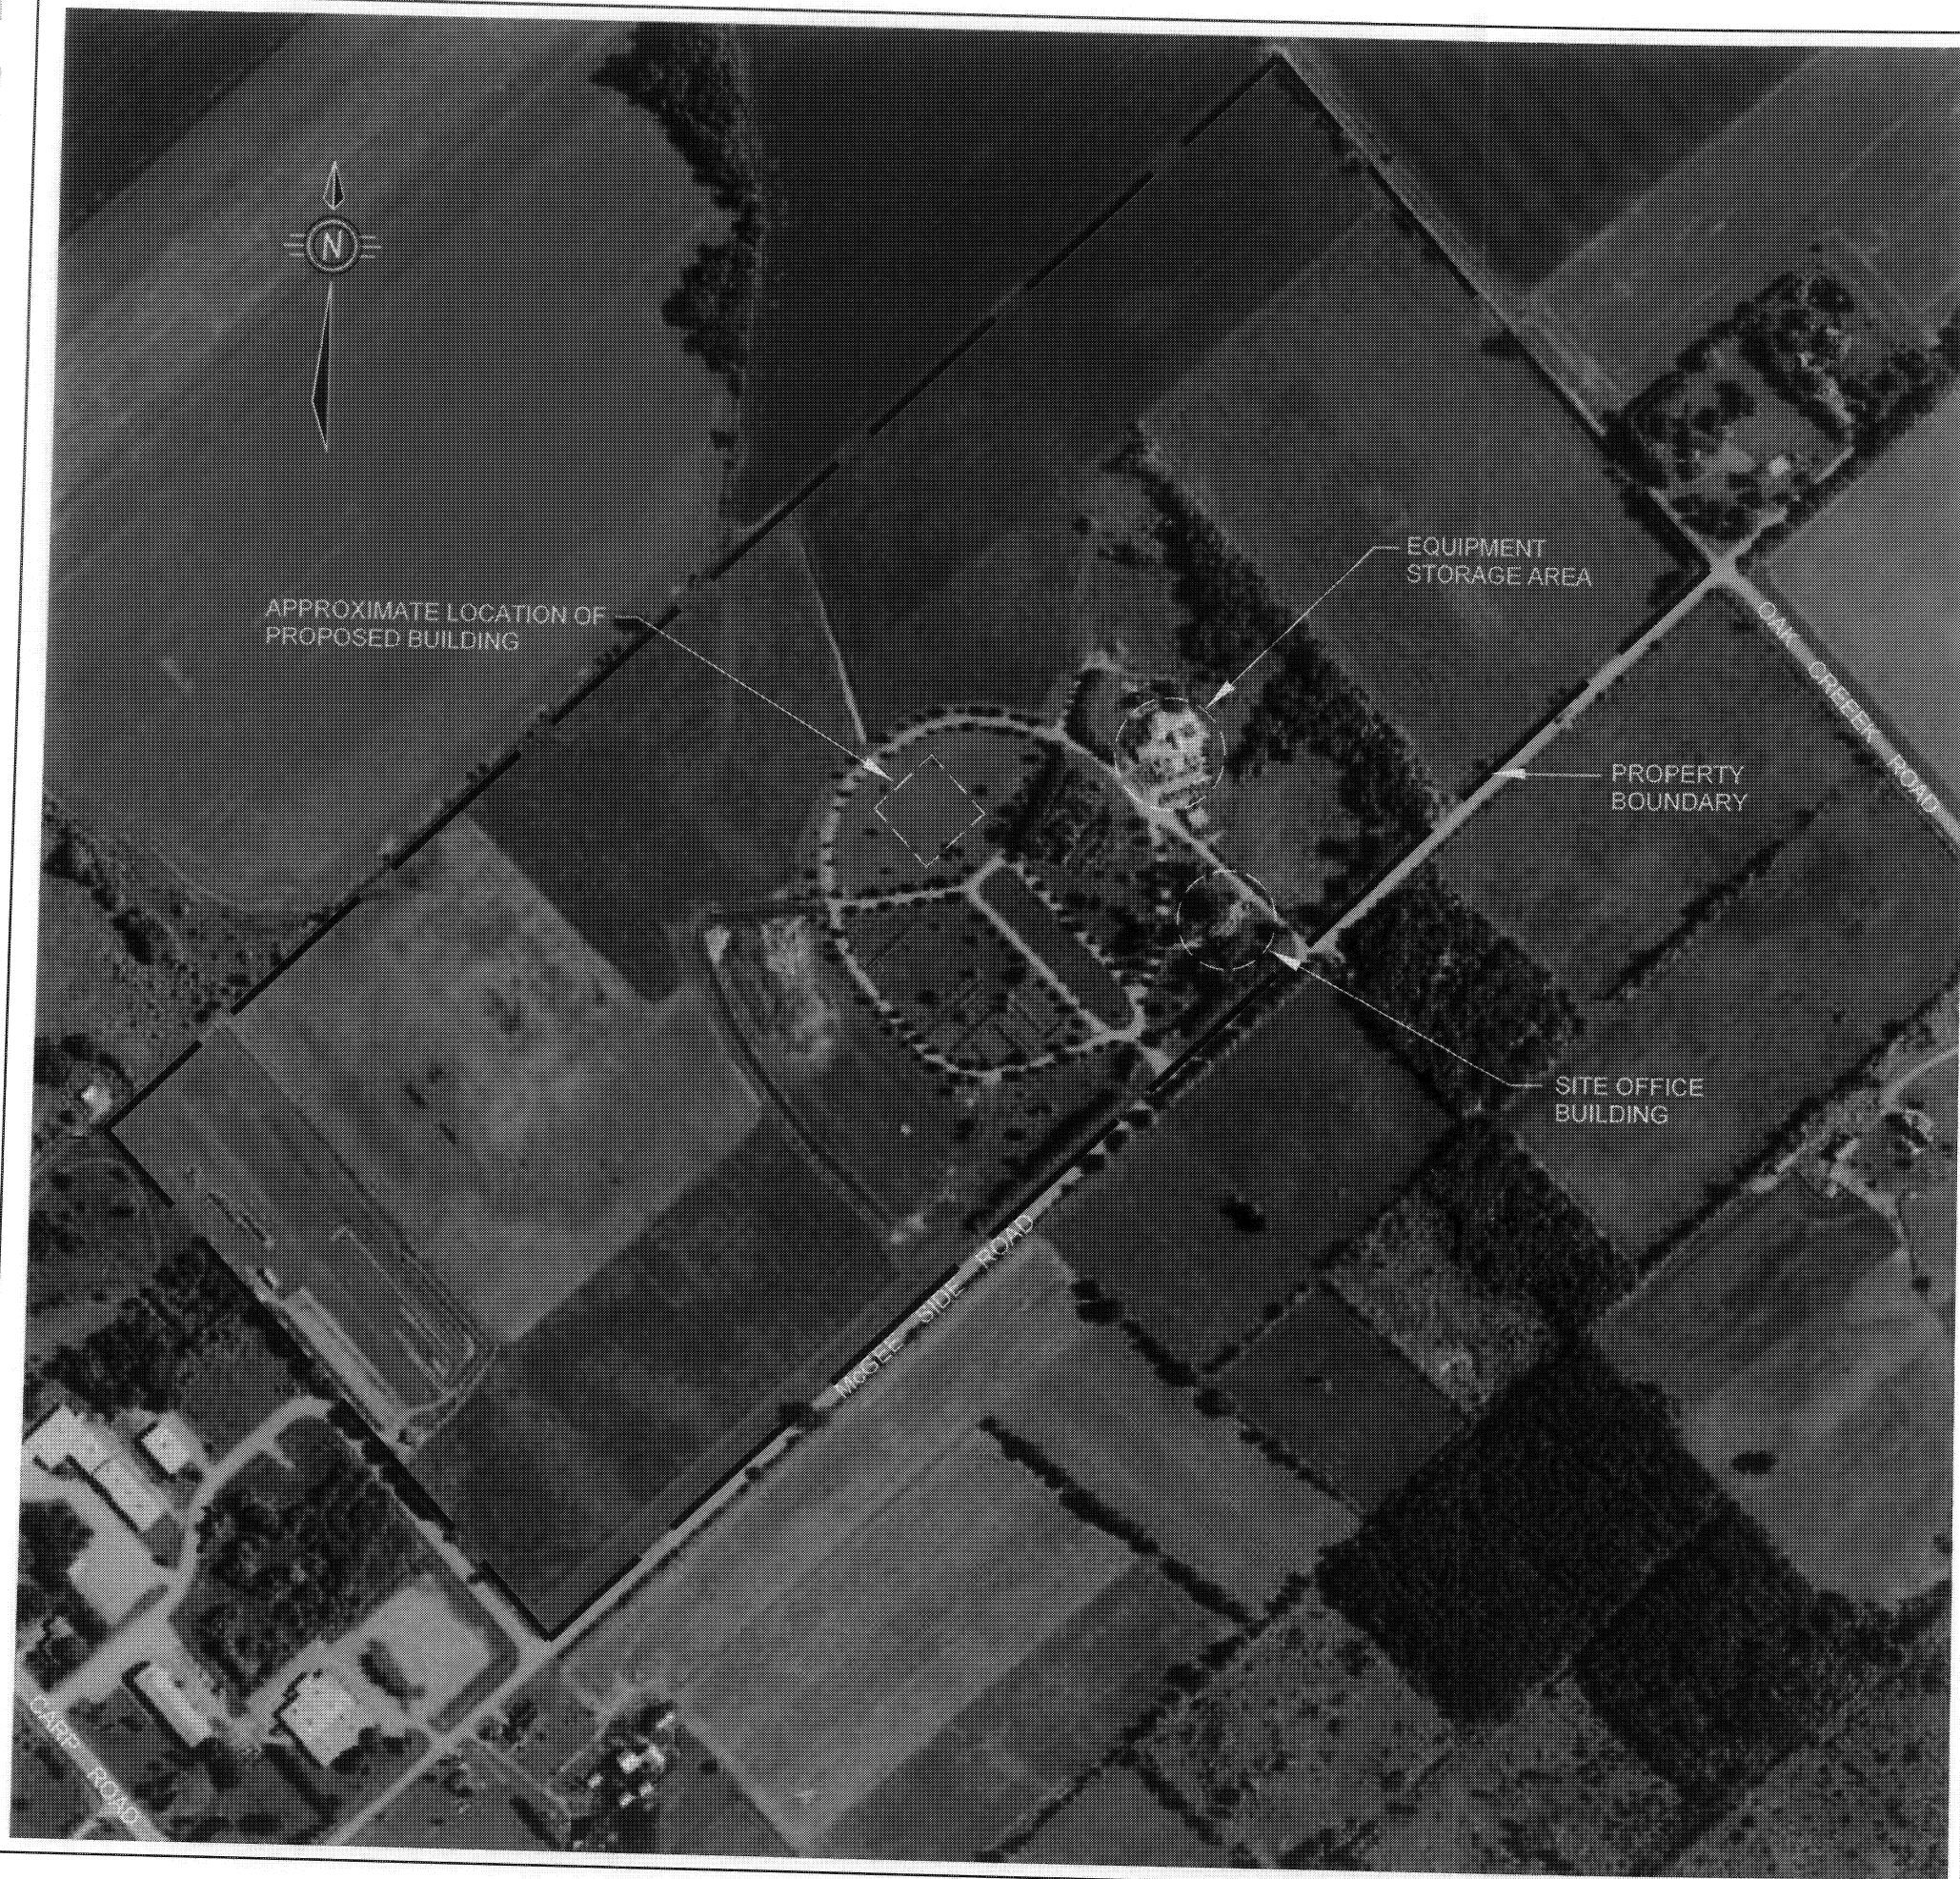
Title TEST WELL, BOREHOLE AND TEST PIT LOCATION PLAN			
		Date July 2010			FIGURE 2

- TP # APPROXIMATE TEST PIT LOCATION IN PLAN
- BH # APPROXIMATE BOREHOLE LOCATION IN PLAN
- BH # BOREHOLE WITH MONITORING WELL INSTALLATION

The approximate locations of the boreholes and test pits advanced as part of the geotechnical investigation are shown on the Test Well, Borehole and Test Pit Location Plan, Figure 2. An aerial photograph of the overall area of the subject site is provided on the Site Plan, Figure 3. Descriptions of the subsurface conditions logged in the boreholes and test pits are provided in the geotechnical report.

The approximate location of the test well is shown on the Test Well, Borehole and Test Pit Location Plan, Figure 2. An aerial photograph of the overall area of the subject site and area of proposed development are provided on the Site Plan, Figure 3. The MOE Water Well Record for the test wells is provided in Appendix E and the geographical reference for the test well is provided in the MOE Water Well Record.
