Phase One Environmental Site Assessment 5924 Hazeldean Road, Ottawa, Ontario

Project Number: OTT-00250806-A0

Type of Document: Final

Date Submitted: February 21, 2019

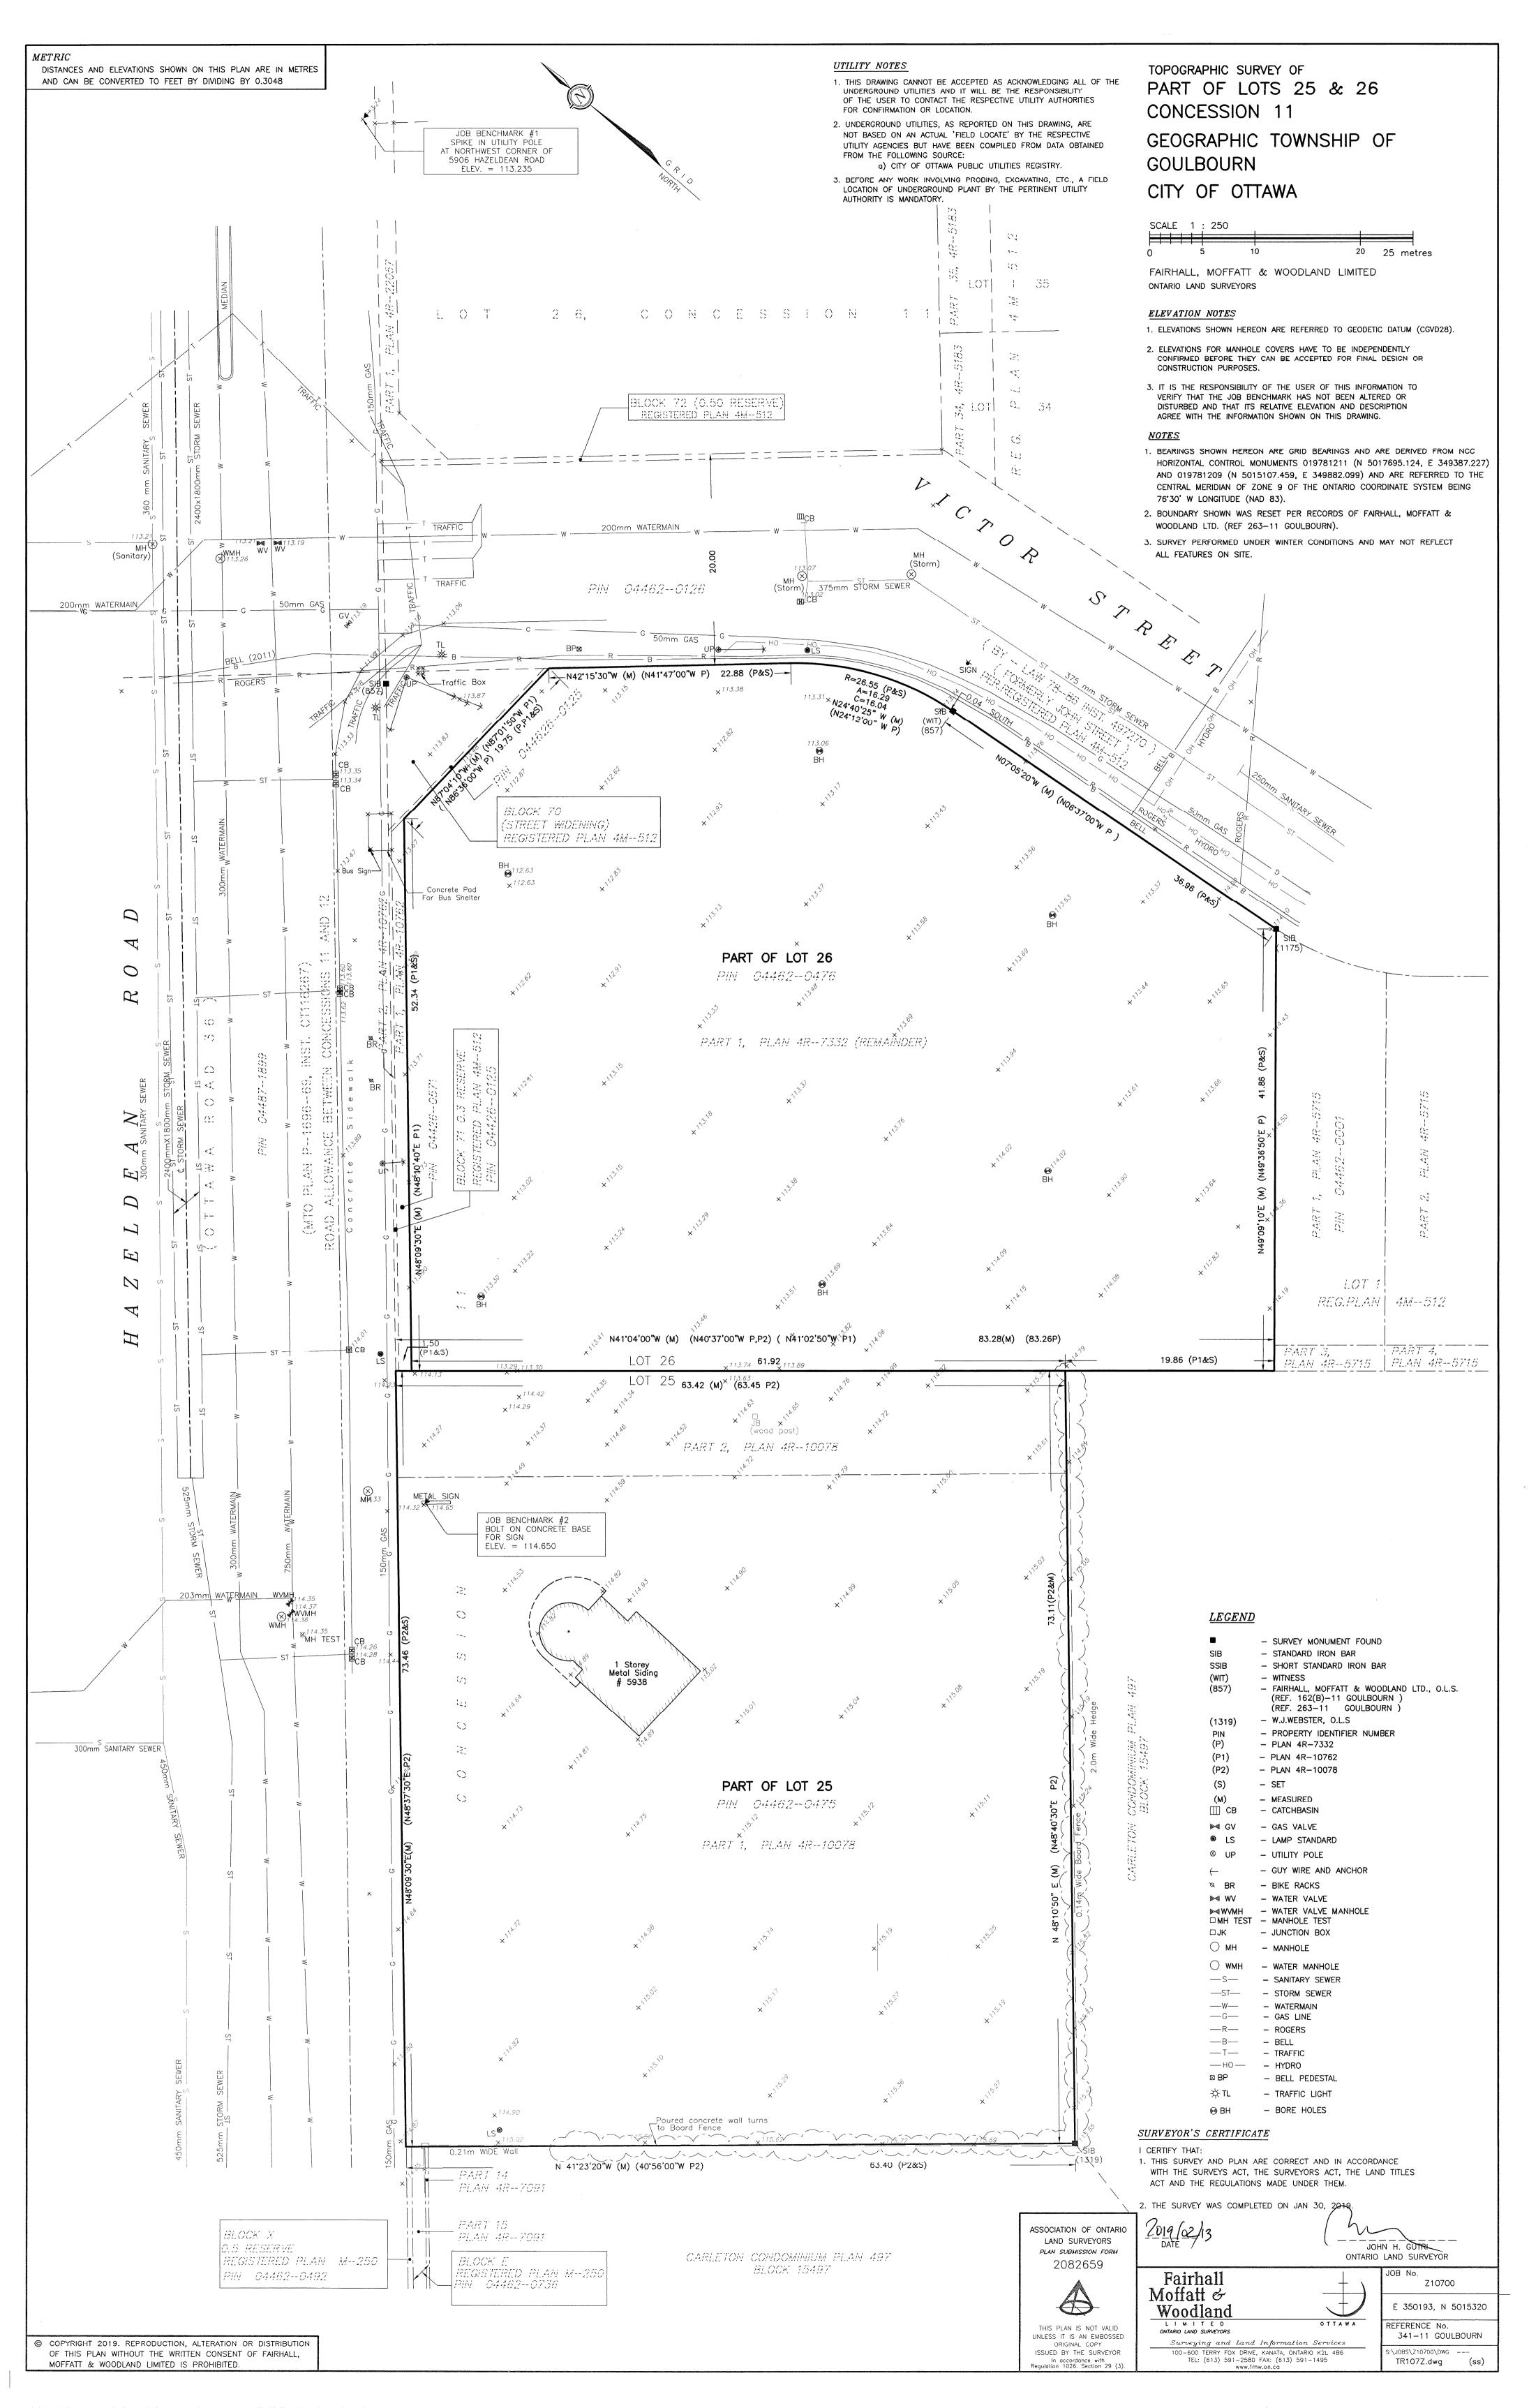
2650 Queensview Drive, Suite 100 Ottawa, ON K2B 8H6, Canada	
FEB.	2019	GNCR DEVELOPMENTS	project no. OTT-00250806-A0
C.H.	M.G.M.	TITLE: PCA AND APEC PLAN	1:750
DRAWN BY M.	M.N. 5924 HAZELDEAN ROAD, OTTAWA, ON		FIG 3

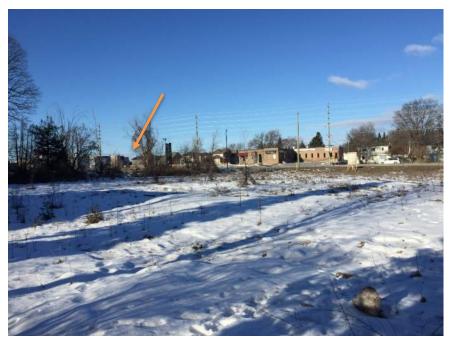
Photograph No. 1
View of Phase One property looking northwest (Ultramar identified)

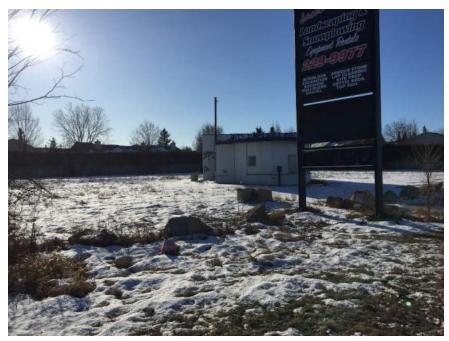
Photograph No. 3

APEC 1 - Adjacent former retail gasoline sales outlet adjacent to the west (5938 Hazeldean Road).

Based on a review of the available records, the adjacent property at 5938 Hazeldean Road is considered a PCA. This property hosted operations as a retail gasoline sales outlet and automotive repair garage from at least 1996 and is presently untenanted. Potential contaminants of concern (PCOC) include petroleum hydrocarbons (PHCs), volatile organic compounds (VOCs), and lead.

PCA	Property	Location	Concern	
1	5938 Hazeldean Road Untenanted property (APEC 1)	-Adjacent to west -Upstream in terms of groundwater flow direction	Former gas station and auto repair garage of older vintage found adjacent and up-stream in terms of assumed groundwater flow direction (APEC 1).	
2	5943 Hazeldean Road Ultramar	-110 m to west, across Hazeldean Road -Upstream in terms of groundwater flow direction	Recent vintage gasoline station found at far side of 4 lane roadway at a significant distance. Not considered a concern due to intervening distance and recent construction.	
3	5899 Hazeldean Road Mr. Gas	-80 m to northeast, across Hazeldean Road -Downstream in terms of groundwater flow direction	Gasoline station found at far side of 4 lane roadway at significant distance, and downstream in terms of assumed groundwater flow direction. Not considered a concern due to intervening distance and being down-gradient.

- PCA 1 5938 Hazeldean Road Former retail gasoline sales outlet and service garage, located adjacent to west of the Phase One property. (PCA#27 – Garages and Maintenance and Repair, PCA#28 – Gasoline and Associated Products Stored in Fixed Tanks).
- PCA 2 5943 Hazeldean Road Retail gasoline sales outlet built in 2015, located adjacent to 110 m west of the Phase One property. (PCA#28 Gasoline and Associated Products Stored in Fixed Tanks). Based on intervening distance and short time frame, this is not considered an APEC.
- PCA 3 5899 Hazeldean Road Retail gasoline sales outlet, located adjacent to 80 m to the northeast of the Phase One property. (PCA#28 – Gasoline and Associated Products Stored in Fixed Tanks). Based on intervening distance and being downslope in terms of the assumed direction of groundwater flow, this is not considered an APEC.

Based on the findings of the Phase One ESA, a Phase Two ESA is required to assess the soil and groundwater conditions at the Phase One property.
