**STAGE 2 ARCHAEOLOGICAL ASSESSMENT
FOR BLOCK 211 OF THE WINDMILL ZIBI
CHAUDIÈRE EAST DEVELOPMENT
CHAUDIÈRE ISLAND
PART LOT 40, CONCESSION A
OTTAWA FRONT
GEOGRAPHIC TOWNSHIP OF NEPEAN
NOW IN THE CITY OF OTTAWA, ONTARIO**

PRAS Project No.: PR19-018

Date: May 24th, 2019

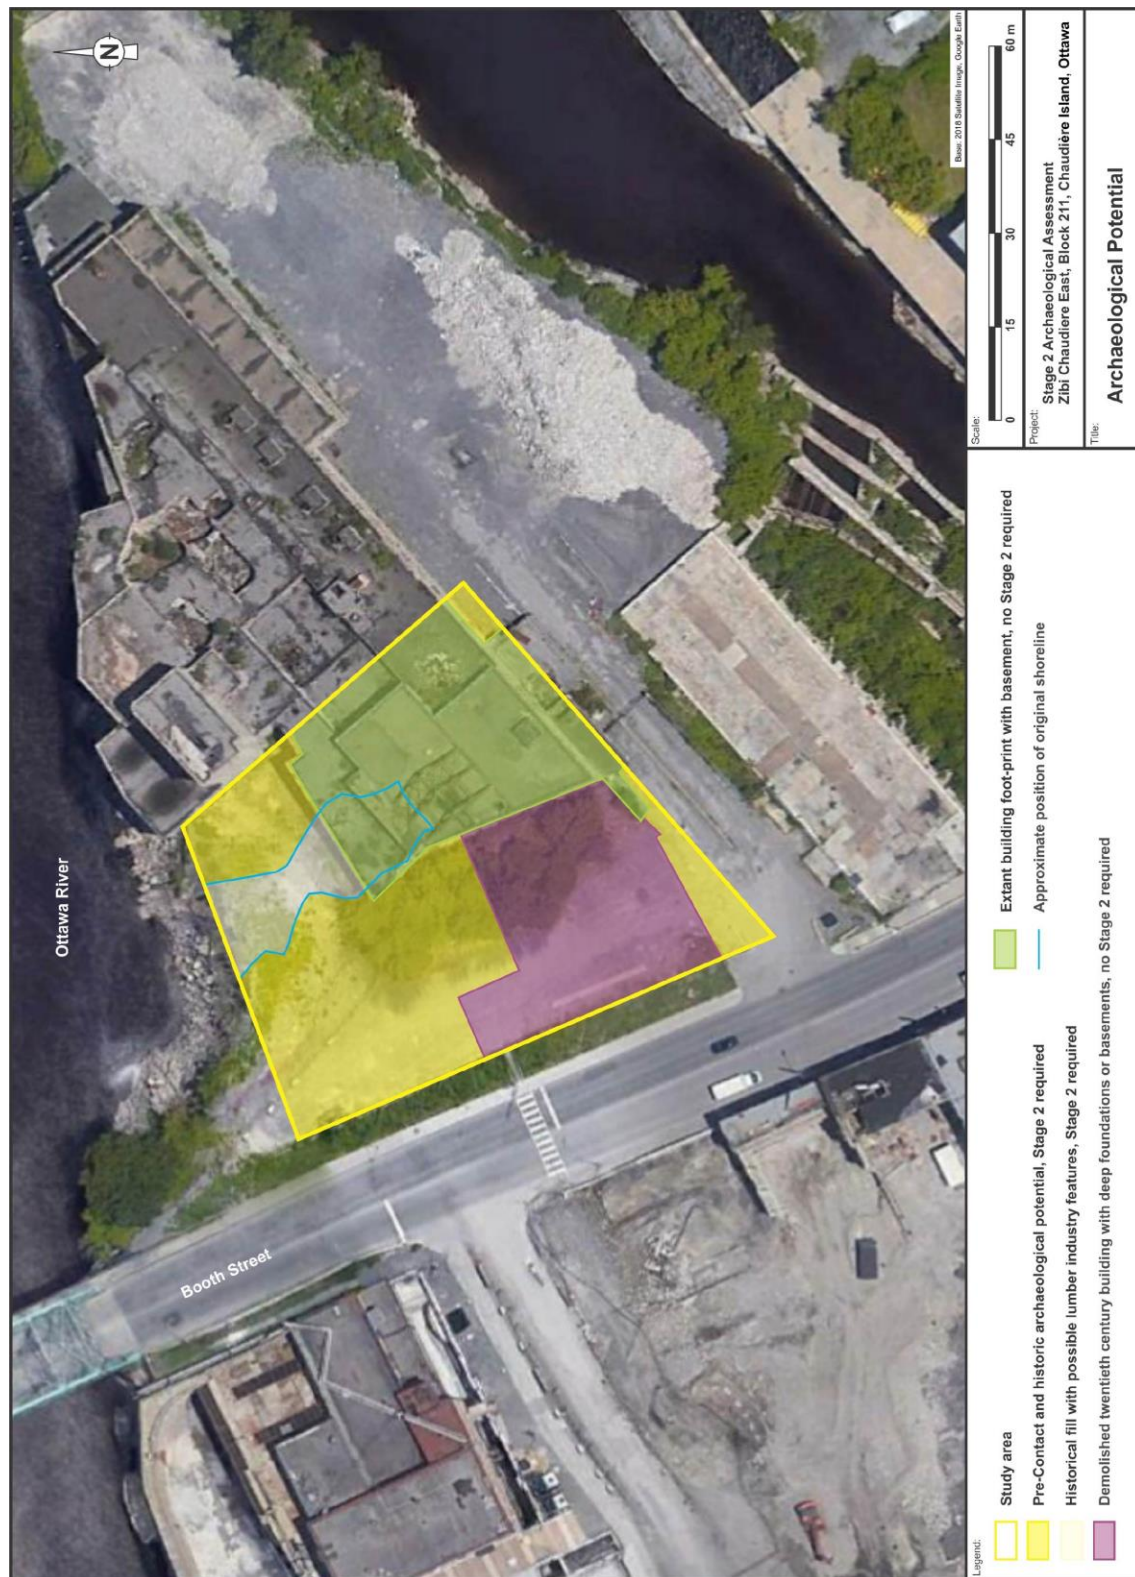
Map 14. Recent satellite imagery (2018) depicting archaeological potential within the Zibi Chaudière East Block 211 study area. This plan has been modified from the full archaeological potential map in the Stage 1 report (Past Recovery 2014:167).

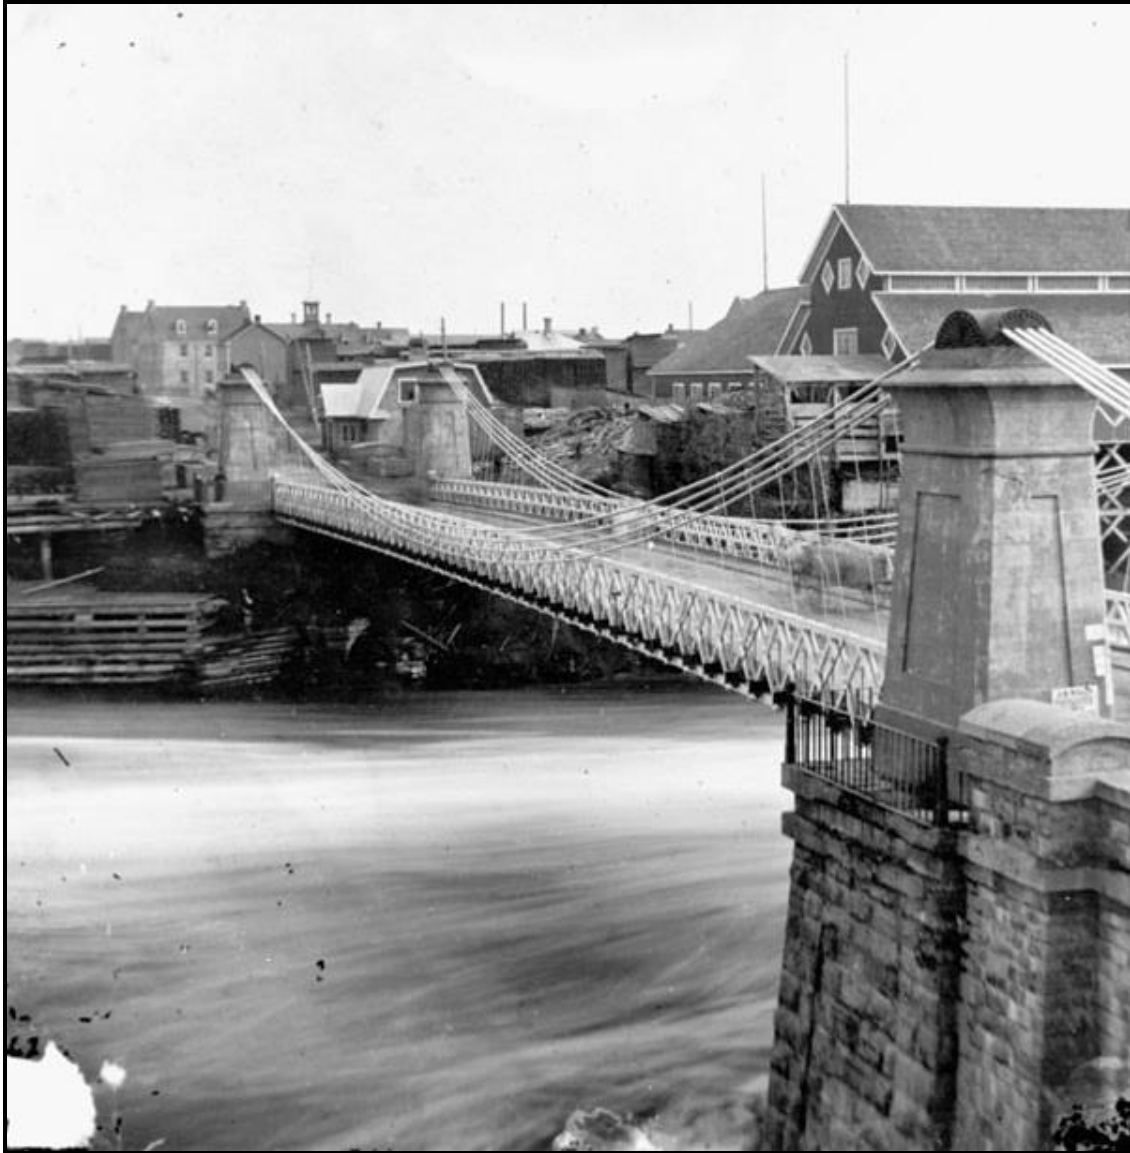
Image 2. The Union Bridge with the J.R. Booth sawmill on the right and the toll house near the end of the bridge between 1867 and 1870, looking south. (LAC PA-012500) The loading dock is evident next to the east side of the bridge, with stacked lumber on higher ground to the south.

It appears that another extensive leveling event occurred during or following the construction of the sulphide pulp mill, in particular significantly raising the height of the former loading dock next to the Union Bridge, as can be seen in early twentieth century images (compare, for example, Image 2 with Image 8). This effectively created a level area around the mill. It is likely that the furnace waste deposits (Lots 1A12 and

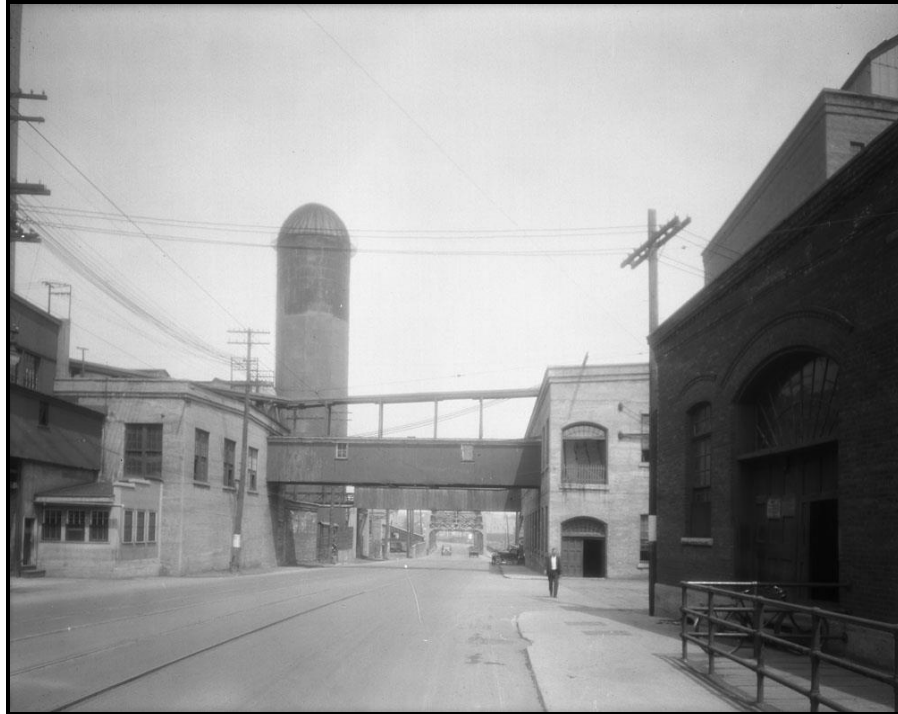
Image 5. The J.R. Booth pulp mill on Chaudière Island c. 1909, looking north-northwest along Bridge Street. (LAC e010934866-v8) The Head Street intersection is on the right, with the west end of the new sulphite pulp mill extending to the Bridge (Booth) Street right-of-way.

As stated above, the west end of the former sulphite pulp mill was removed between 1965 and 1968. This was a substantial concrete building as recorded in both early twentieth century photographs and fire insurance plans, ranging in height from two storeys immediately adjacent to Booth Street to between three and six storeys further to the east (see Maps 9 to 11 and Images 5 to 10). The extensive demolition layers in Trenches 1A (Lots 1A8 to 1A10) and 1B (Lot 1B2) were likely added at the time this part of the building was removed, and appear to have contained material from this structure. The concrete sulphite pulp mill had been erected by 1912, and while Trench 1B lay outside of the foot-print of the building, the concrete pedestal exposed in the west profile (Lot 1B5) was most likely contemporary, perhaps erected to support one of the large acid vats depicted on the 1912 and later fire insurance plans (see Maps 9 to 11). This was the only feature encountered in the three test trenches.

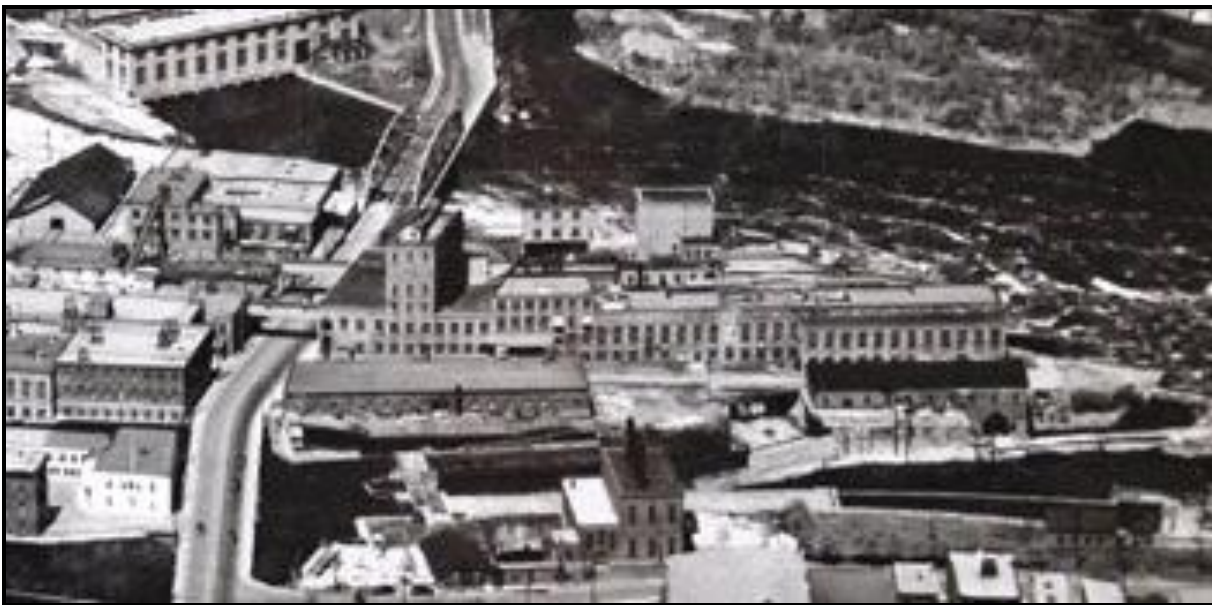
Image 10. Oblique aerial photograph showing Chaudière Island, 1950, looking northwest. (NCC XIII-0-02, 966)

All of the J.R. Booth Ltd. premises were sold to the E.B. Eddy Company in 1946. The entire property can be seen in an oblique aerial photograph taken in 1950, which shows few evident changes (Image 10). The final available fire insurance plan, published in 1956, indicates that the one-storey wooden addition along the north side of the sulphite pulp mill had been removed (Map 11). Chaudière Street and Head Street were formally closed by City of Ottawa By-Law 316-60 in 1960. The west end of the sulphite pulp mill was demolished between 1965 and 1968, and the resulting vacant space adapted for employee parking (Map 12). The E.B. Eddy Co. site was purchased by Domtar Inc. in 1998 and then closed in 2007.

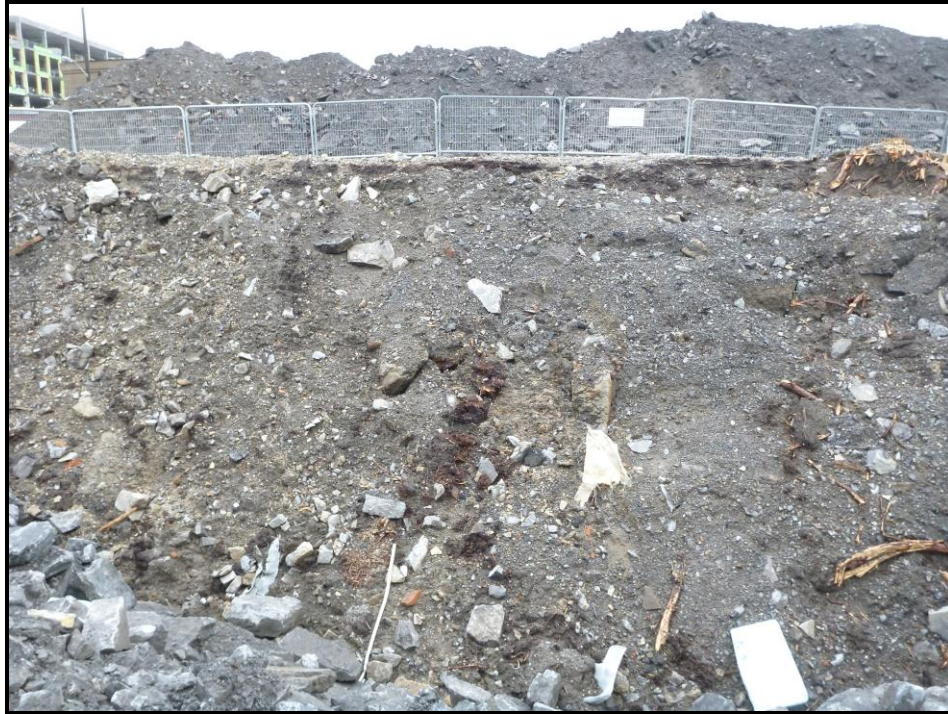
Image 15. View of the western end of the recently removed section of the former box factory showing an in situ concrete wall, facing west-southwest. (PR19-018D039)

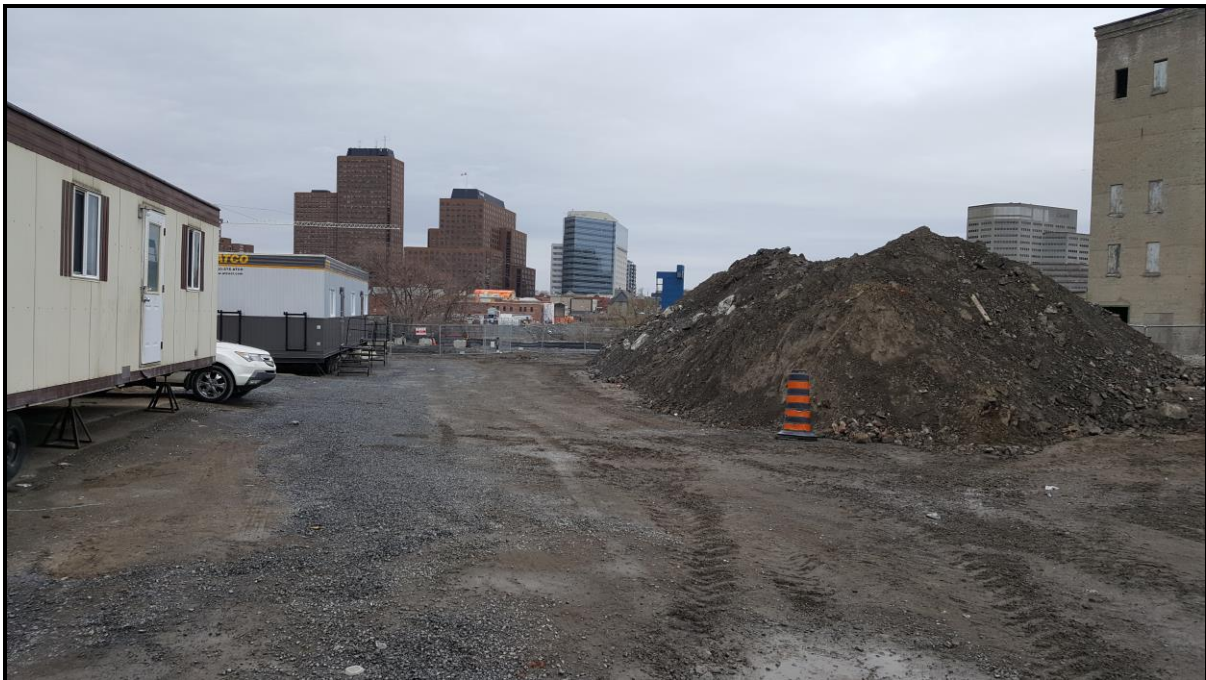
Image 16. View of the west half of the study area showing piled fill and on-site trailers, facing north-northwest. (PR19-018D006)

installation of the manhole sections and resulting in the piled material across the east side of the former parking area (Image 19). Thus much of the Block 211 study area either retained no archaeological potential or could not be tested given on-site obstacles. Nevertheless there were sections that retained potential and were accessible, including the central part of the former parking area and the eastern half of the section to the north of the recently demolished part of the former pulp mill (Image 20; see Images 16 to 18).

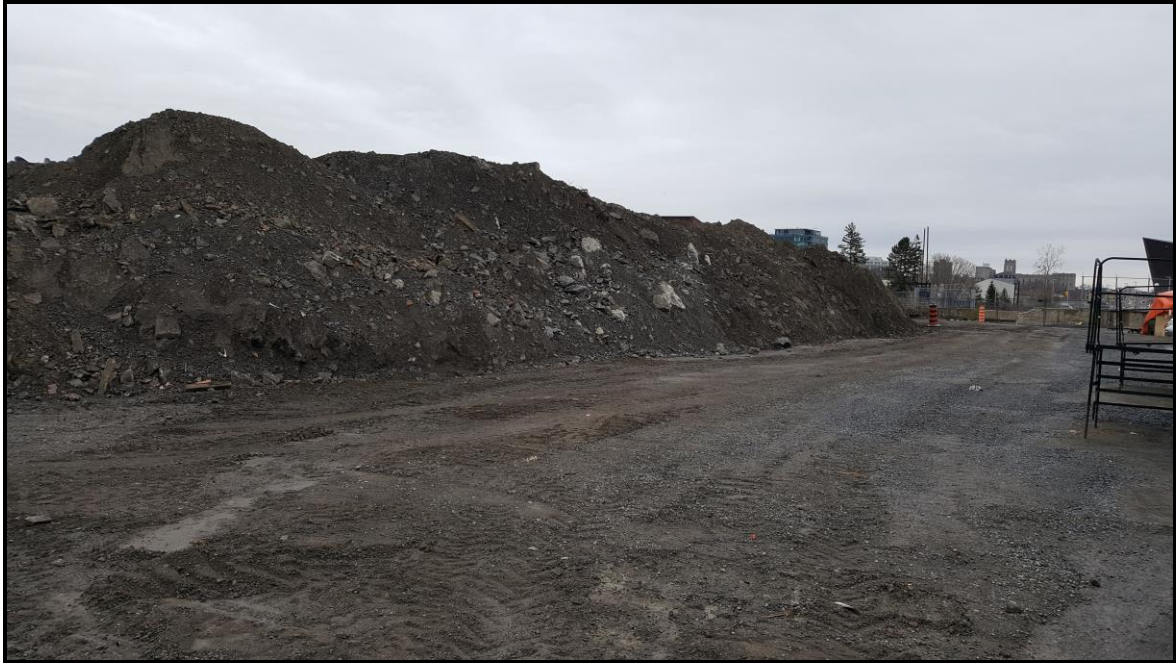
Image 17. View of the west half of the study area showing piled fill, facing southeast. (PR19-018D010)

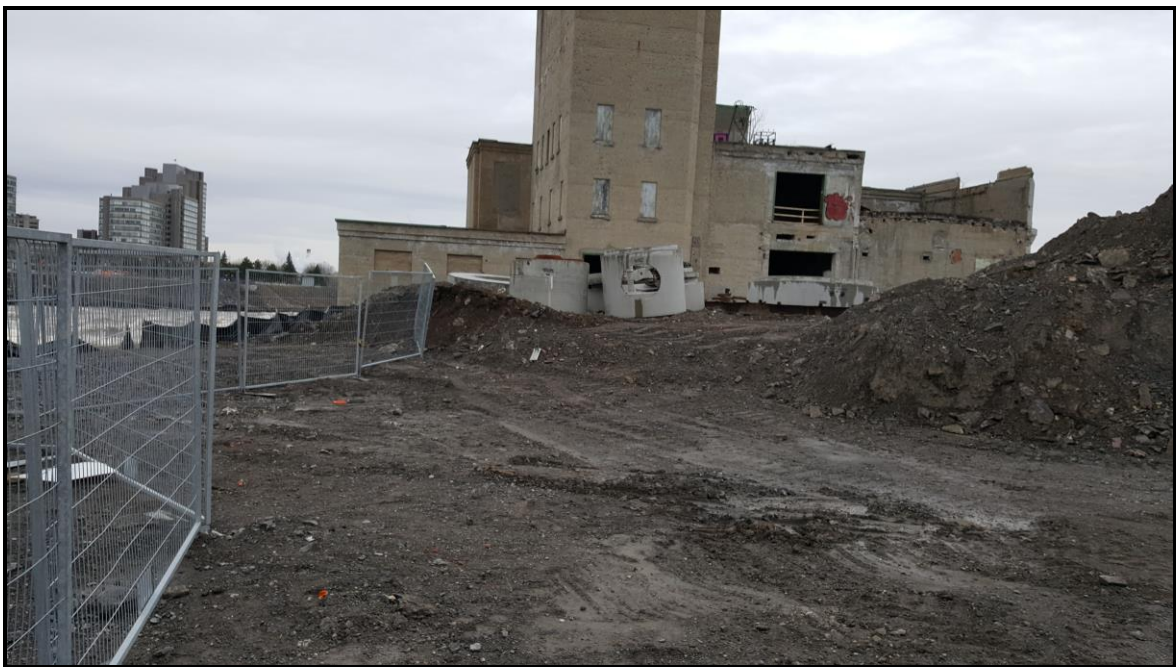
Image 18. View of the north end of the study area showing piled fill and barriers next to steep slope and the recent manhole excavation, facing east-northeast. (PR19-018D013)

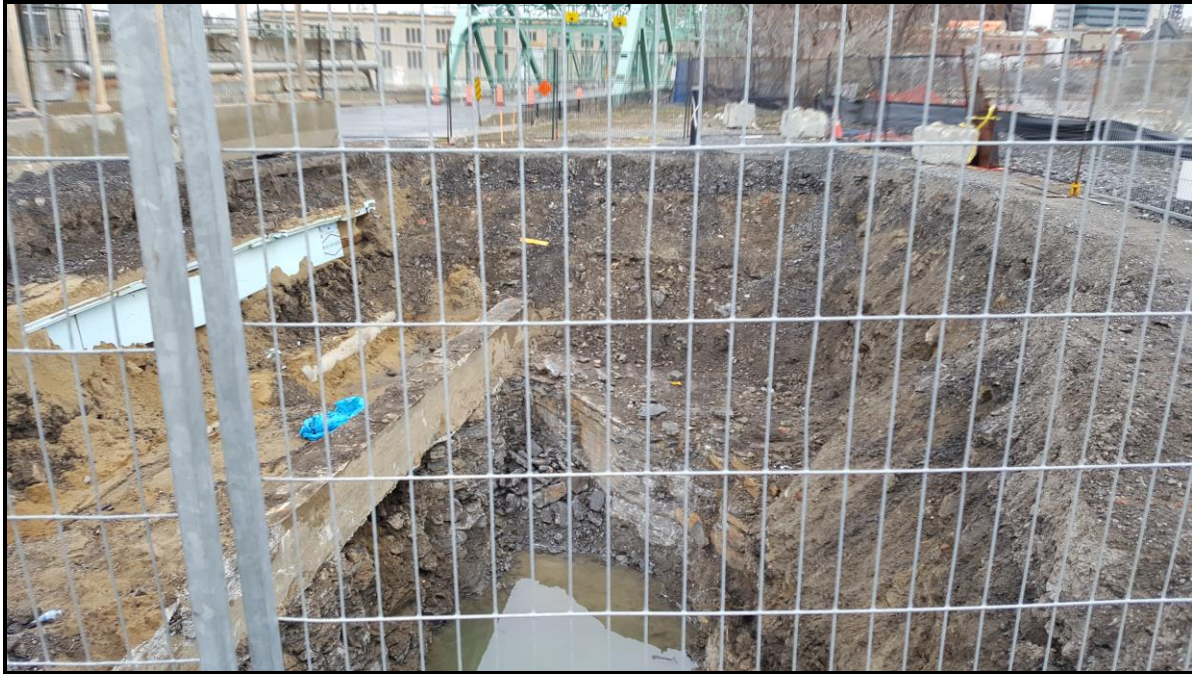
Image 19. View of the recent manhole excavation along the north edge of the study area, facing north-northwest. (PR19-018D016)

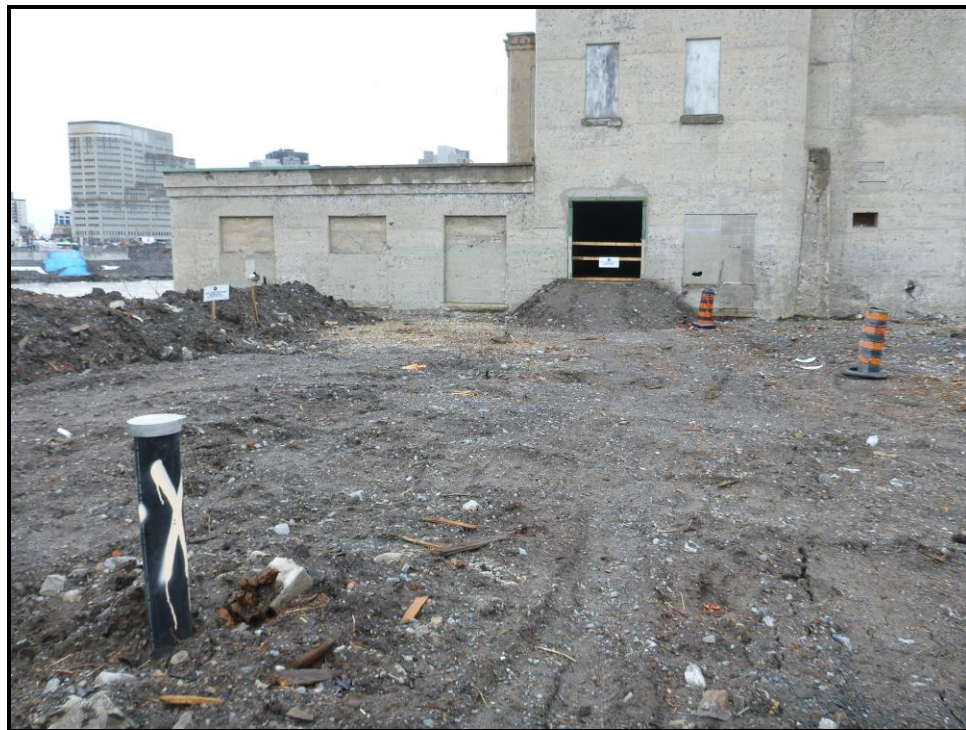
Image 20. View of the relatively undisturbed north end of the study area, facing east-northeast. (PR19-018D033)

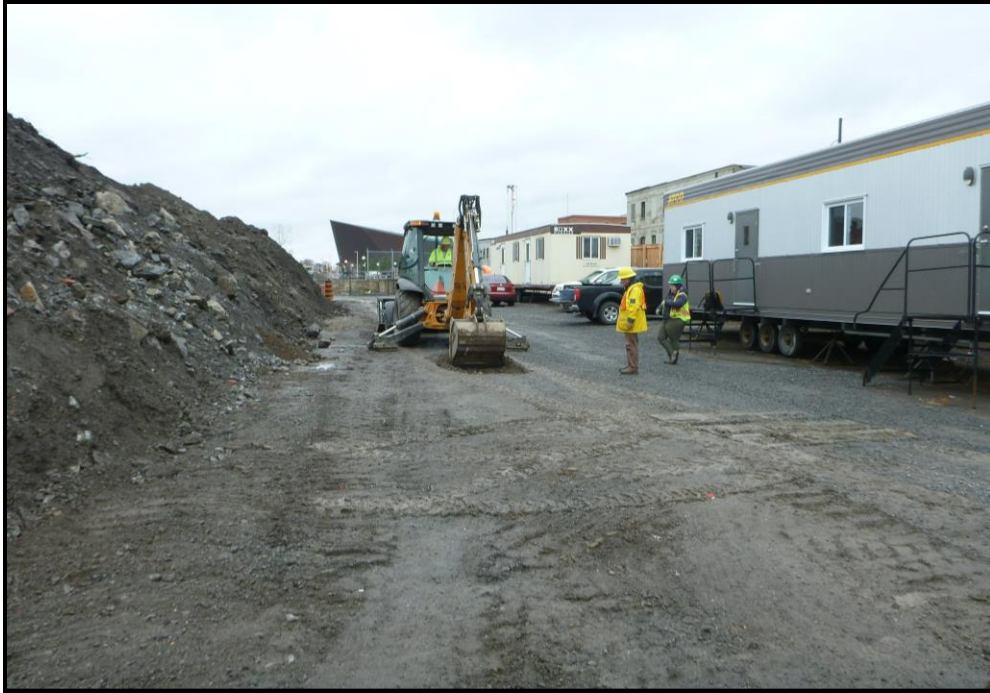
Image 21. Staff monitoring the mechanical excavation of Trench 1B, facing south-southeast. (PR19-018D031)

All test trenches were carefully excavated using a back-hoe with a smooth-edged ditching bucket, removing a few centimetres of material at a time under the supervision of a licenced archaeologist (Image 21). The trenches varied slightly in length and width as a result of the material and any obstacles encountered, but generally were the length of the reach of the backhoe arm and the width of the ditching bucket. The entire study area was assigned Operation 1, with each trench given a sub-operation letter in the order of excavation. Different soil layers identified during excavation were each assigned a lot number in the order of appearance and any artifacts noted were collected and assigned to the appropriate soil layer. Upon the completion of the initial stage of excavation (reaching a depth of 1.2 m), one of the revealed long soil profiles was cleaned and recorded through photography and measured drawings at 1:20 scale (Image 22). Excavation was then continued in all three trenches until bedrock or an obstacle preventing further soil removal was encountered, with any additional recording undertaken from ground level without entering the trench. All soil stratigraphy, any evidence of disturbance and any cultural features were noted, and each test trench was plotted on a site map. After recording activities had been completed, each trench was immediately back-filled for site safety reasons and compacted using the back-hoe bucket.

Trench 1B was located to the south of Trench 1A, positioned between the trailers and the excavated dirt piles but to the north of the known location of the former pulp mill (see Image 21; see Map 15). The trench measured c. 4 m (north-south) by 1.2 m (east-west).

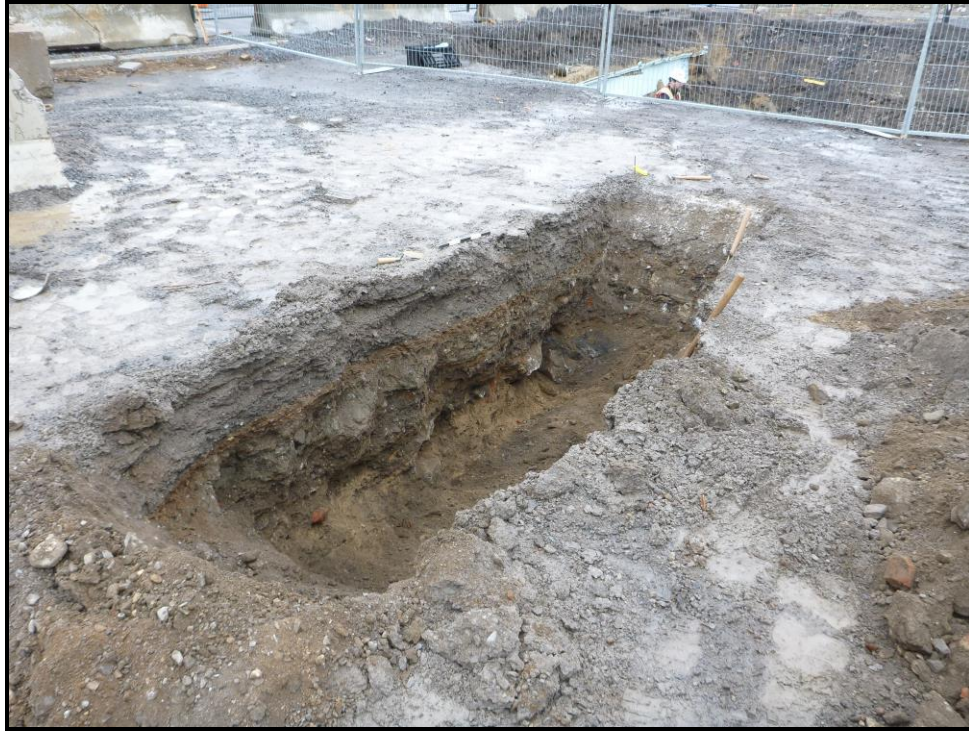
Image 23. View of the location of Trench 1A, facing northwest. (PR19-018D051)

Trench 1A was located in the northwest corner of the study area and measured 4.3 m (north-south) by 1.1 m (east-west; Image 23; see Map 15). This trench was positioned to avoid the large open excavation for the manhole, the trailers and the excavated dirt piles.

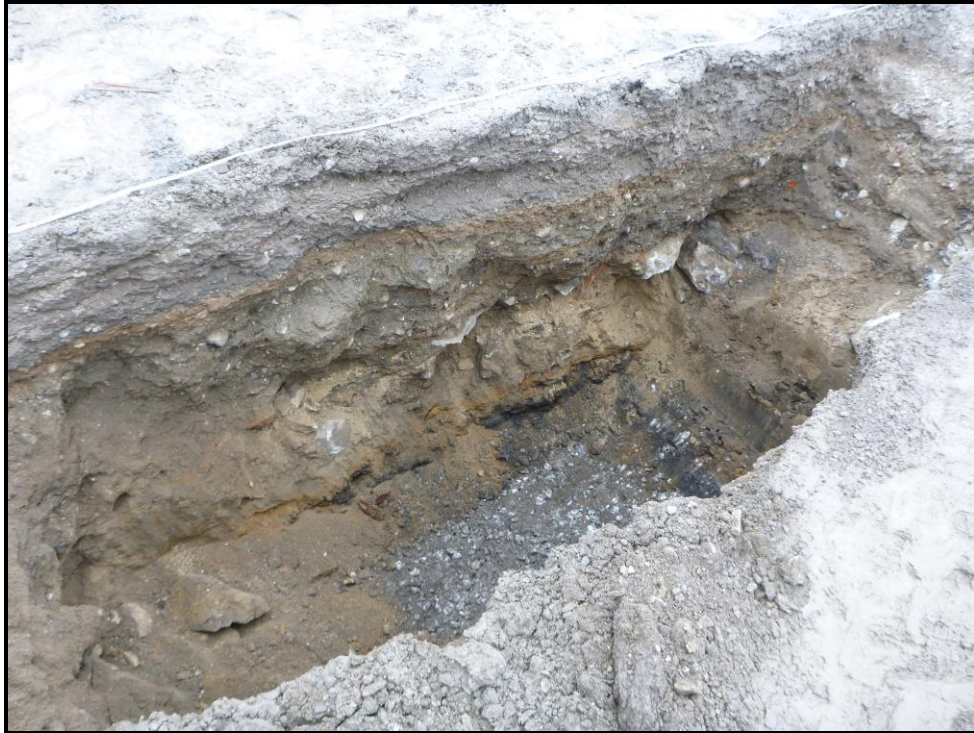
Image 25. West profile of Trench 1A, facing northwest. (PR19-018D068)

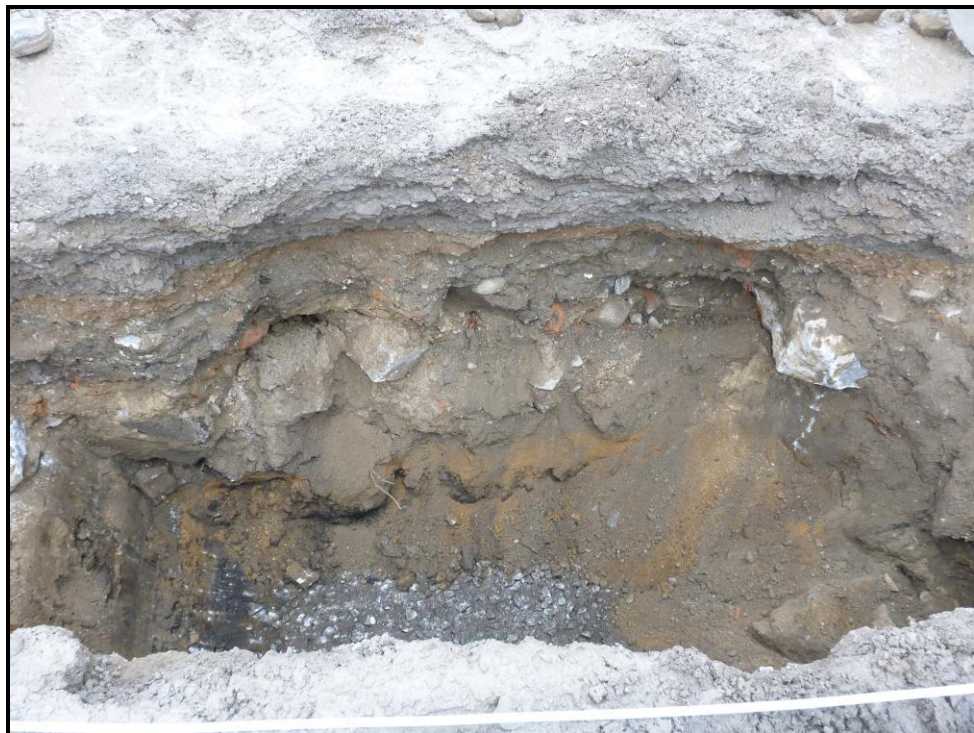
Image 26. East profile of Trench 1A, facing east-northeast. (PR19-018D073)

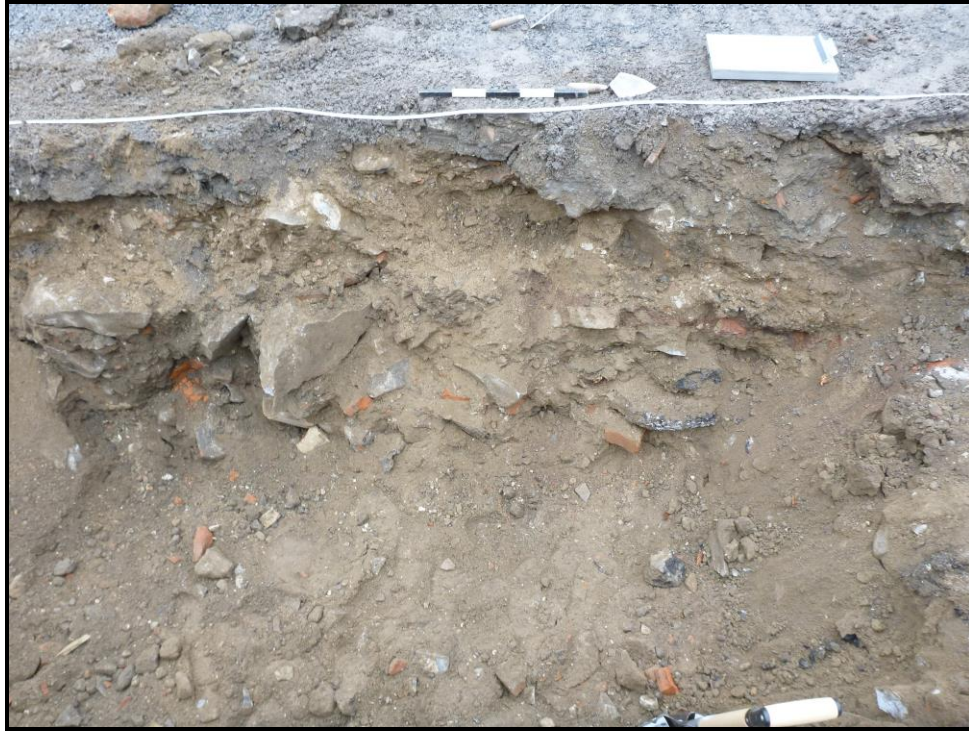
Image 28. Initial west profile of Trench 1B showing the Lot 2 debris layer, facing west-southwest. (PR19-018D052)

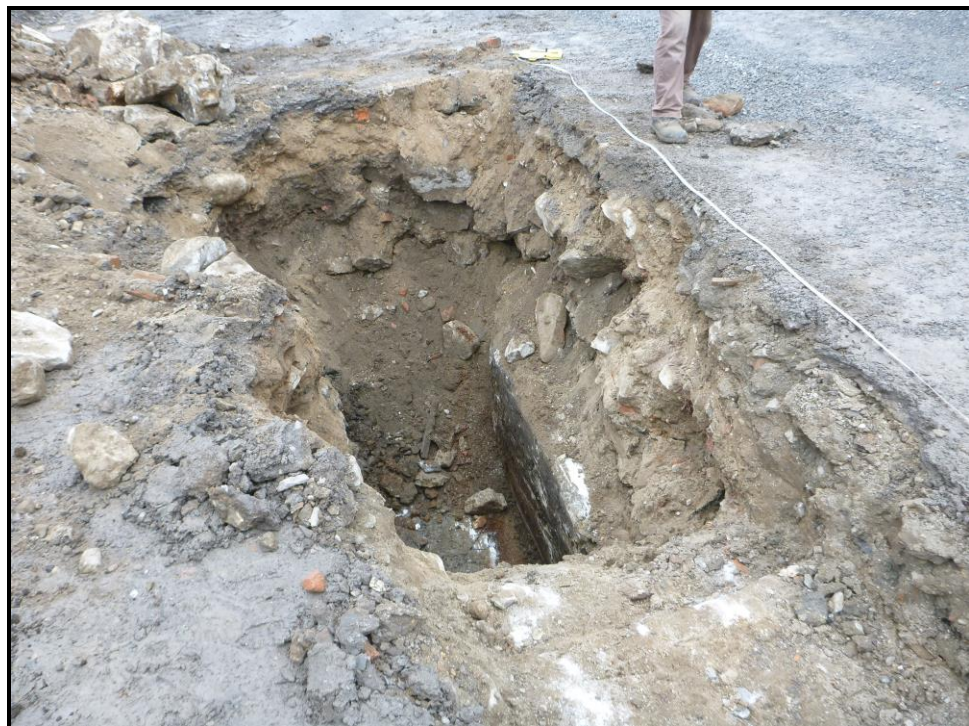
Image 29. View of Trench 1B showing the concrete wall, facing south. (PR19-018D062)

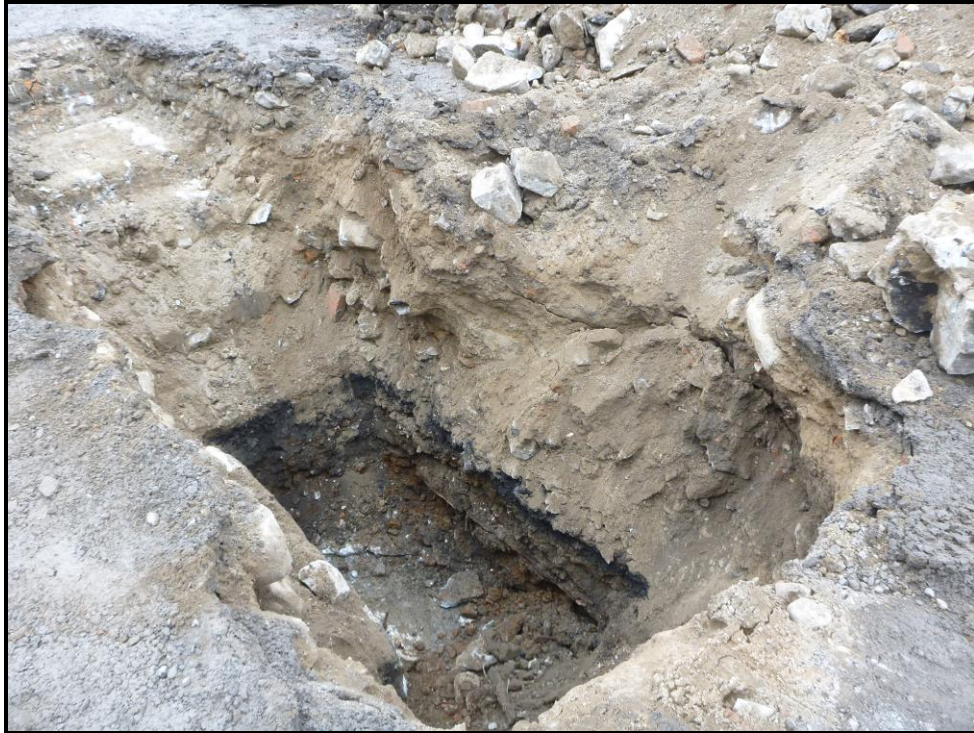
Image 30. East profile of Trench 1B, facing north. (PR19-018D078)

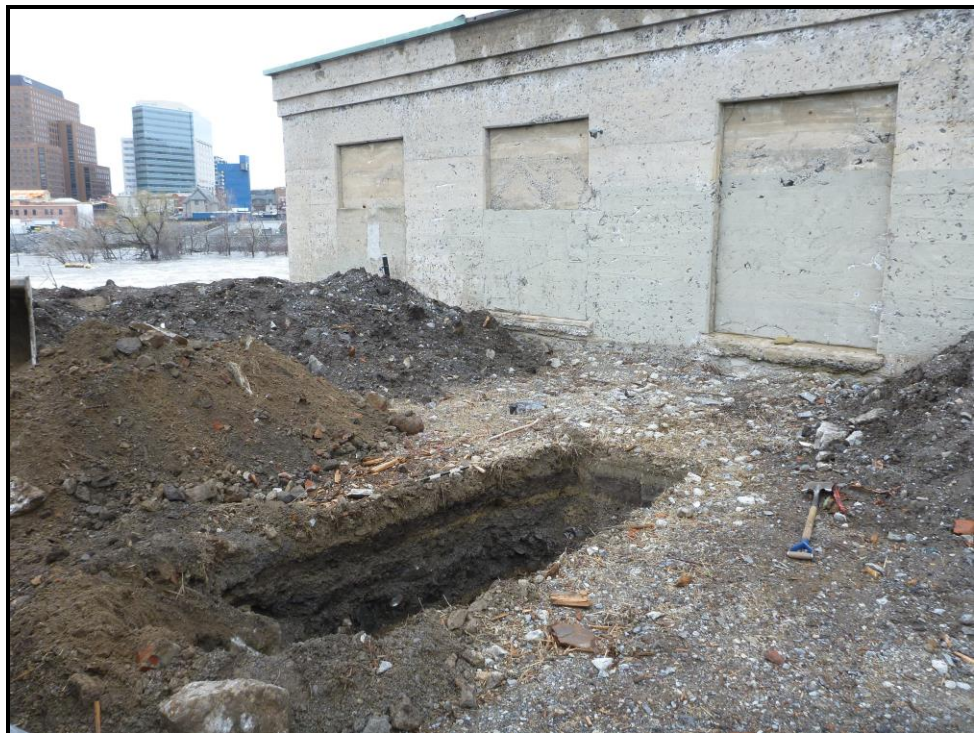
Image 31. View of the location of Trench 1C, facing north-northeast. (PR19-018D058)

Trench 1C was located in the northeast quarter of the study area, 4 m west of the remaining former pulp mill building. Unlike the other two trenches, this unit was excavated in an east-west direction and measured 2.9 m (east-west) by 1.1 m (north-south; Image 31; see Map 15).

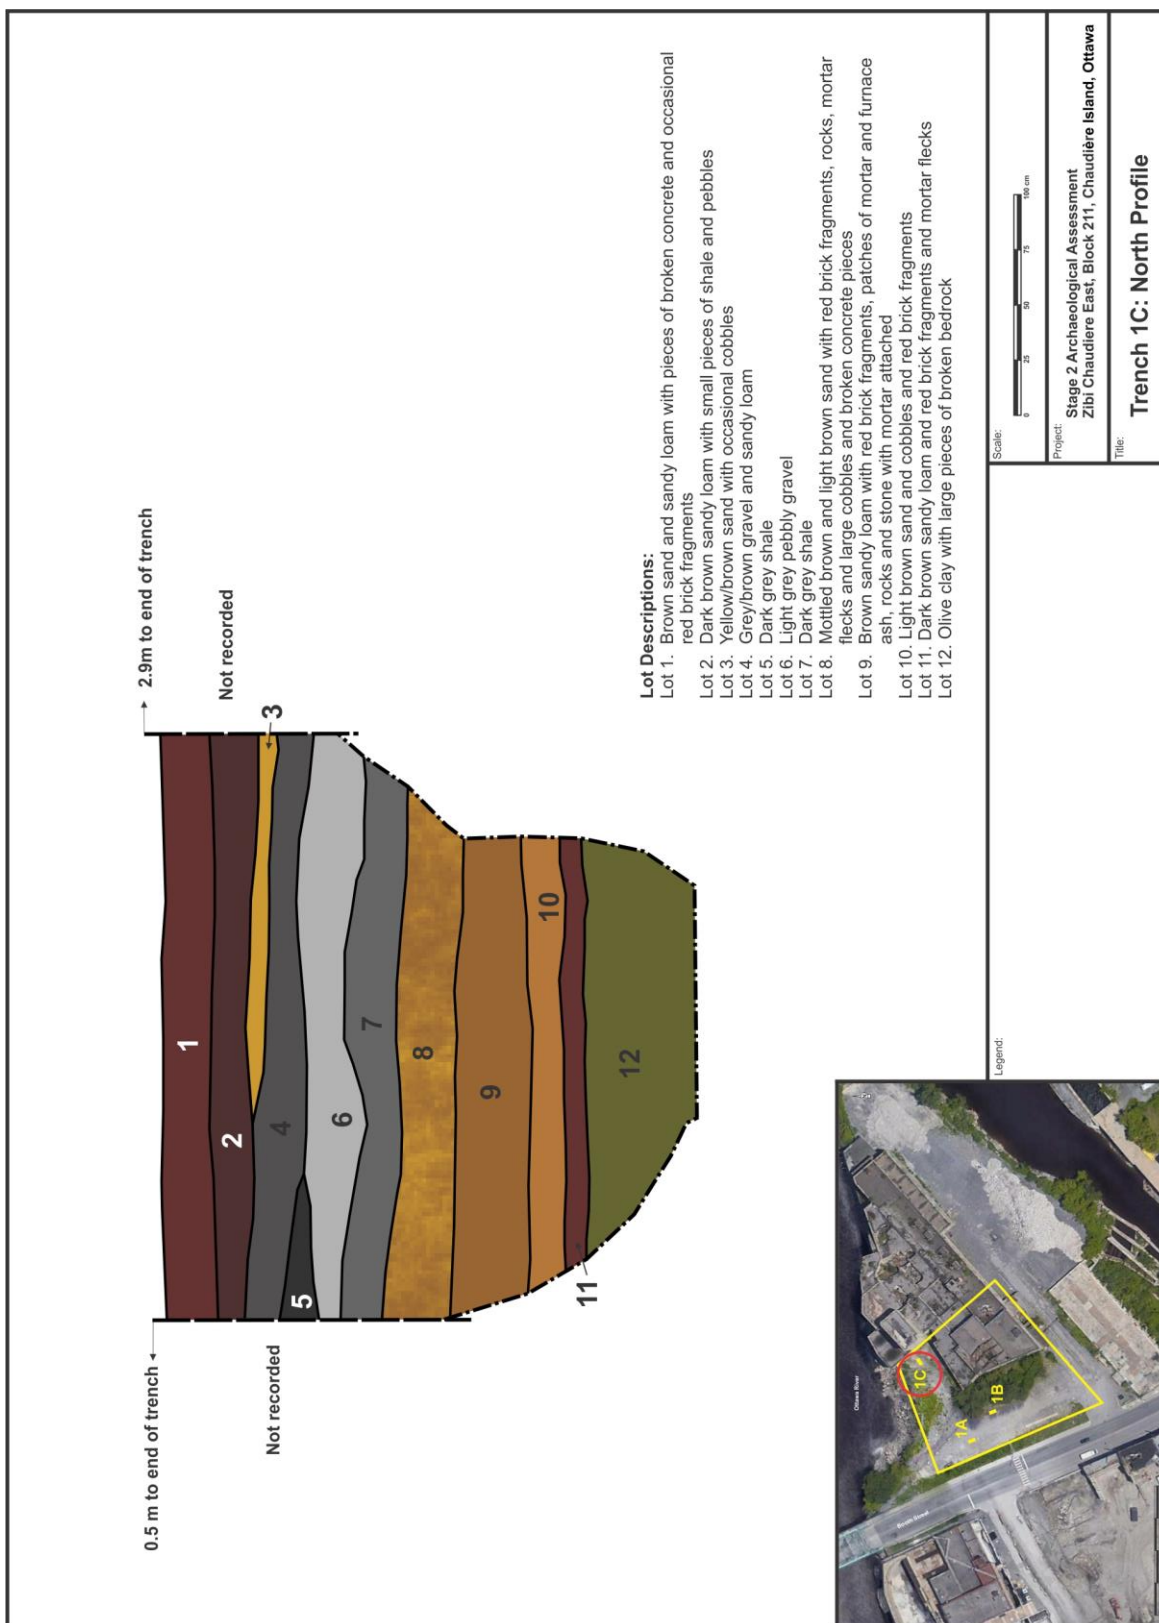
The soil stratigraphy in Trench 1C consisted initially of 18 cm of mixed brown sand and sandy loam with pieces of broken concrete and occasional red brick fragments (Lot 1), followed by 8 cm to 16 cm of dark brown sandy loam with small pieces of shale and pebbles (Lot 2; Images 32 and 33; Table 6). Below this in the east half of the trench was a 4 cm to 6 cm thick layer of yellow/brown sand with occasional cobbles (Lot 3) overlying an up to 20 cm thick deposit of grey/brown gravel and sandy loam (Lot 4).

At the west end of the unit Lot 4 lay above a stratum of dark grey shale, but this quickly petered out 1 m to the east. All of the layers below covered the entire trench. These included 8 cm to 20 cm of light grey pebbly gravel (Lot 6), over 12 cm to 20 cm of dark grey shale (Lot 7). Below Lot 7 were several demolition/fill deposits consisting in turn of c. 20 cm of mottled brown and light brown sand with rocks, red brick pieces and broken concrete (Lot 8), 20 cm to 25 cm of brown sandy loam with red brick fragments, limestone rocks with mortar attached, mortar and furnace ash (Lot 9), and 10 cm of light brown sand with cobbles and red brick fragments (Lot 10). Beneath Lot 10 was a c. 8 cm layer of dark brown sandy loam containing red brick pieces and mortar patches (Lot 11), which overlay at least 40 cm of olive clay with large pieces of broken bedrock (Lot 12). Excavation was halted at that point as voids in the clay/rock matrix indicated that the deposit continued extensively, likely to bedrock. No artifacts were found during the excavation of Trench 1C.

Image 32. Trench 1C: north profile.

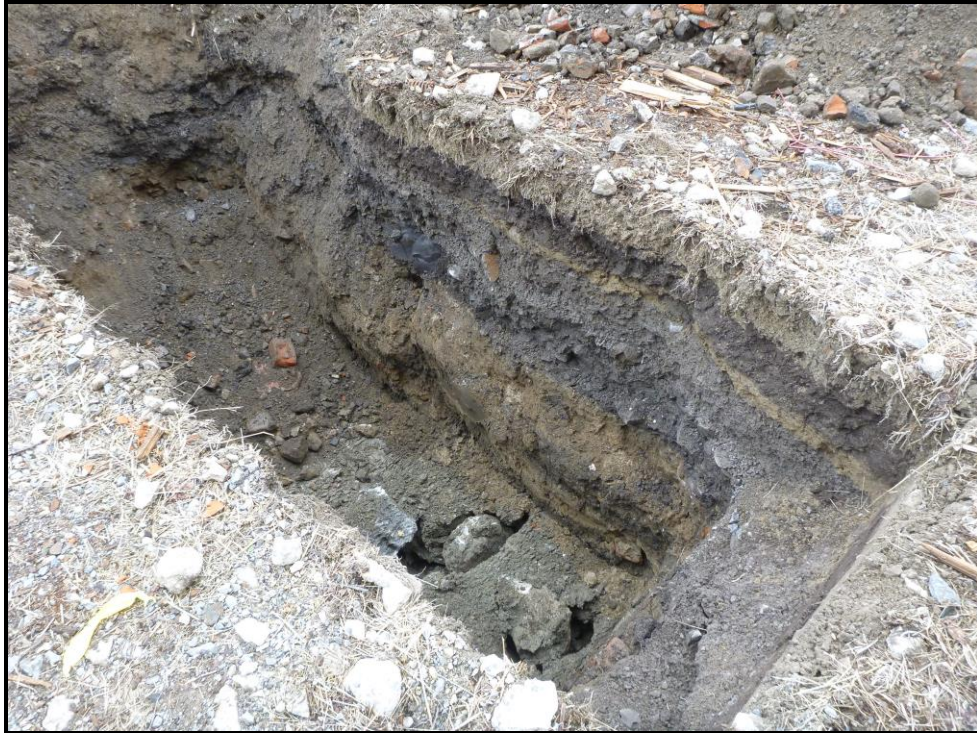
Image 33. North profile of Trench 1C, facing northwest. (PR19-018D076)
