Phase I Environmental Site Assessment

701 Churchill Avenue
Ottawa, Ontario

April 9, 2019

Report: PE4583-1

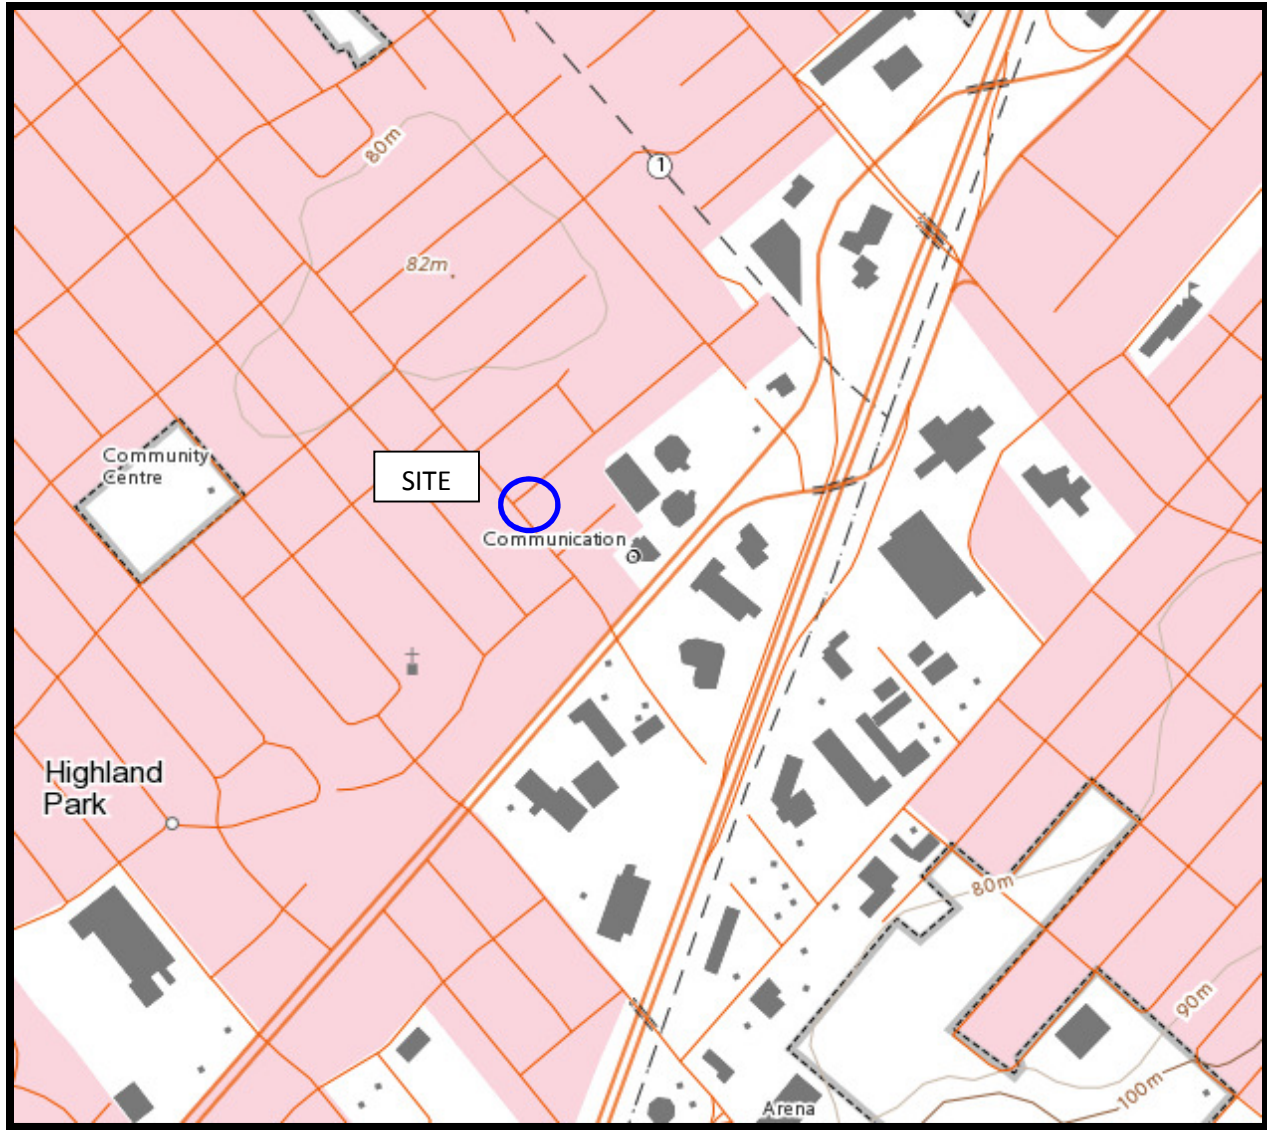
FIGURE 2
TOPOGRAPHIC MAP

Topographic maps were obtained from Natural Resources Canada - The Atlas of Canada website. The topographic maps indicate that the subject site and surrounding area slopes down gently to the south and southeast. An illustration of the referenced topographic map is present in Figure 2 - Topographic Map following the body of this report.

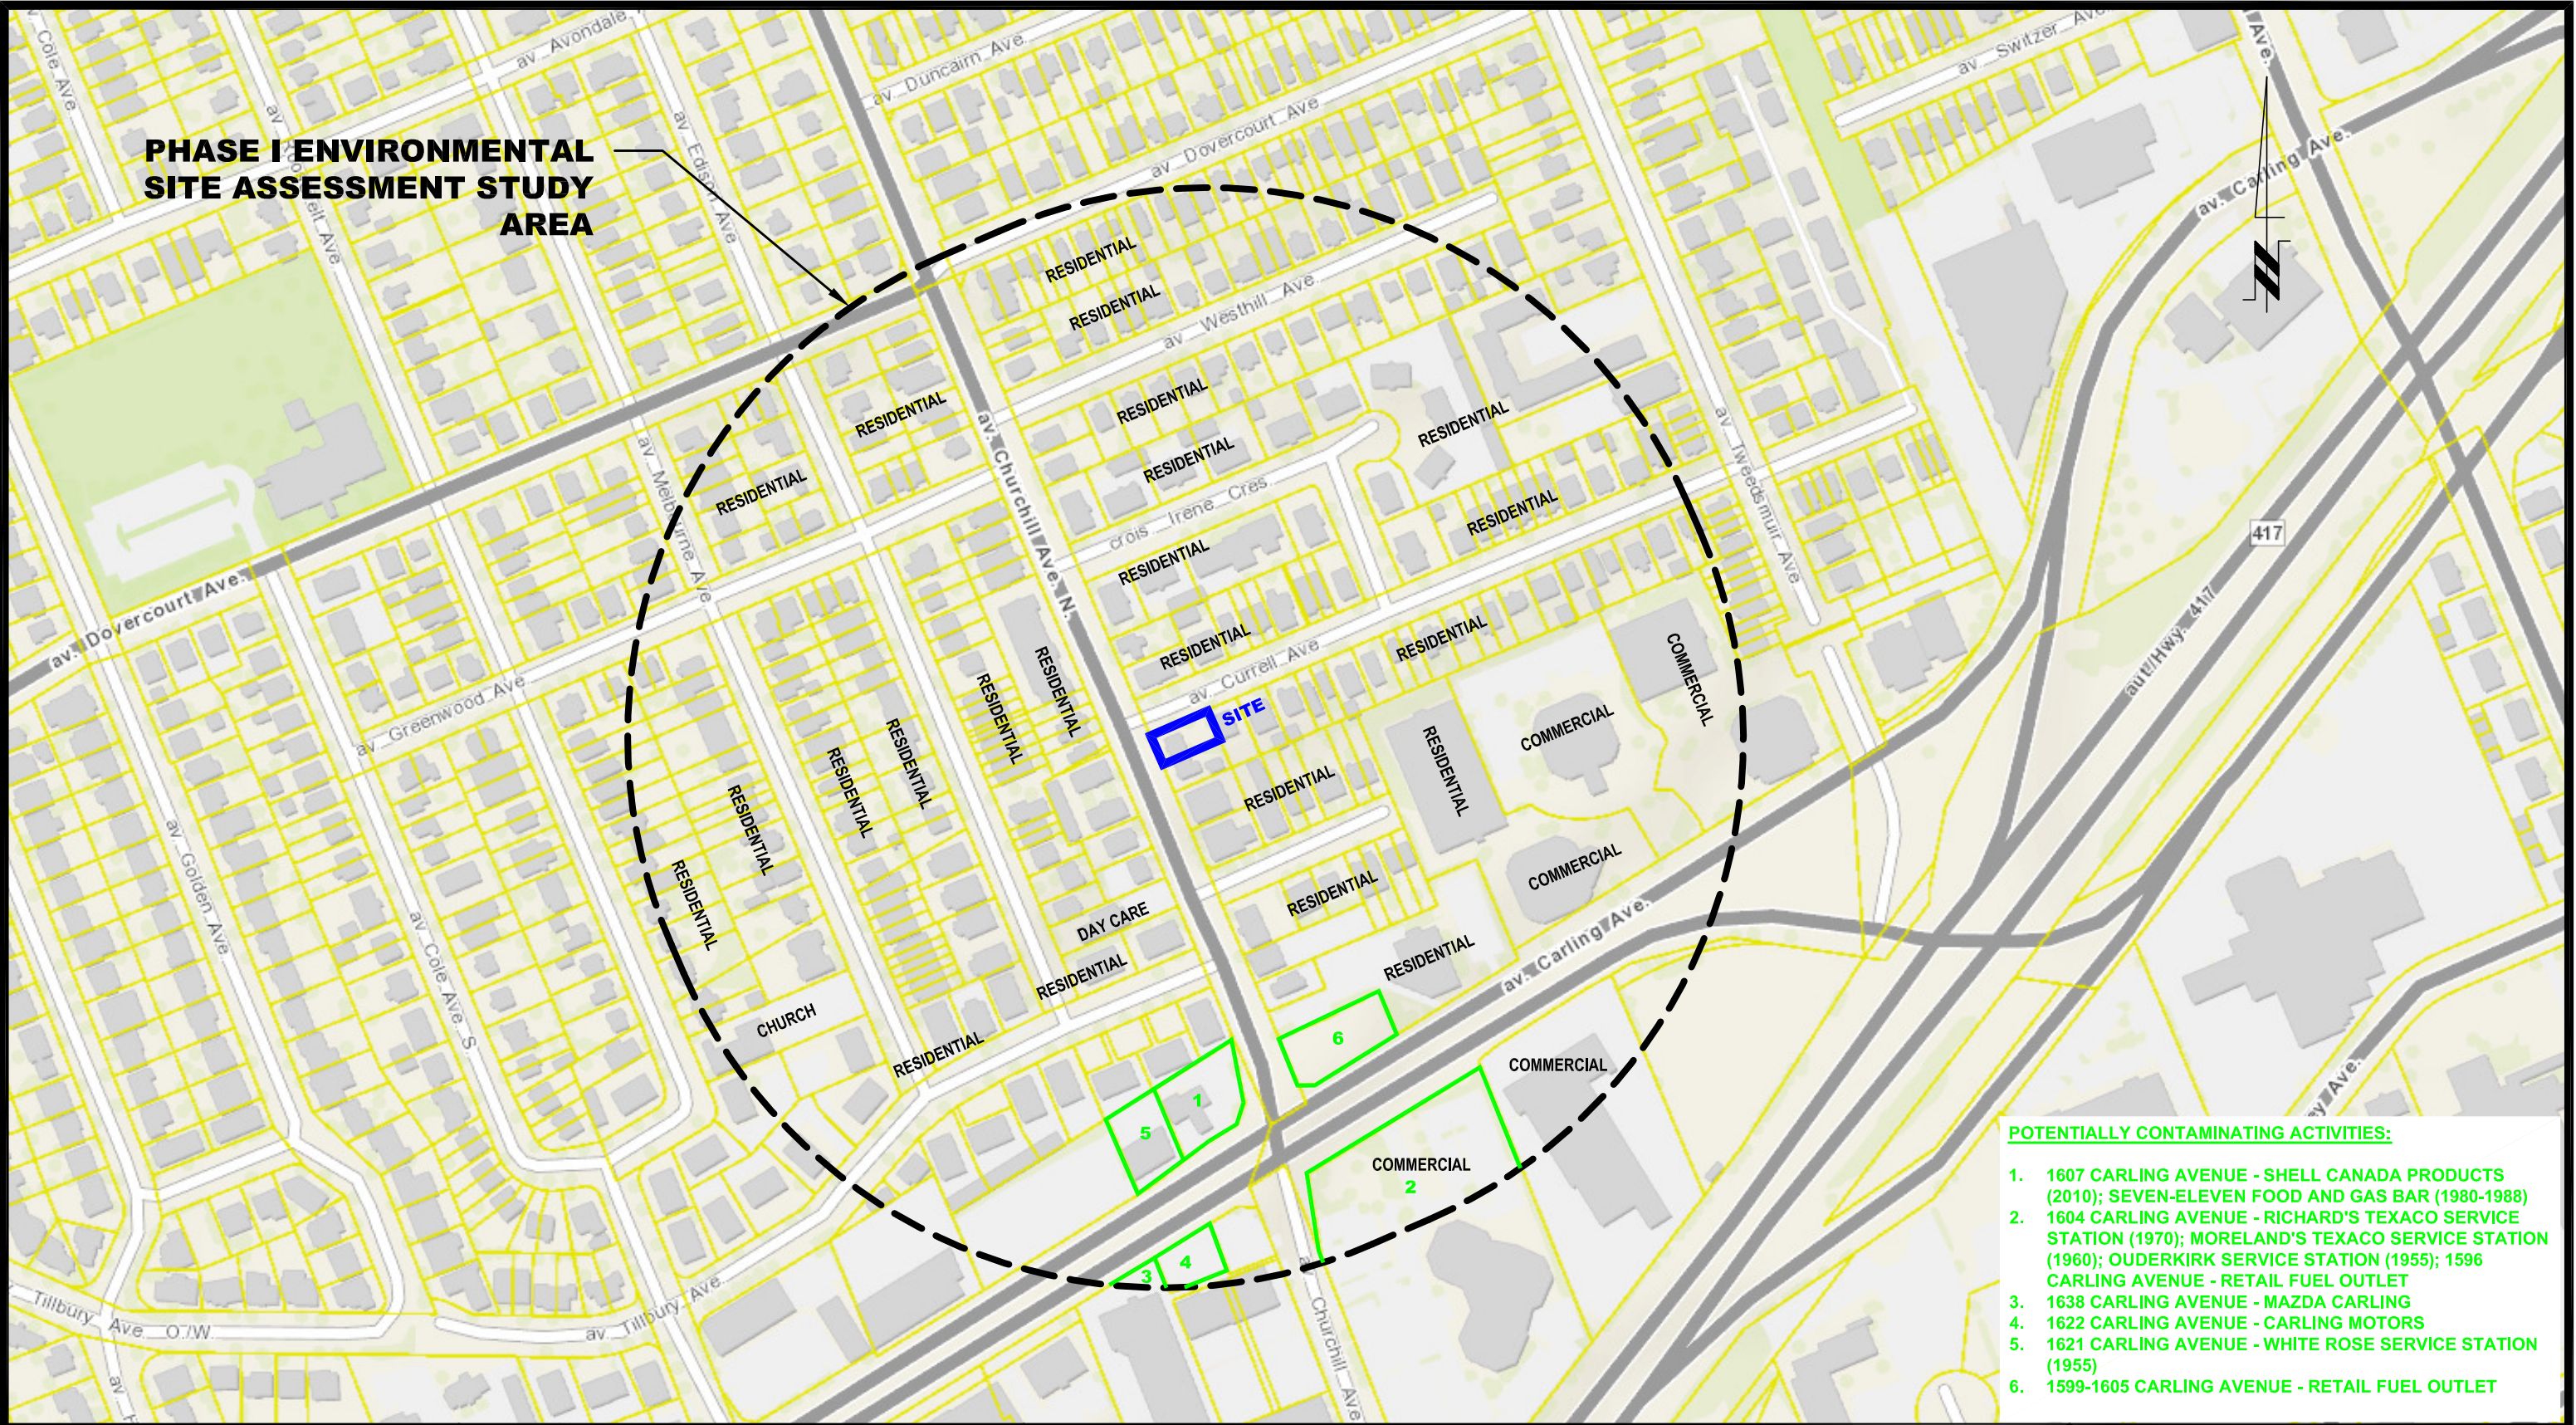
DRAWING PE4583-2 – SURROUNDING LAND USE PLAN

- POTENTIALLY CONTAMINATING ACTIVITIES:**
- 1. 1607 CARLING AVENUE - SHELL CANADA PRODUCTS (2010); SEVEN-ELEVEN FOOD AND GAS BAR (1980-1988)
 - 2. 1604 CARLING AVENUE - RICHARD'S TEXACO SERVICE STATION (1970); MORELAND'S TEXACO SERVICE STATION (1960); OUDERKIRK SERVICE STATION (1955); 1596 CARLING AVENUE - RETAIL FUEL OUTLET
 - 3. 1638 CARLING AVENUE - MAZDA CARLING
 - 4. 1622 CARLING AVENUE - CARLING MOTORS
 - 5. 1621 CARLING AVENUE - WHITE ROSE SERVICE STATION (1955)
 - 6. 1599-1605 CARLING AVENUE - RETAIL FUEL OUTLET

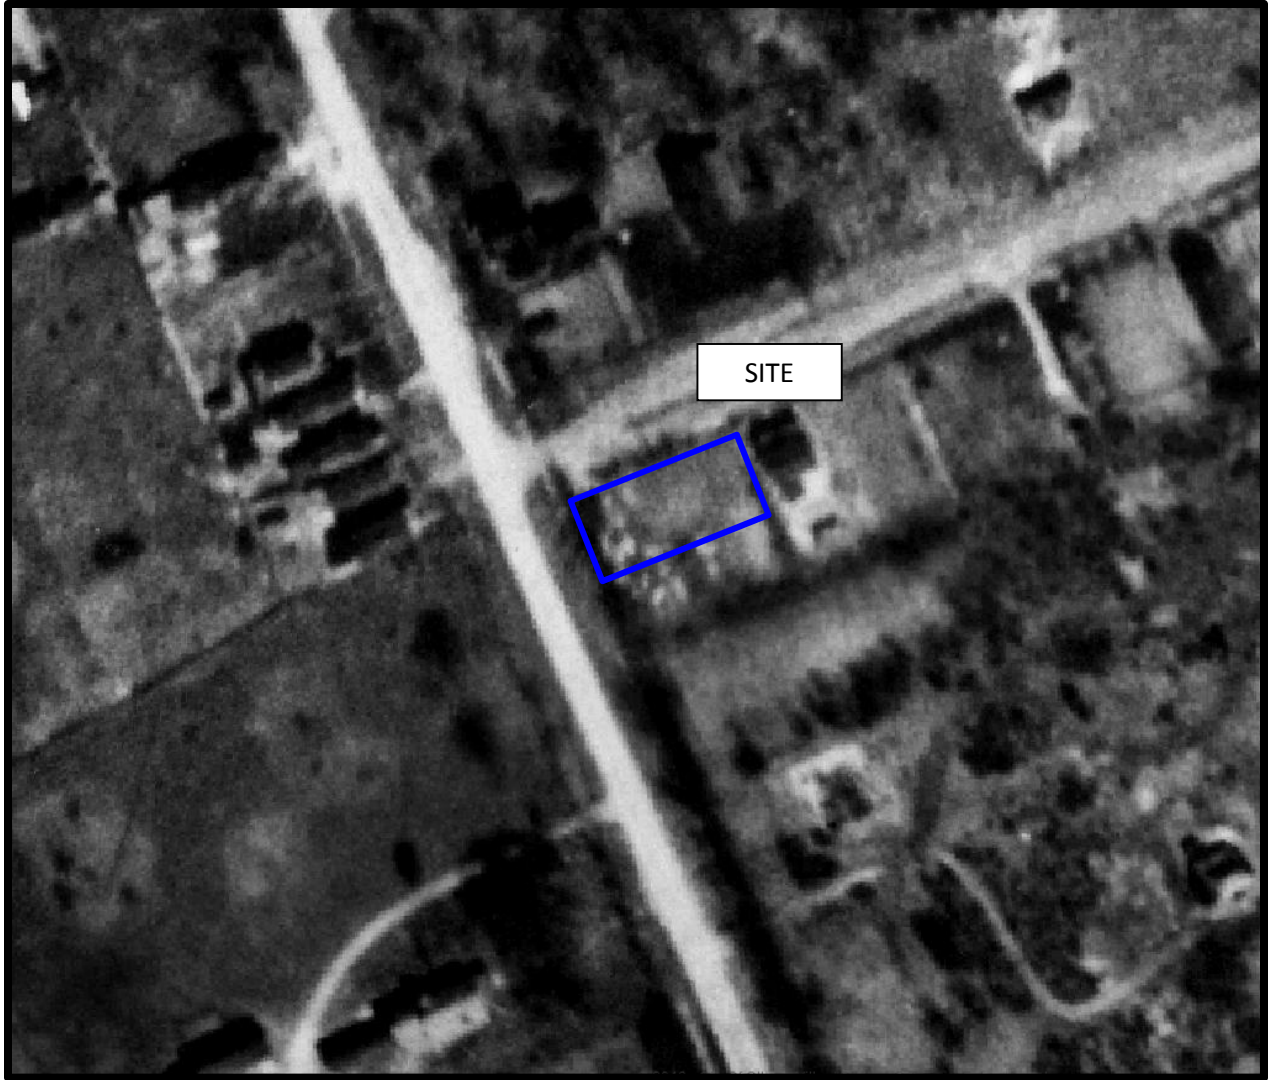
AERIAL PHOTOGRAPH
1928

1928	The subject site appears vacant, falling within the garden of a detached dwelling located to the east of the site. The surrounding area appears sparsely developed with houses.
1958	The subject site is occupied by a detached dwelling, fronting on to Churchill Avenue. The surrounding area is developed with detached houses and apartment blocks.
1965	No significant changes have been made to the subject site. The whole area pictured is developed with residential buildings at this time.
1976	No significant changes have been made to the subject site or surrounding properties.
2002	No significant changes have been made to the subject site. Several houses located east of the subject site have been replaced with a large apartment block.
2011	No significant changes have been made to the subject site or surrounding properties.
2017	No significant changes have been made to the subject site or surrounding properties.

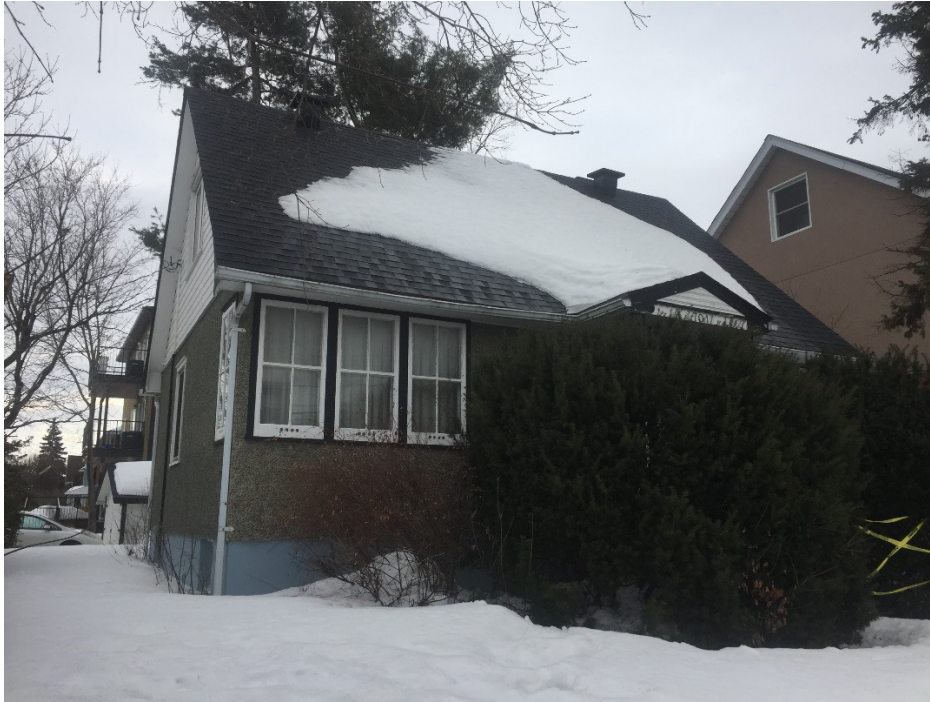
The main building was constructed on a concrete foundation, finished with pebbledash/stucco and with a sloped shingled roof. The building was historically heated by an oil burning furnace, with both the furnace and above ground storage tank located in the basement. Relict structures suggested the building may historically have been heated with coal. At the time of the inspection the furnace oil tank was empty and the building was heated temporarily with portable electric heaters.

Photo 1; Front elevation of the property facing northeast.

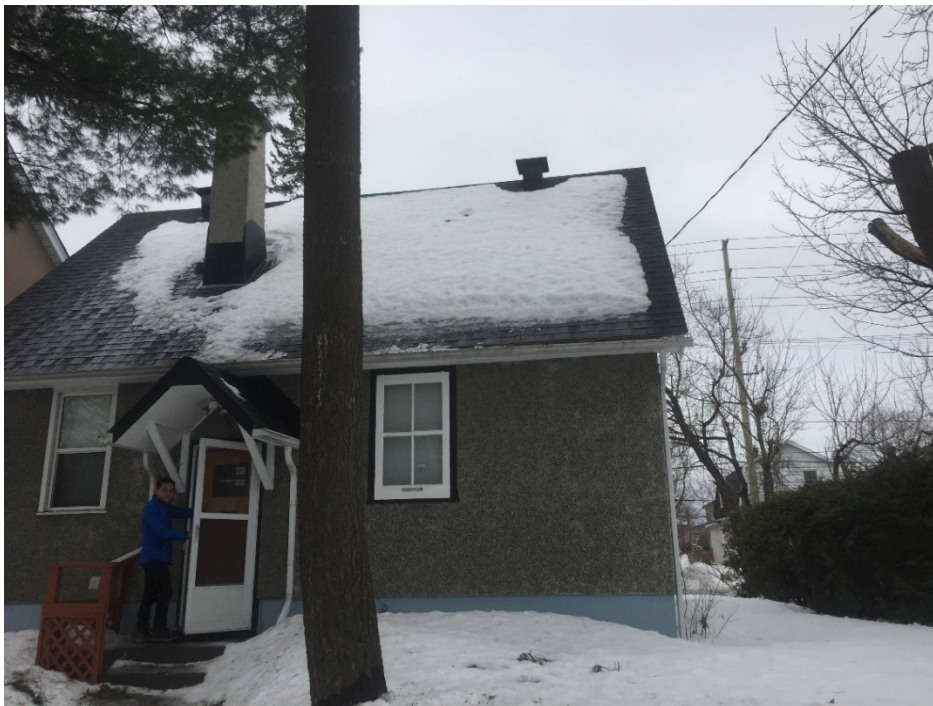
Photo 2; Rear elevation of the property, facing south.

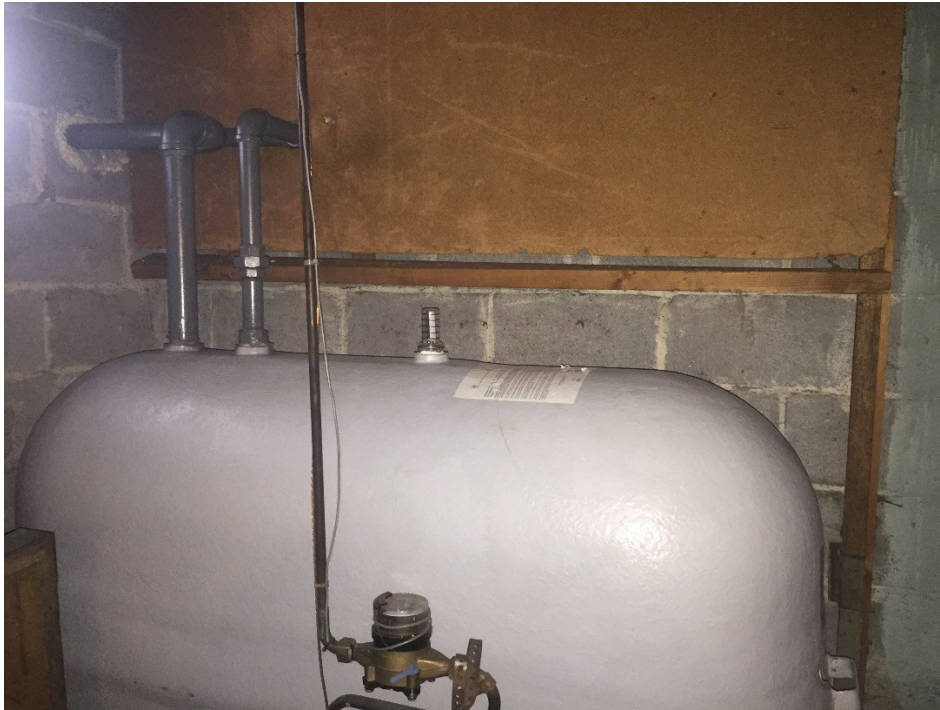
A 909-litre fibreglass above ground storage tank (AST) dating from 2015, was located in the building's basement. The gage on the top of the tank indicated it was empty. Previously the tank would have stored furnace oil. No staining was noted on or around the tank and no odour was detected. The tank feed pipe was situated above an "oil yeller" automatic leak detection system. The feed pipe ran to a pump located beside the furnace which had a separate "oil yeller" tray. Vent/fill pipes penetrated the exterior wall at the southern corner of the building.

The AST is a potential source of contamination, however, no evidence of potential leaks was noted during the assessment that indicated any such leaks have occurred.

Photo 3; Above ground fibreglass furnace oil tank located in the basement.

While the AST could have been a potential source of contamination, there was no evidence to suggest that there had ever been a leak. To corroborate our observations, it is recommended that an inspection of the soil/bedrock beneath the southwest corner of the basement (where the AST is situate) be conducted following the demolition/removal of the building's foundation.

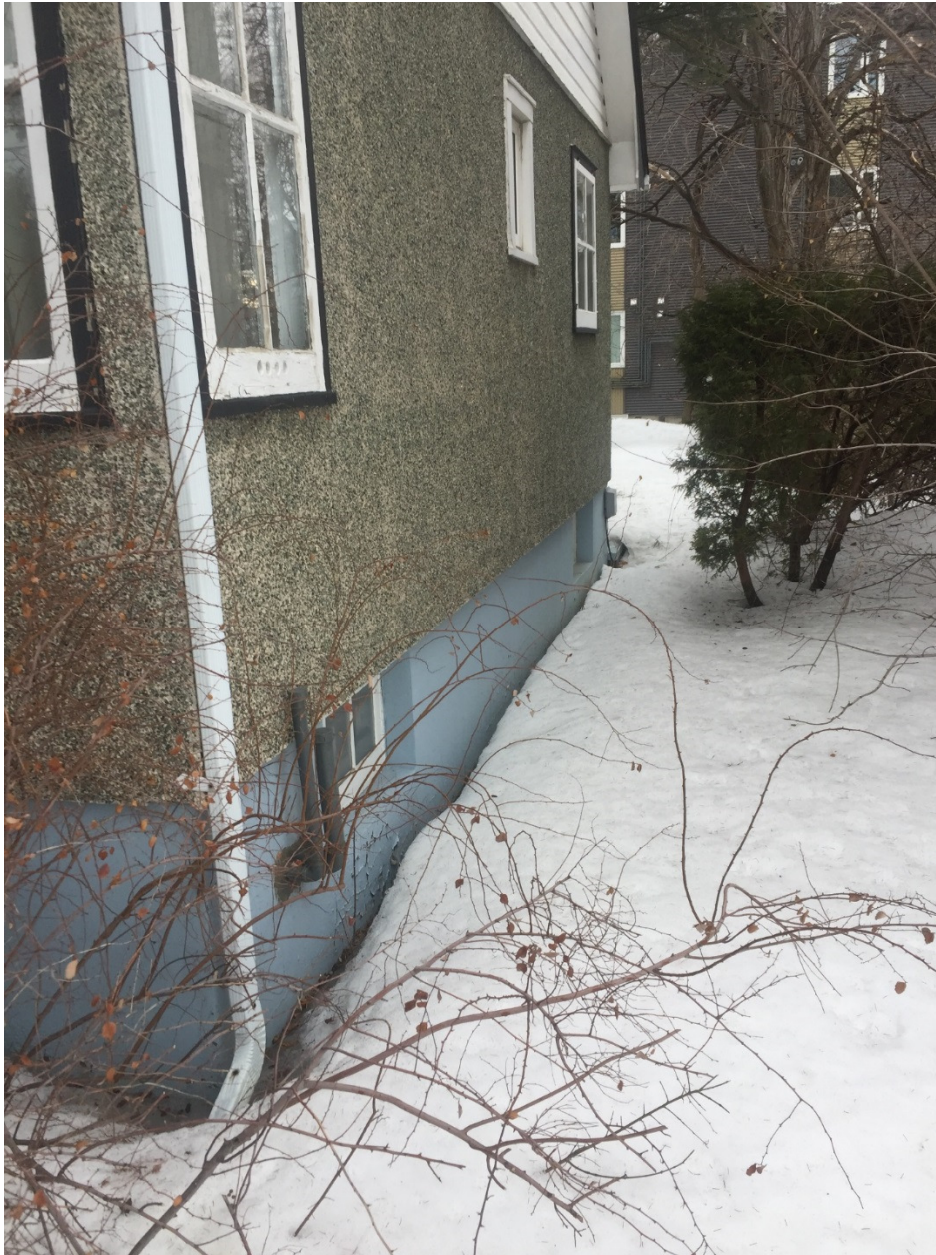
Photo 4; Vent/fill pipes located on the southern corner of the building.
