Phase I - Environmental Site Assessment Update

2660 Norberry Crescent &
740 and 840 Springland Drive
Ottawa, Ontario

Greatwise Developments

Report: PE1407-2

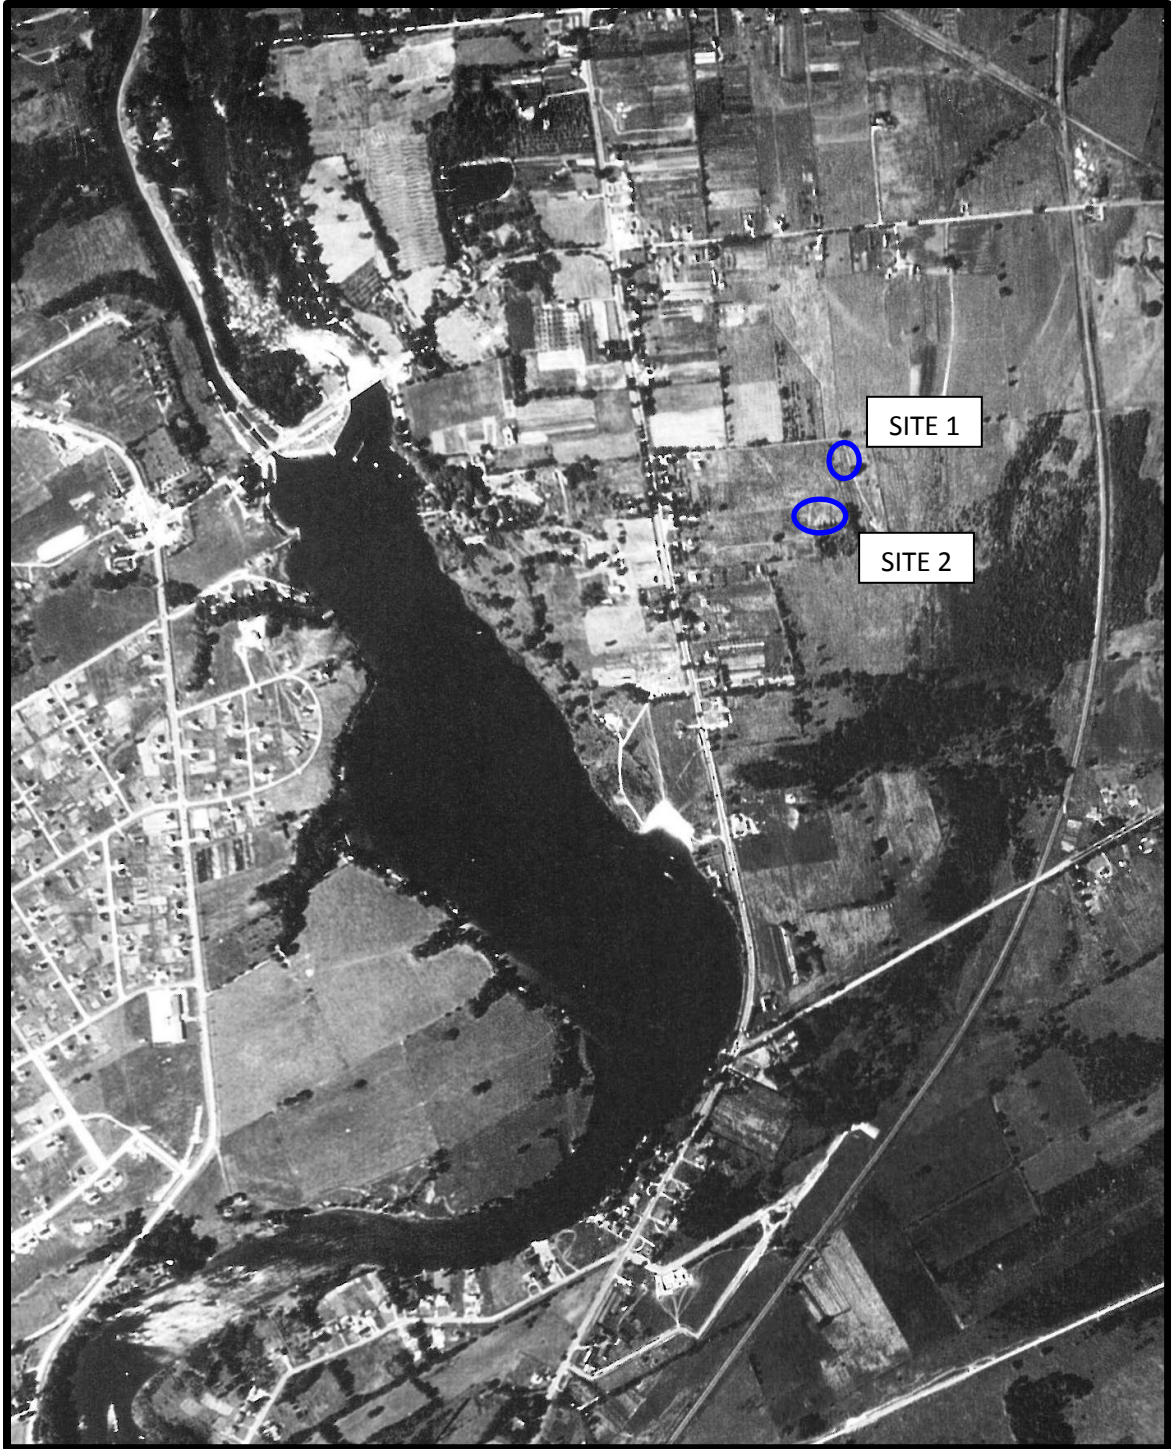
AERIAL PHOTOGRAPH
1951

| 1951 | The subject site and neighbouring lands appear vacant, possibly used for agricultural purposes. To the west, Riverside Drive is present with some residential development. |

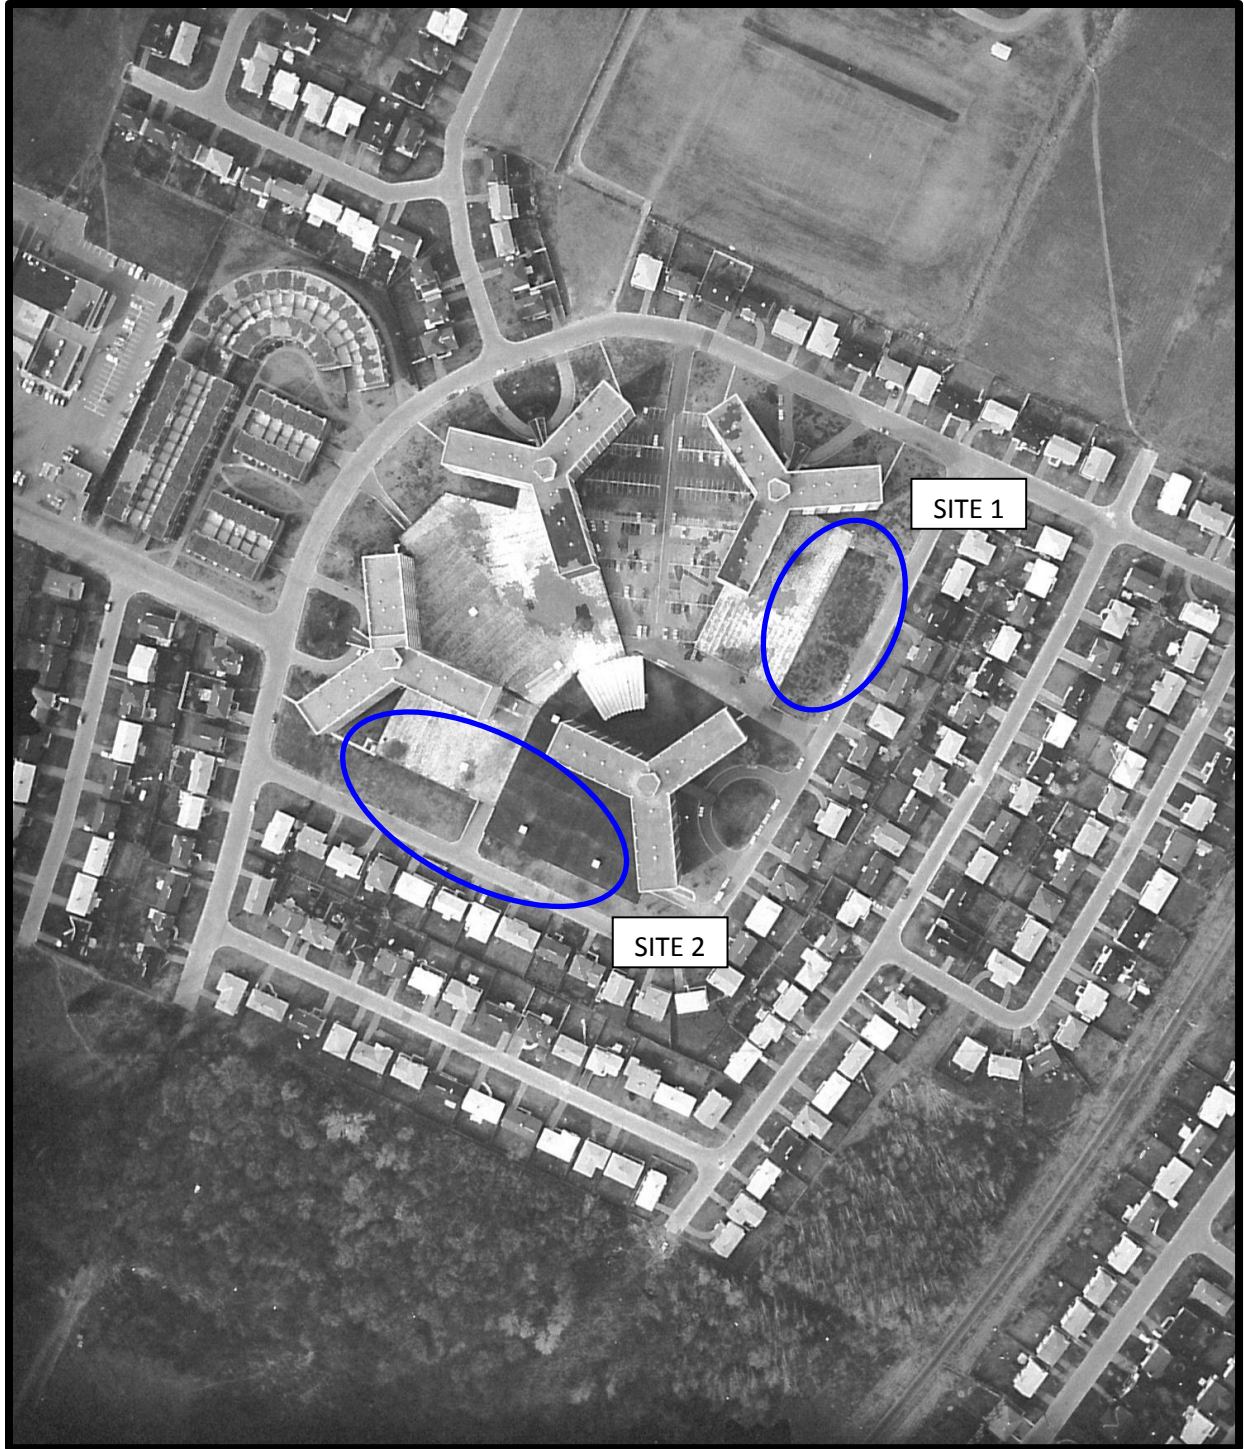
AERIAL PHOTOGRAPH
1968

| 1968 | The fourth apartment building, at 2660 Norberry, has been constructed. The land west of the site has been developed with residential structures, followed by a commercial development. |

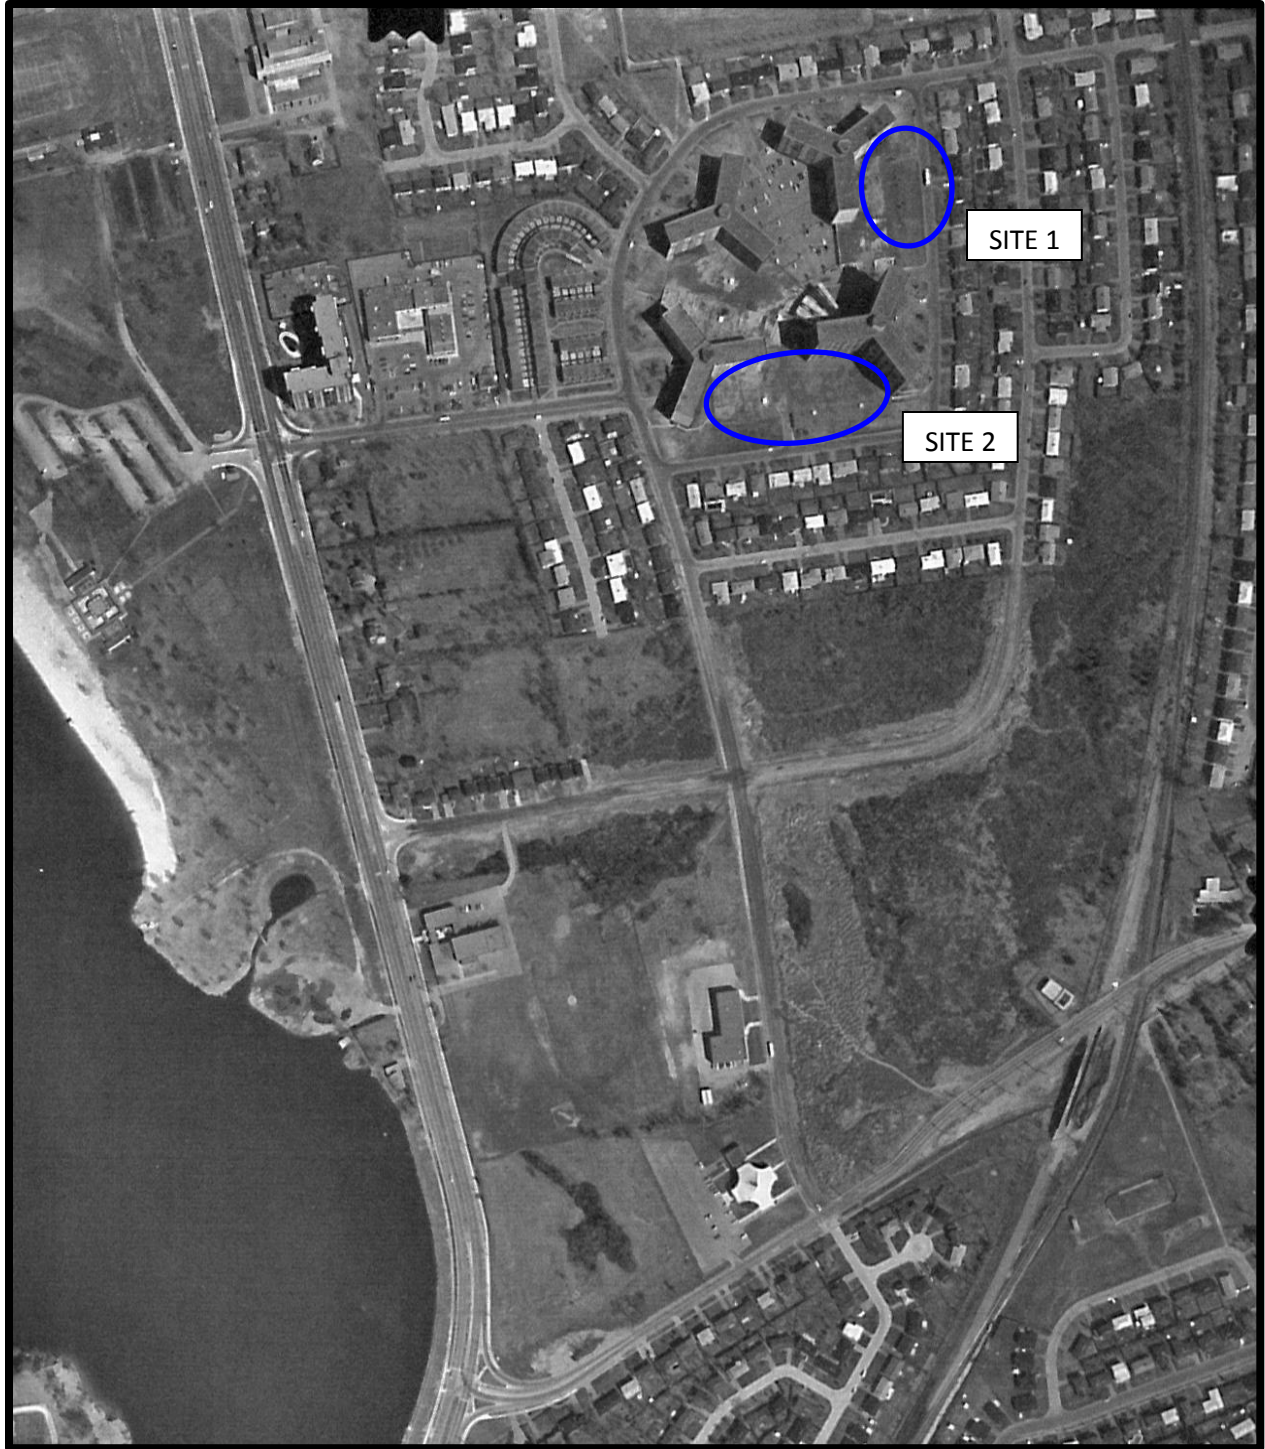
AERIAL PHOTOGRAPH
1975

| 1975 | No apparent changes have been made to the subject site or adjacent and neighbouring properties. |

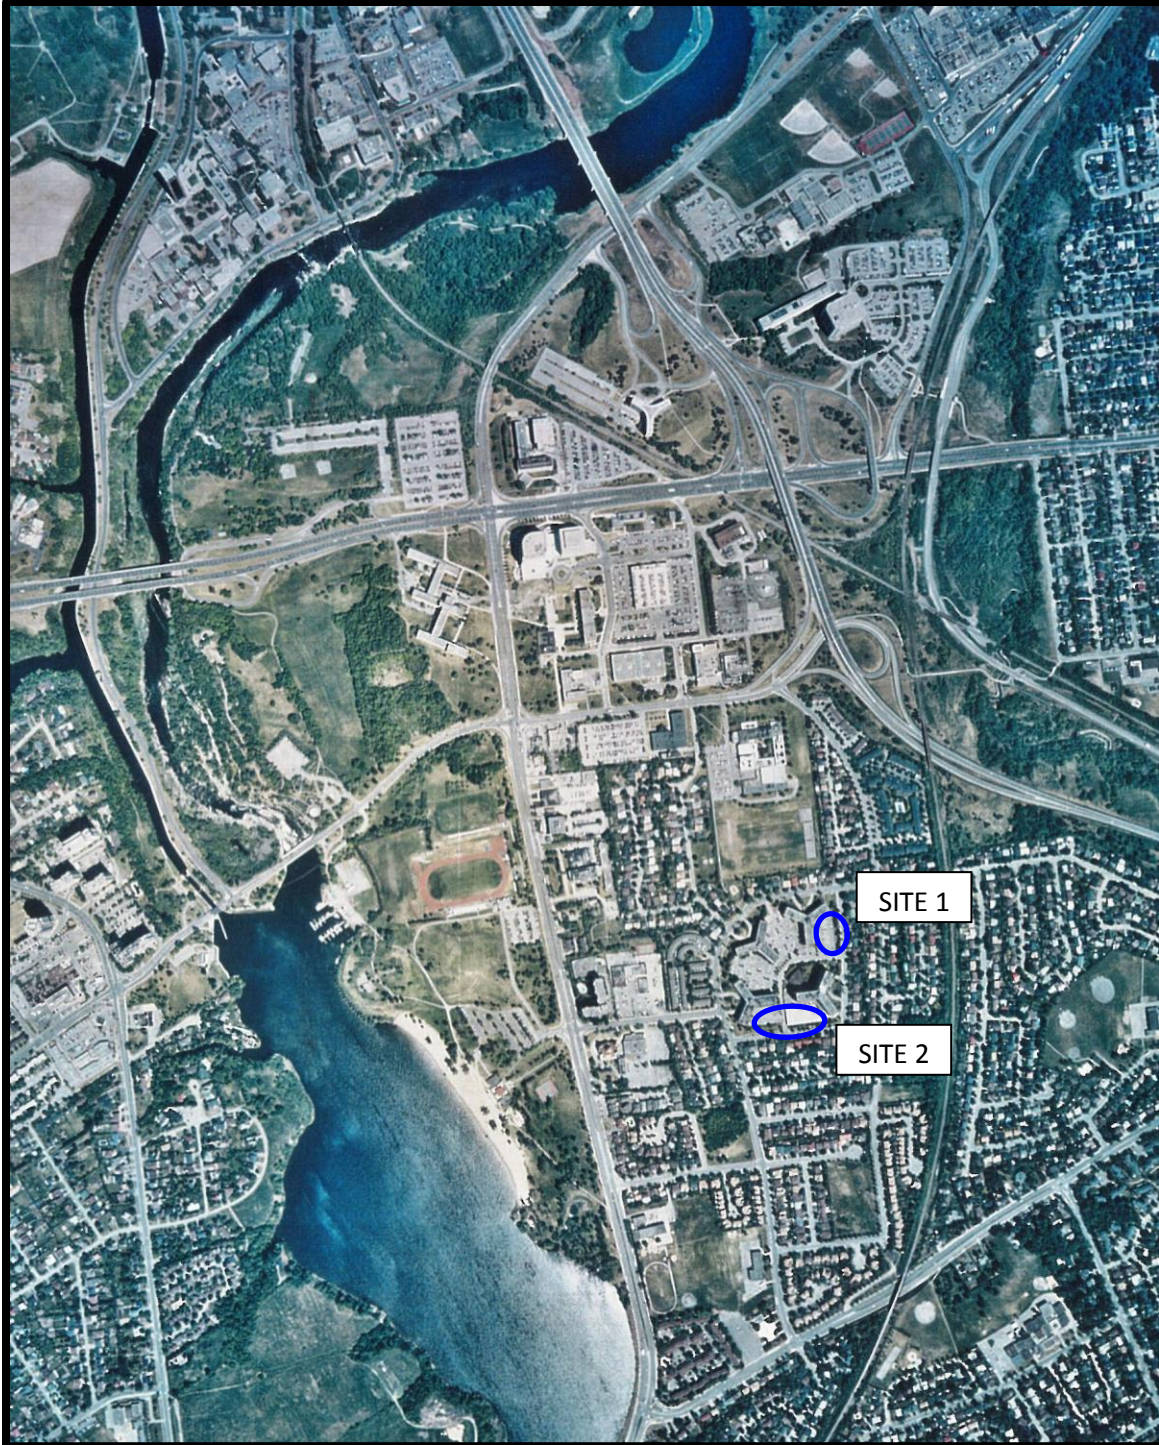
AERIAL PHOTOGRAPH
1991

| 1991 | No apparent changes have been made to the subject site or adjacent properties. Further residential development has occurred to the south and southwest |

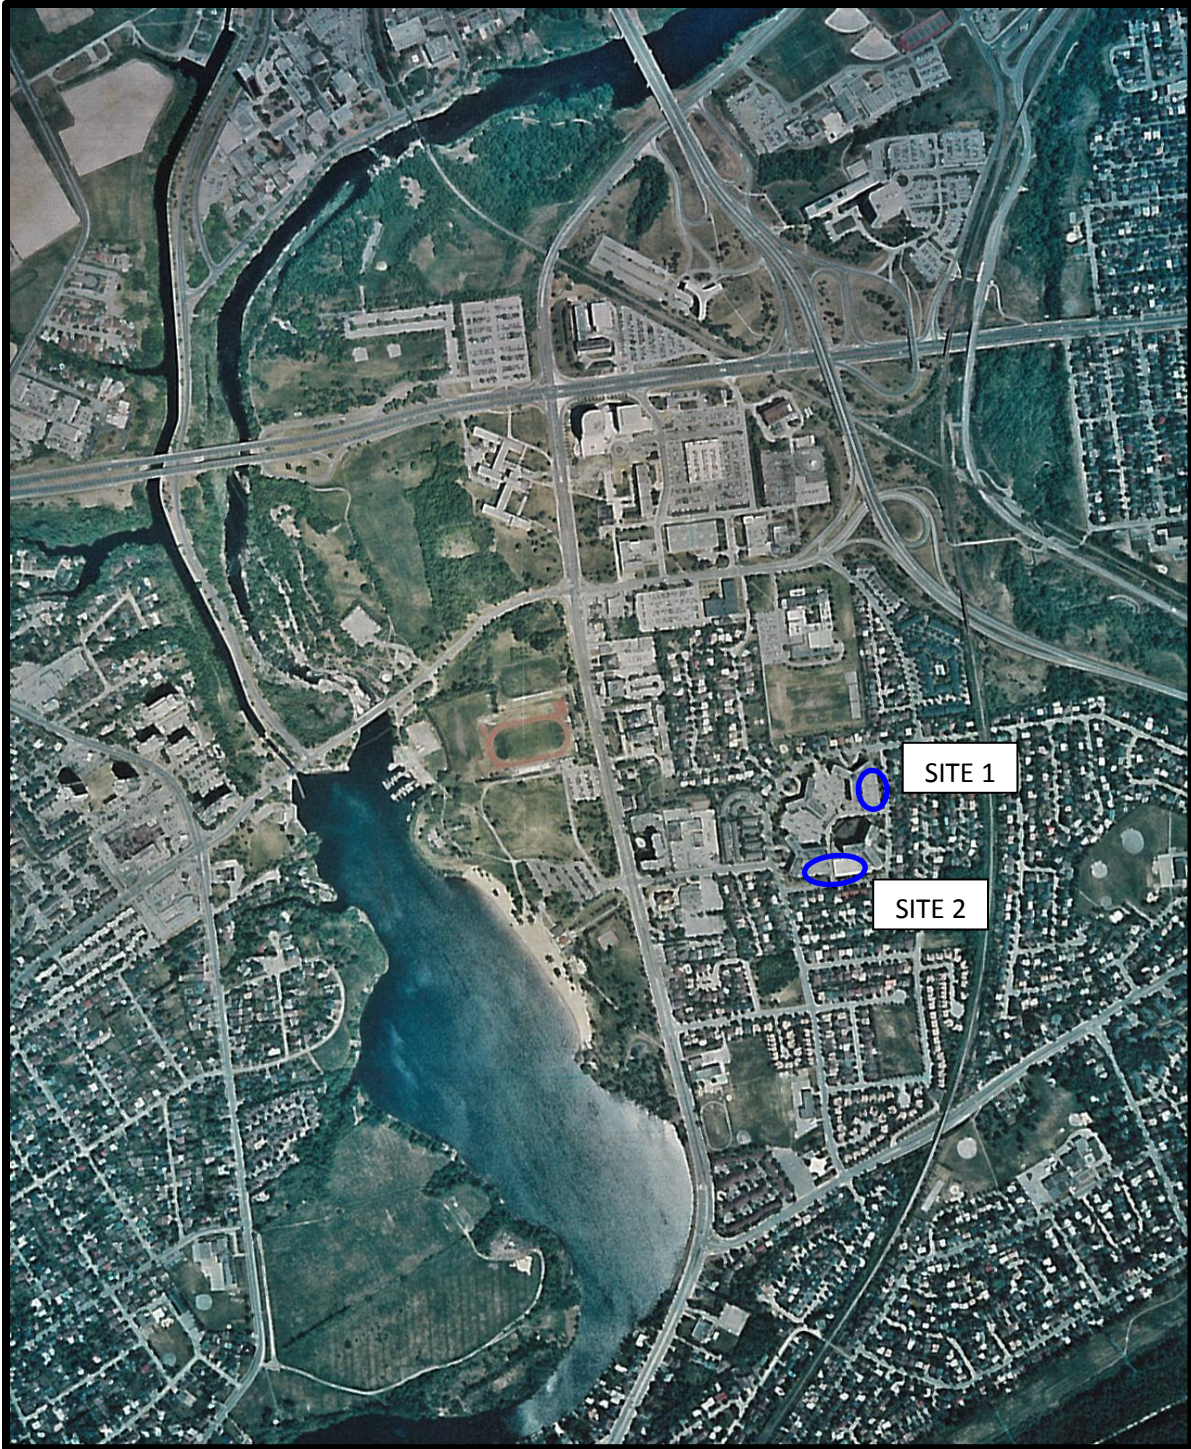
AERIAL PHOTOGRAPH
1999

| 1999 | No apparent changes have been made to the subject site or adjacent and neighbouring properties. |

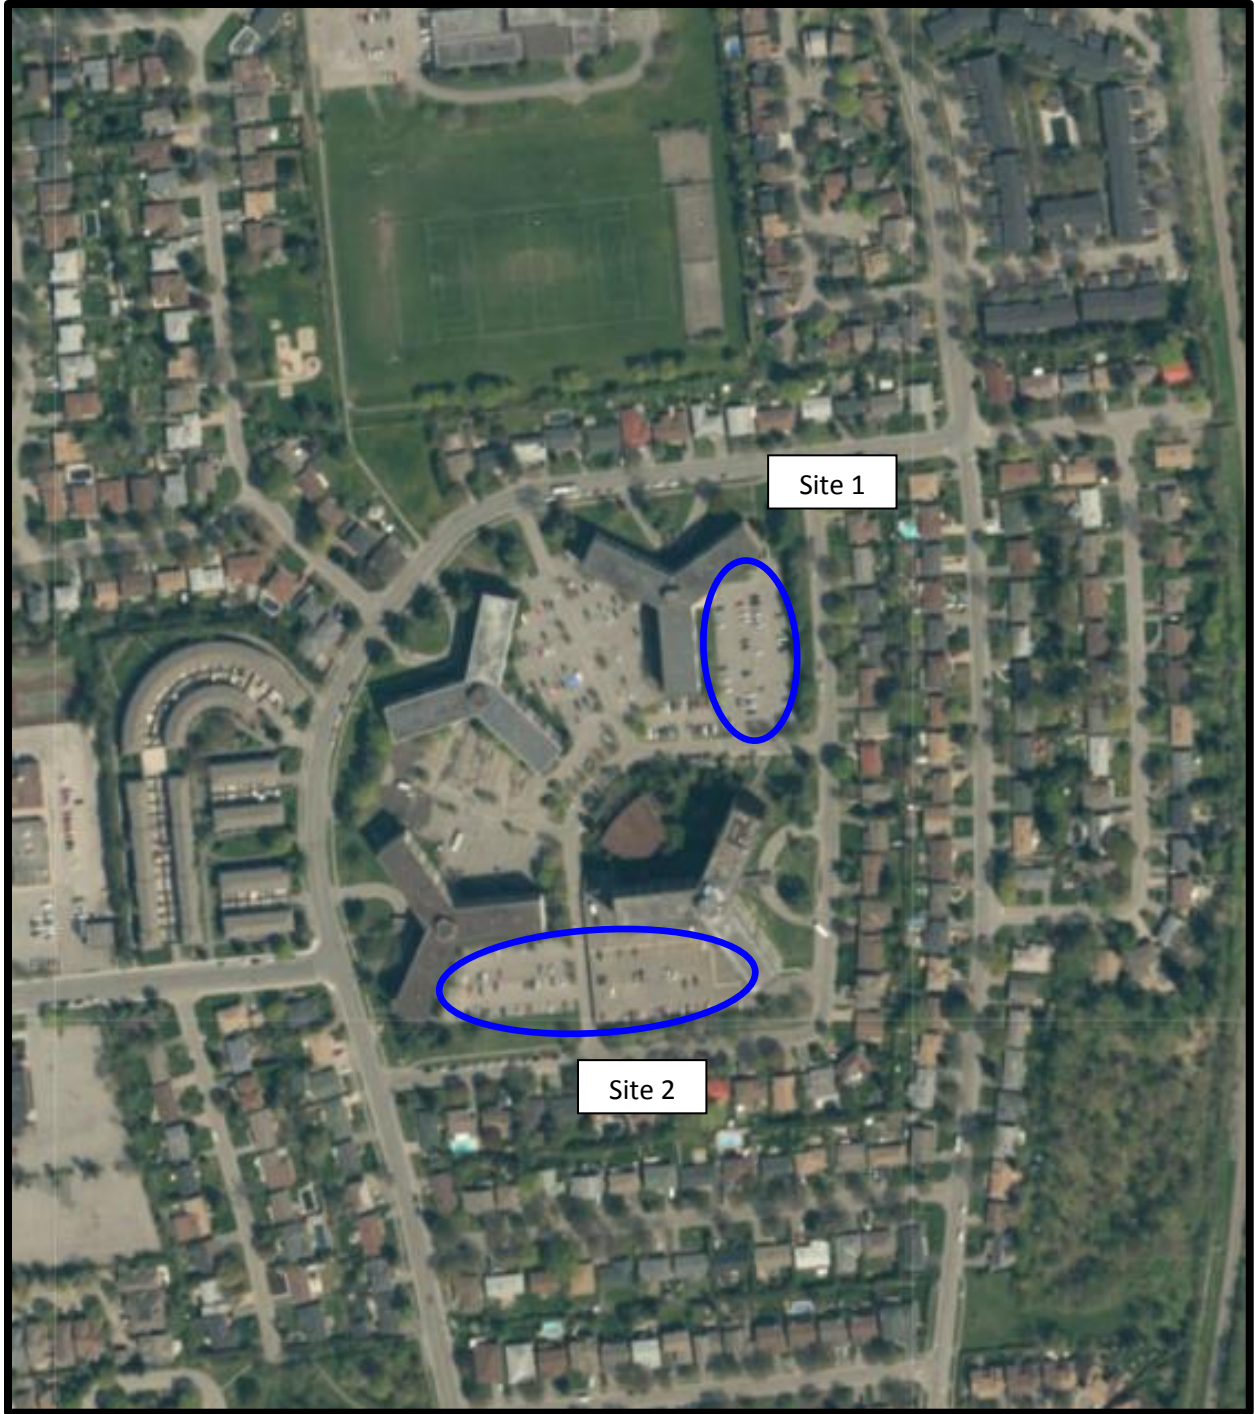
AERIAL PHOTOGRAPH
2017

2017 (City of Ottawa) No apparent changes have been made to the subject site or adjacent and neighbouring properties.

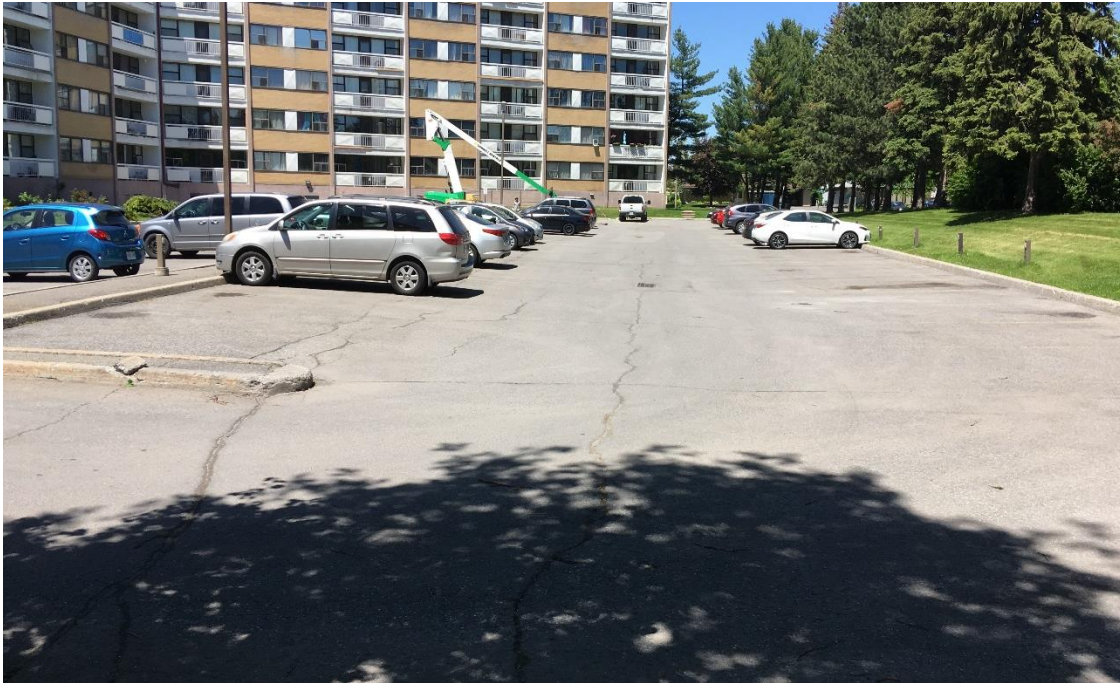
Subject site Area 1, along the east property line, is currently asphaltic parking and grass boulevard. Subject site Area 2, along the south property line, is currently occupied by a two level parkade (eastern portion of Area 2) and an asphalt parking lot and grass boulevard (western portion of Area 2). Each parking lot had four (4) catch basins. Site drainage occurs primarily by sheet flow to the onsite catch basins and infiltration on the grass boulevards. No signs of contamination, ponded water or stressed vegetation was noted at the time of the site visit.

Photograph 1. View of Area 1 of the subject site.

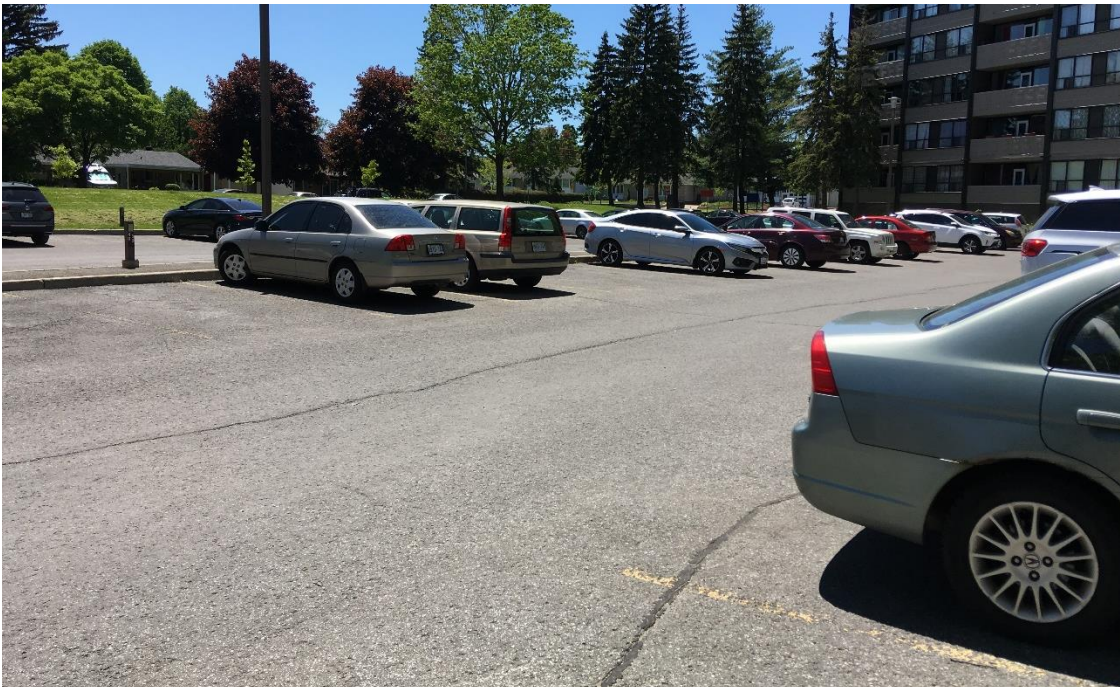
The ground level of the two level parkade, situated on the eastern portion of Area 2 was inspected. Unused fluorescent light fixtures were present with no bulbs. Four catch basins were noted on the ground-level of the parkade. No signs of staining, odour or ponded water were noted at the time of the site visit.

Photograph 2: View of Area 2 of the subject site.
