Phase I - Environmental Site Assessment

1499 Star Top Road
Ottawa, Ontario

December 7, 2018

Report: PE4482-1

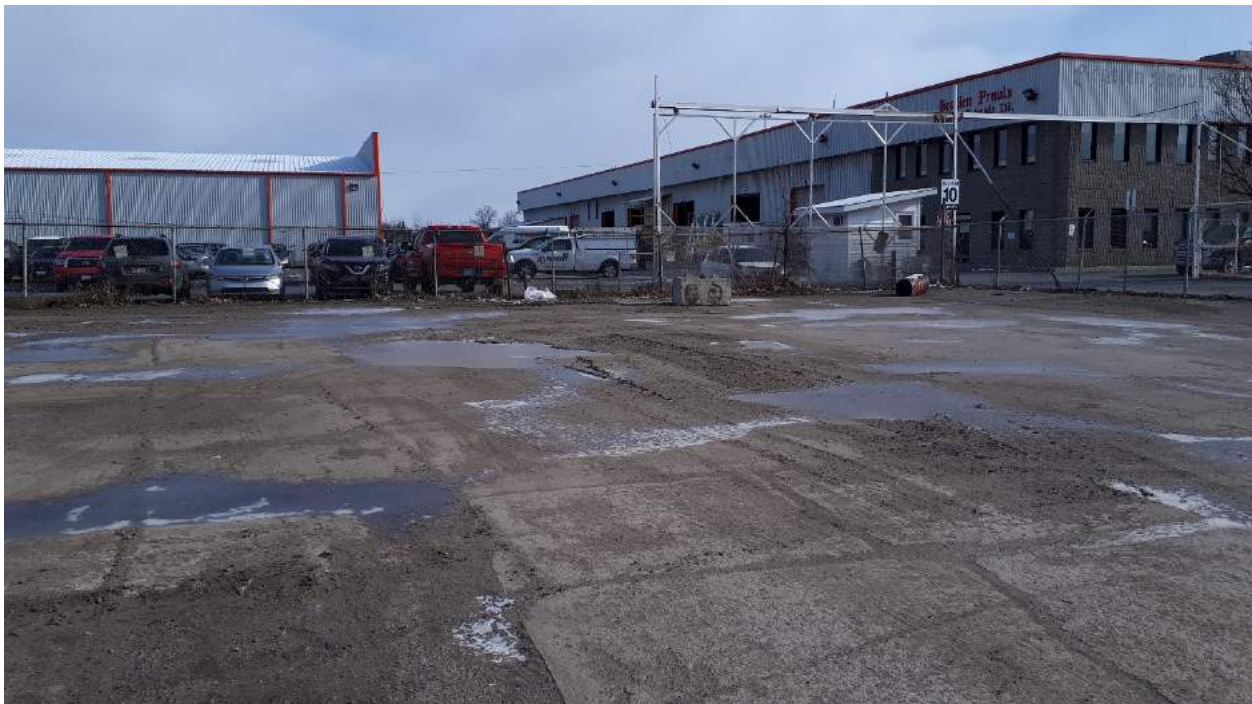
Water drainage on the subject site occurs by runoff to catch basins on Star Top Road. No ponded water or surficial staining were observed during the exterior assessment of the subject site. A concrete slab was observed in the paved area on the south side of the building, in the location of the former aboveground fuel storage tanks.

Photograph 2: View of the paved area to the south of the subject building; the former AST slab is visible at bottom-right.

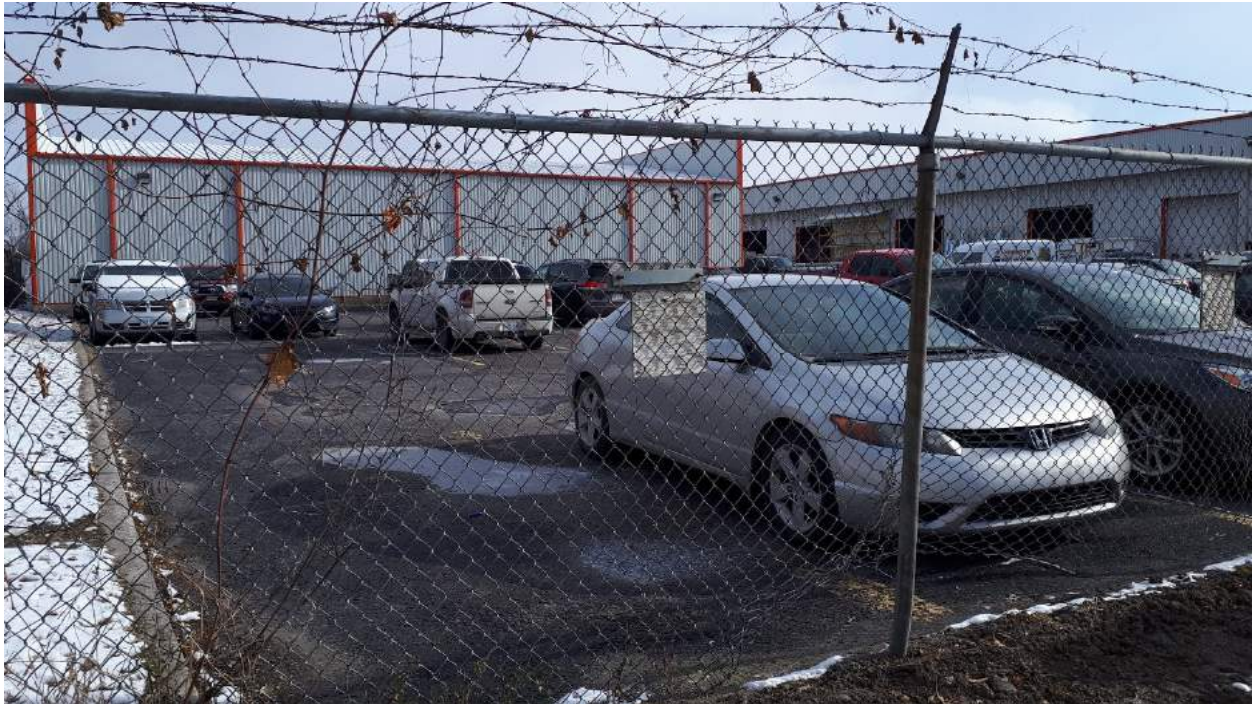
Photograph 3: View of the east side of the subject property, looking east. The fence separates the east and west portions of the site.

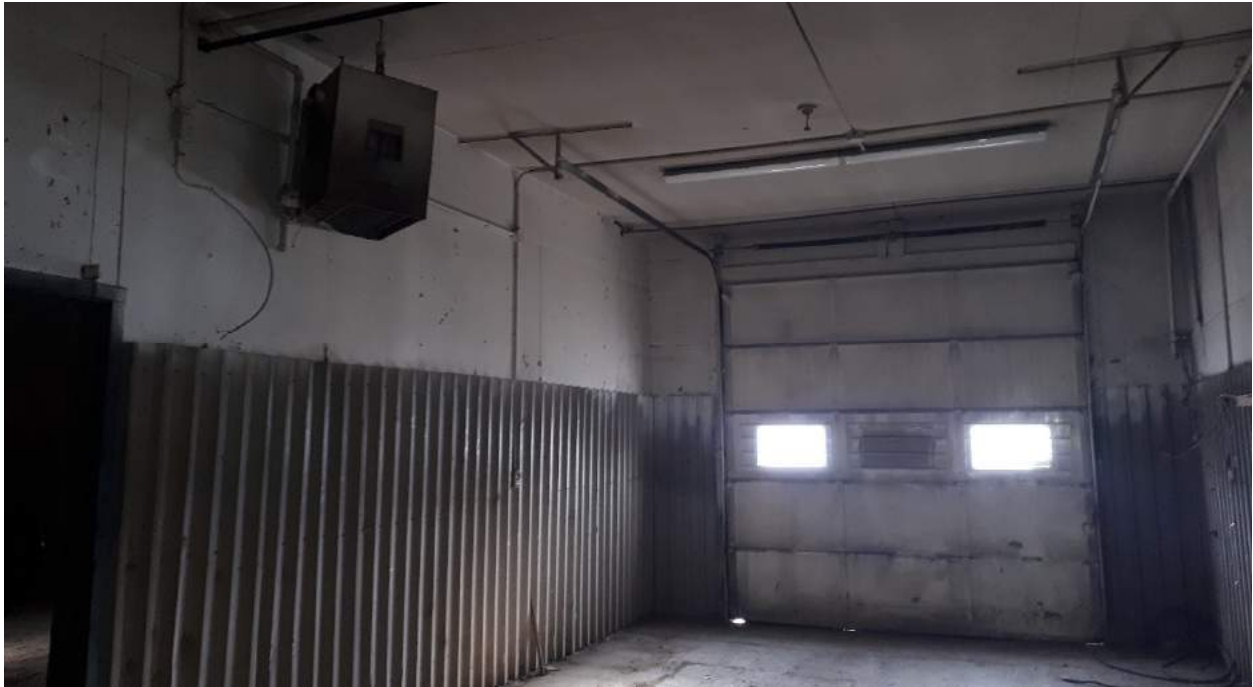
No sump pit was observed in the subject building at the time of the site assessment. Two dry drainage pits were observed in the garage bays, with drainage pipes extending out of the building towards the east. The pipe termini could not be determined at the time of the site visit. Traces of oil were visible in the pits. These pits and drainage pipes are a PCA and APEC on the Phase I Property.

Photograph 5: View of the first (west) garage bay.

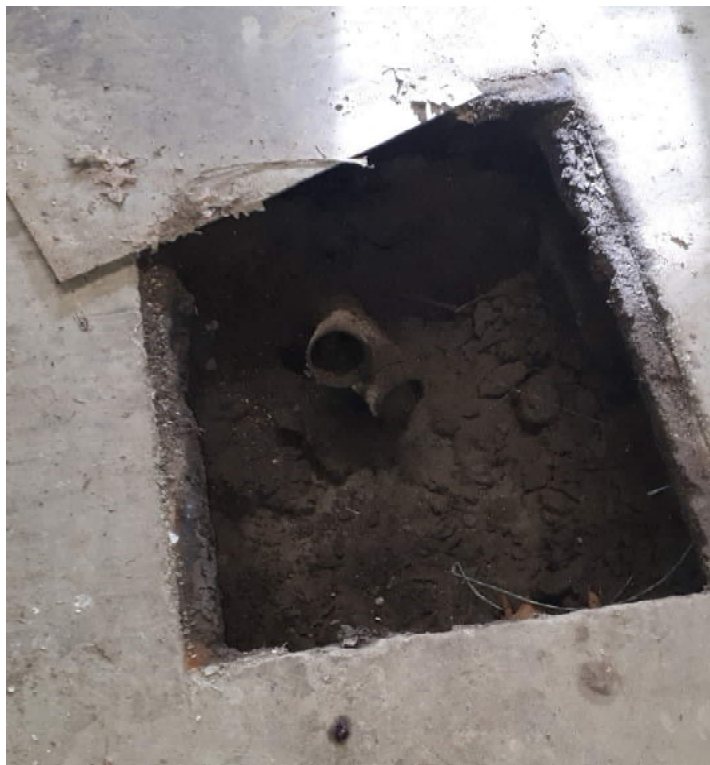
Photograph 6: View of the garage bay floor pit with drainage pipe.

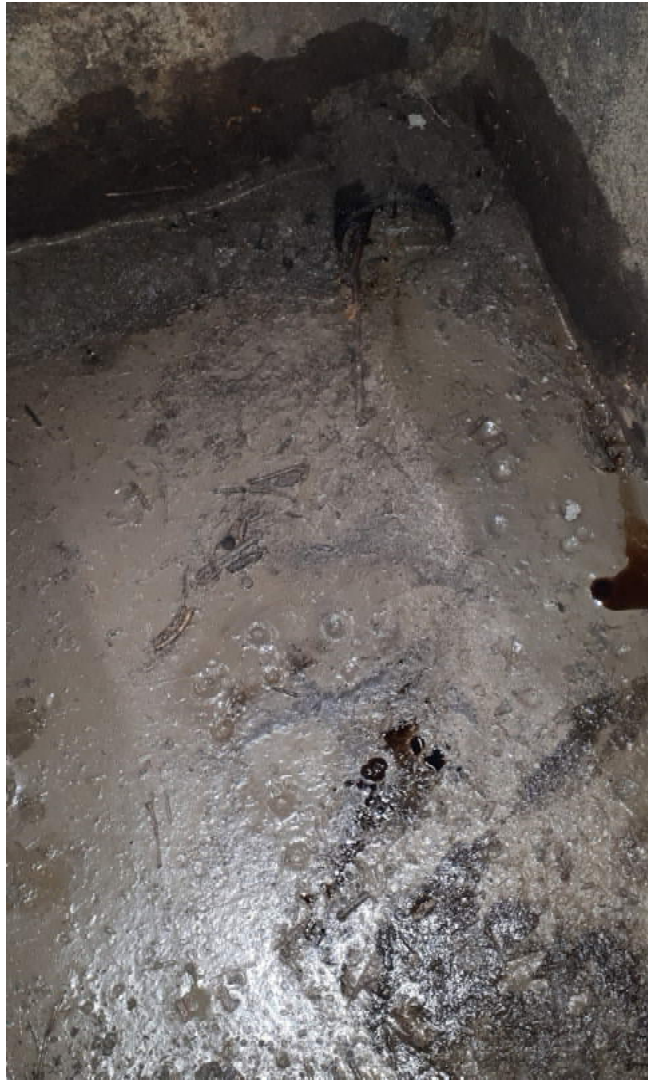
the building exterior to the east; the pipe termini could not be determined at the time of the site visit. A trace of oil was observed in the bottom of the pit in one of the bays. These garage bays and associated drainage systems are PCAs and an APEC on the subject property.

Photograph 7: View of the floor pit with drainage pipe and residual oil in the second (east) garage bay.

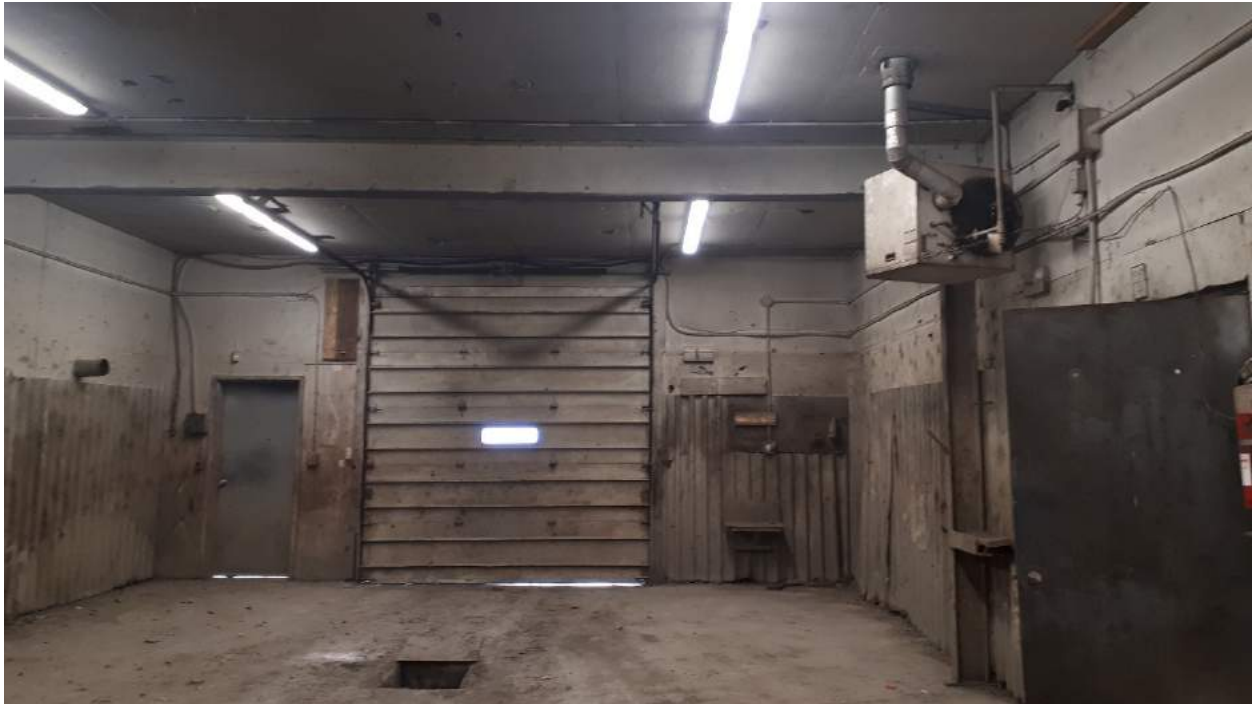
Photograph 8: View of the second (east, and larger) garage bay.

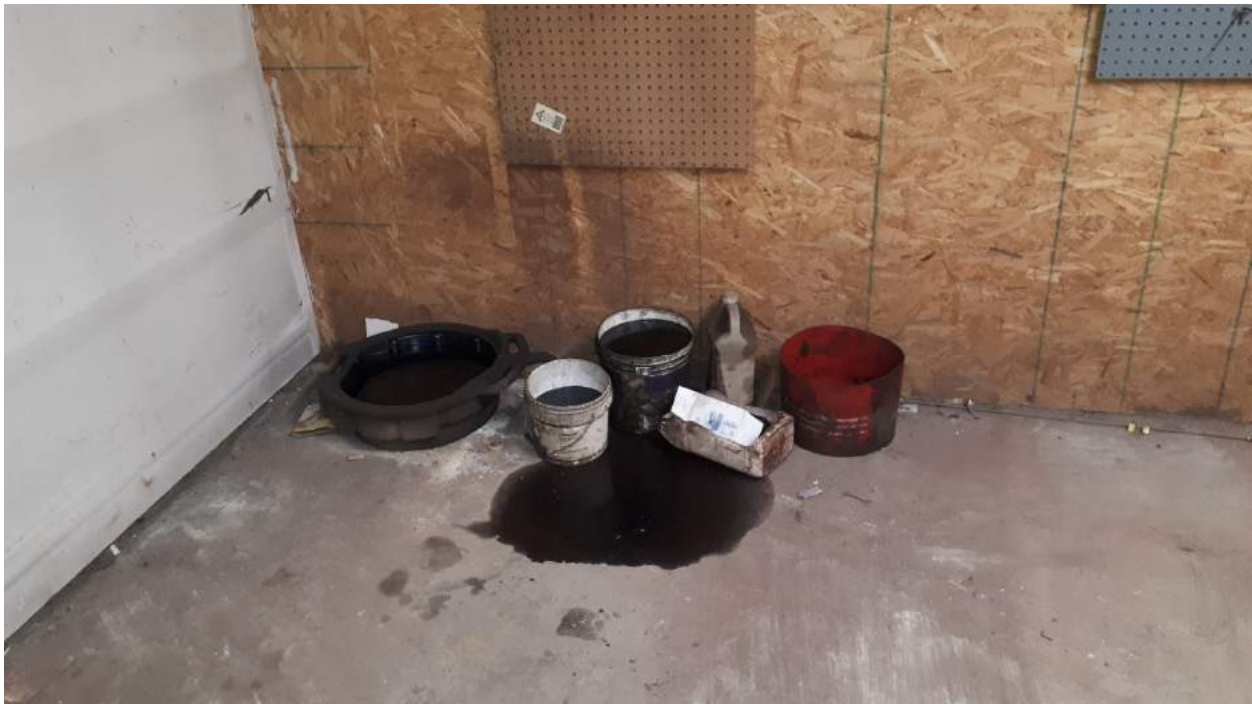
No fuels were observed to be stored on the exterior of subject property. Some waste oil was improperly stored in buckets in one of the garage bays, and had a pool of oil surrounding the buckets.

Photograph 9: Waste oil stored and spilled in the storage area at the rear of the second garage bay.

The spilled waste oil and oil in buckets located in the garage bay should be properly cleaned/disposed of.
