Kollaard Associates

**PHASE I
ENVIRONMENTAL SITE ASSESSMENT
58 FLORENCE STREET
CITY OF OTTAWA, ONTARIO**

DATE: April 5, 2019

190186

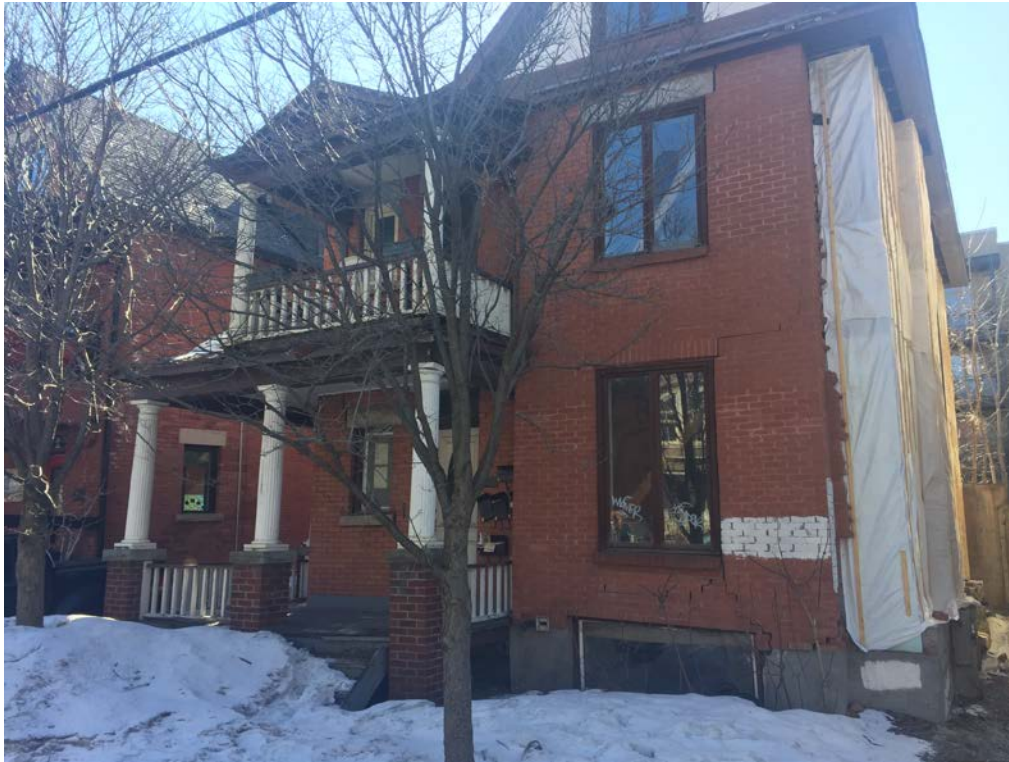
58 Florence Street

- The site is currently occupied by a two and a half storey, single family dwelling with one basement level, a paved driveway and a backyard.
- The dwelling has a stone foundation and is clad in brick. It is understood that the building was constructed between 1879-1901.
- An extensive renovation and a two storey addition was completed in about 1991. The dwelling includes a total of five rental units, three on the first floor, one in the basement and a two storey rental unit in the rear addition.
- Areas not occupied by the dwelling or driveway are grass surfaced.

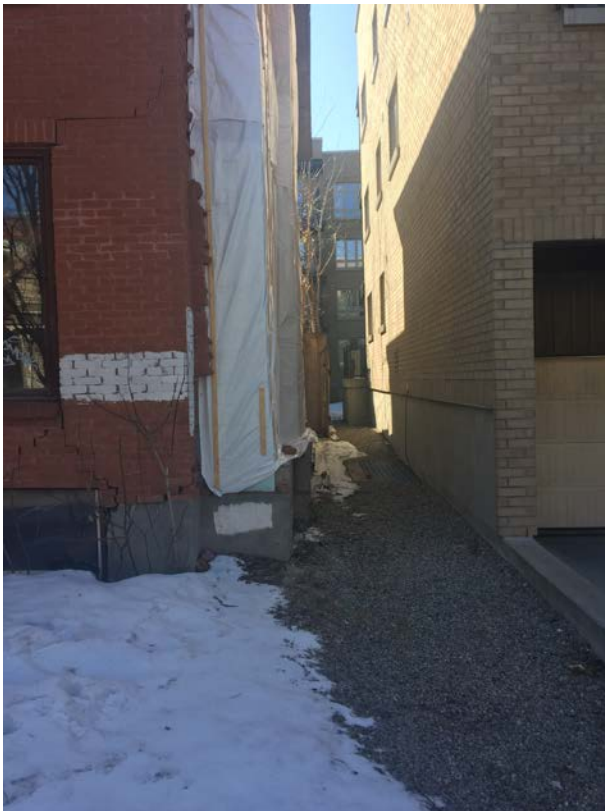
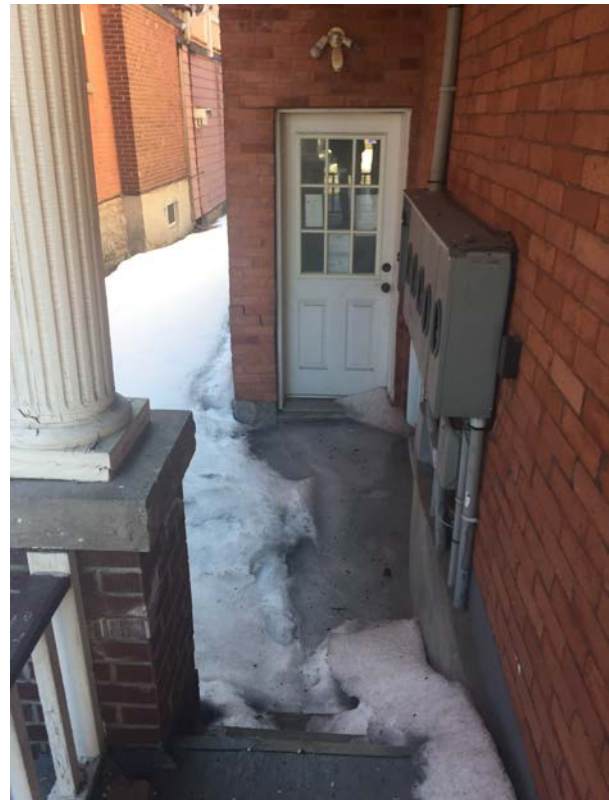
The site is currently occupied by a two and a half storey building. Building construction is described as wooden framed, stone and/or poured concrete foundation with brick cladding.

East and West Side of Dwelling

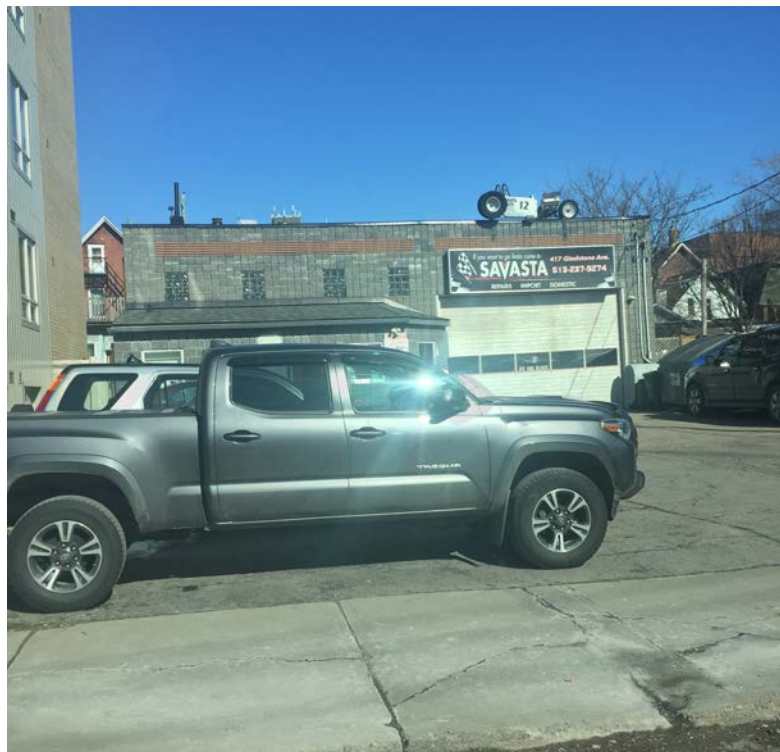
An existing gas station is located about 162 metres southeast of the site at 450 Bank Street. An existing automobile garage (Savasta Automotive Repair Inc.) is located about 24 metres southeast of the subject site. An existing automobile garage (Mike's Auto Repair) also exists about 68 metres south of the site.

View of existing garage located about 20 metres southeast of the site

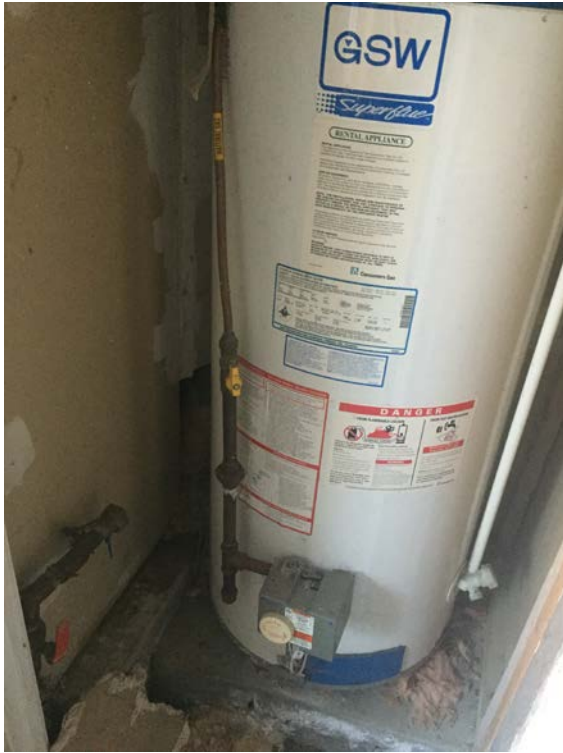
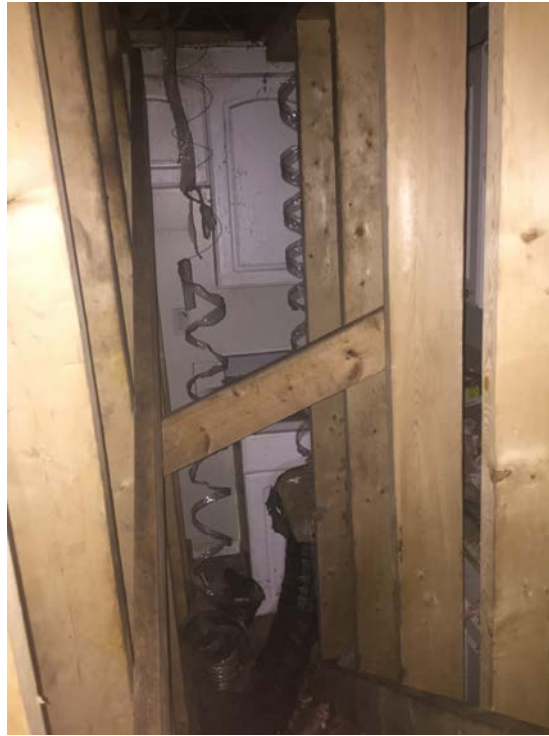
The dwelling at the site was serviced by a natural gas. Each unit has a natural gas fireplace. A natural gas fireplace was also observed within a basement unit of the dwelling.

There were no signs of fill pipes around the exterior of the foundation. No evidence of an above ground fuel oil storage tank was observed within the basement of the dwelling. No fuel oil odours were noted at the time of the site visit. The existing owner indicated that the dwelling was serviced by natural gas when it was purchased in 1989.

View of disconnected natural gas water heater in basement

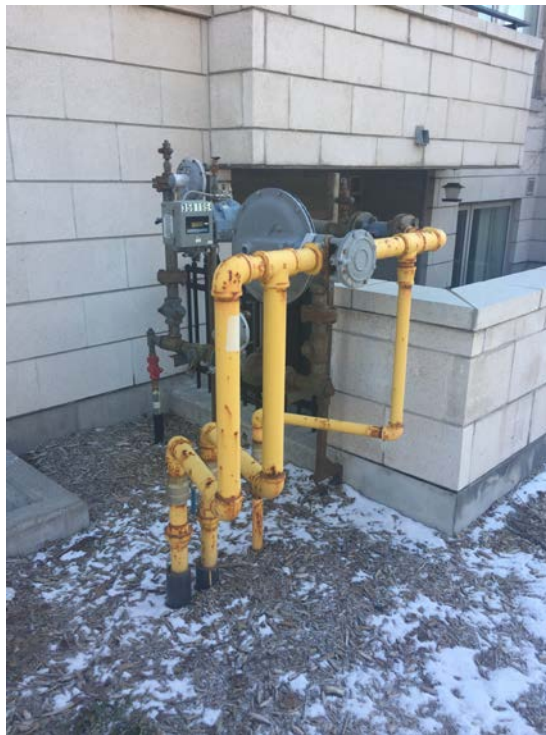
View of natural gas meters for residential building located immediately west of 32 Florence Street
