Phase I Environmental Site Assessment

341 Gloucester Street
Ottawa, Ontario

July 23, 2018

Report: PE4313-1

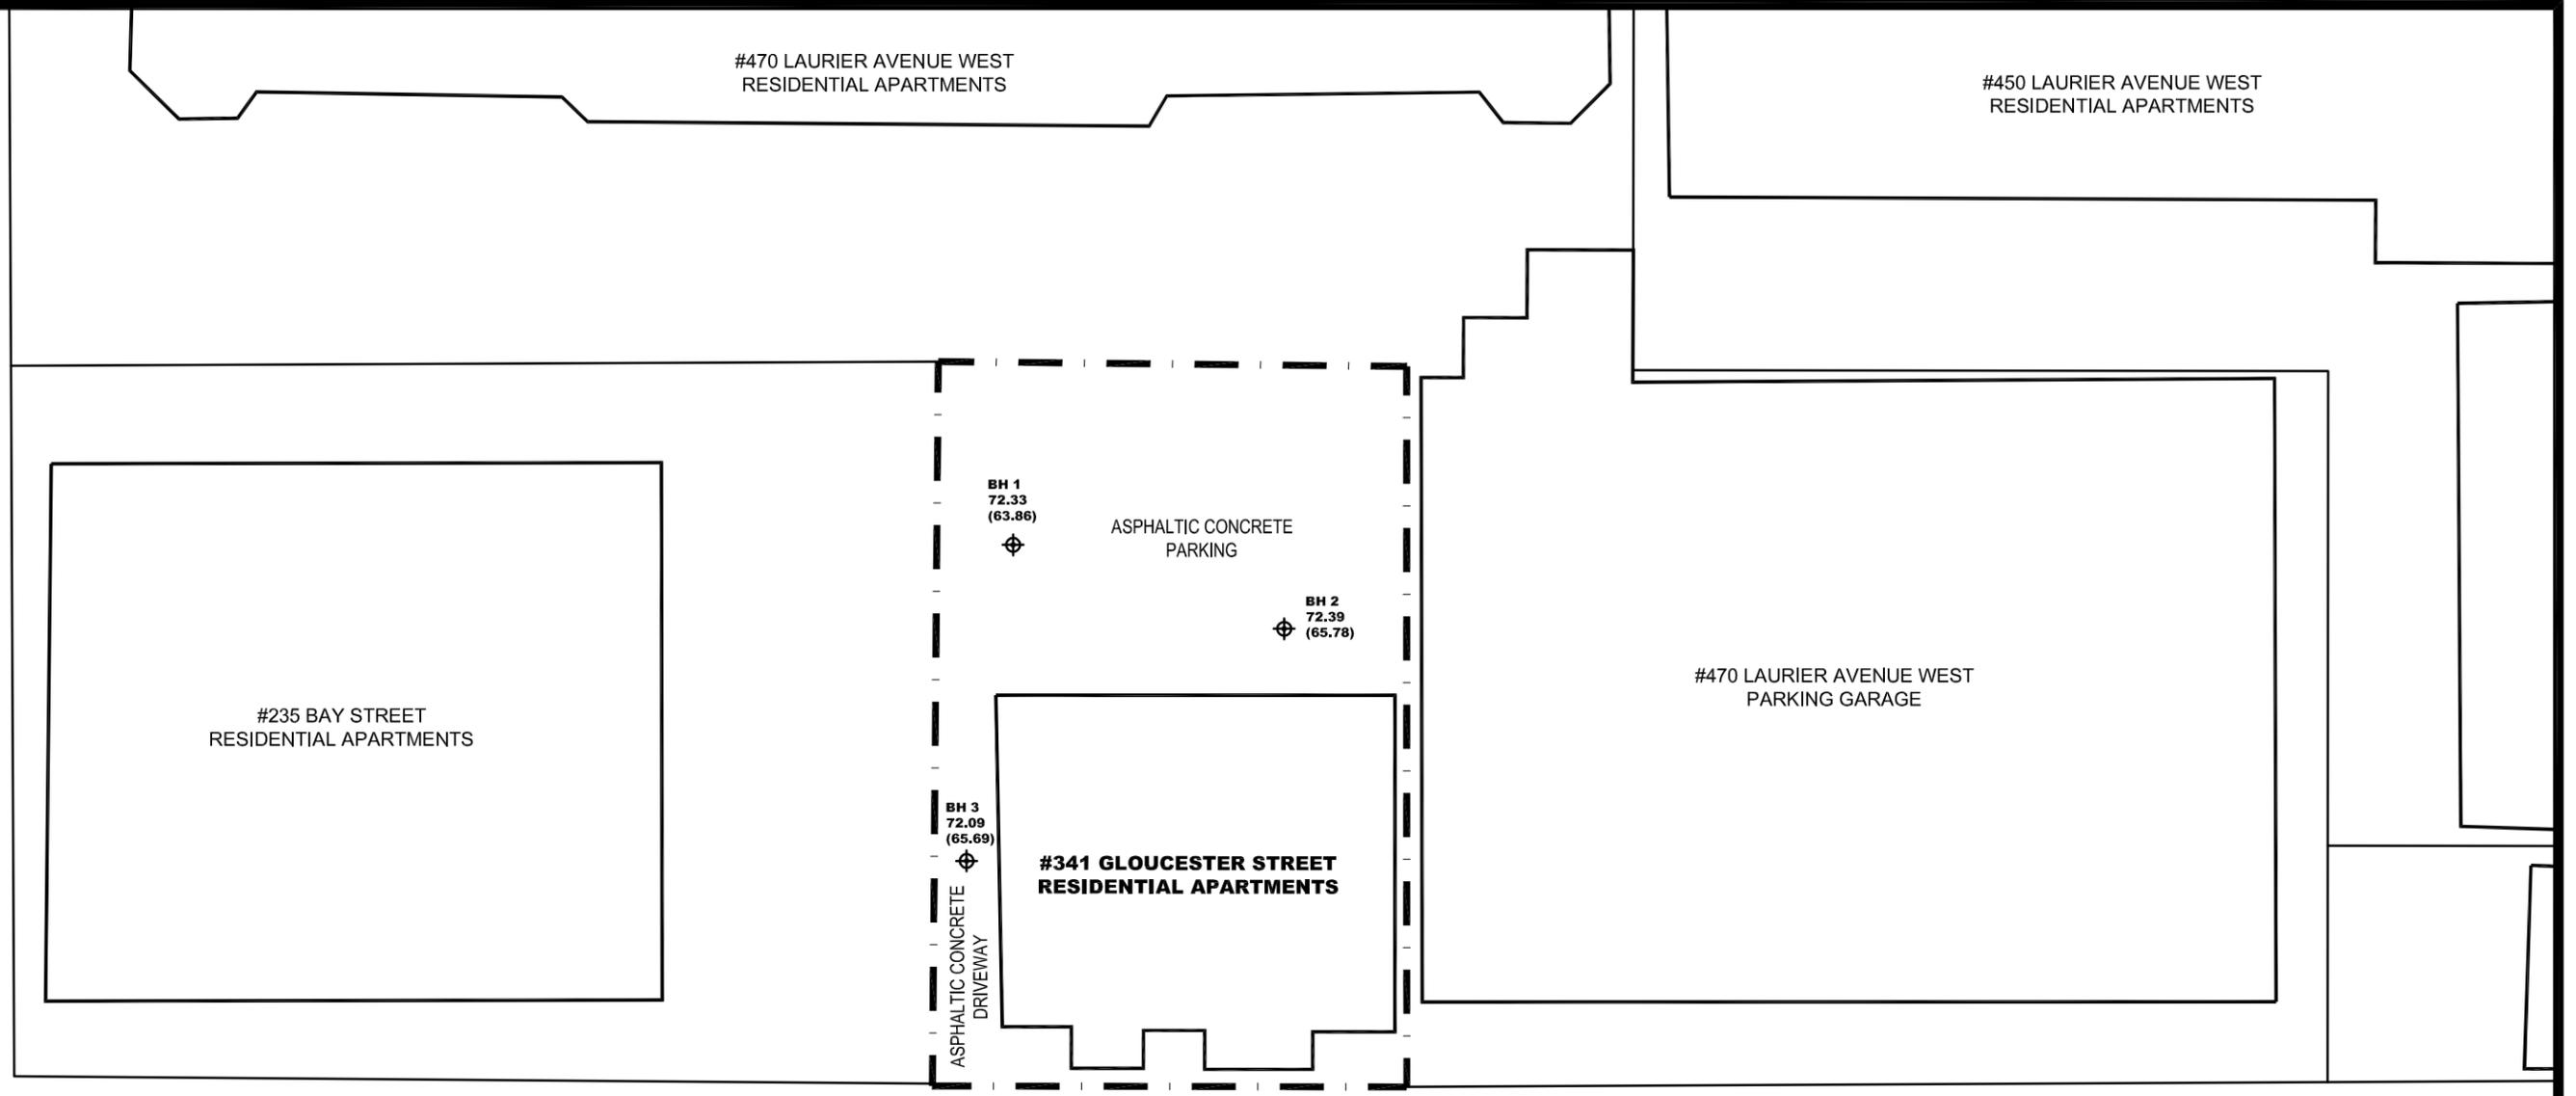
DRAWING PE4313-1 – SITE PLAN

The geotechnical investigation conducted by Paterson included the placement of three (3) boreholes instrumented with groundwater monitoring wells. The subsurface profile encountered consisted of asphalt overlying fill material extending in depth from 1.4 to 3.7 meters below ground surface. The fill material is underlain by a native glacial till layer followed by shale and limestone bedrock at depths ranging from 4.7 to 5.5 m below ground surface. The groundwater table was estimated to be at 6 to 7 m depth. Samples of fill were submitted for laboratory analysis to determine its quality for off-site disposal and found to exceed the MOECC Table 3 residential standards for some metal and poly-nuclear aromatic hydrocarbon (PAH) parameters. The groundwater was also tested and found to be clean.

LEGEND:
 ⊕ BOREHOLE WITH MONITORING WELL LOCATION
 72.09 GROUND SURFACE ELEVATION (m)
 (65.69) GROUNDWATER SURFACE ELEVATION (m)
 TBM - CATCHBASIN SURFACE. ASSUMED ELEVATION = 100.00m.

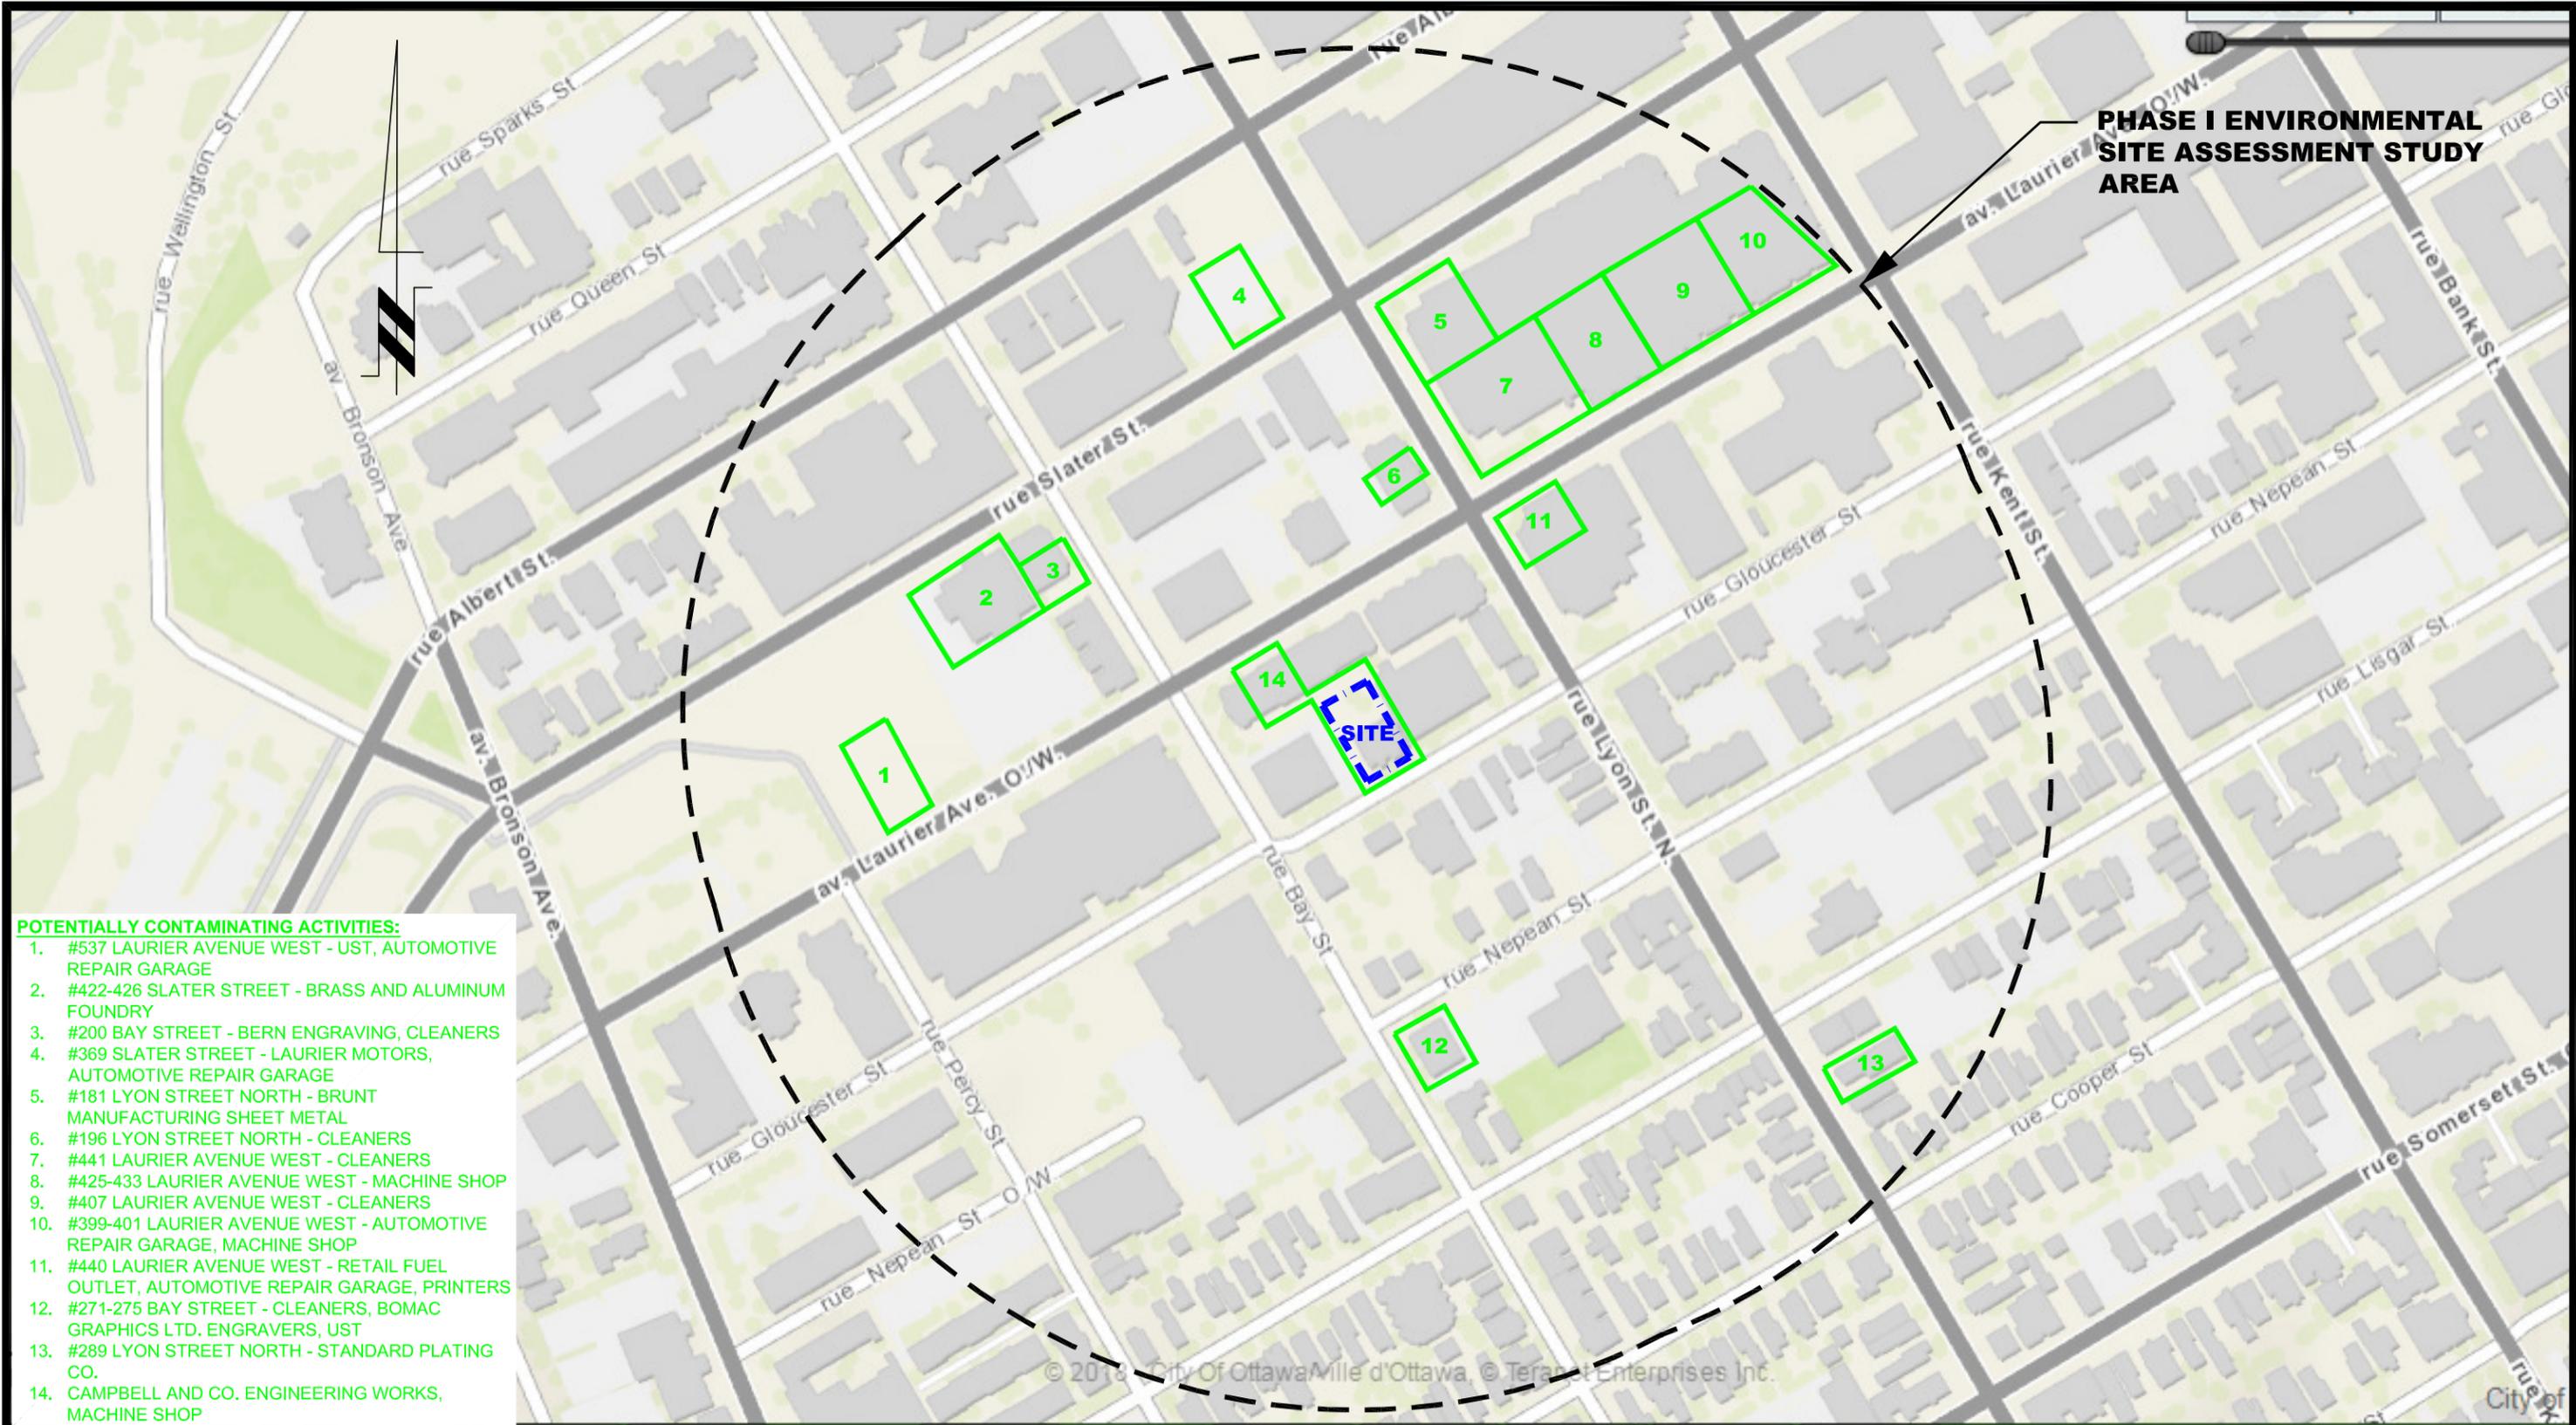
DRAWING PE4313-2 – SURROUNDING LAND USE PLAN

**PHASE I ENVIRONMENTAL
SITE ASSESSMENT STUDY
AREA**

- POTENTIALLY CONTAMINATING ACTIVITIES:**
1. #537 LAURIER AVENUE WEST - UST, AUTOMOTIVE REPAIR GARAGE
 2. #422-426 SLATER STREET - BRASS AND ALUMINUM FOUNDRY
 3. #200 BAY STREET - BERN ENGRAVING, CLEANERS
 4. #369 SLATER STREET - LAURIER MOTORS, AUTOMOTIVE REPAIR GARAGE
 5. #181 LYON STREET NORTH - BRUNT MANUFACTURING SHEET METAL
 6. #196 LYON STREET NORTH - CLEANERS
 7. #441 LAURIER AVENUE WEST - CLEANERS
 8. #425-433 LAURIER AVENUE WEST - MACHINE SHOP
 9. #407 LAURIER AVENUE WEST - CLEANERS
 10. #399-401 LAURIER AVENUE WEST - AUTOMOTIVE REPAIR GARAGE, MACHINE SHOP
 11. #440 LAURIER AVENUE WEST - RETAIL FUEL OUTLET, AUTOMOTIVE REPAIR GARAGE, PRINTERS
 12. #271-275 BAY STREET - CLEANERS, BOMAC GRAPHICS LTD. ENGRAVERS, UST
 13. #289 LYON STREET NORTH - STANDARD PLATING CO.
 14. CAMPBELL AND CO. ENGINEERING WORKS, MACHINE SHOP

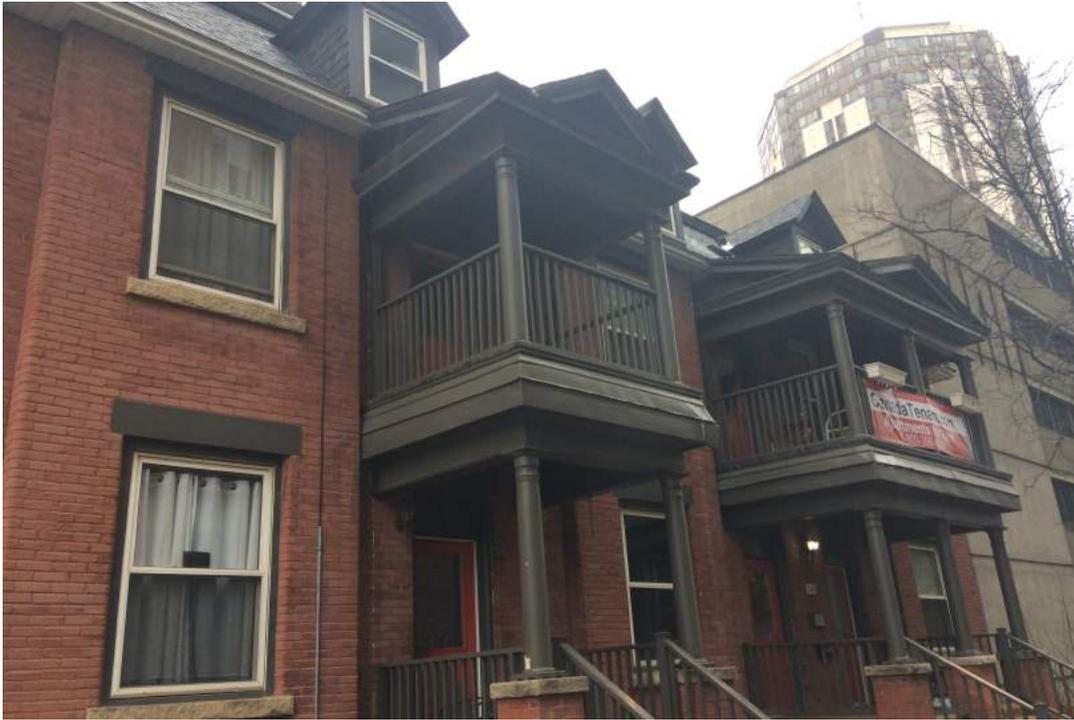
The structure at 341 Gloucester Street has a brick exterior with a sloped asphalt shingled roof and stone and concrete foundation. The interior was finished with drywall and/or plaster walls and ceilings. The living room ceiling had a decorative plaster finish. The floors were finished with either carpet (in stairwell), vinyl floor tiles, ceramic tiles, hardwood, and concrete in the basement.

Photograph 1: View of the front of the subject building, looking north.

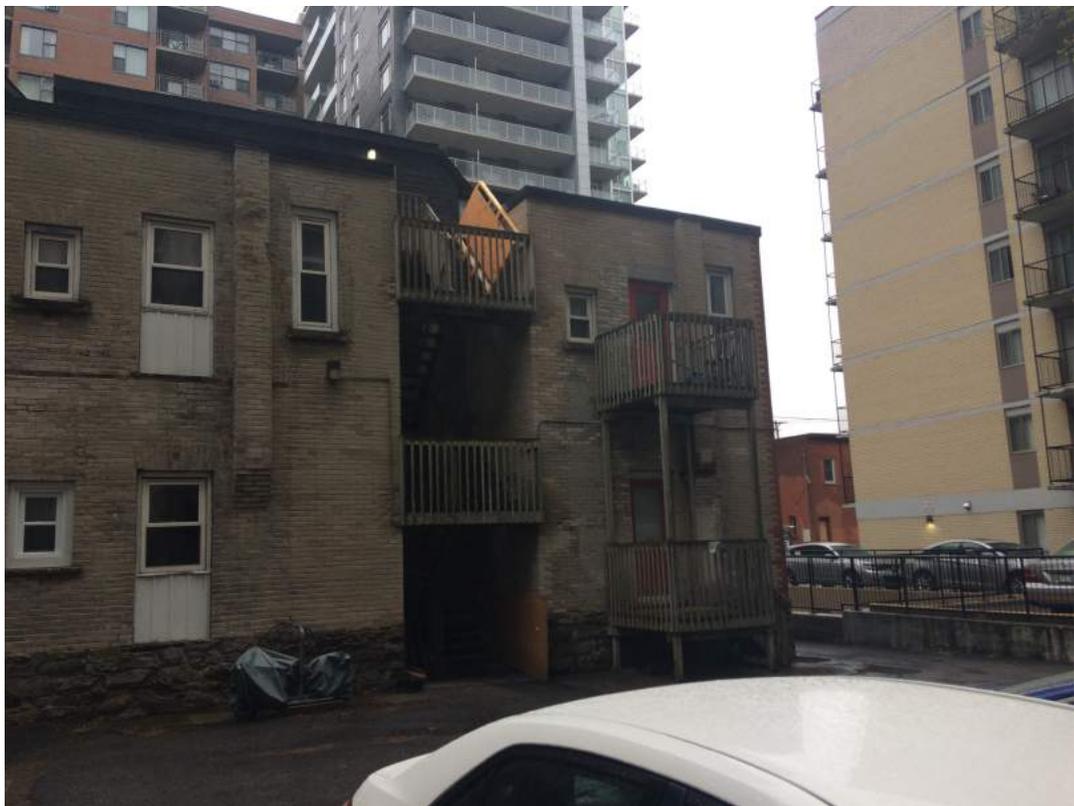
The subject building consists of a single residential triplex building that occupies approximately half of the property. Parking is located at the rear of the building, which is accessed by a driveway along the western side of the building. A pad-mounted transformer was present at the southeast corner of the property. No staining was observed in the vicinity of the transformer.

Photograph 2: View of the rear of the subject site, looking south.

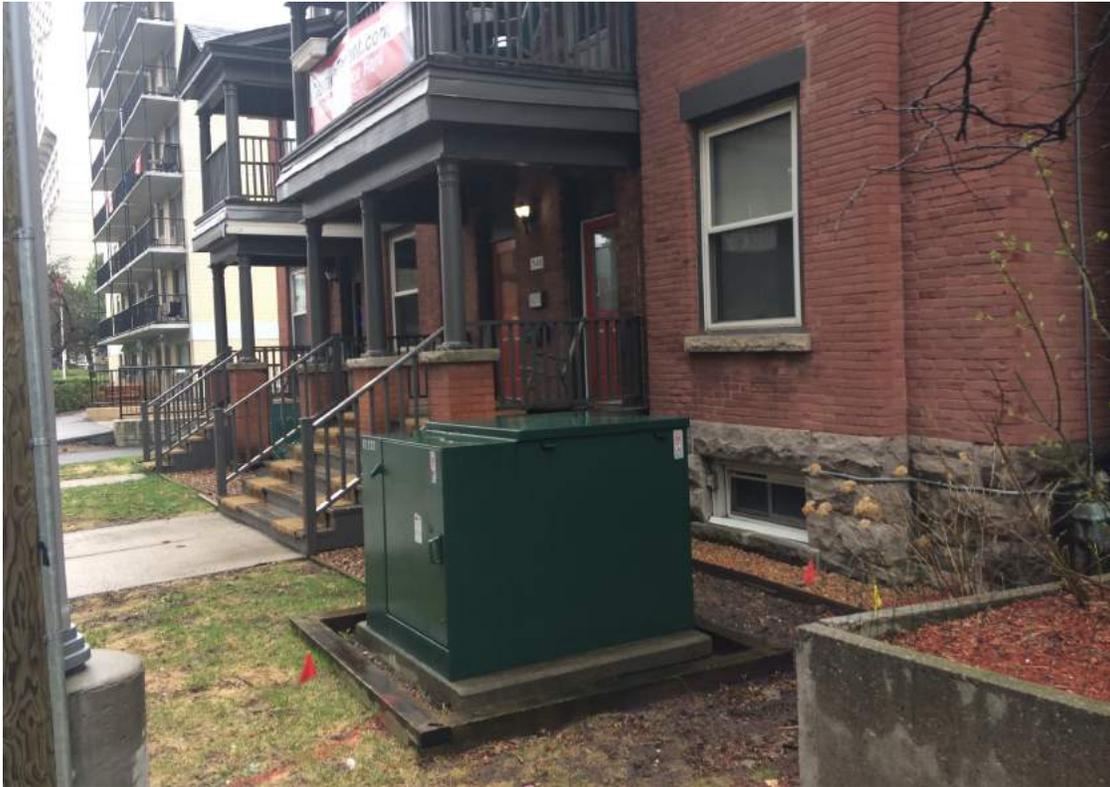
Photograph 3: Transformer and natural gas connection at the southeast corner of the subject structure.

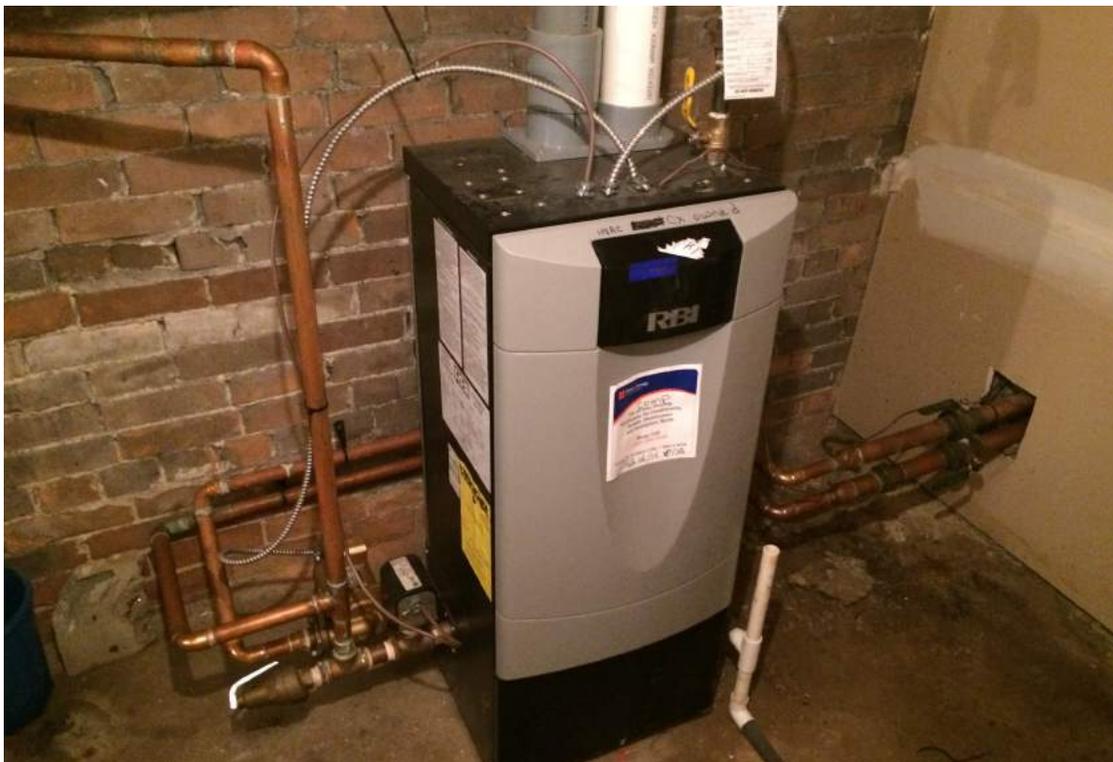
Photograph 4: Natural gas boiler located in the basement of the subject building.
