## **Phase I-Environmental Site Assessment**

10 McArthur Avenue  
Ottawa, Ontario

**March 27, 2019**

Report: PE4562-1

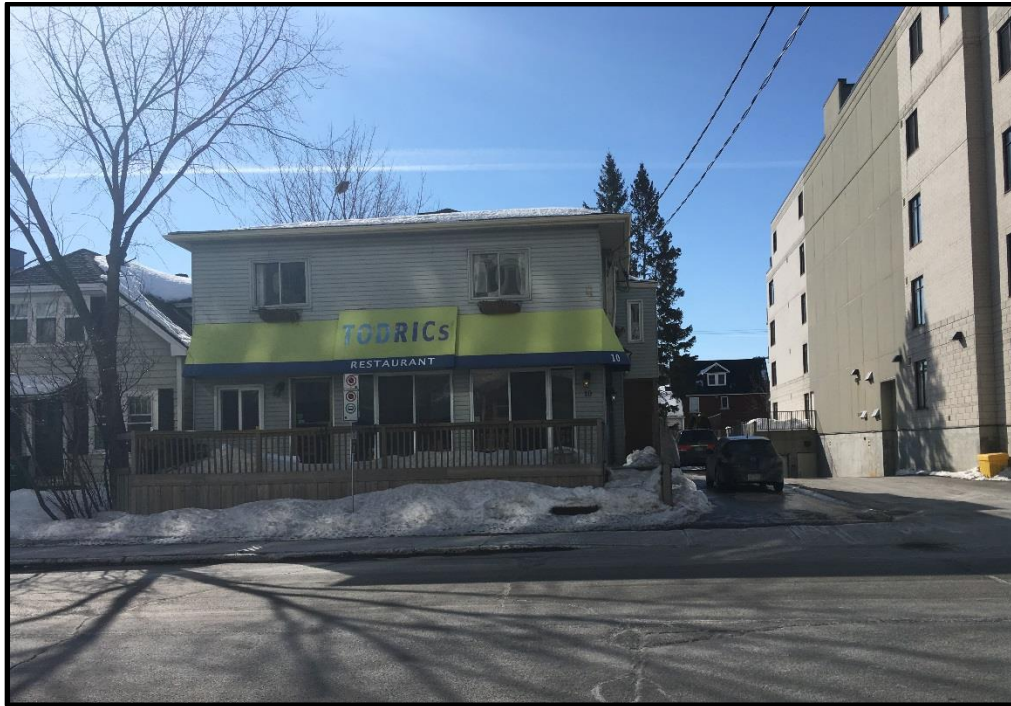
A two (2)-storey building with a stone and concrete foundation, constructed pre-1928, is present onsite. The exterior of the building is finished in beige vinyl siding and a sloped shingle style roof.

Photograph 1: North face of the subject building, 10 McArthur Avenue, looking south.

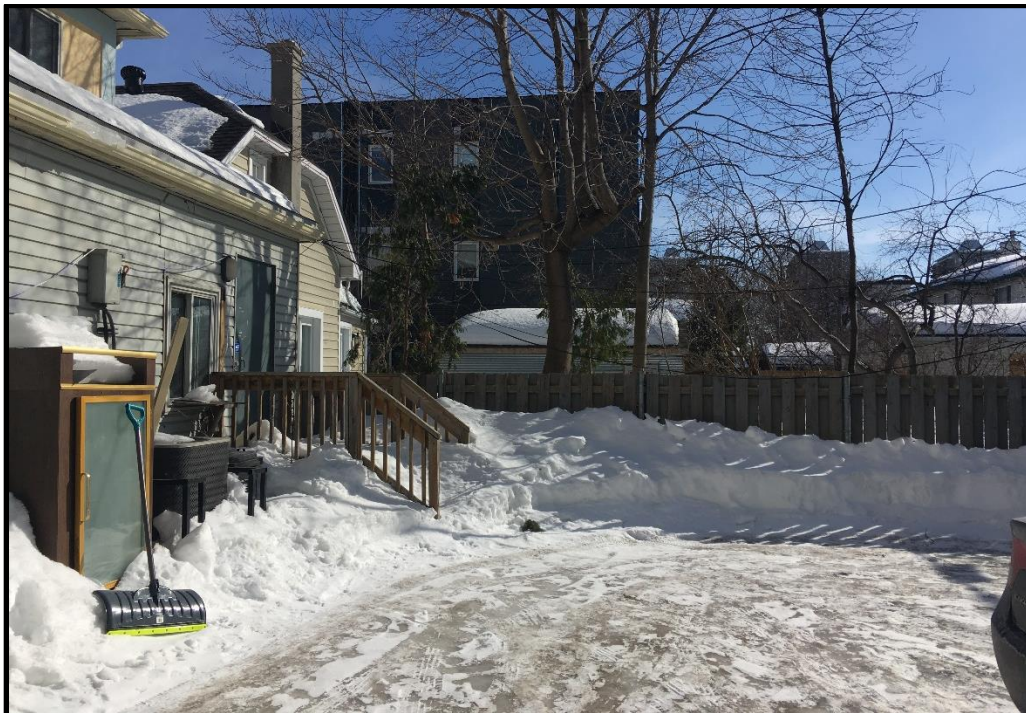
The site is occupied by a mixed-use building that is currently used for residential purposes. The western and southern portions of the property are asphaltic paved areas. The southern exterior area of the site is used for vehicular parking and storage. One groundwater monitoring well was noted on the western part of the property.

Photograph 2: Southern portion of the subject property (rear), looking east.
