Phase Two Environmental Site Assessment

89 Richmond Road, Ottawa, ON

Type of Document:
Final

Project Number:
OTT-00240343-A0

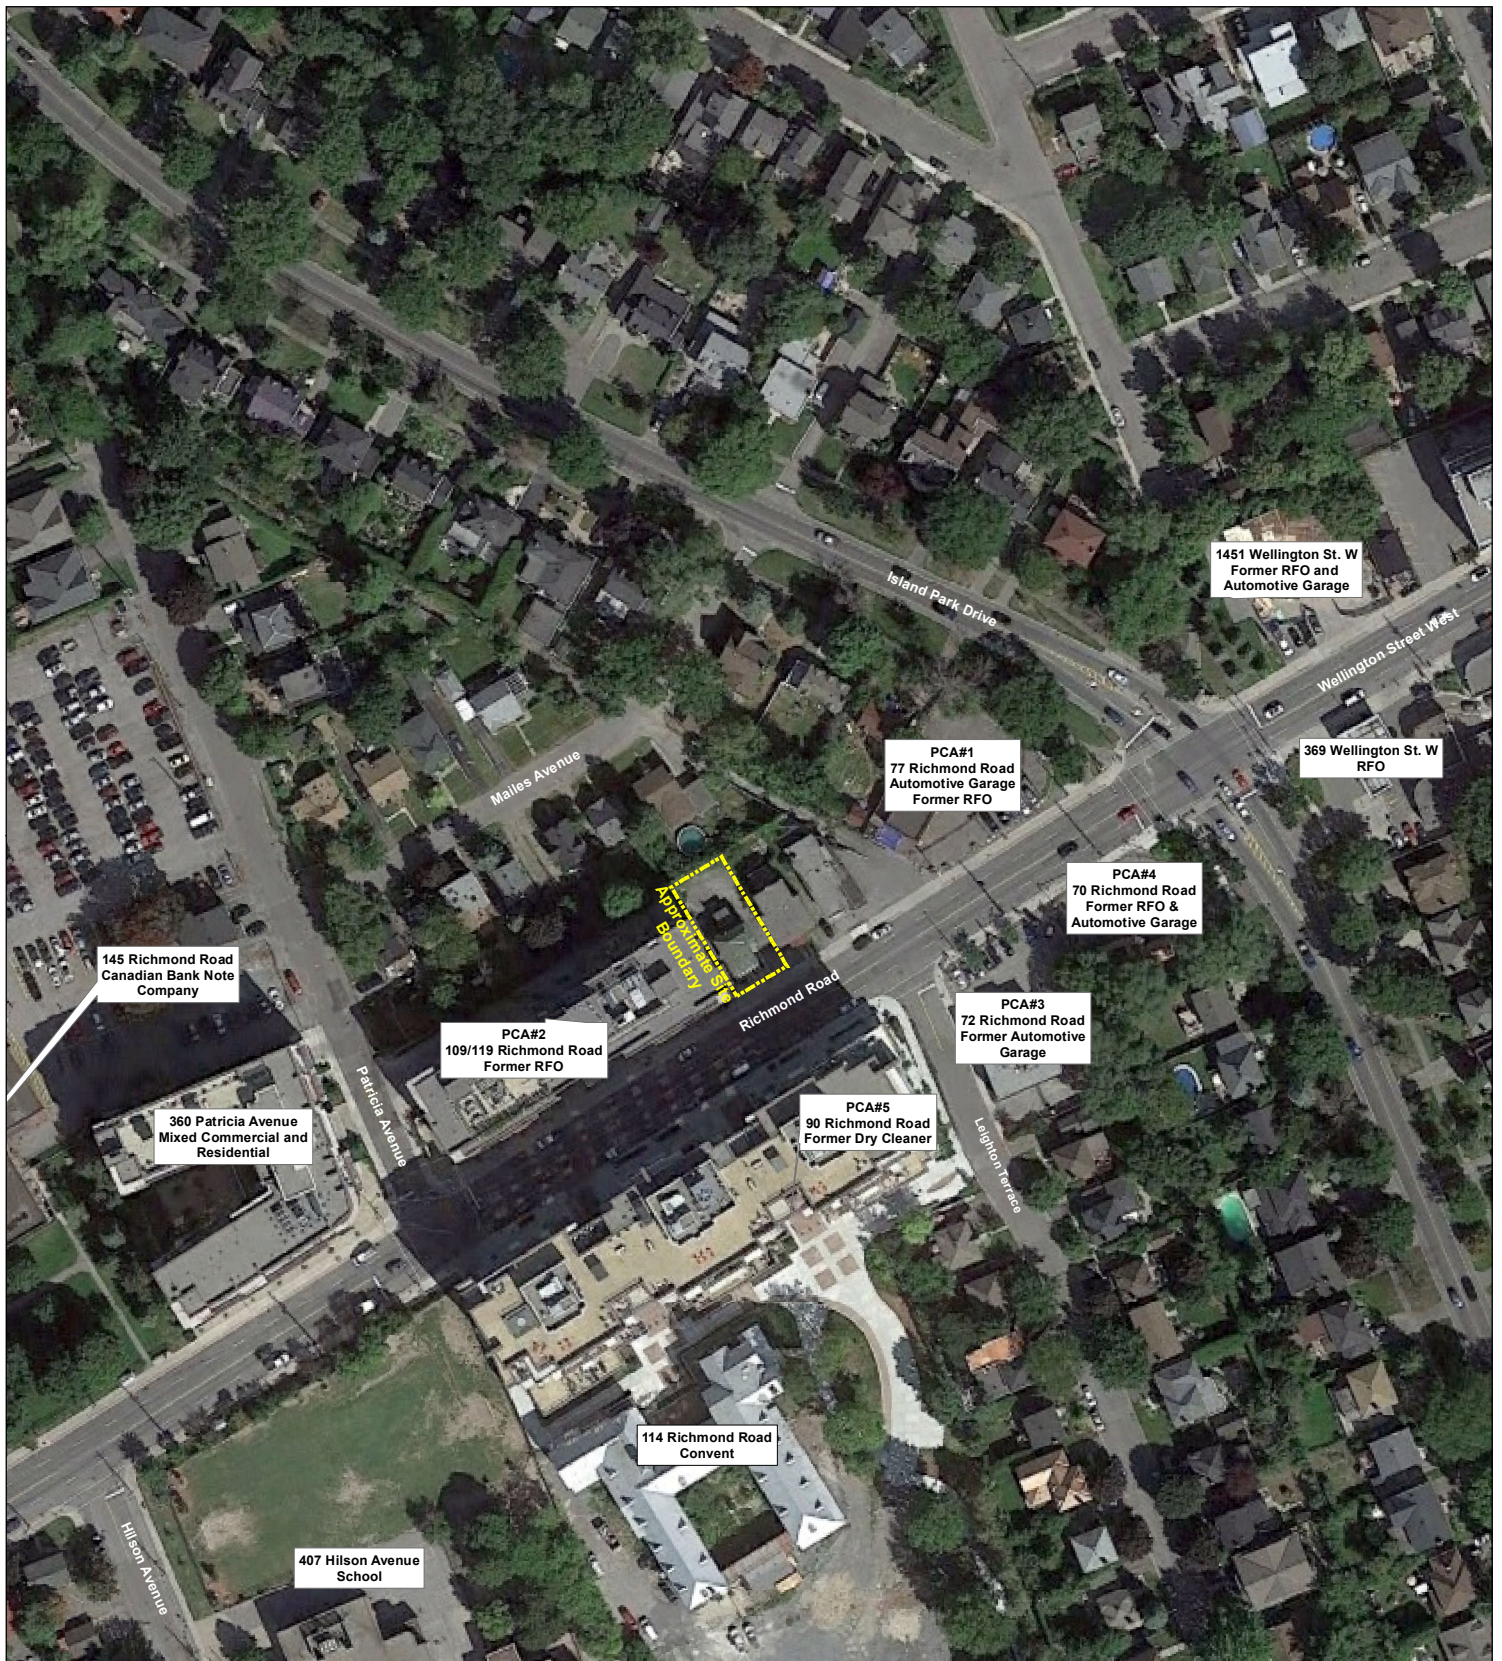
FIG. No.:
2

PCA Potentially Contaminating Activity

Based on the Phase One ESA findings, a Phase Two ESA was recommended to assess the soil and groundwater quality at the Site from the above-noted APECs. A site plan with the APECs is provided on Figure 3.
