December 19, 2018
File: PE4018-LET.02

Subject: **Phase I - Environmental Site Assessment Update
2704, 2706, 2724 and 2734 Draper Avenue
Ottawa, Ontario**

GREATWISE DEVELOPMENTS
PHASE I - ENVIRONMENTAL SITE ASSESSMENT
 2704, 2706, 2724 AND 2734 DRAPER AVENUE
 OTTAWA, ONTARIO
SITE PLAN

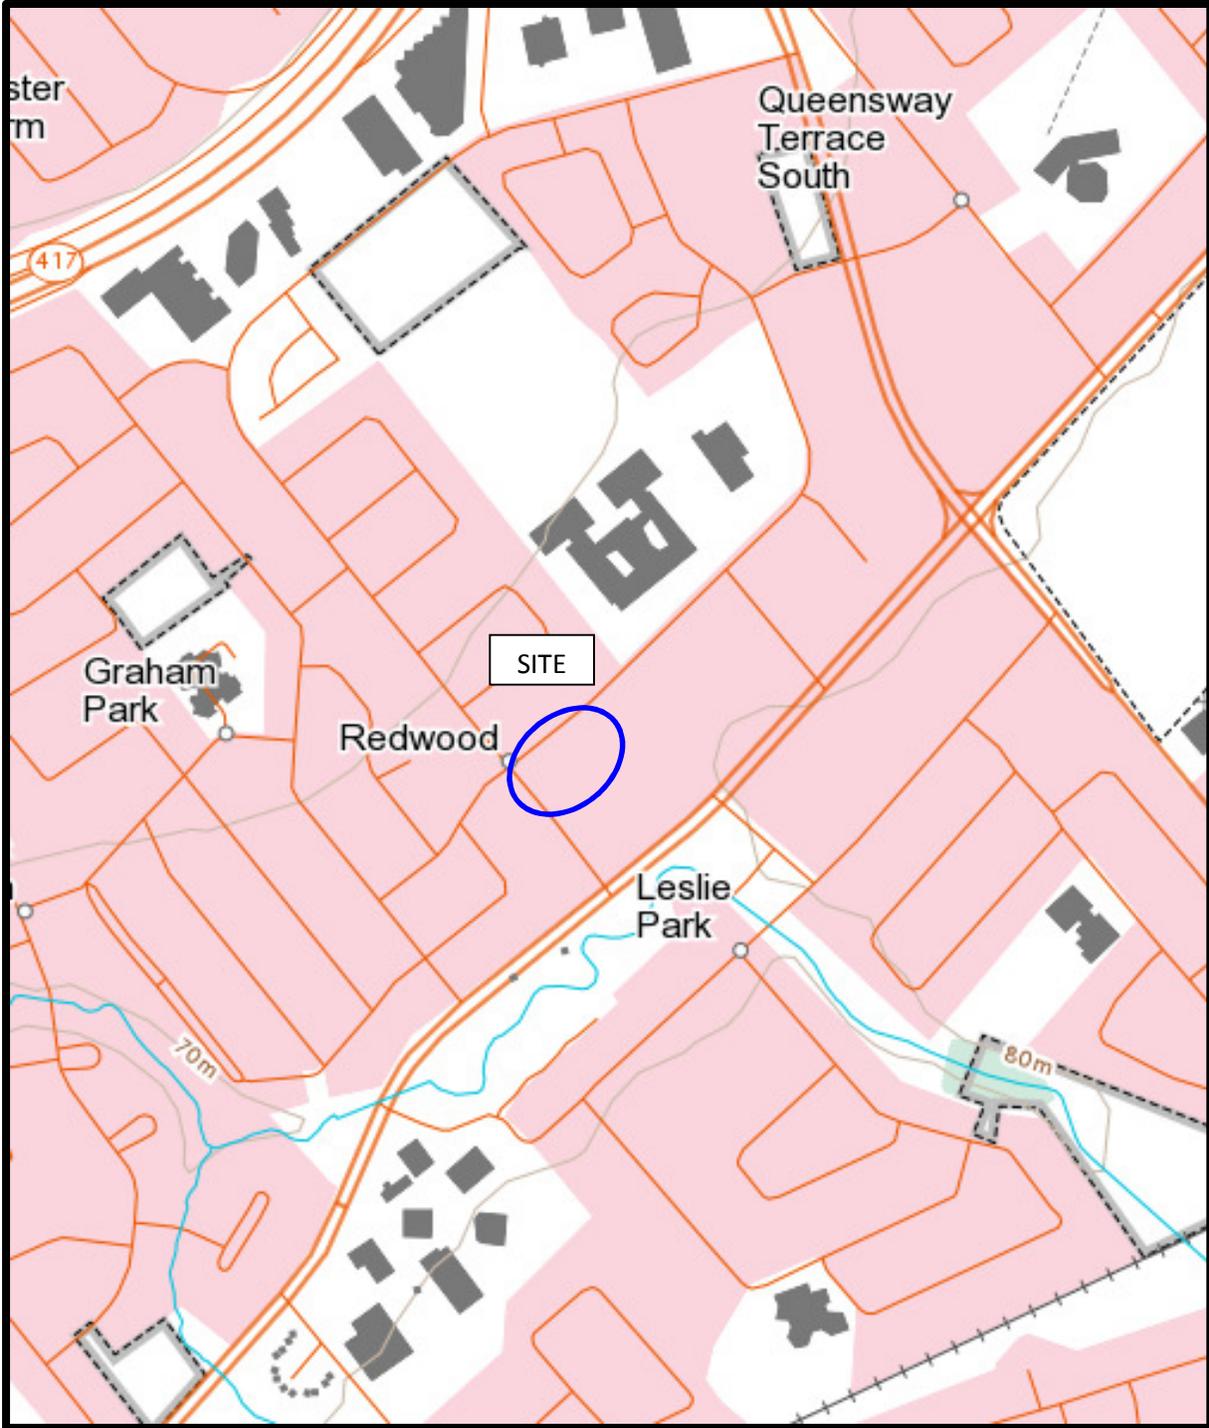
FIGURE 2
TOPOGRAPHIC MAP

Topographic maps were obtained from Natural Resources Canada – The Atlas of Canada website and from the City of Ottawa website. The topographic maps indicate that the elevation of the subject site is approximately 75 m ASL, and that the regional topography in the general area of the site slopes downward to the north. According to the maps, the nearest water body is Graham Creek, located approximately 100 m south of the Phase I Property. An illustration of the referenced topographic map is presented on Figure 2 – Topographic Map, appended to this report.

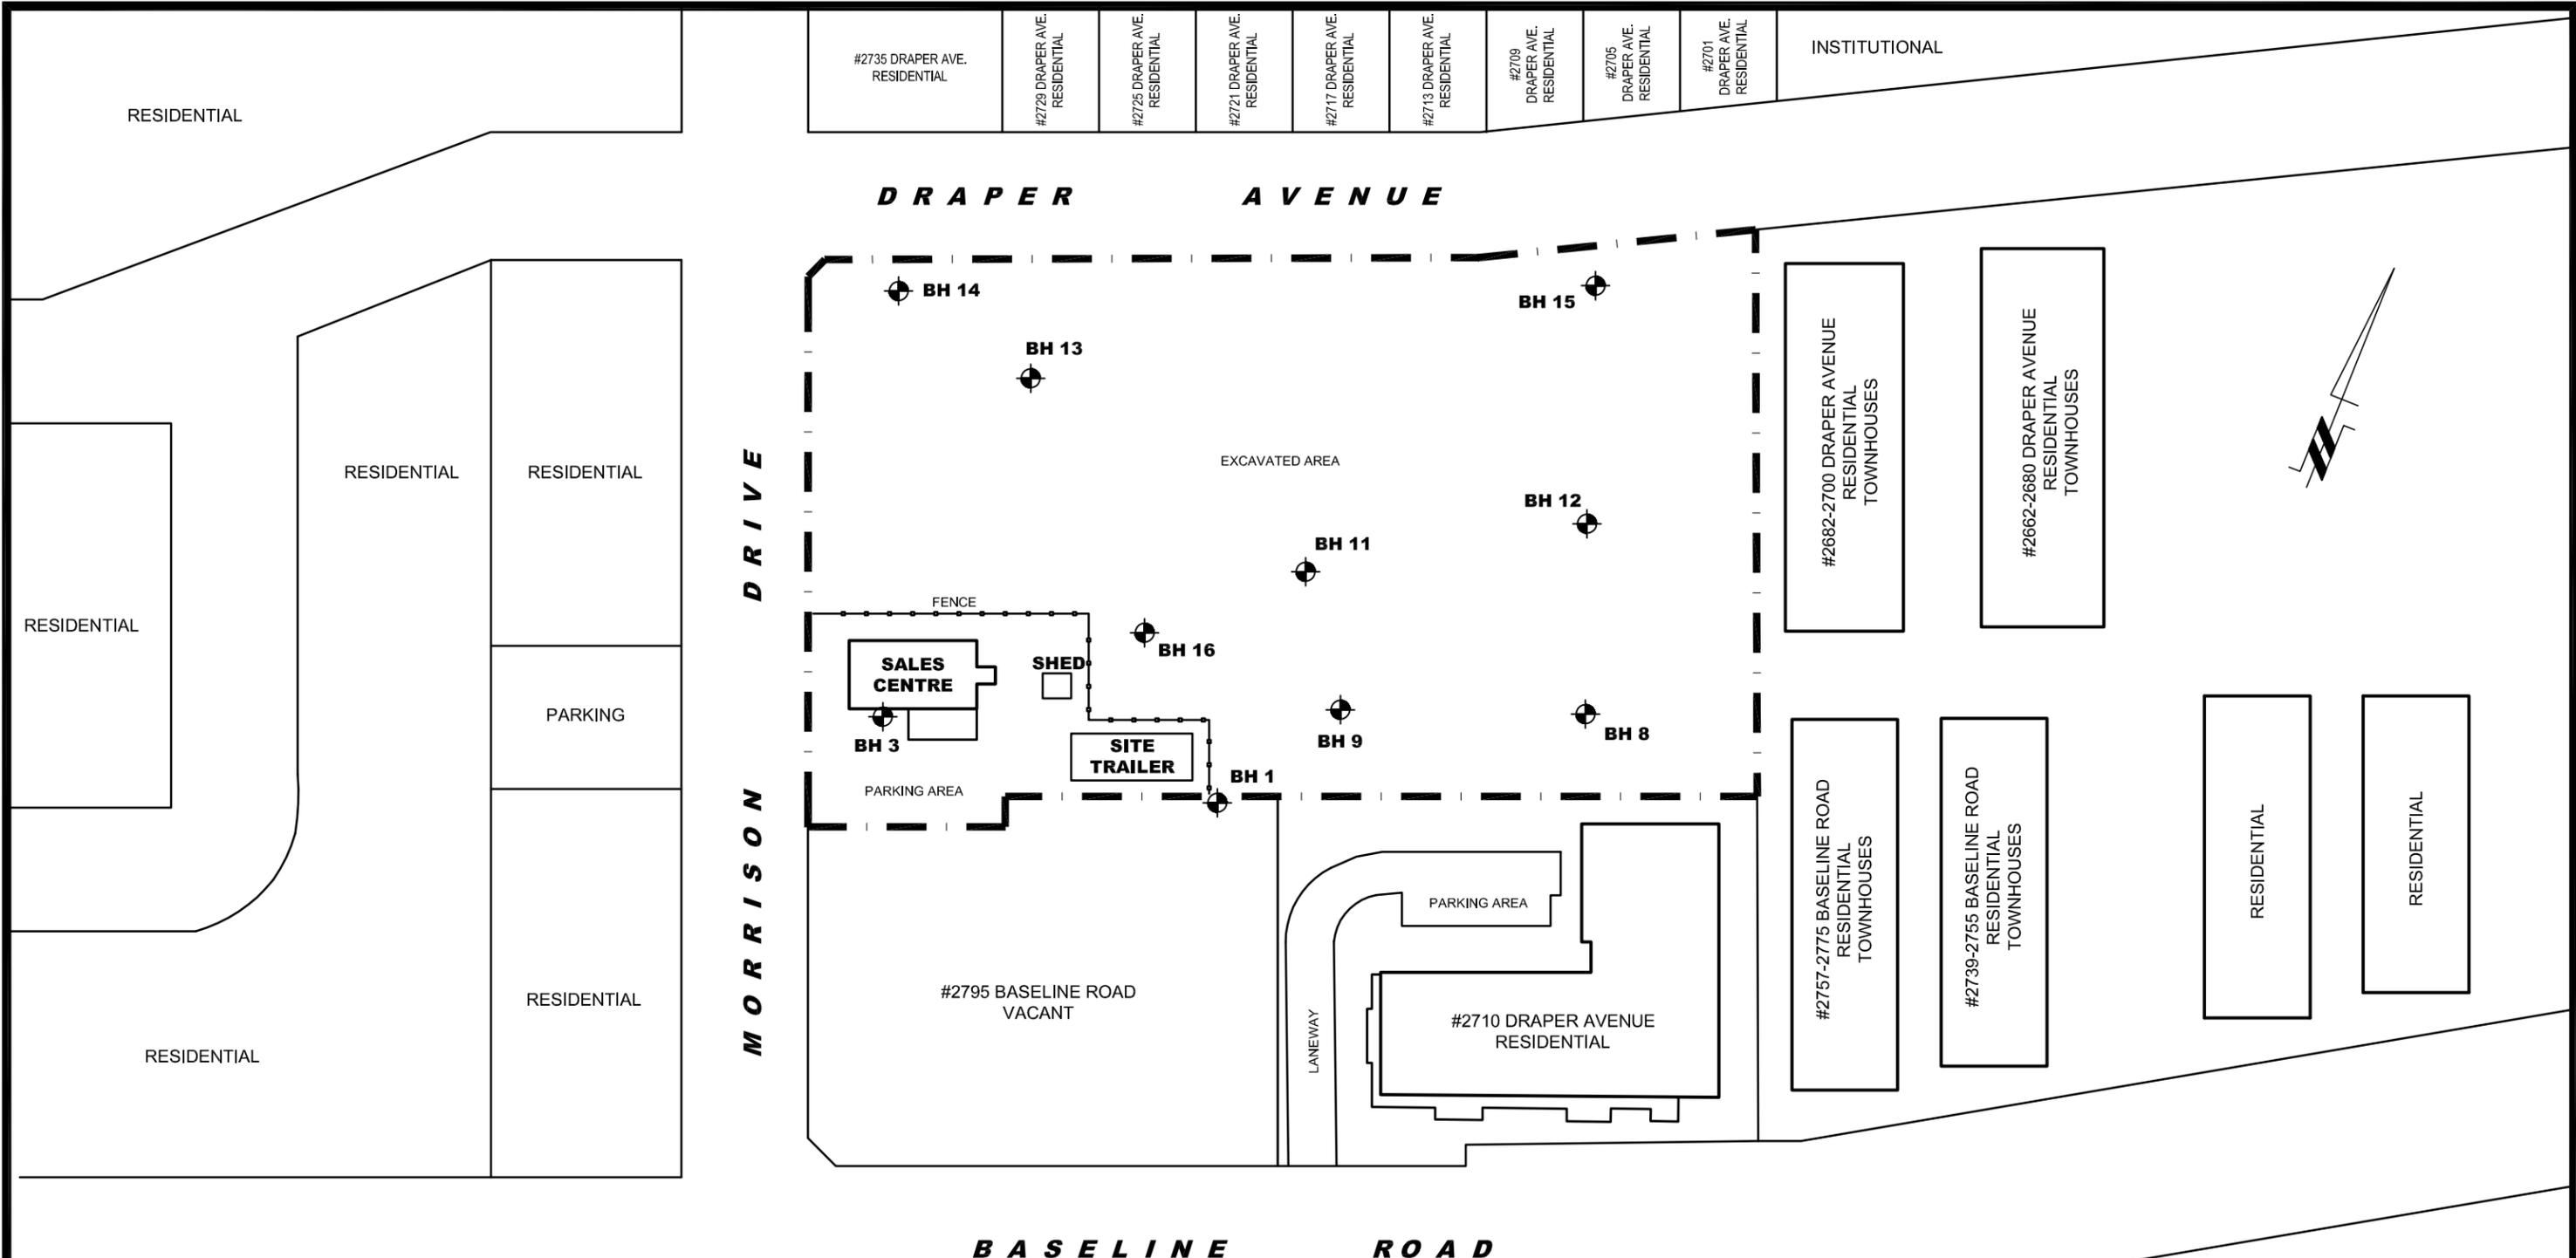
Scale:	1:1000	Date:	12/2018
Drawn by:	RCG	Report No.:	PE4018-LET.02
Checked by:	MB	Dwg. No.:	PE4018-1R
Approved by:	MSD	Revision No.:	0

The Phase I Property is situated approximately 60 m north of Baseline Road, at the southeast corner of the intersection of Draper Avenue and Morrison Drive, in the City of Ottawa, Ontario. It is currently occupied by a construction site trailer, sales centre, and what appears to be a storage shed. The property was previously occupied by four (4) residential apartment buildings in addition to the sales centre. The site topography slopes slightly down to the north, and is at the grade of adjacent roadways, while the regional topography in the general area of the Phase I Property also slopes down to the north. Site drainage consists of infiltration or sheet flow to catch basins on surrounding roadways. The configuration of the subject site is shown on Drawing PE4018-1R - Site Plan, which is appended to this report.

At the time of the site visit, the apartment buildings on the Phase I Property had been demolished. The former building footprints were marked with excavated pits, and the ground surface consisted of topsoil, granular fill material, and some weed growth. A construction site trailer was present at the southern side of the property, and the sales office building was still present in the southwest corner.

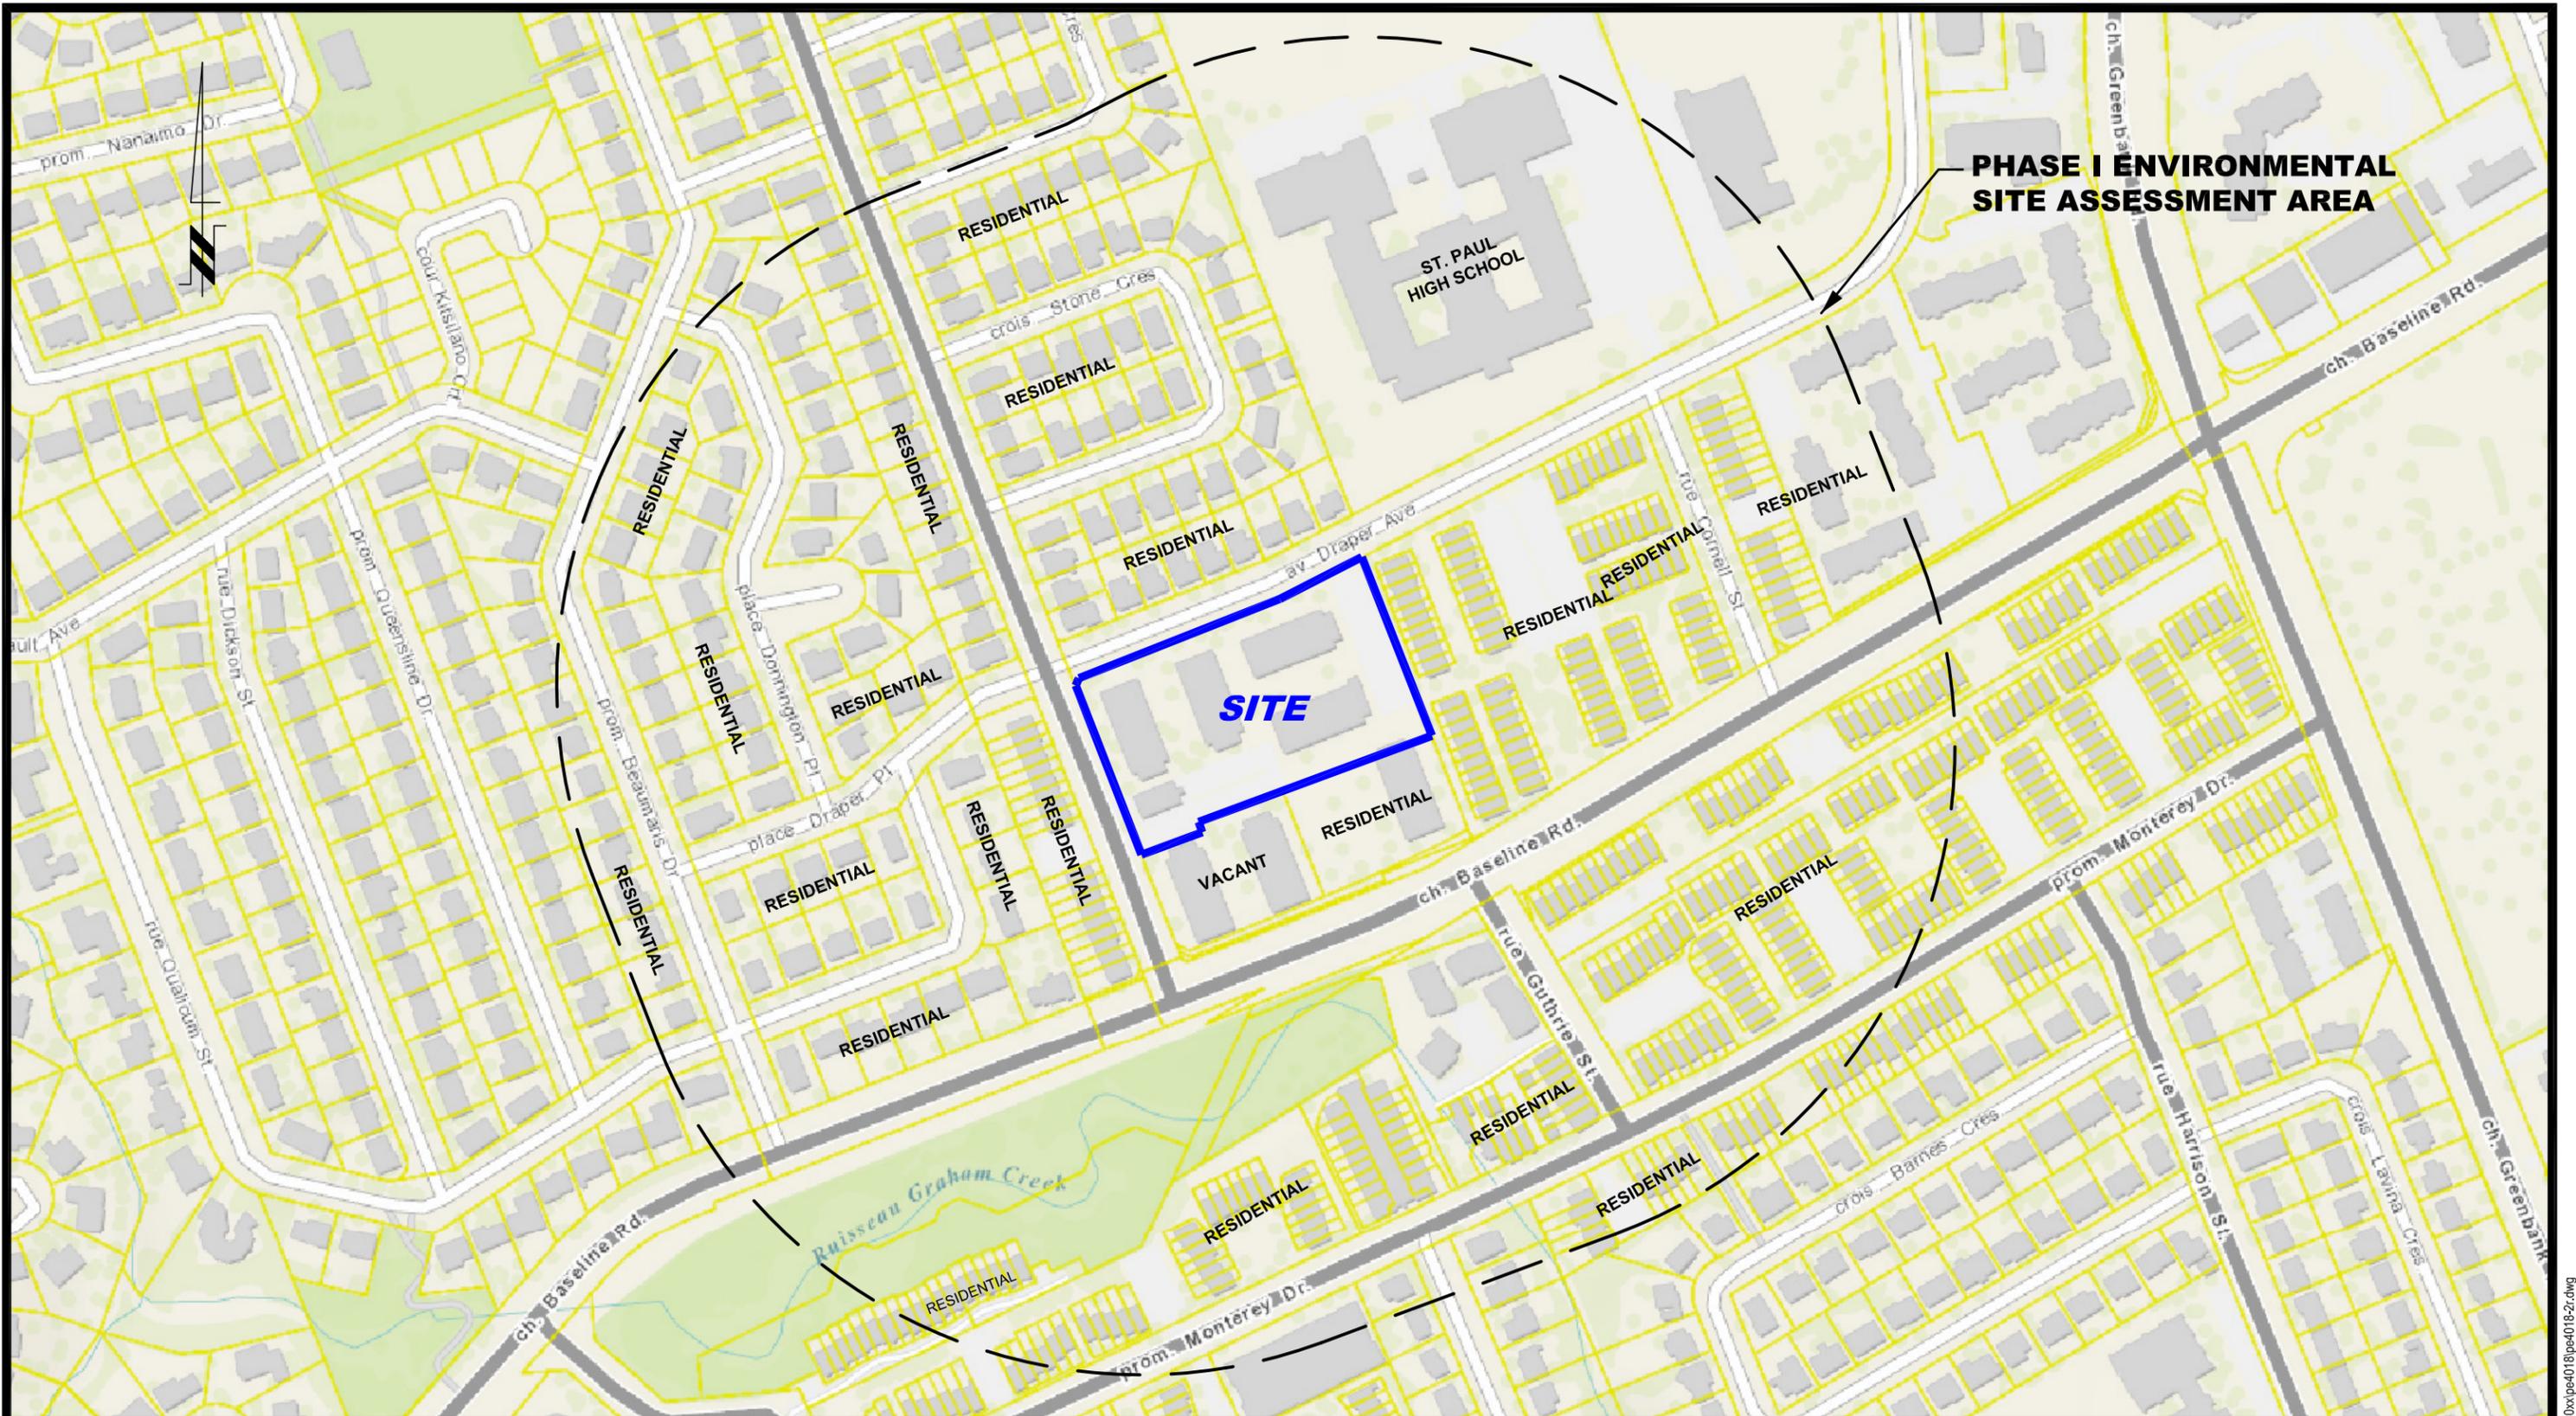
Date: 12/2018
Report No.: PE4018-LET.02
Dwg. No.: **PE4018-2R**
Revision No.: 0

The surrounding properties were observed from publicly accessible areas, at the time of the site visit. Current land use within the Phase I Study Area is shown on Drawing PE4018-2R - Surrounding Land Use Plan.

Neighbouring land use in the Phase I Study Area was historically used for a combination of residential and institutional purposes. Neighbouring land use is shown on Drawing PE4018-2R – Surrounding Land Use Plan.

Current land use within the Phase I Study Area is a combination of residential and institutional. No existing PCAs were identified within the 250 m study area at the time site visit.
