## **Phase I Environmental Site Assessment**

2795 Baseline Road  
Ottawa, Ontario

**January 11, 2019**

Report: PE4018-2

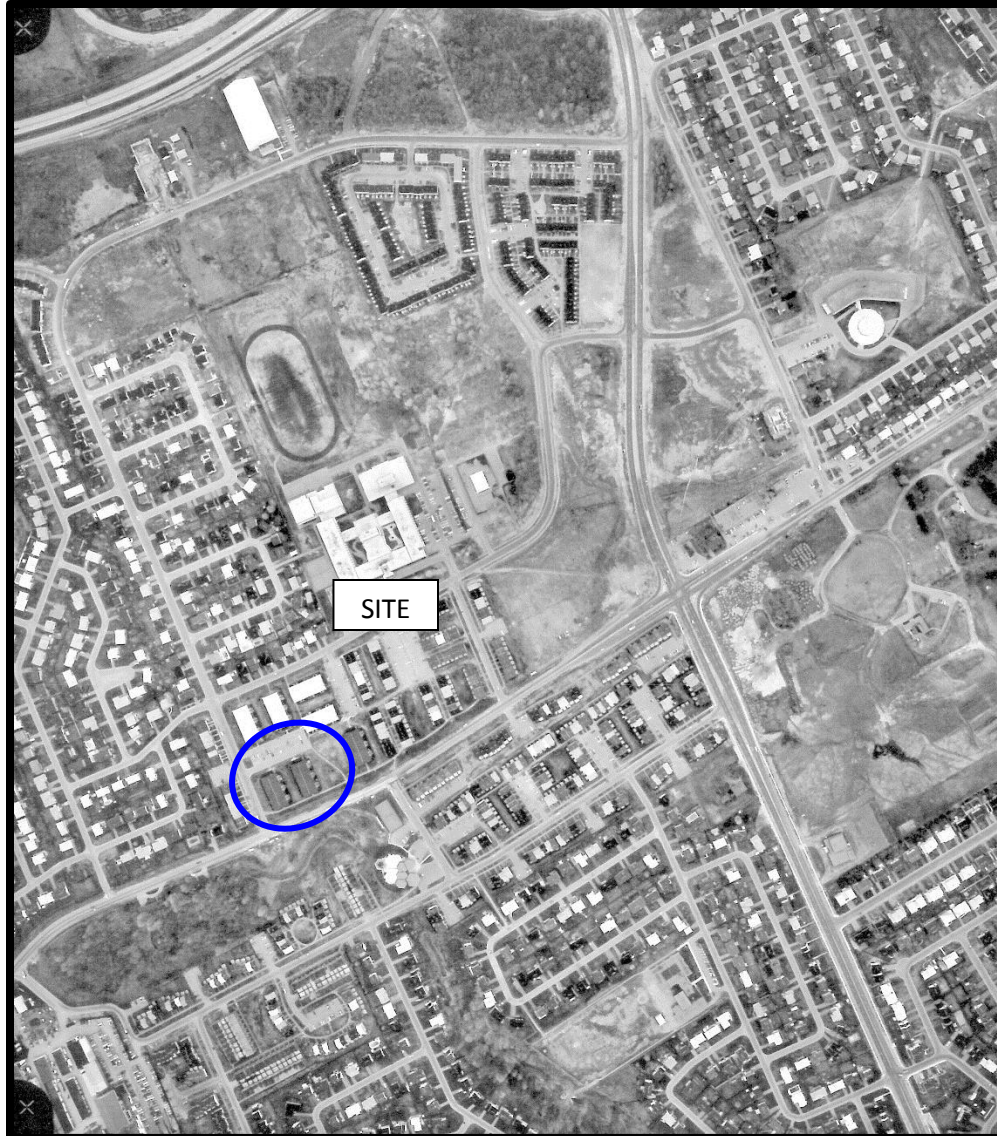
AERIAL PHOTOGRAPH  
1973

| 1973 | The subject site has been developed with a townhome complex. The adjacent properties are now developed with the existing buildings. Several vacant lots remain in the Phase I ESA study area. |

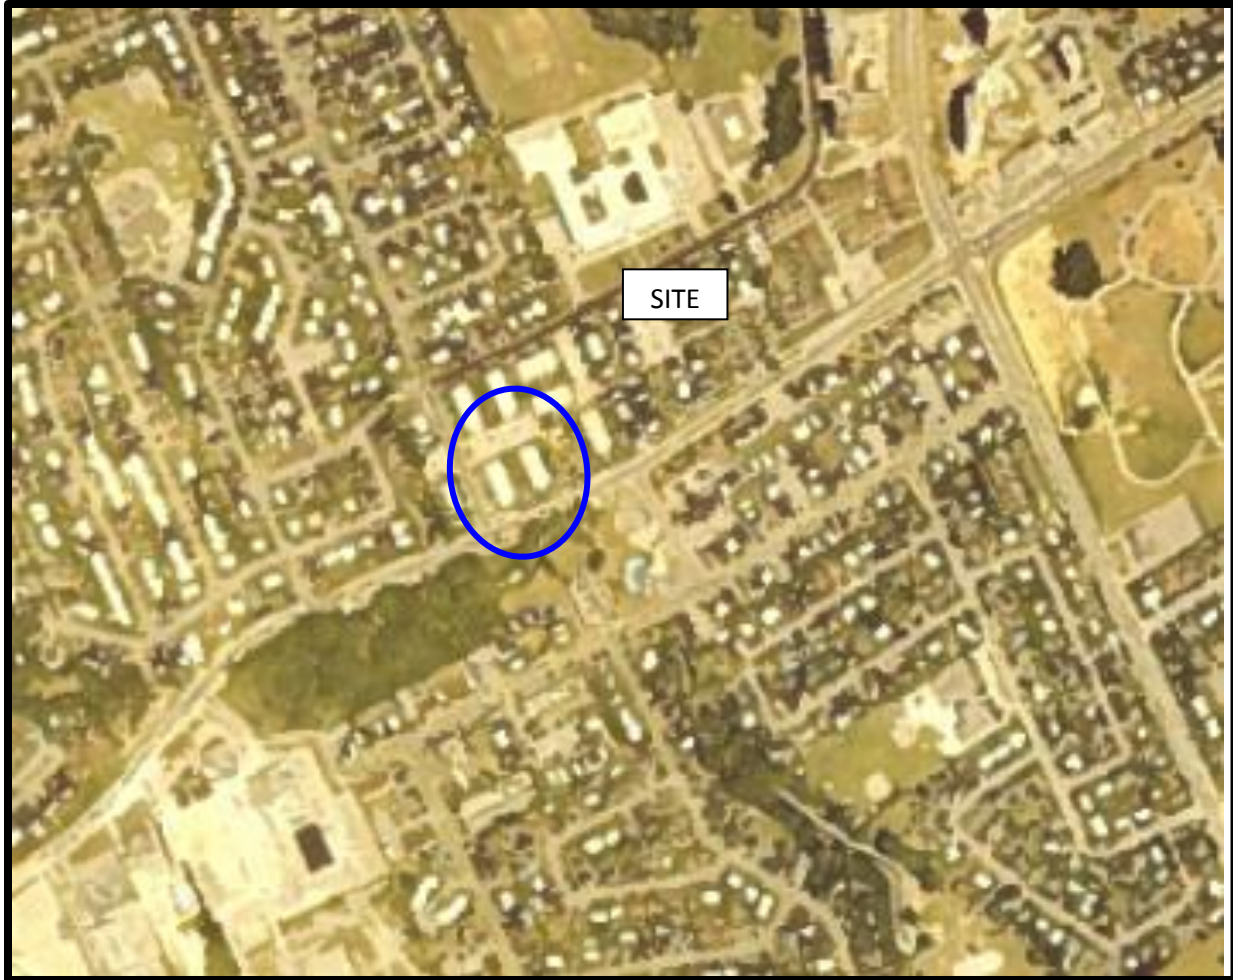
AERIAL PHOTOGRAPH  
1983

| 1983 | No significant changes have been made to the subject site or the surrounding properties. |

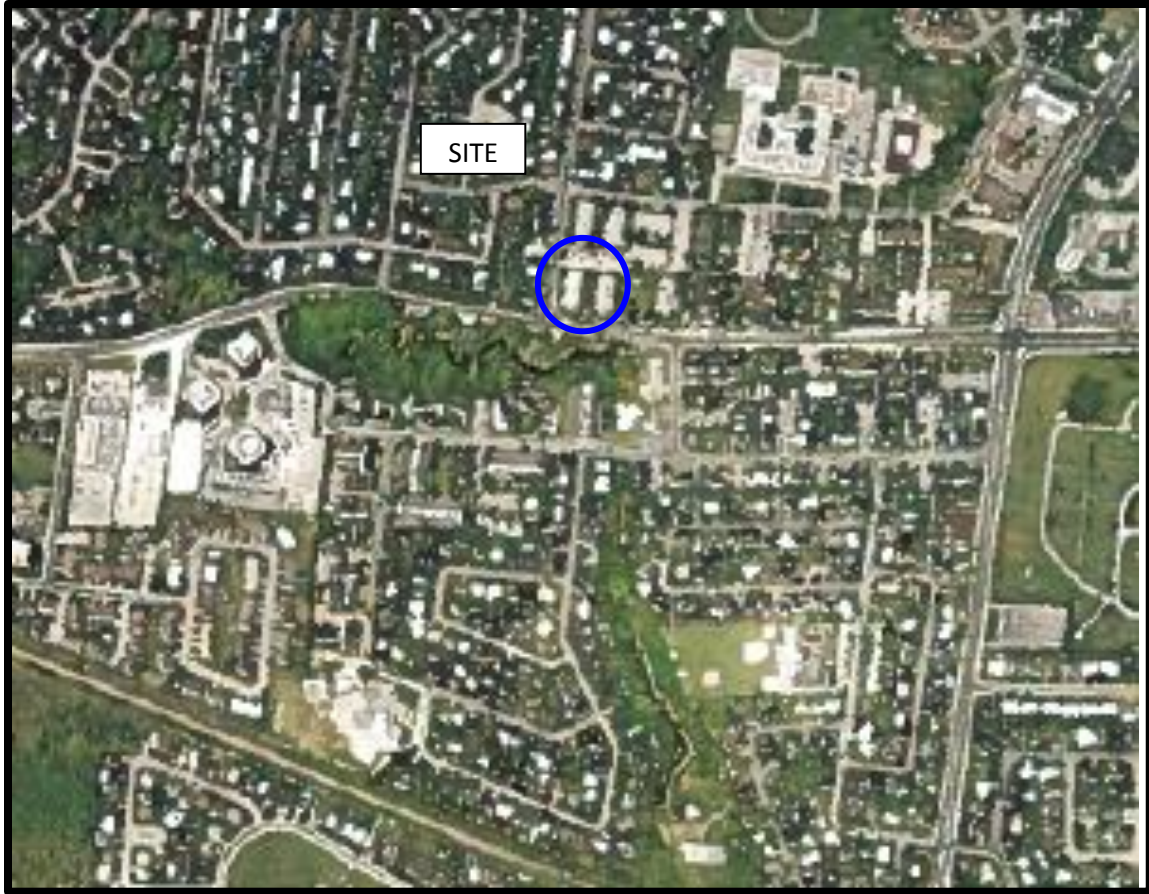
AERIAL PHOTOGRAPH  
1996

| 1996 | No significant changes have been made to the subject site or surrounding properties. |

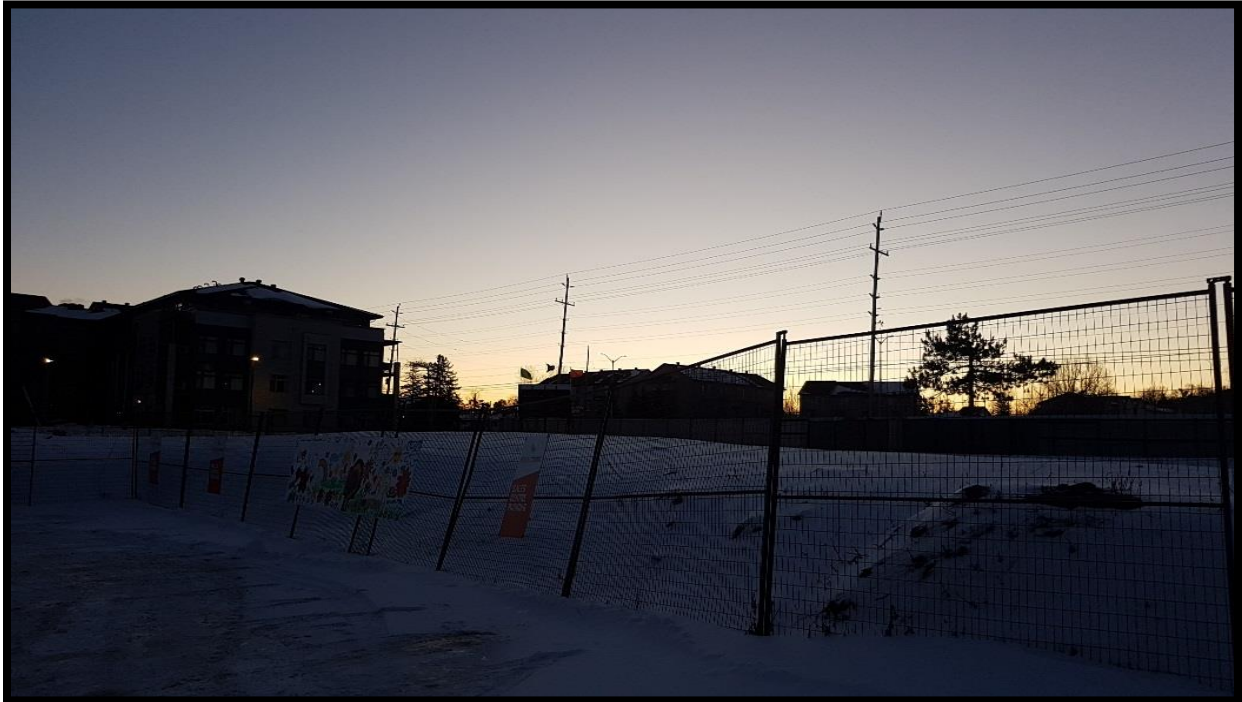
Photograph 1: Looking south across the property. Property is shown to be fenced and snow covered.

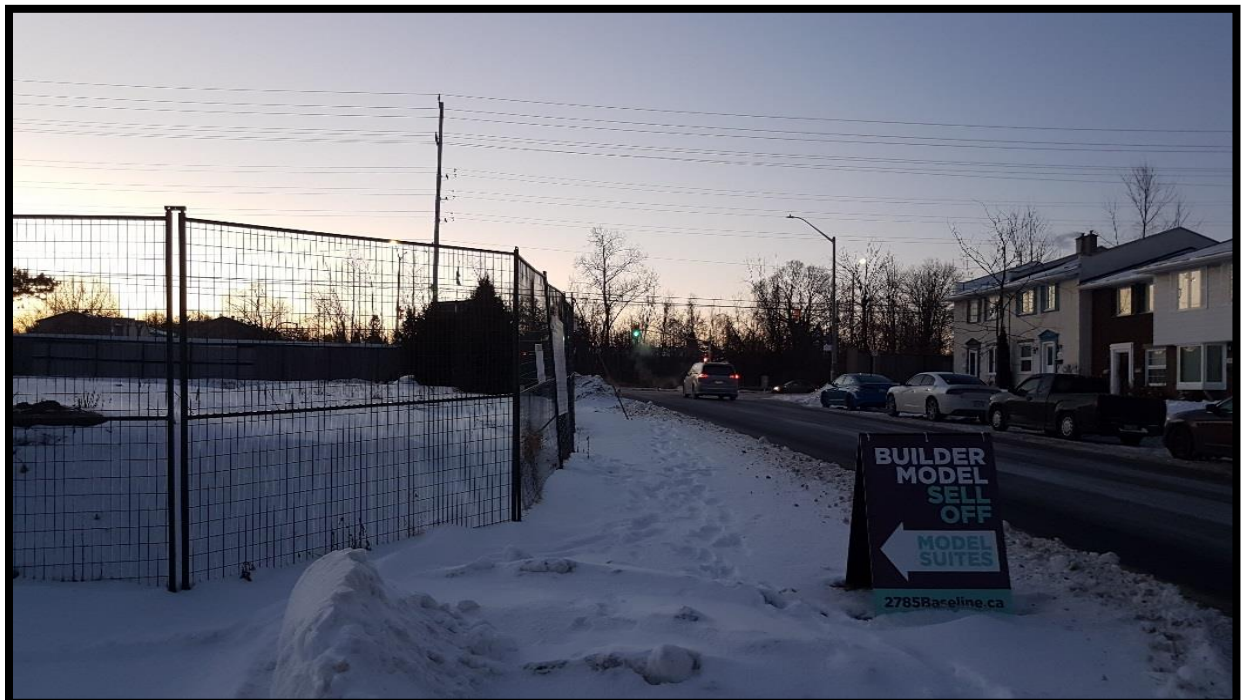
Photograph 2: Looking South along Morrison Drive.
