# Phase Two Environmental Site Assessment 337 Montgomery Street, Ottawa, Ontario

## Project Number: OTT-00241785-B0

Date Submitted: June 13, 2019

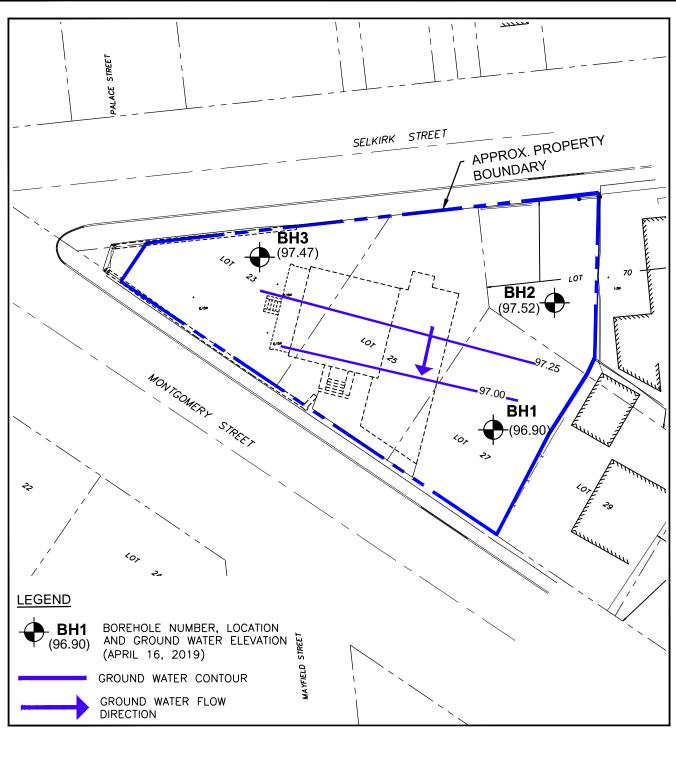
1:4000	CLIENT:	MAYBACH HOMES INC.	OTT-00241785-A0
APRIL 2019	TITLE:	PHASE TWO ESA - GROUNDWATER CONTOUR PLAN	
M.N.		337 MONTGOMERY STREET, OTTAWA, ON	FIG 6

Groundwater elevations and water levels were measured at the Phase Two property on April 16, 2019. Groundwater was encountered at a depth of 3.17 m bgs in BH2 to 3.57 m bgs in BH1. No petroleum sheens were observed in the monitoring wells during either sampling event.

- Shale bedrock was encountered at a depth of 5.1 m to 6.0 m. Groundwater was encountered at a
  depth of 3.17 m bgs in BH 2 to 3.57 m bgs in BH 1. No petroleum sheens were observed in the
  monitoring wells during the sampling event. Based on the groundwater elevations, the groundwater
  flow direction is to the south.

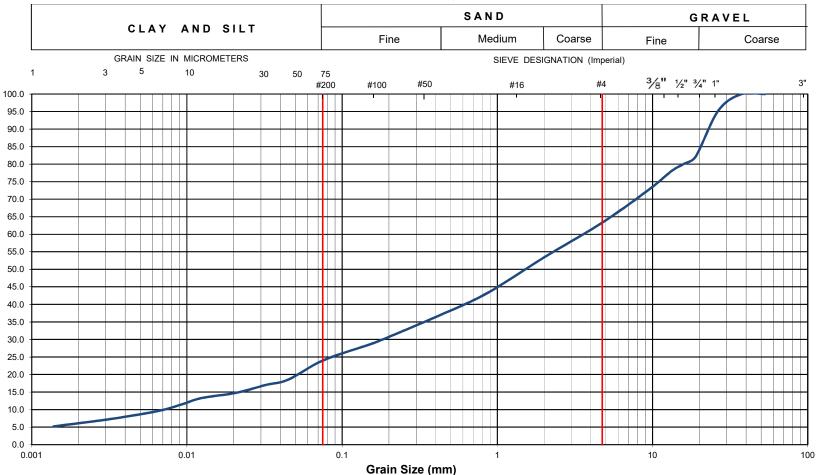
The grain size analyses showed that less than 50% of the soil had a grain size of silt or finer. This indicates that the native soil is coarse grained. The results of the grain size analyses are found in Appendix A.

EXP Project No.:	OTT-00241785-B0	Project Name :		Geotechnical Investigation							
Client :	N/S	Project Location	roject Location : 337 Montgomery St. Ottawa. ON								
Date Sampled :	April 4, 2019	Borehole No:		BH1 Sample No.: SS5 Depth (m): 3.0-					3.0-3.7		
Sample Description :		% Silt and Clay	24	% Sand 39 % Gravel			37	Figure :	VVVV		
Sample Description :		Silty San	Silty Sand & Gravel (SM)						rigule .	XXXX

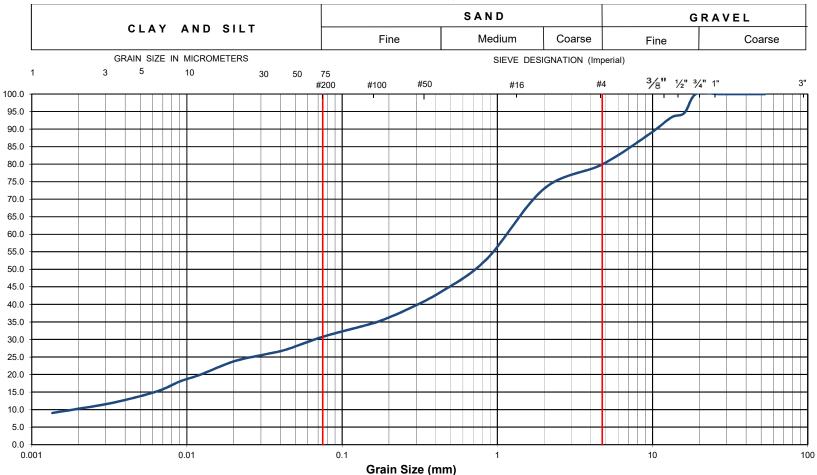
EXP Project No.:	OTT-00241785-B0	Project Name :		Geotechnical Investigation							
Client :	N/S	Project Location	Project Location : 337 Montgomery St. Ottawa. ON								
Date Sampled :	April 5, 2019	Borehole No:	nole No: BH3 Sample No.: SS4 Depth (m):					Depth (m) :	2.3-2.9		
Sample Description :		% Silt and Clay	31	% Sand 49 % Gravel				20	Figure: xxxx		
Sample Description : Silty Sand some Gravel (SM)									rigule .	***

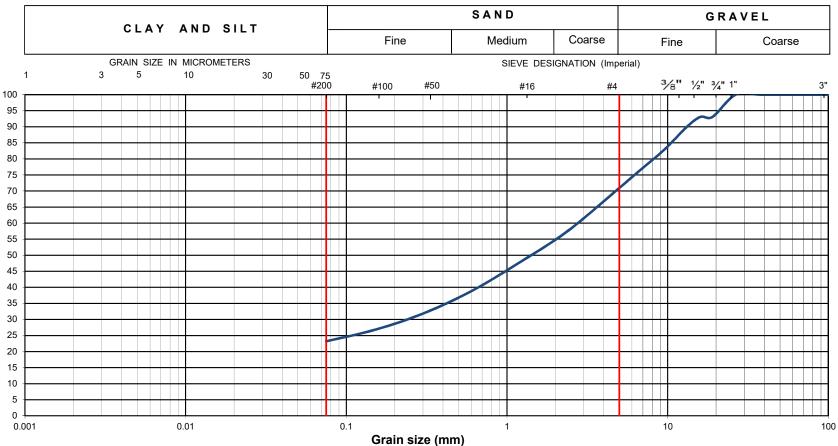
EXP Project No.:	OTT-00241758-B0 Project Name : Geotechnical Investigation								
Client :	N/S	Project Location	Project Location: 337 Montgomery St. Ottawa. ON						
Date Sampled :	April 4, 2019	Borehole No:		BH1	Sample	: S	S3	Depth (m) :	1.5-2.1
Sample Composition :		Gravel (%)	30	Sand (%)	48	Silt & Clay (%)	22	Figure :	xxx
Sample Description :

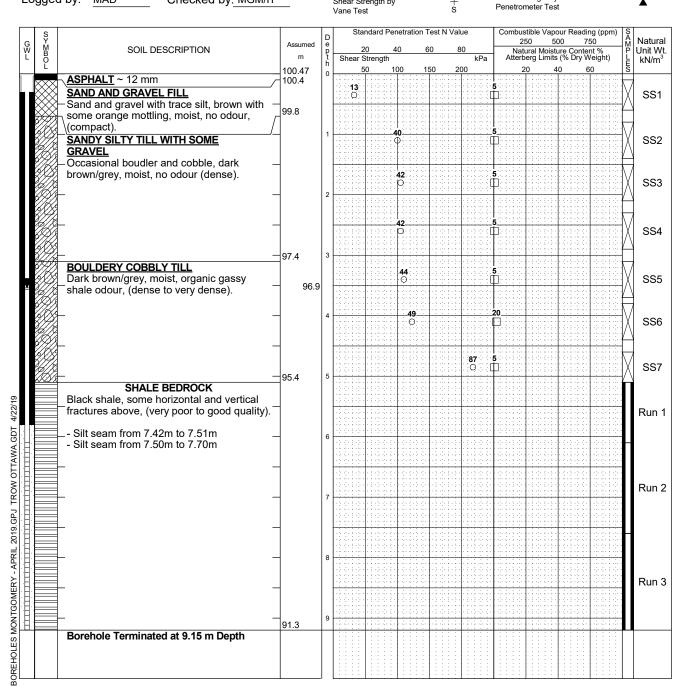
# Log of Borehole BH1

A 12 to 20 mm layer of asphalt was observed in BH1 and BH2. A 50 cm layer of topsoil was found at the ground surface in BH3. Sand and gravel fill material was observed in BH1 and BH2 and ranged in thickness from 0.6 m to 1.5 m. No petroleum odours were identified in the fill material.
