**Phase One Environmental
Site Assessment
337 Montgomery Street,
Ottawa, Ontario**

OTT-00241785-B0

Final

May 8, 2019

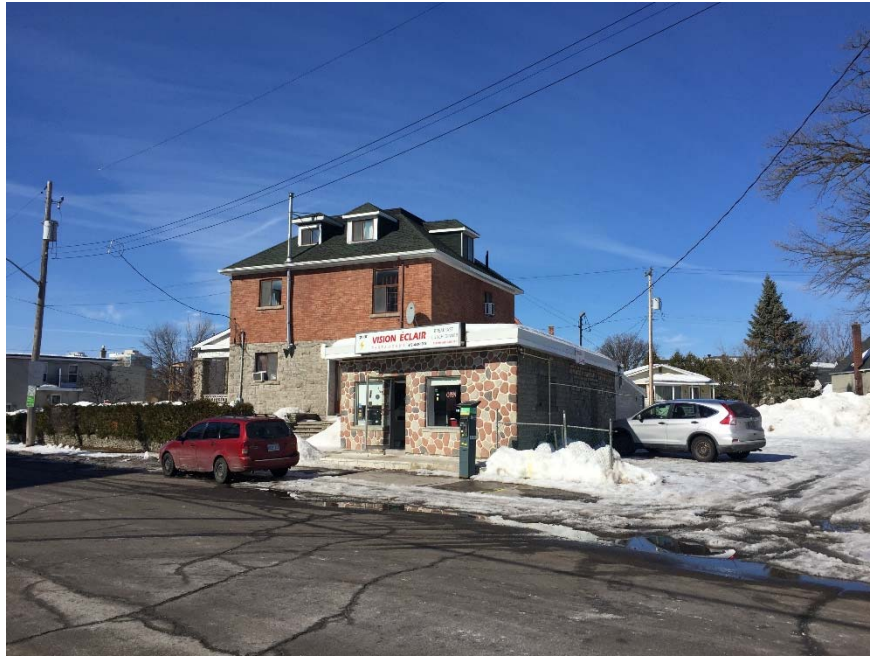
Photograph No. 1

View of the site building facing northwest

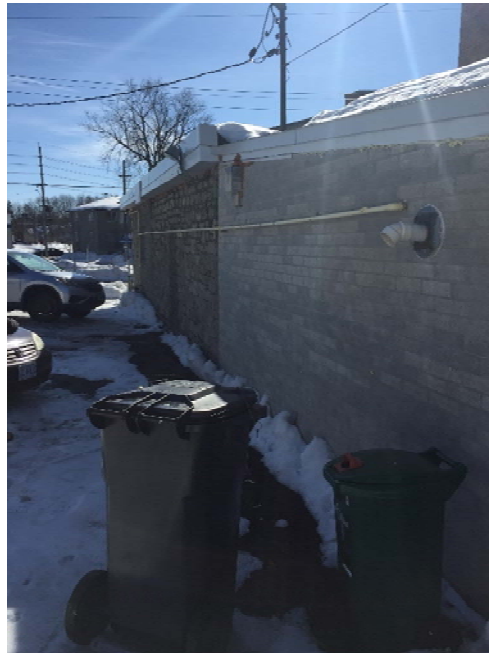
Photograph No. 2

View of the site eastern building facing

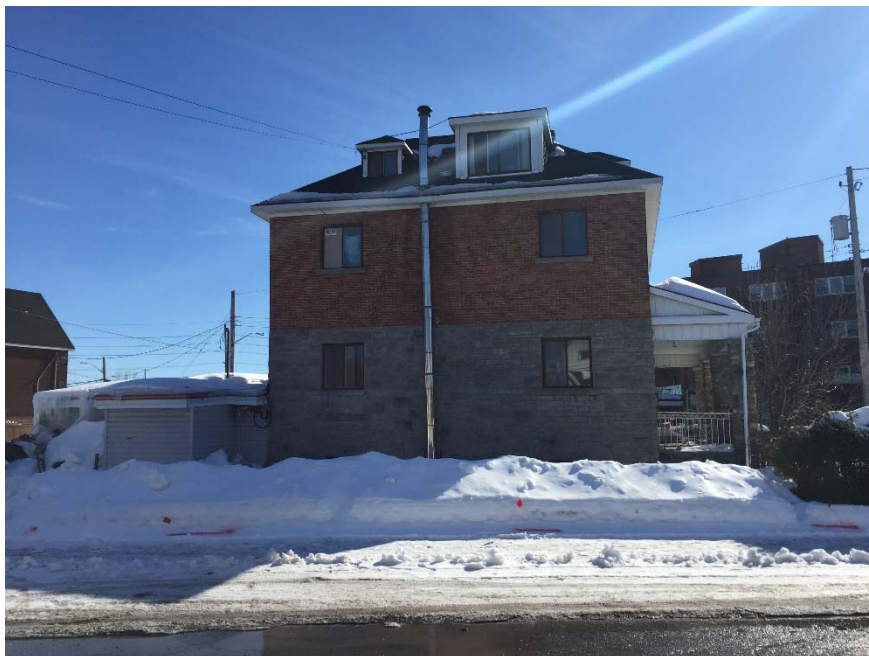
Photograph No. 3

View of the northern part of the property, looking west

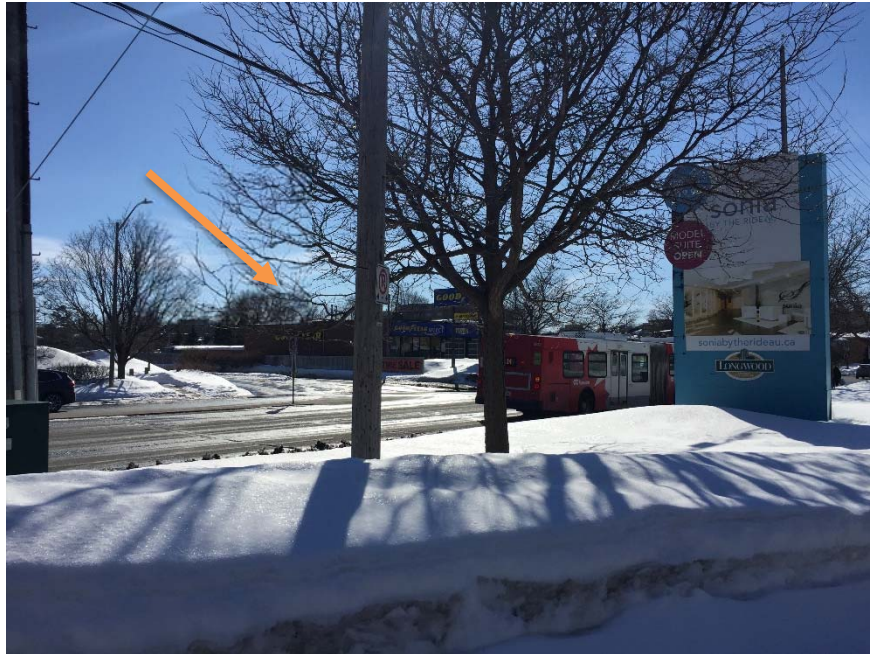
Photograph No. 5

- PCA 5 – 52 MacArthur Avenue – Active automotive repair garage, 100 m south of the subject property (PCA#10 Commercial Autobody Shops). Based on intervening distance and the assumed westerly groundwater flow direction, this is not considered an environmental concern for the subject site.

Automotive repair garage 110 m to the south at 52 Macarthur Avenue

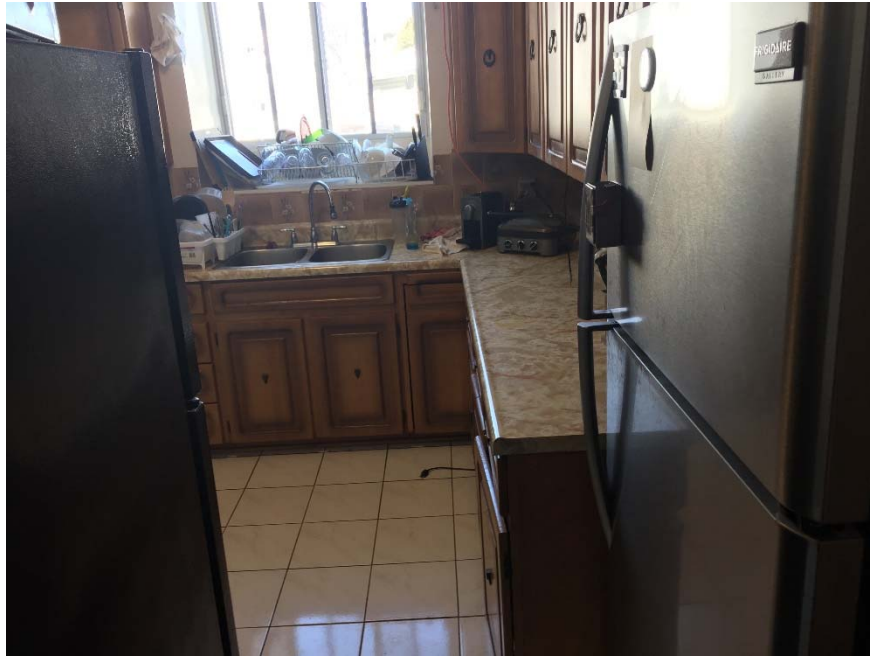
Photograph No. 7

The two-storey residential building is red brick & faux field stone block clad with a peaked roof and a field stone and mortar foundation. The interior is finished with hardwood floors, painted plaster-on-lathe walls, and "popcorn" finish ceilings. The basement has a concrete floor with wood panel walls.

Representative view of interior of the main residential building

Based on the date of construction (constructed in 1930s), there is the potential for ACM to have been used during the construction or renovations of the site building. Prior to any renovations or demolition of the site building it is recommended that a Designated Substance Survey (includes asbestos sampling) be performed in order to determine if asbestos is present within the building.
