Environmental Impact Statement 2740 Cedarview

August 26, 2019

KILGOUR & ASSOCIATES LTD.
www.kilgourassociates.com
Project Number: DCRP 763

Headwater Drainage Feature Assessment DCR Phoenix Cedarview / Fallowfield

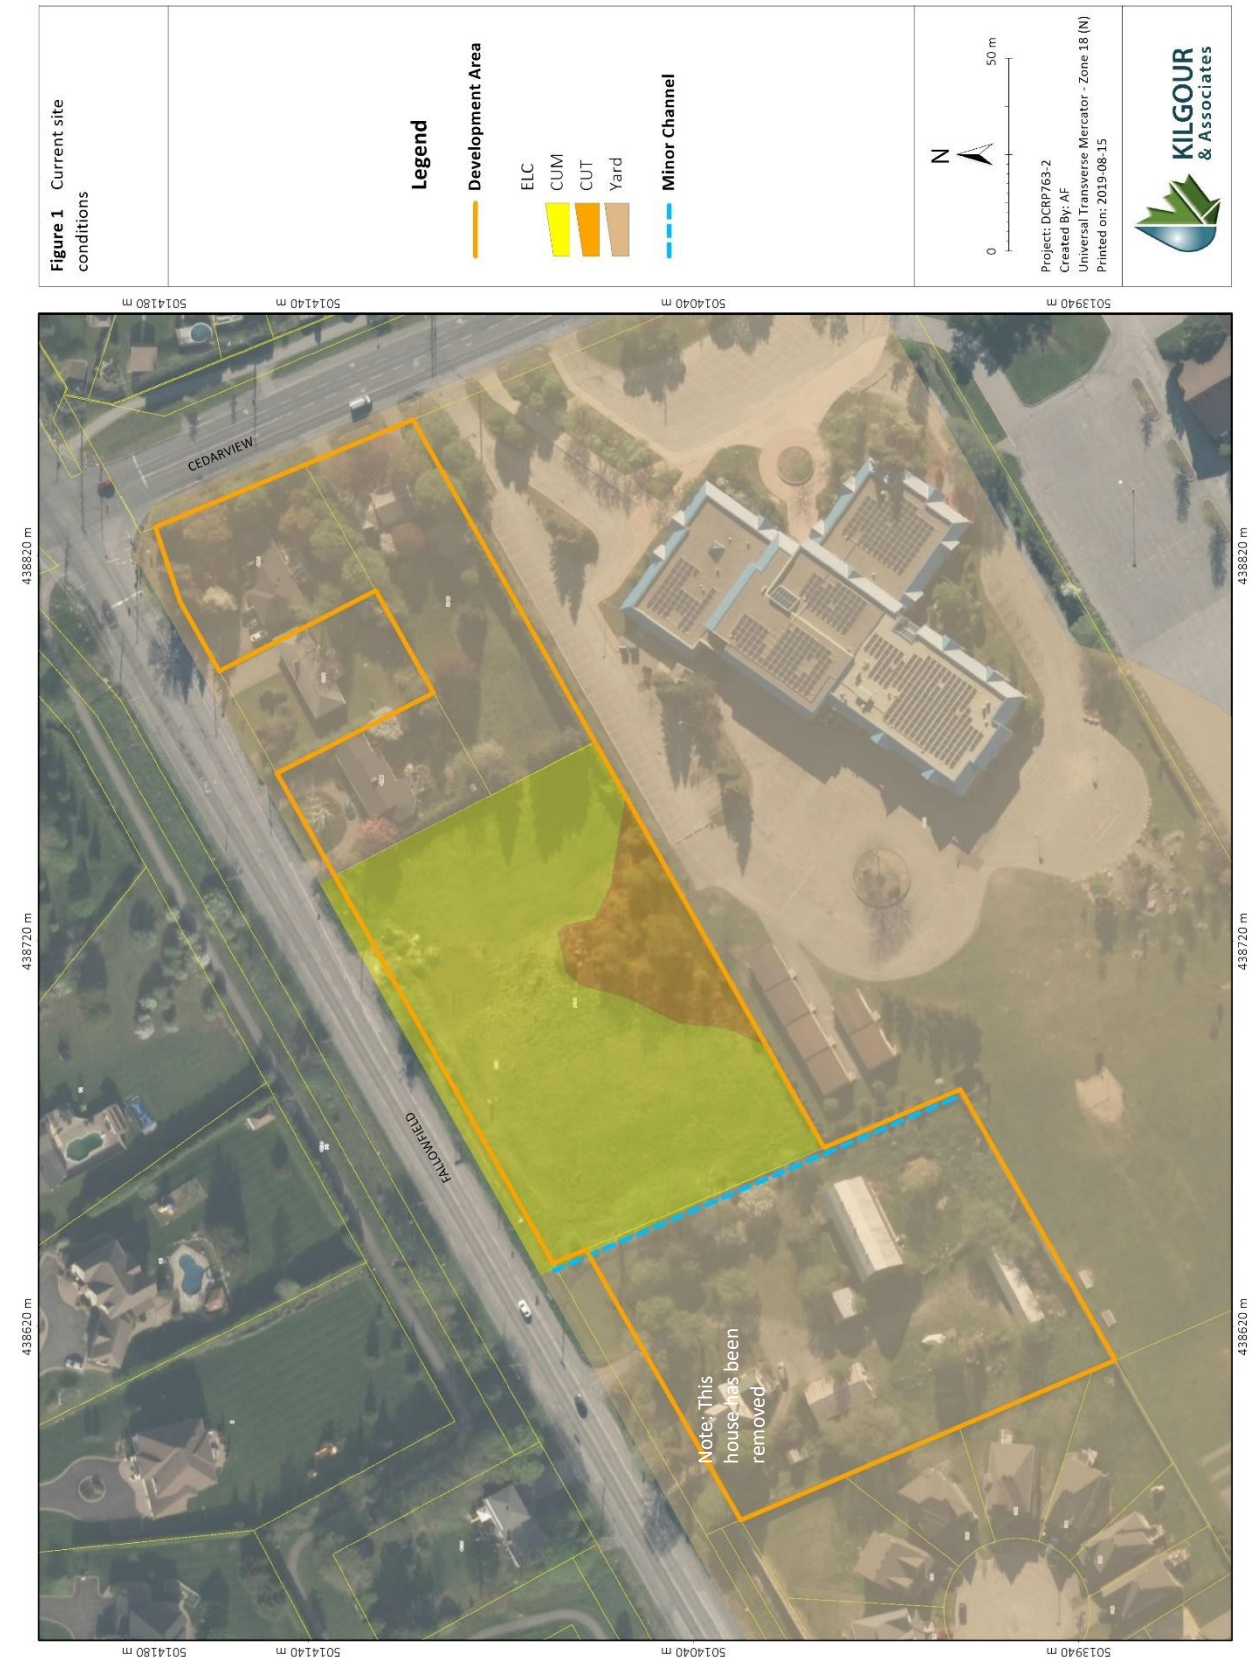
Site land cover is depicted in Figure 1. The site currently is comprised of three residential dwellings with accompanied manicured lawns, a former farmstead (that since has been demolished) with ancillary buildings and manicured yard, and an old field grassland with small patches of trees. Scattered trees also occur on the farmstead and in yards of the residential dwellings.

Overall, the site contains low quality wildlife habitat, with a high level of human disturbance and non-native plant and tree species. The grassland area located in the center of the site is categorized as Cultural Meadow (CUM) (Lee et al., 1998). This area was used for agricultural purposes until 2014 (according to air photos from geoOttawa (2018b) and gone fallow since then. Cultural Thicket (CUT), forest, and wetland habitats exist to the west of the site, along O'Keefe Court. Additional, CUT and wetland habitat exists to the northeast, the site across the crossing at Fallowfield Road, and Cedarview Road.

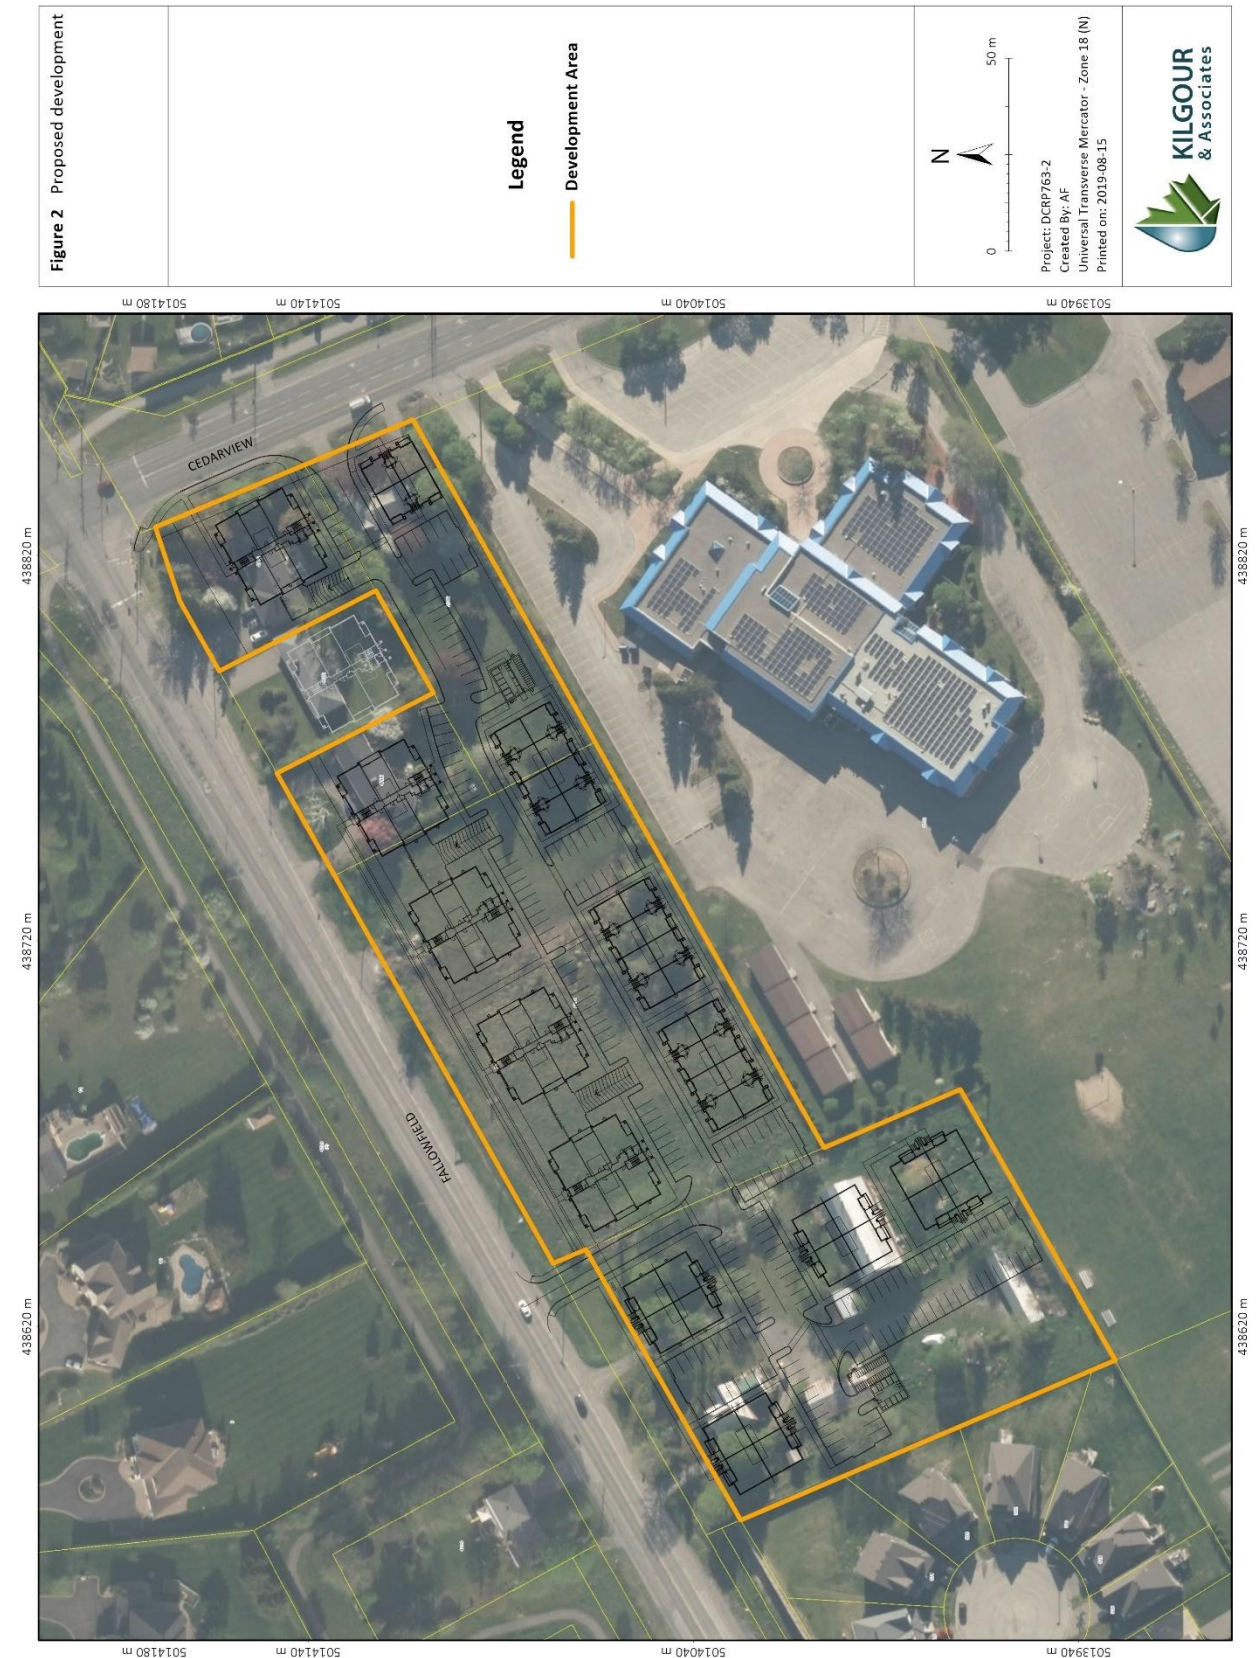
The project supported by this EIS is the construction of residential units on the site in the form of 13 low-rise apartment and stack unit blocks (Figure 2). The existing land parcel at 4192 Fallowfield Road, does not form part of the subject site and will remain untouched by the current project. Site preparation will otherwise require the removal of existing site buildings – i.e. at the farmstead and two other residential lots.

The small channel on site will be entombed in a culvert extending over the site and replacing the existing culvert under the schoolyard. Modification of this feature will require approval from the RCVA.

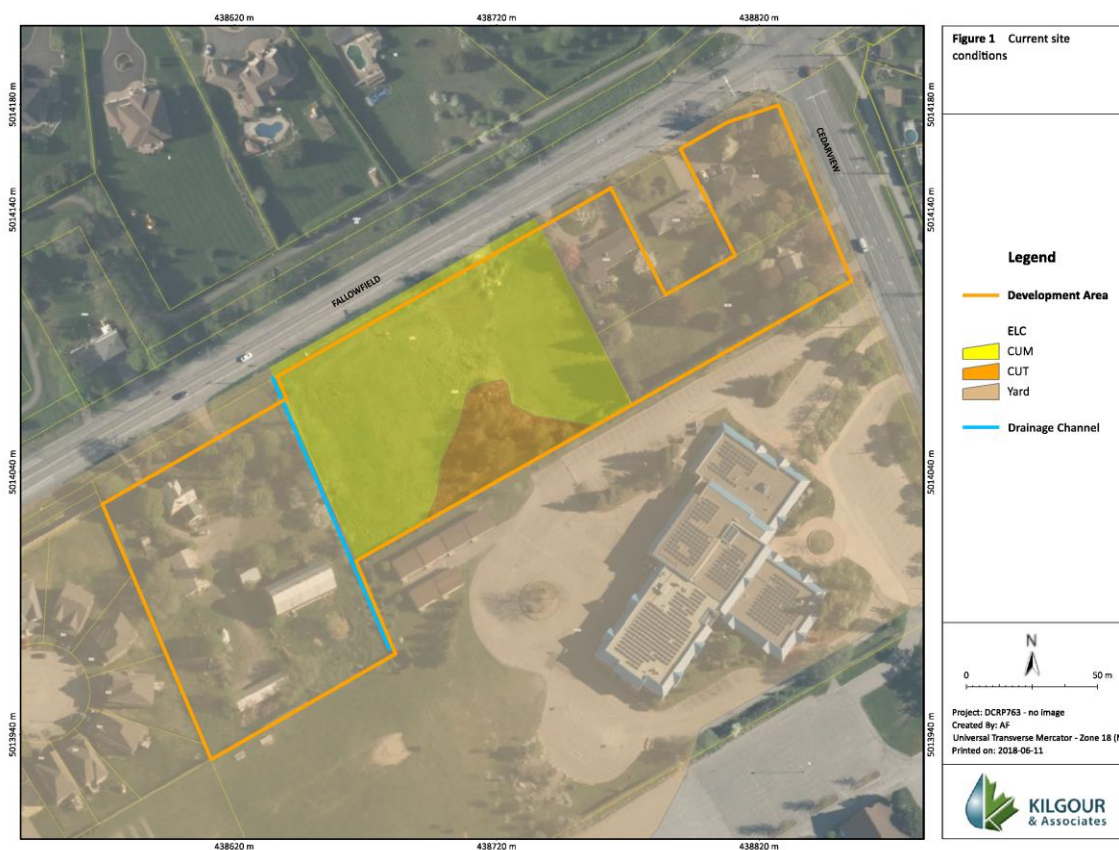
Figure 1. HDF reaches

The site includes a single drainage channel (Figure 1).

The single reach on site is Reach 1 is a 115 m drainage channel, with a width of ~50 cm for most of its length. The channel conveys flows southward from site and from the roadside ditch along Fallowfield. The channel leads to a 115 m long culvert passing through the adjacent school yard. That culvert releases water at the south side of the schoolyard to ditch system, conveying flows 420 m to the southeast to the Foster Drain at Hélène-Campbell Road.

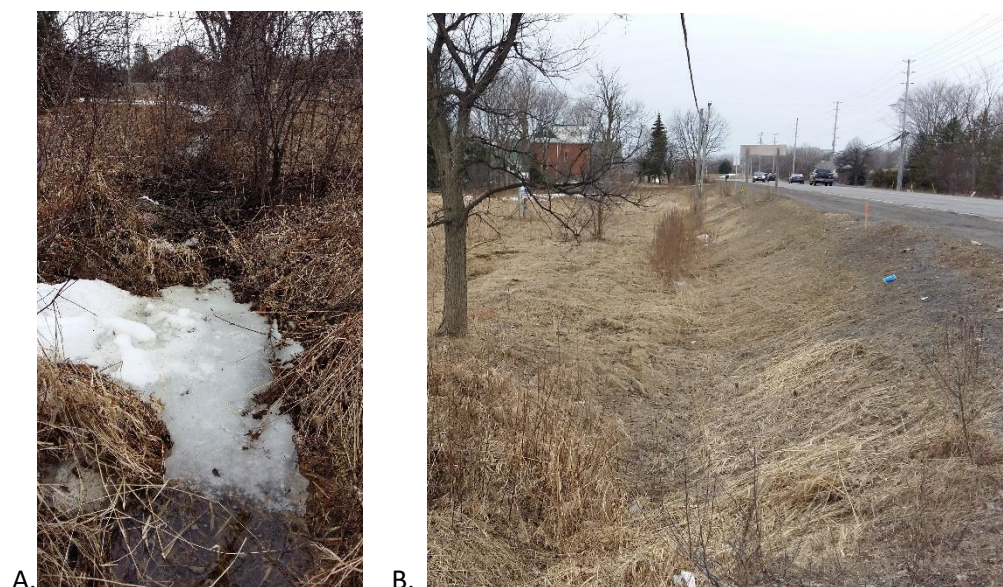
Figure 2. Drainage channel (A) and roadside ditch (B) leading to it March 29, 2018.

At the time of the survey, the south end entrance to the culvert was completely obscured by trash debris (as was much of the channel) and vegetation. The feature had ~ 15 cm of standing water along much of its length. Downstream flow was undetectable. At the upstream end however, there was a slight backwards tickle to the Fallowfield roadside ditch (which was otherwise dry) as the channel sits slightly higher than the ditch. The channel would only receive flows from top end if the roadside ditch was filled significantly. With a long culvert at its bottom end, and dry roadside ditch at the top end, the standing water present in the feature onsite (from adjacent snow melt) was effectively isolated.

The channel was filled with grass and leafy debris. The channel passes through a cultural meadow. Until 2014, the east side was under active agriculture and the west side was a lawn area. In 2018, the banks were covered in tall grass with a few trees.

This chain of classification descriptors leads to a management directive of **Mitigation** for this reach. This feature is not required to be maintained per se, but its functionality can be replicated. The feature

currently serves primality to convey lot drainage and, possibly during very wet periods, drainage from the upstream areas via the Fallowfield roadside ditch. Drainage from this feature is currently to a long culvert. Extending the existing culvert across the current site should not anticipated to further reduce functionality of the feature. Allochthonous inputs from the site are currently limit to early spring period. These could be replaced by similar inputs from the roadside ditch if lot level flows were directed to that feature before entry to the culvert. Low Impact Development (LID) options are the preferred approaches for the area stormwater plan to the extent that they can be implemented.

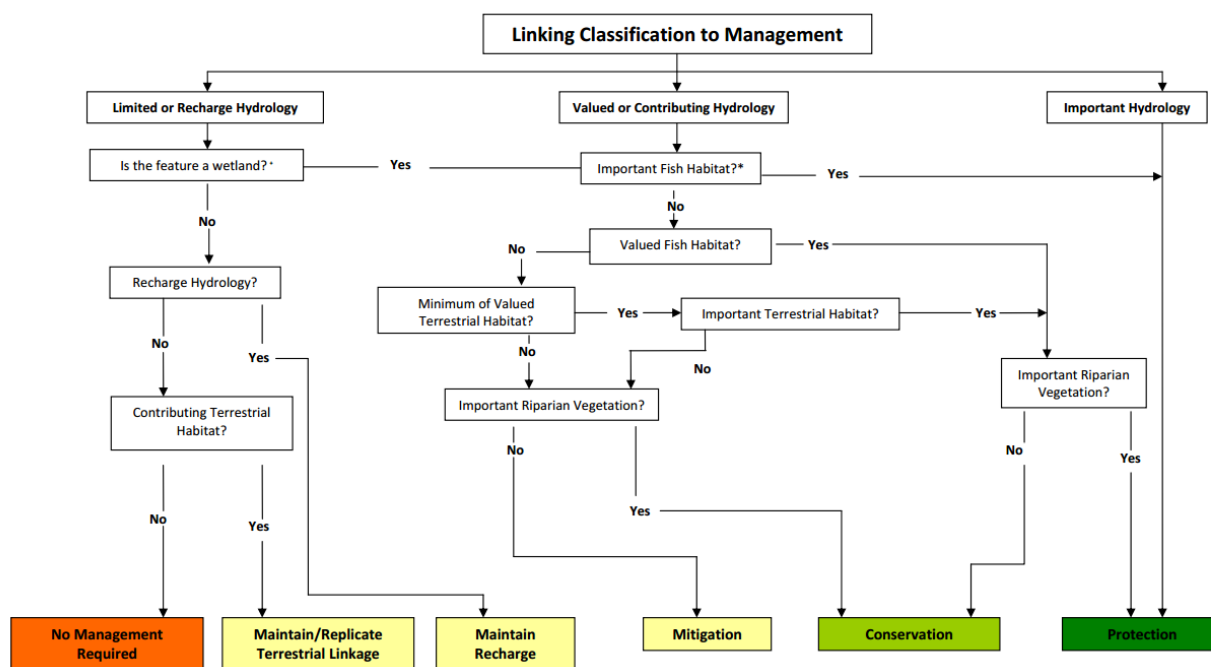
Figure 3. Headwater Drainage Feature Assessment (HDFA) flow chart providing direction on management options

The classification categories identified in Section 2 provide the basis of the management recommendations provided here. The following flow chart (Figure 2) combines and translates the classification results to management recommendations.

This feature is a small, ephemeral drainage channel between a lawn young cultural meadow (recently abandoned farm land). Following the HDFA Guide flow chart linking component classification to management directives (Figure 2), this reach:

1. Provides Contributing Hydrology;
2. Does not provide Important Fish Habitat;
3. Does not provide Valued Fish Habitat;
4. Does not provide Valued/Important Terrestrial Habitat; and
4. Does not provide Important Riparian Vegetation.
