Phase I Environmental Site Assessment

25 Grant Street
Ottawa, Ontario

March 21, 2019

Report: PE4563-1

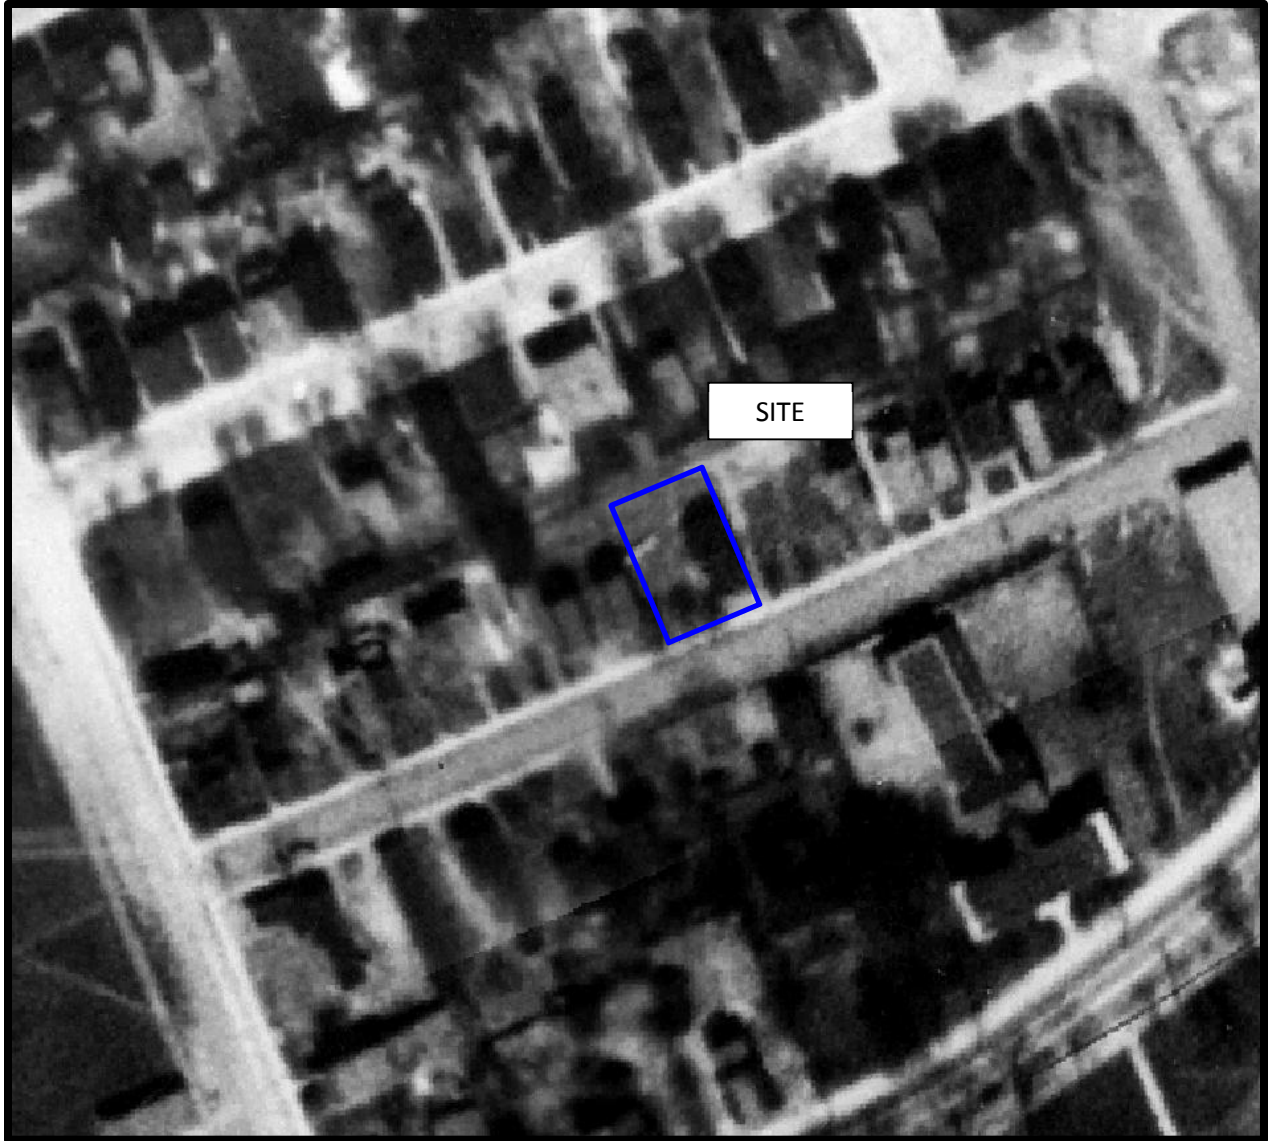
AERIAL PHOTOGRAPH
1928

| 1928 | The subject site appears to be occupied by a detached dwelling on the eastern part of the property. The surrounding area is occupied by residential properties with a church to the southeast. |

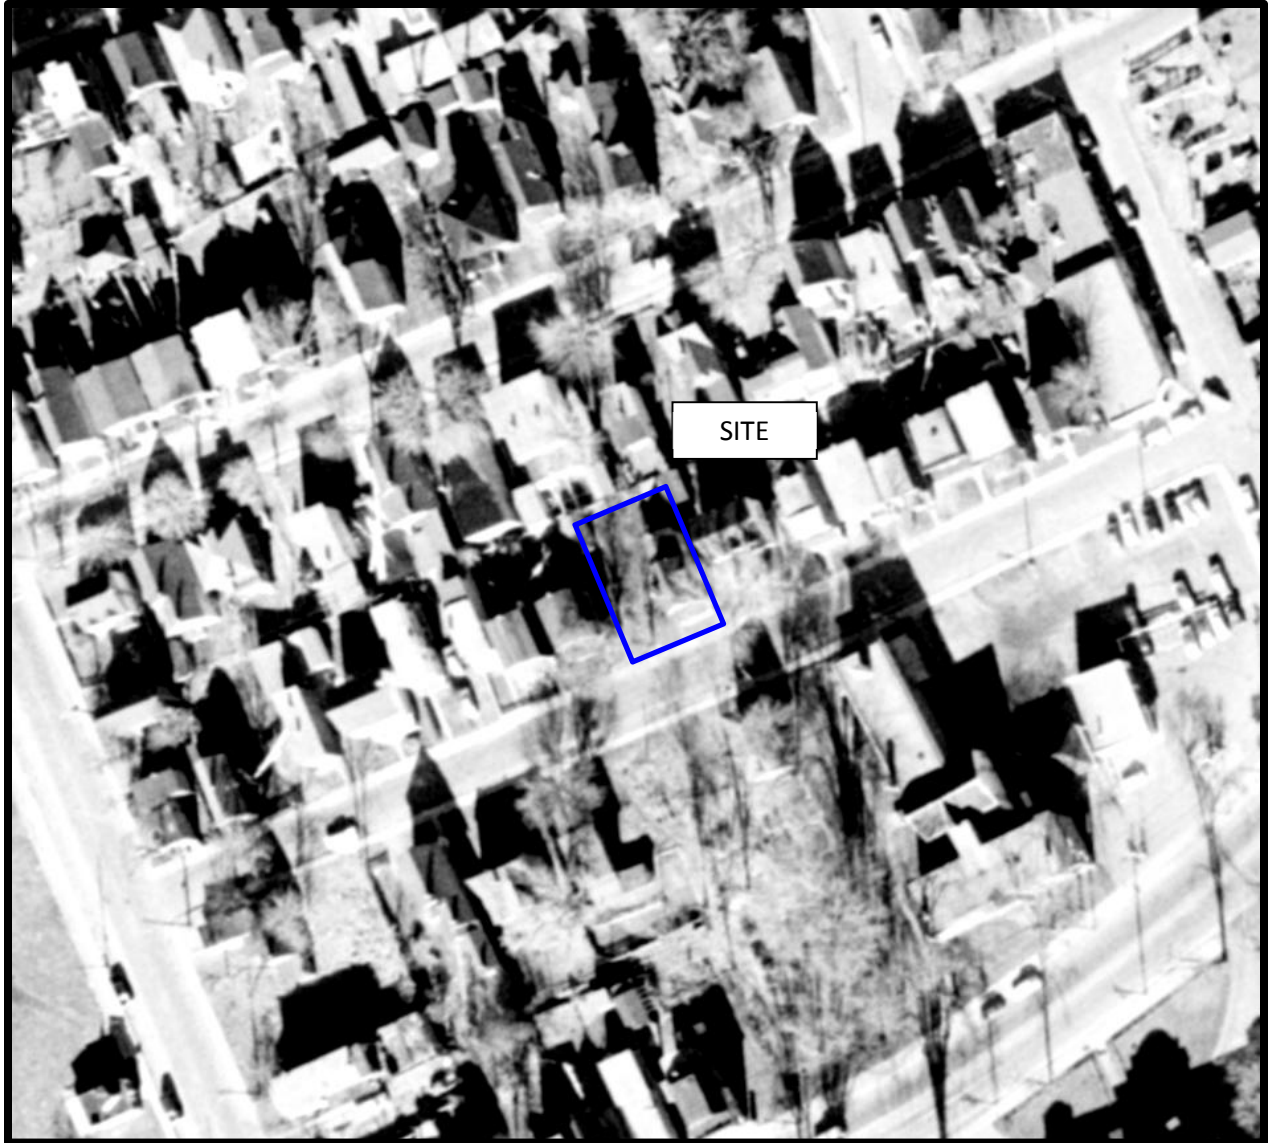
AERIAL PHOTOGRAPH
1958

| 1958 | No significant changes have been made to the subject site. Commercial buildings appear to be present to the east of the subject site, north and south of the intersection between Grant Street and McCormick Street. From the street directories, these are believed to be a garage and service station respectively. |

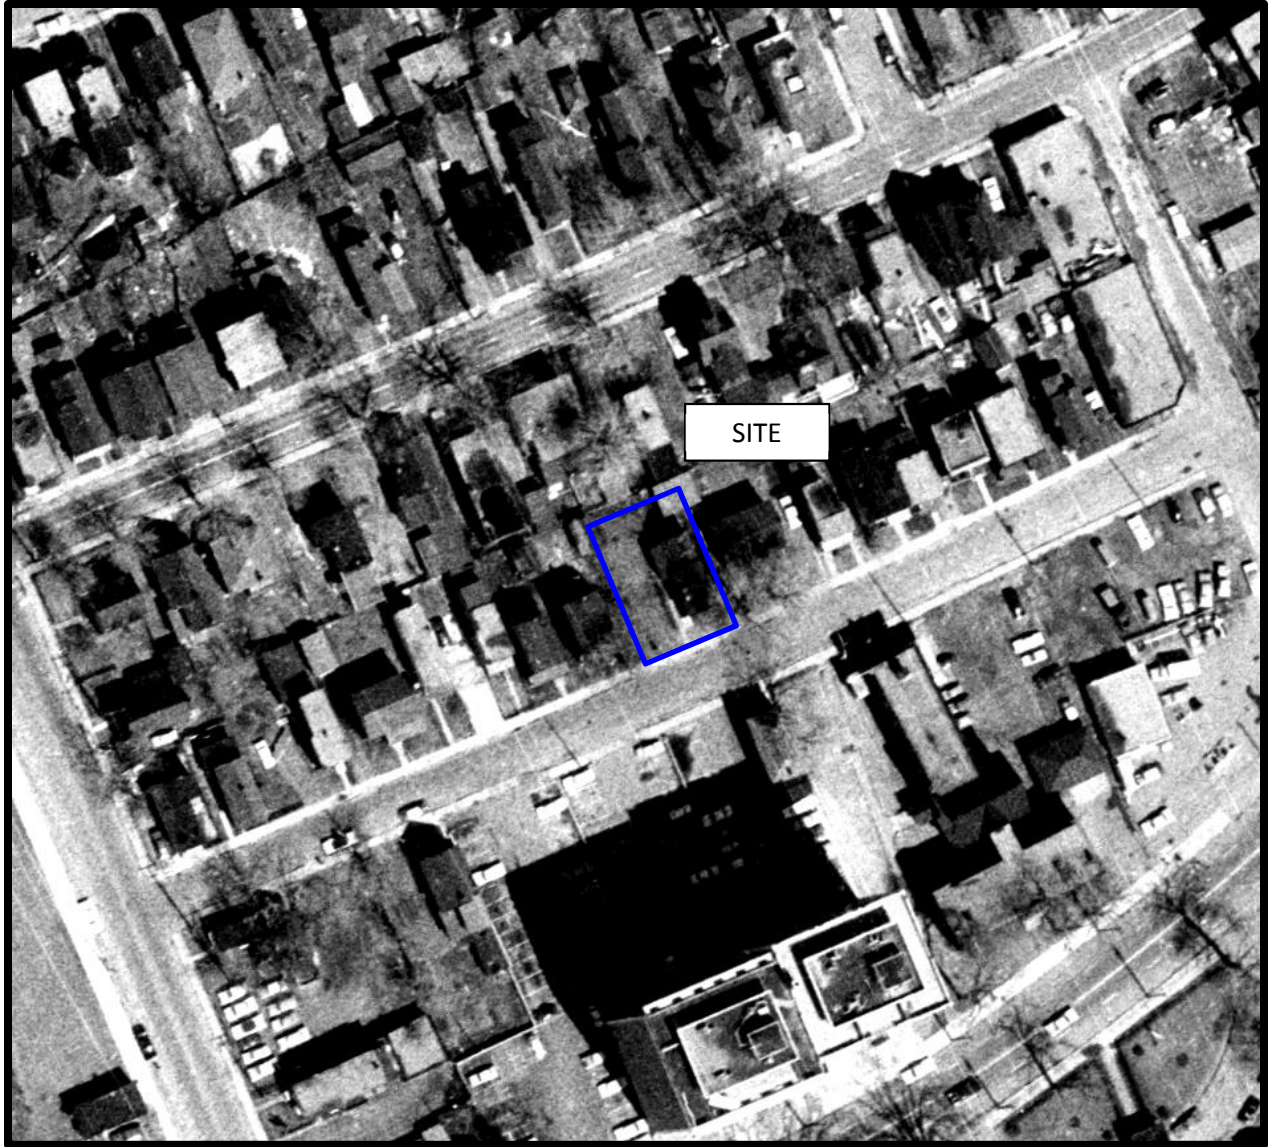
AERIAL PHOTOGRAPH
1965

| 1965 | No significant changes have been made to the subject site. An apartment block was constructed to the south of the site along with a parking lot. |

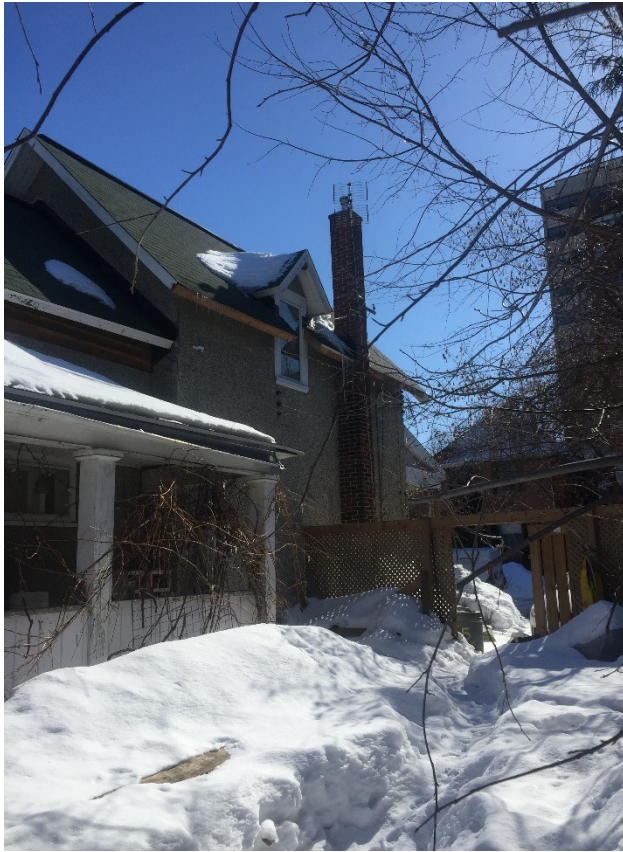
The main building, constructed on a stone foundation and finished with pebble-dash and with a sloped shingled roof, is heated by a natural gas-fired boiler, located in the basement. A metal hatch in the basement suggested the building was historically heated with coal.

Photo 1 – Western elevation of the house facing southeast.

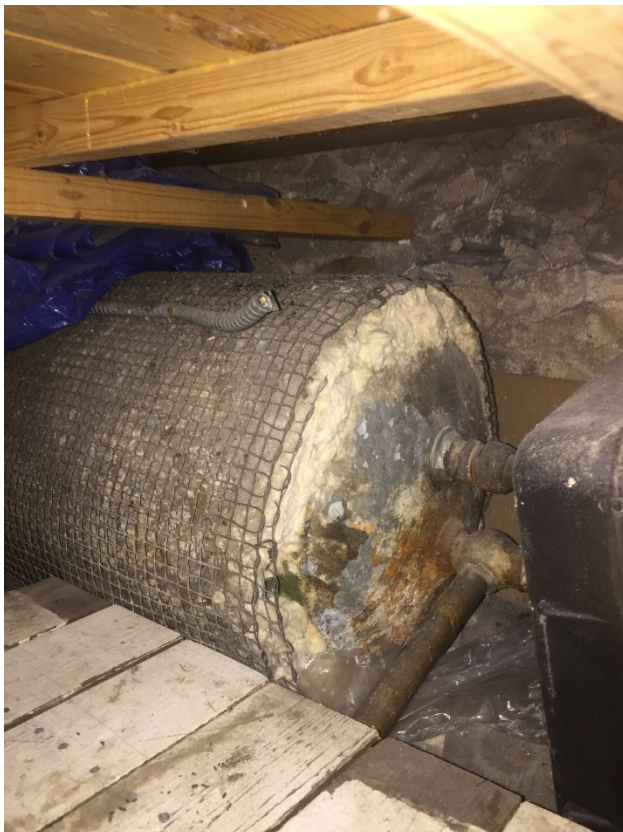
An insulated aboveground storage tank was present in the basement. This tank was likely a historic hot water tank. No fuel tanks or pipework were noted.

Photo 2 – Insulated tank located in the basement.

Based on the age of the subject building, asbestos containing materials (ACMs) are potentially present in the subject structure. The potential ACMs include water tank insulation, drywall joint compound, plaster, vinyl tile and linoleum. Both wall materials and floor coverings in the property were in generally poor condition. An asbestos survey of the building must be conducted in accordance with Ontario

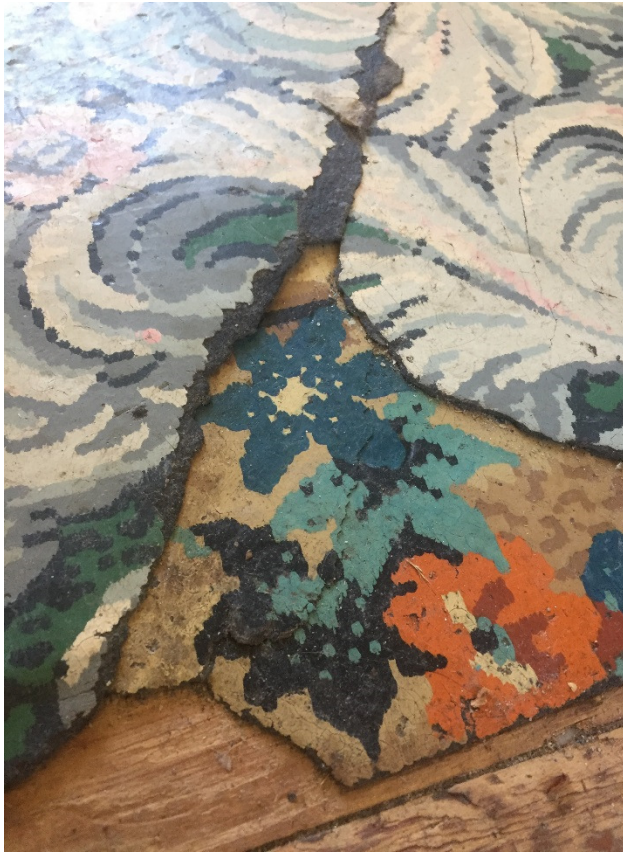
Photo 3 – Linoleum floor coverings in the second floor bedroom.

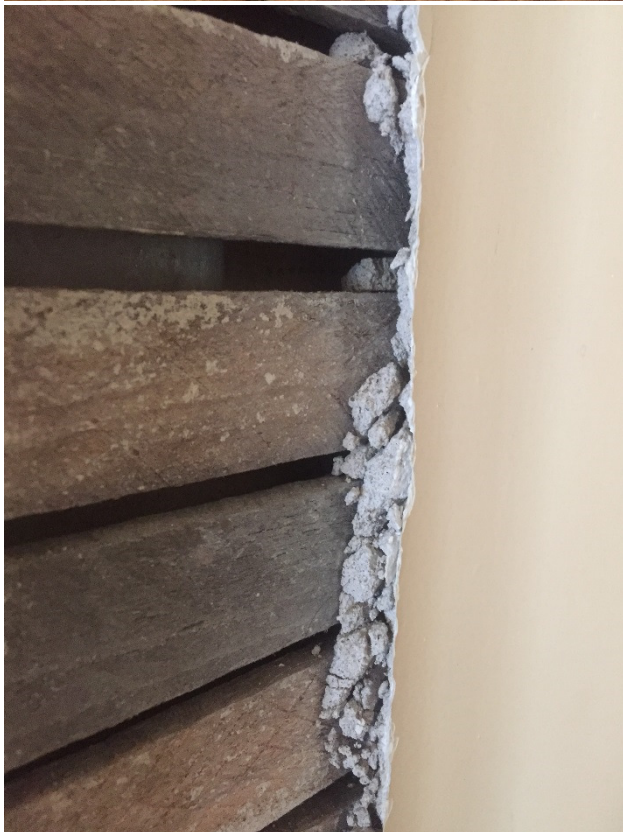
Based on the age of the building there is the potential for lead-based paints to be present. Painted surfaces were generally in poor condition. A survey should be conducted prior to demolition of the building.

Photo 4 – Plaster walls in a poor state of repair.

Lead-based paint may be present beneath more recent non-lead-based paint products on any remaining original surfaces within the building. It is recommended that original paint is tested for lead content prior to its disturbance. Major work involving lead-based paint or other lead containing products must be done in accordance with Ontario Regulation 843, under the Occupational Health and Safety Act.
