## Phase I Environmental Site Assessment

246 Gilmour Street  
Ottawa, Ontario

June 10, 2019

Report: PE4643-1

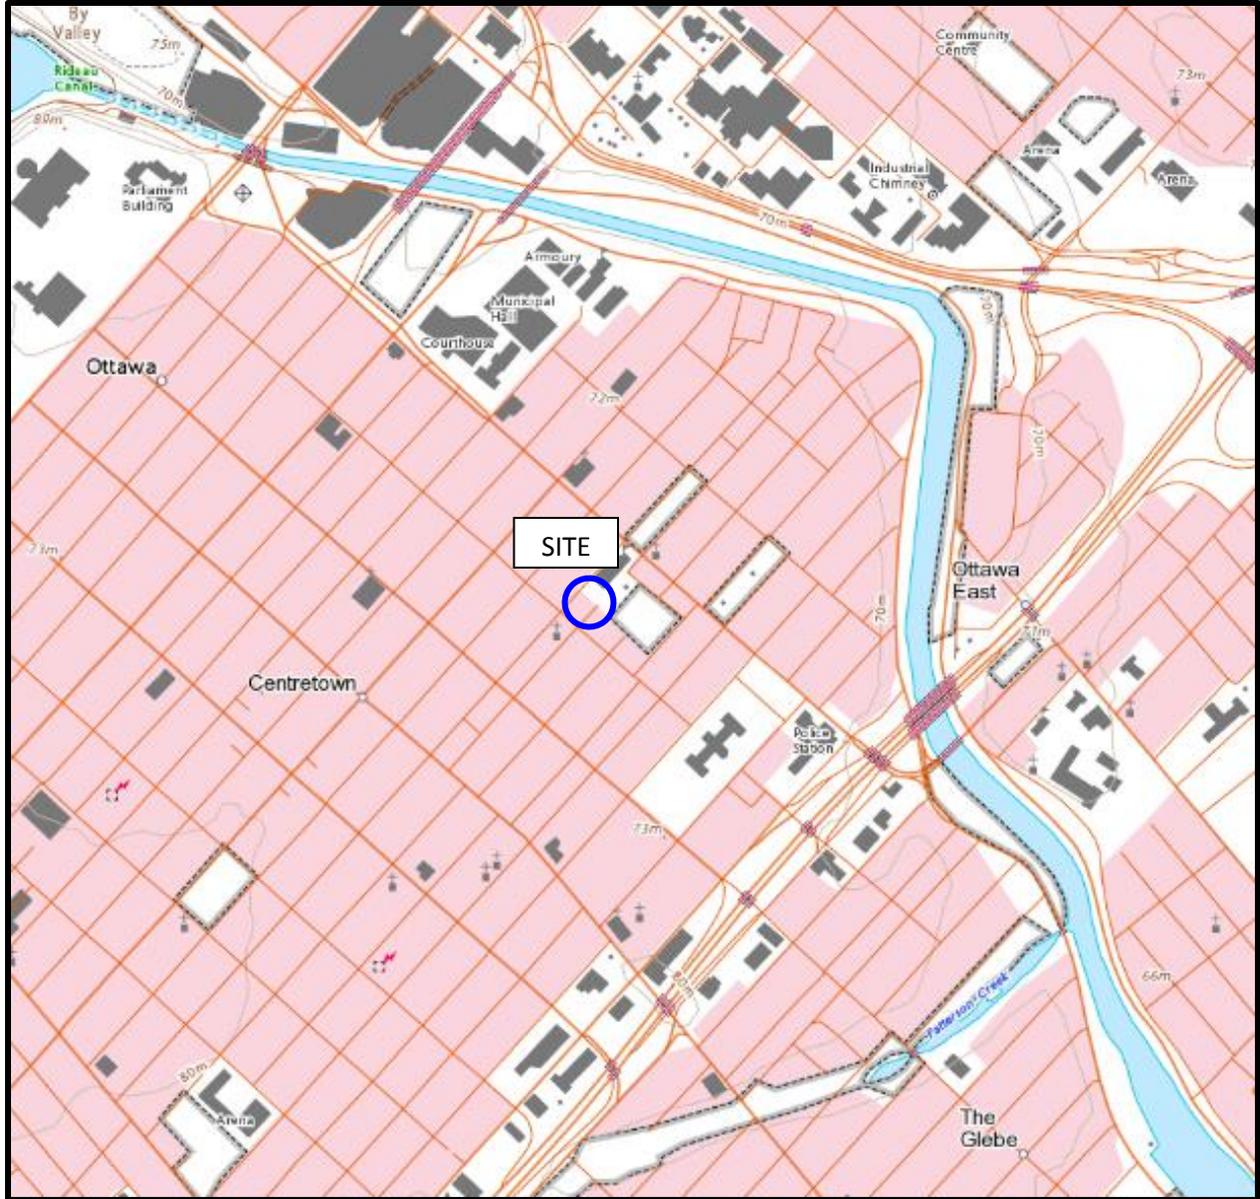
FIGURE 2  
TOPOGRAPHIC MAP

Topographic maps were obtained from Natural Resources Canada – The Atlas of Canada website and from the City of Ottawa website. The topographic maps indicate that the local topography in the immediate vicinity of the site is relatively flat, while the regional topography generally slopes gently downwards in a southeasterly direction.

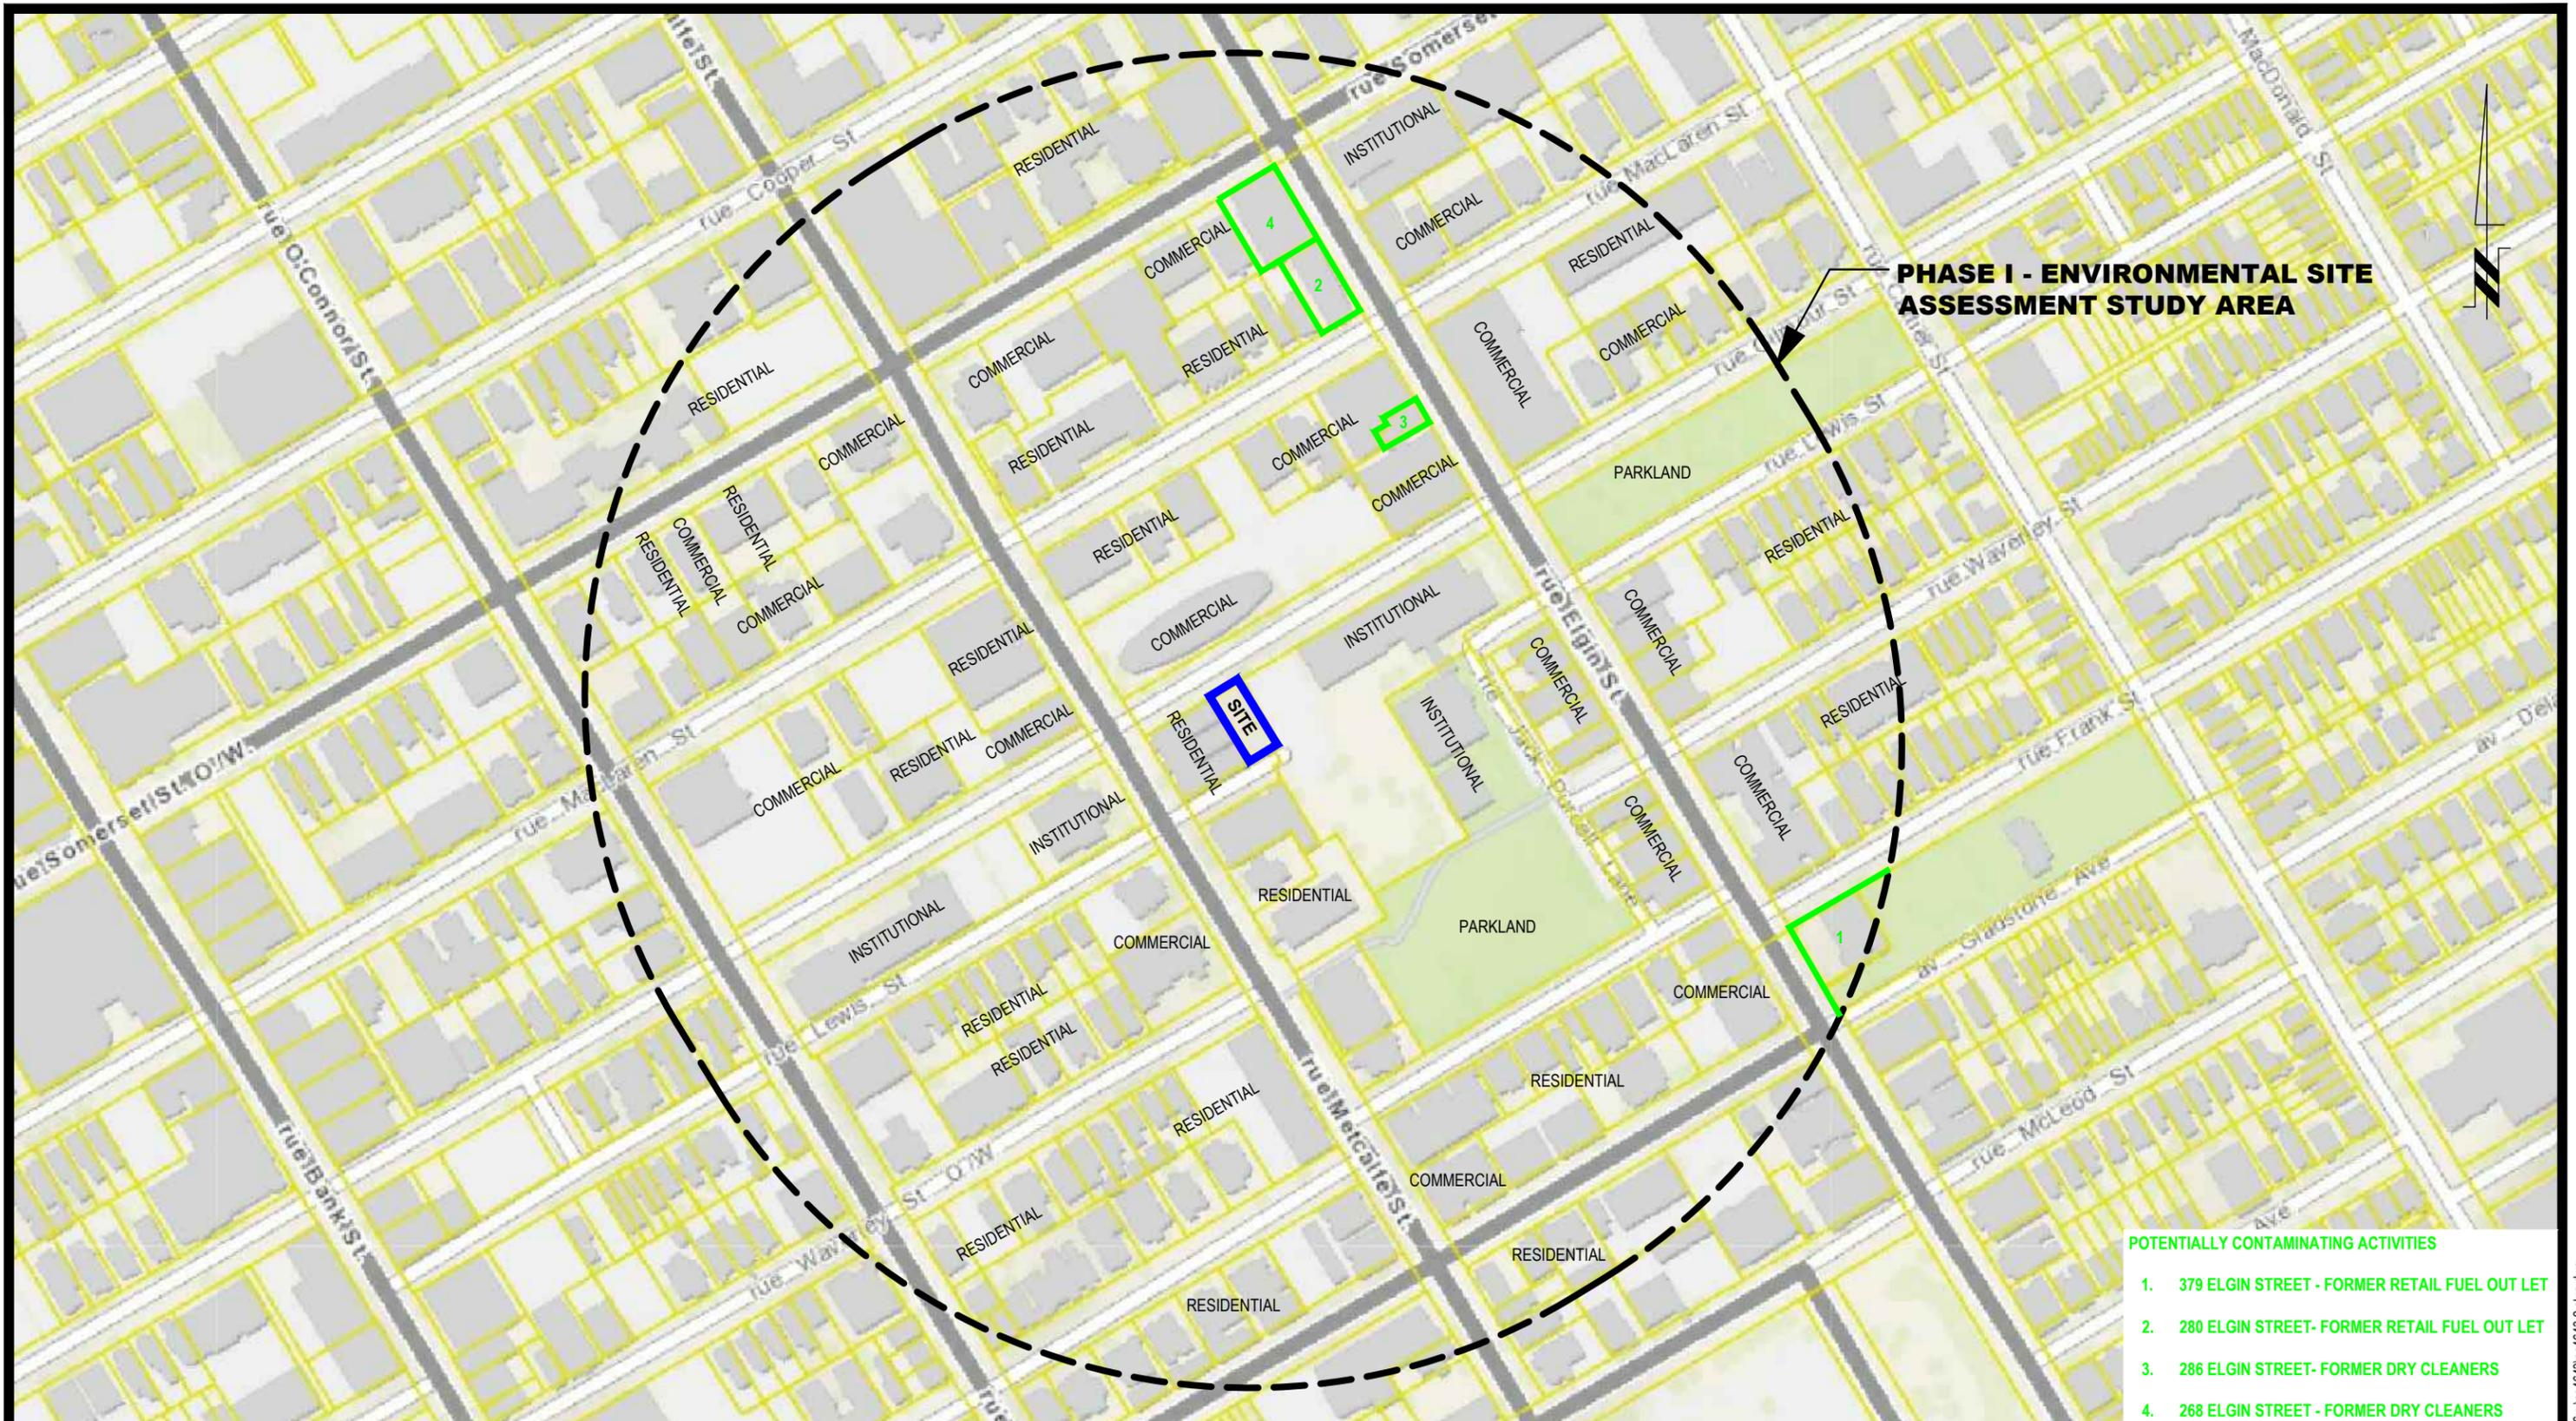
**PHASE I - ENVIRONMENTAL SITE ASSESSMENT STUDY AREA**

- POTENTIALLY CONTAMINATING ACTIVITIES**
- 1. 379 ELGIN STREET - FORMER RETAIL FUEL OUT LET
  - 2. 280 ELGIN STREET - FORMER RETAIL FUEL OUT LET
  - 3. 286 ELGIN STREET - FORMER DRY CLEANERS
  - 4. 268 ELGIN STREET - FORMER DRY CLEANERS

Based on their respective separation distances, these PCAs are not considered to represent areas of potential environmental concern (APECs) on the Phase I Property. PCAs identified in the FIPs review are shown on Drawing PE4643-2 Surrounding Land Use Plan.

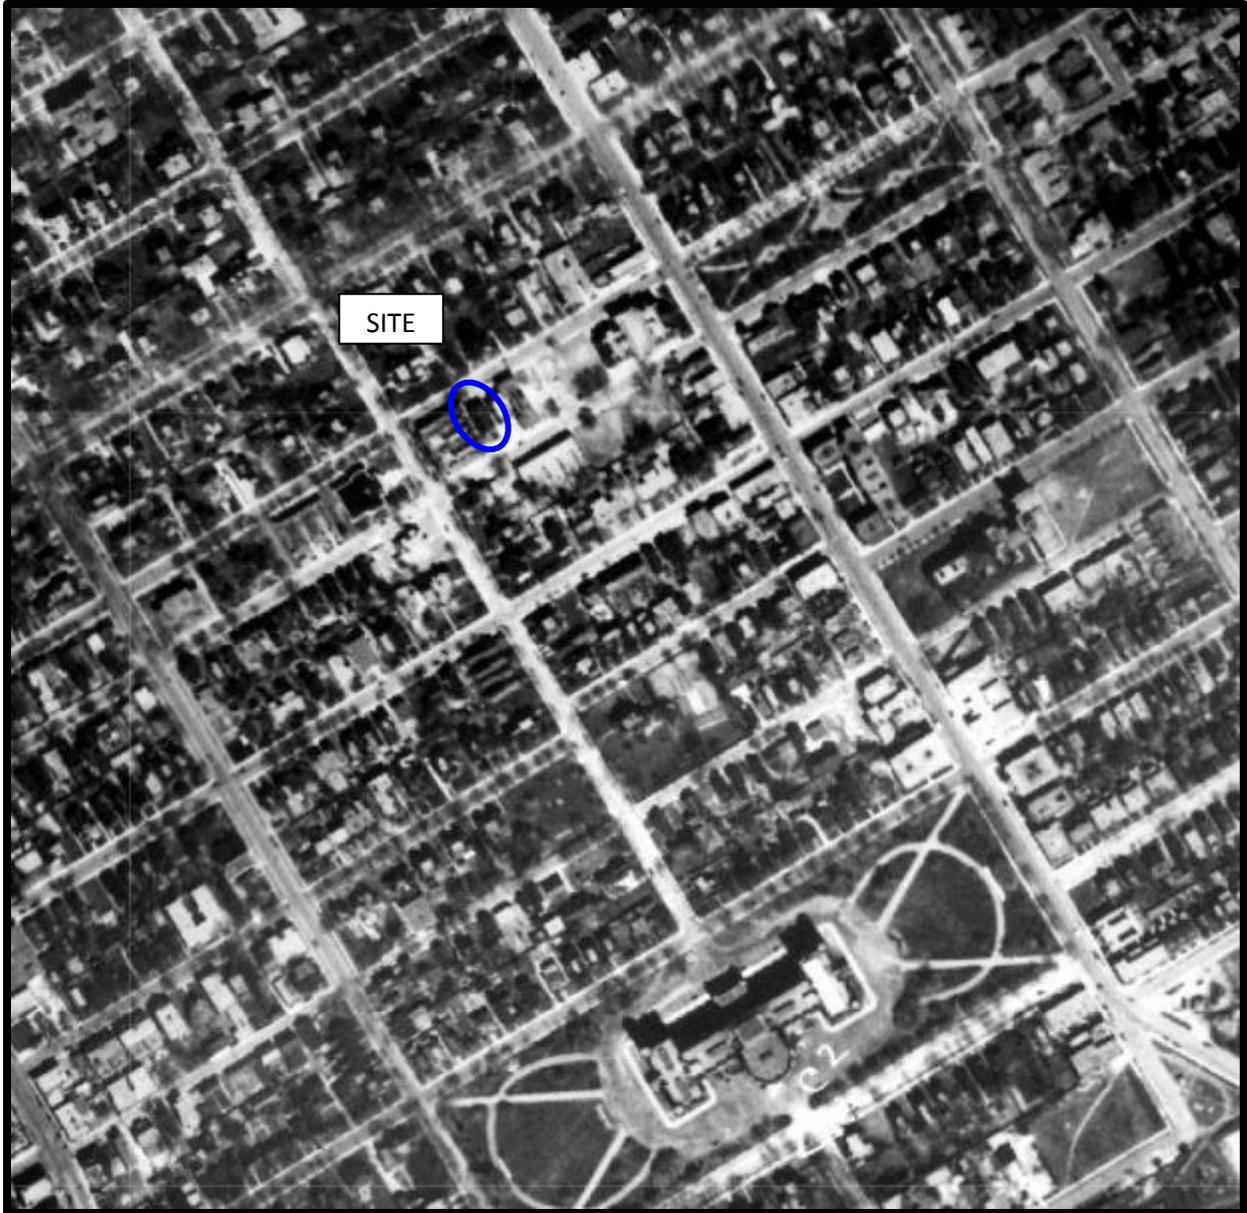
AERIAL PHOTOGRAPH  
1928

| 1928 | The Phase I Property is occupied by a residential building. The area surrounding the subject site is entirely developed with residential and commercial properties. |

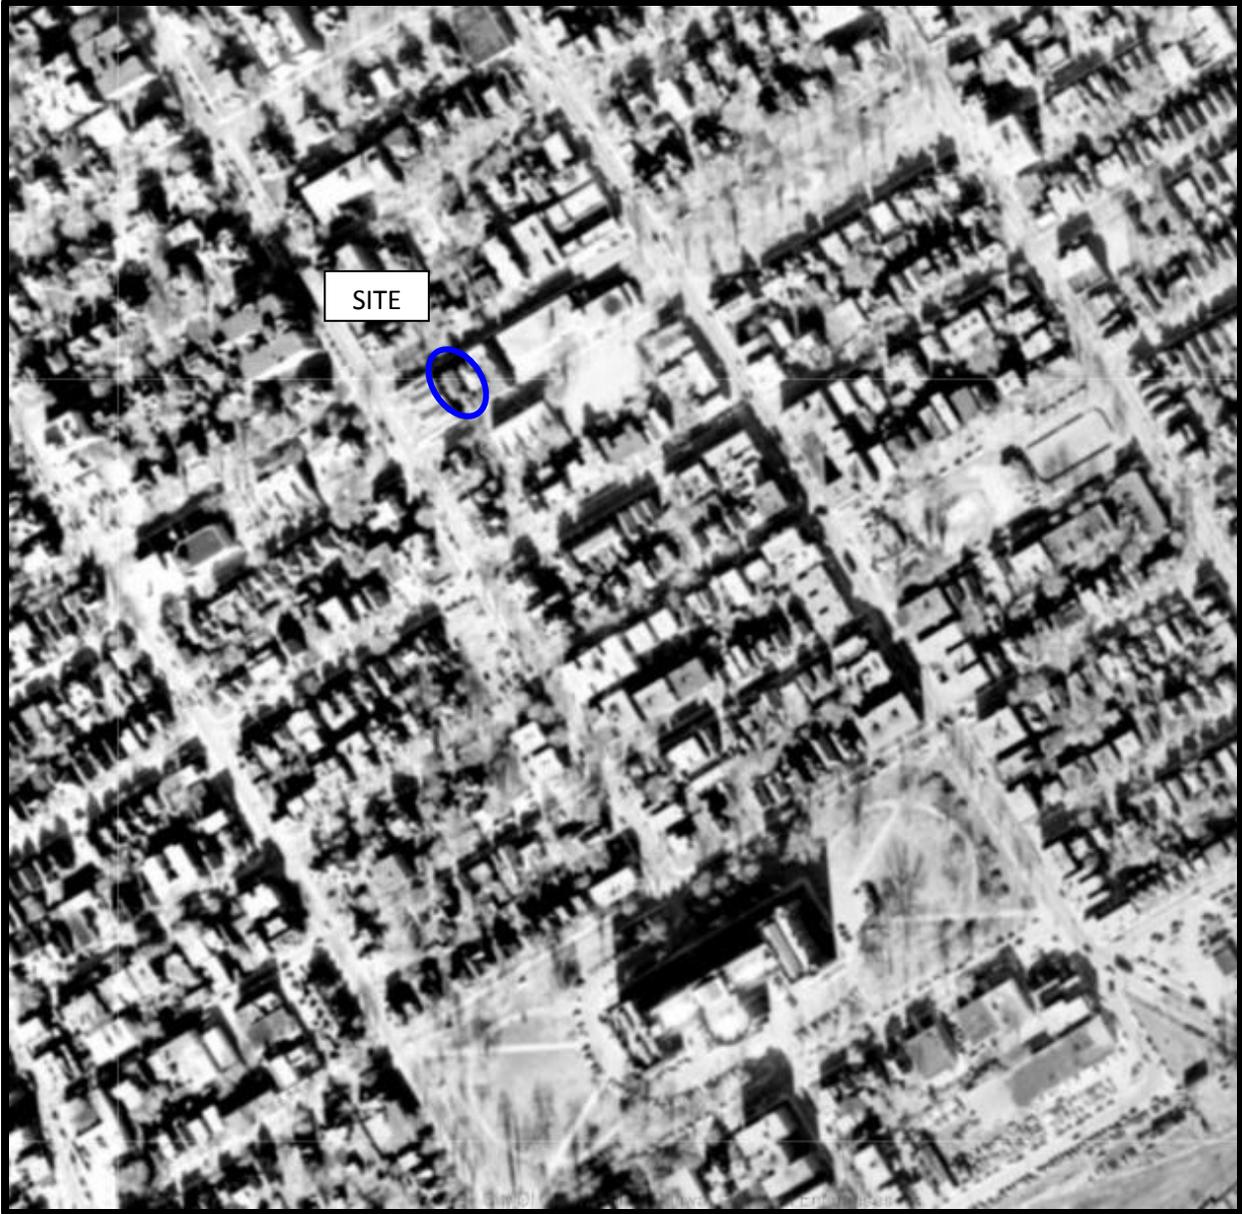
AERIAL PHOTOGRAPH  
1958

| 1958 | No significant changes are apparent on the subject site or the surrounding lands. |

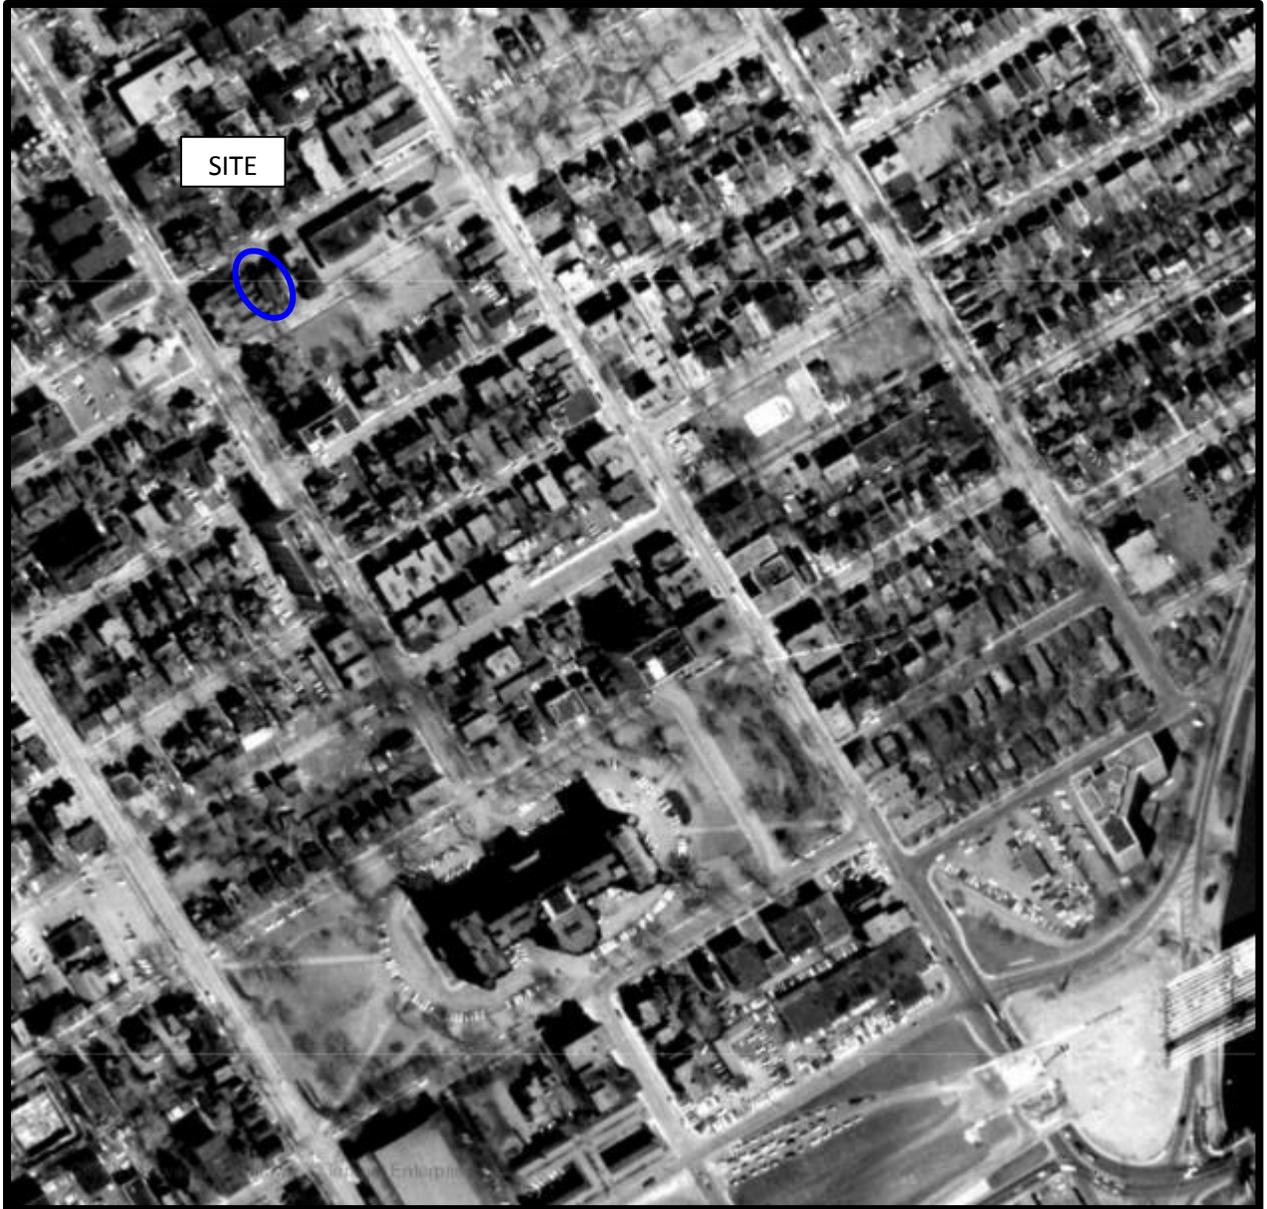
AERIAL PHOTOGRAPH  
1965

| 1965 | The subject site and surrounding lands appear unchanged from the previous photograph. |

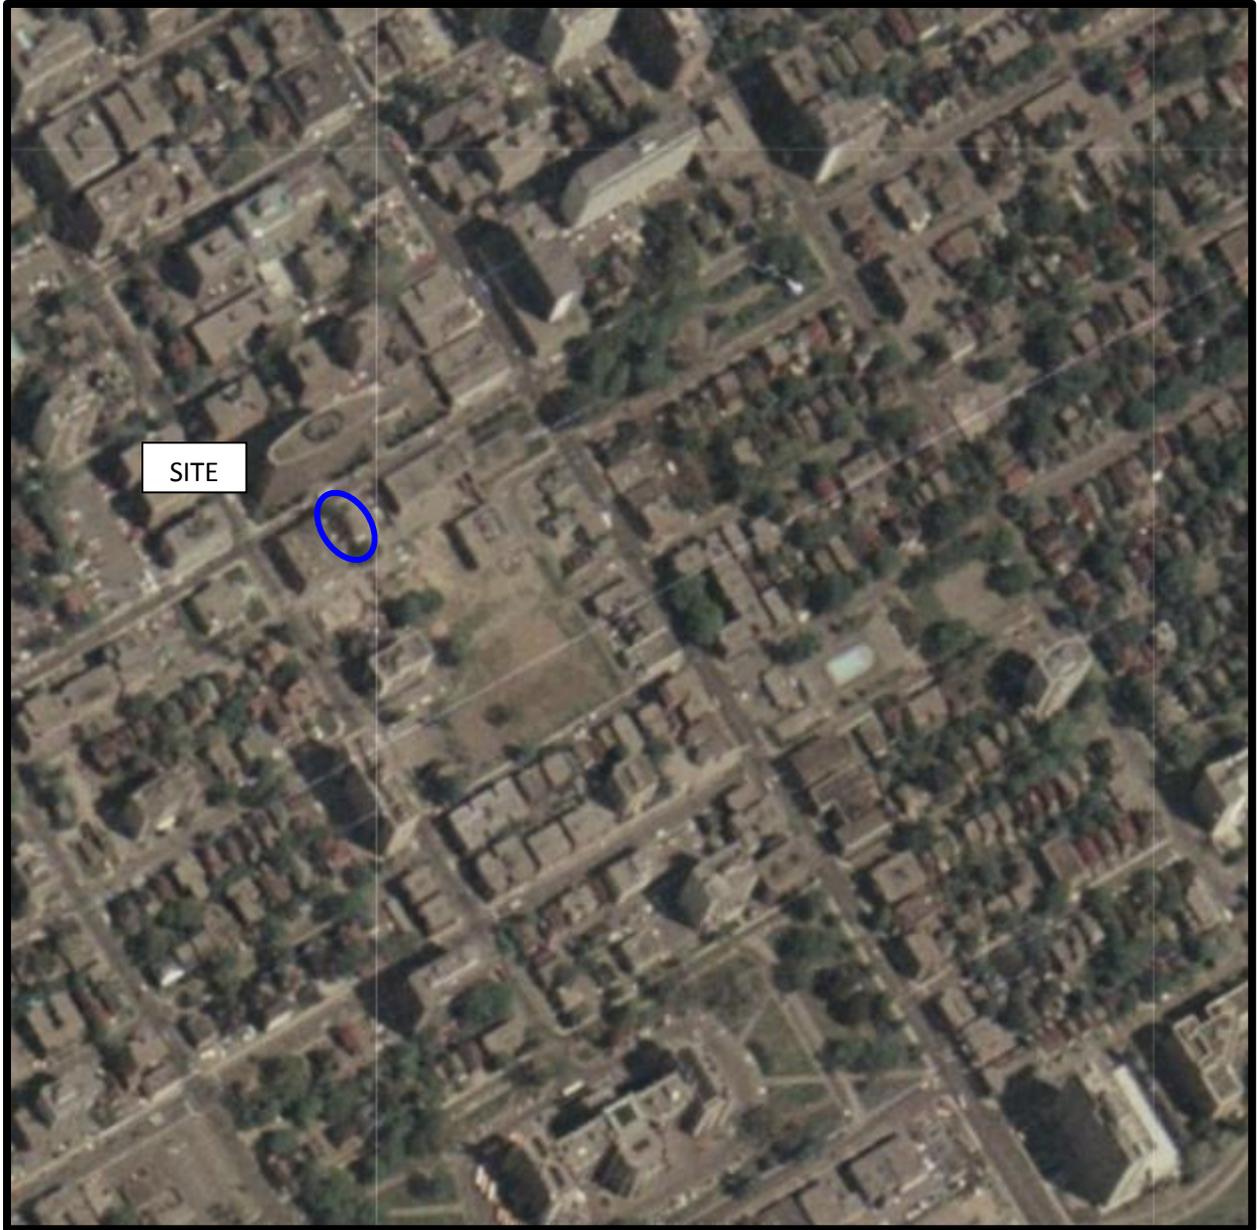
AERIAL PHOTOGRAPH  
1976

| 1976 | The site appears unchanged from the previous photograph. The neighbouring property across Gilmour Street is occupied by a large oval shaped commercial office building at this time. Properties further to the south are now vacant at this time. |

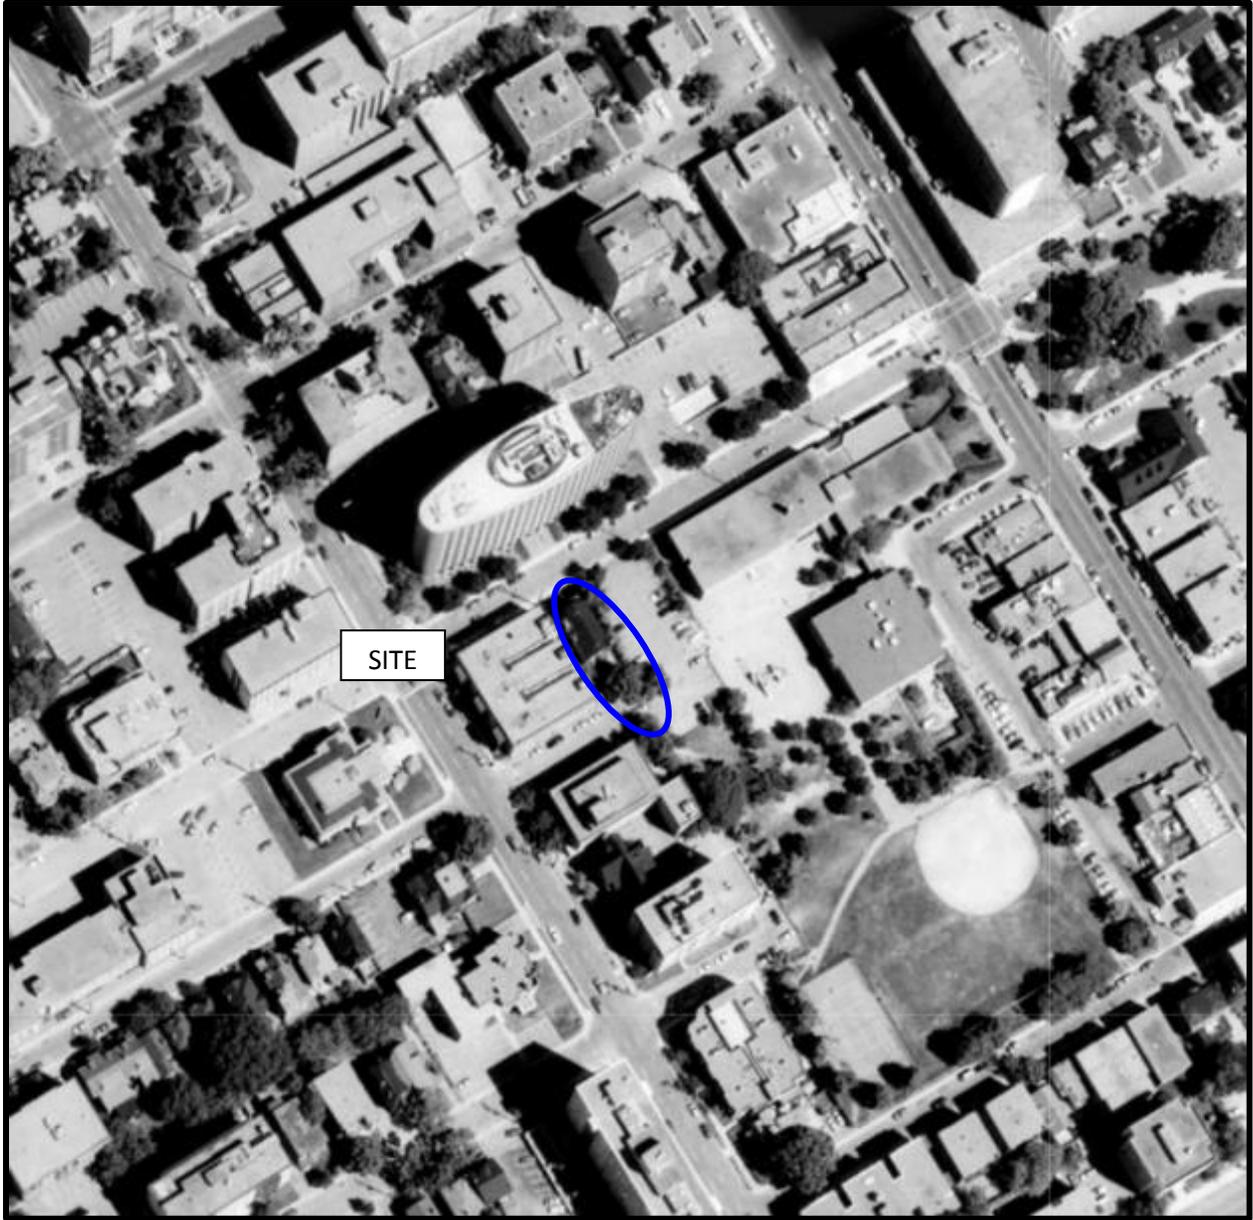
AERIAL PHOTOGRAPH  
1991

| 1991 | No significant changes are apparent on the subject site or neighbouring lands. Properties further to the south are now occupied by a residential apartment building and a baseball field. |

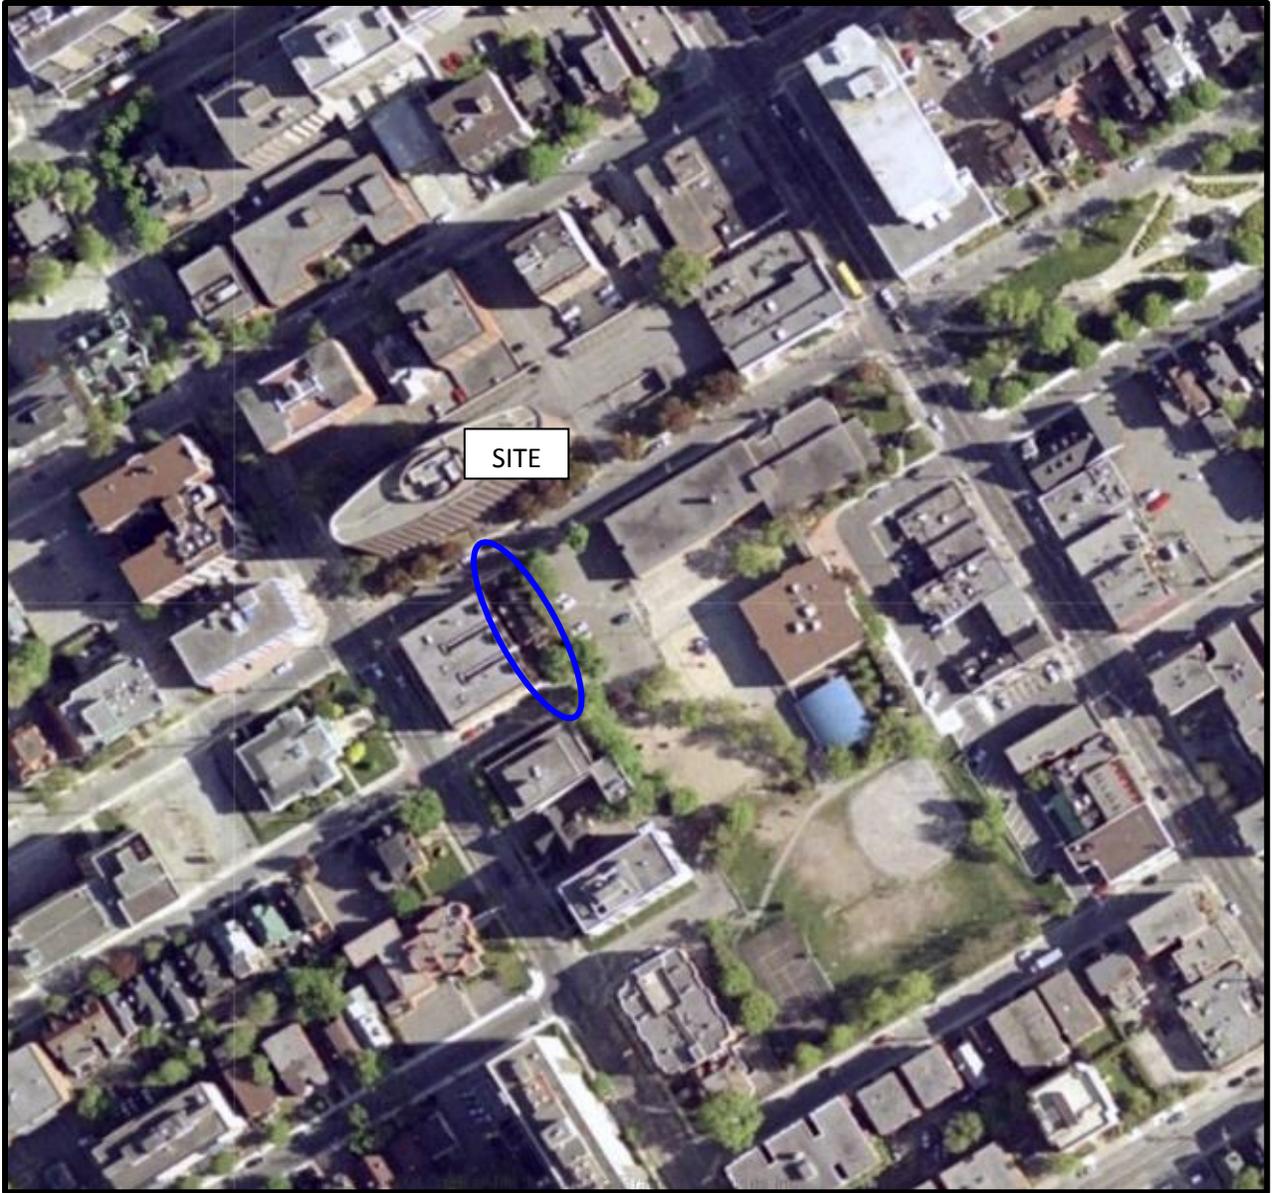
AERIAL PHOTOGRAPH  
2002

| 2002 | The subject site and surrounding lands appear unchanged from the previous photograph. |

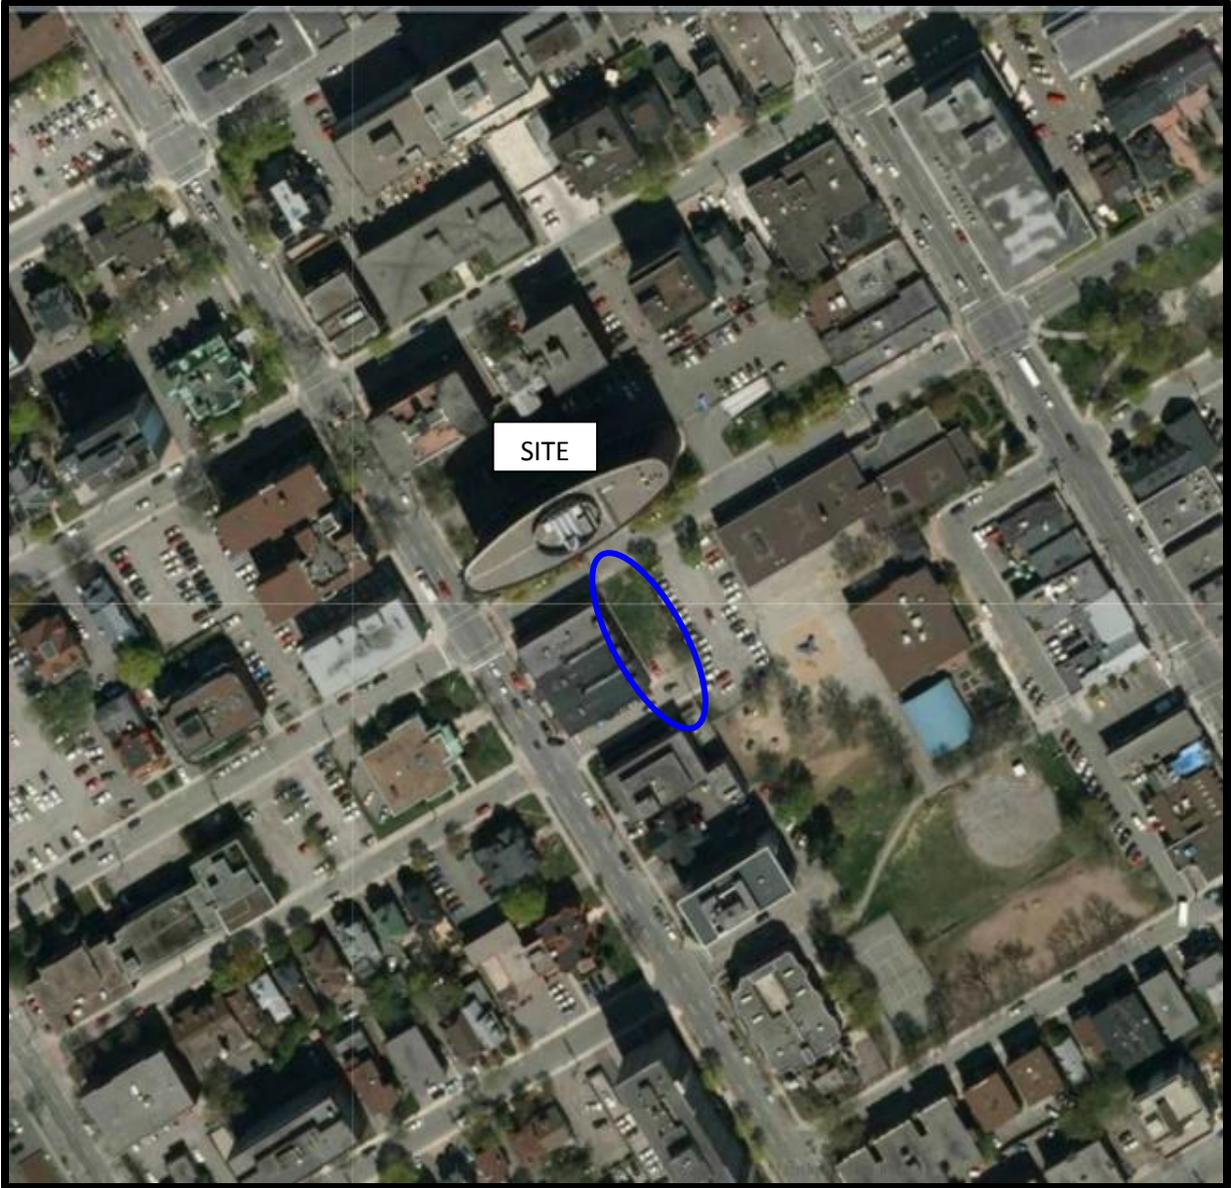
AERIAL PHOTOGRAPH  
2011

| 2011 | The subject site is vacant at this time. No significant changes have been made on the surrounding lands. |

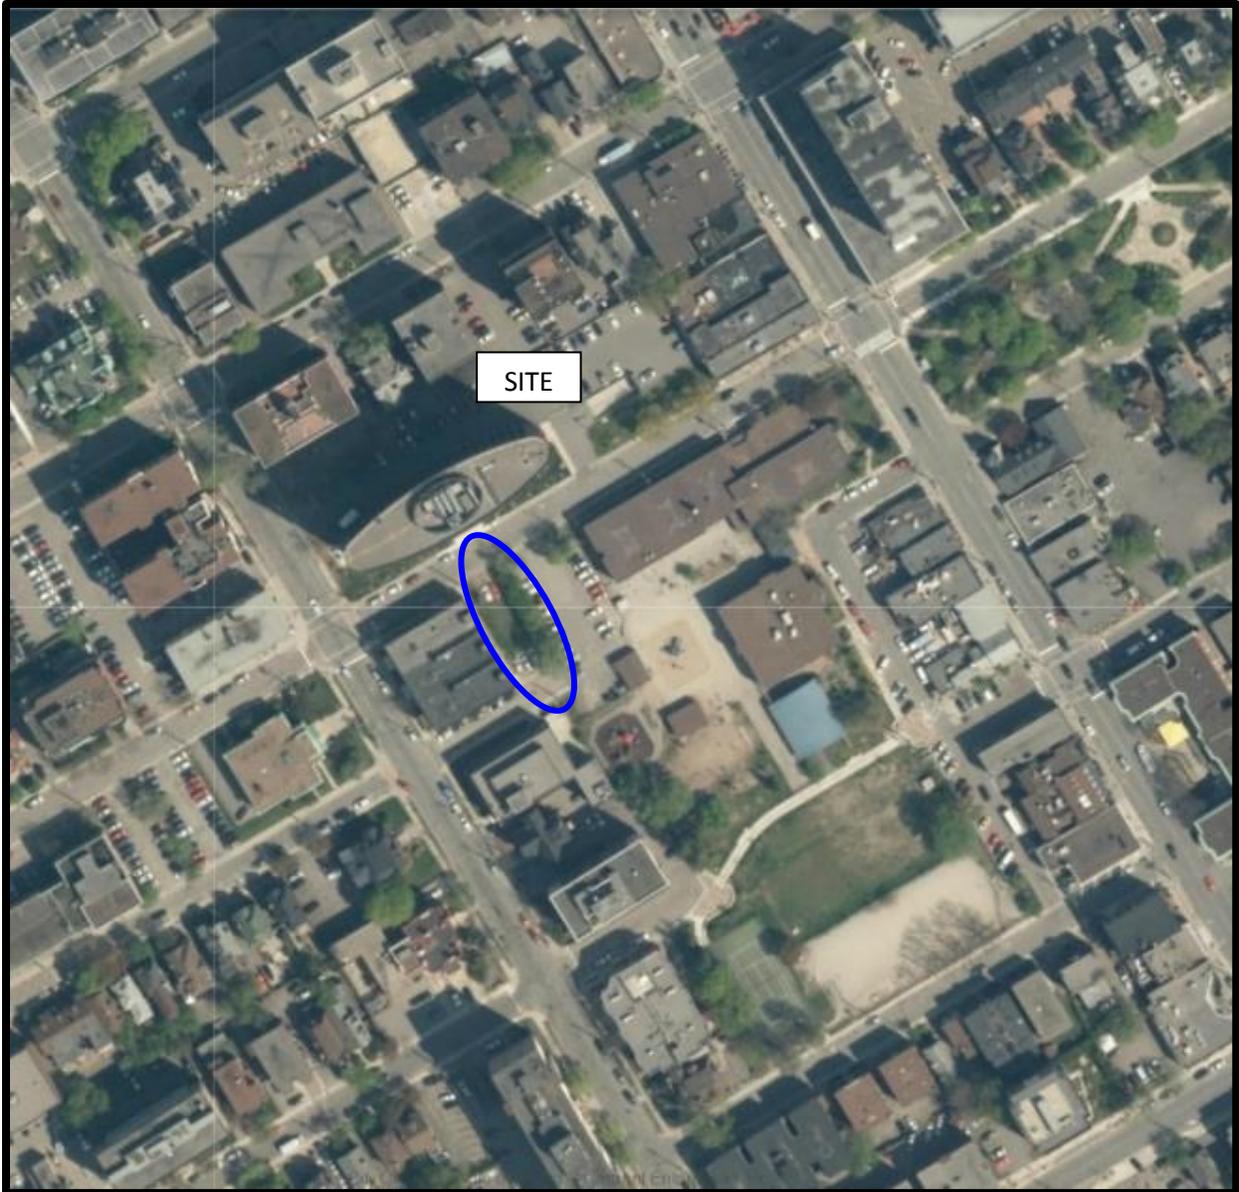
AERIAL PHOTOGRAPH  
2017

| 2017 | The subject site and surrounding lands appear unchanged from the previous photograph. |

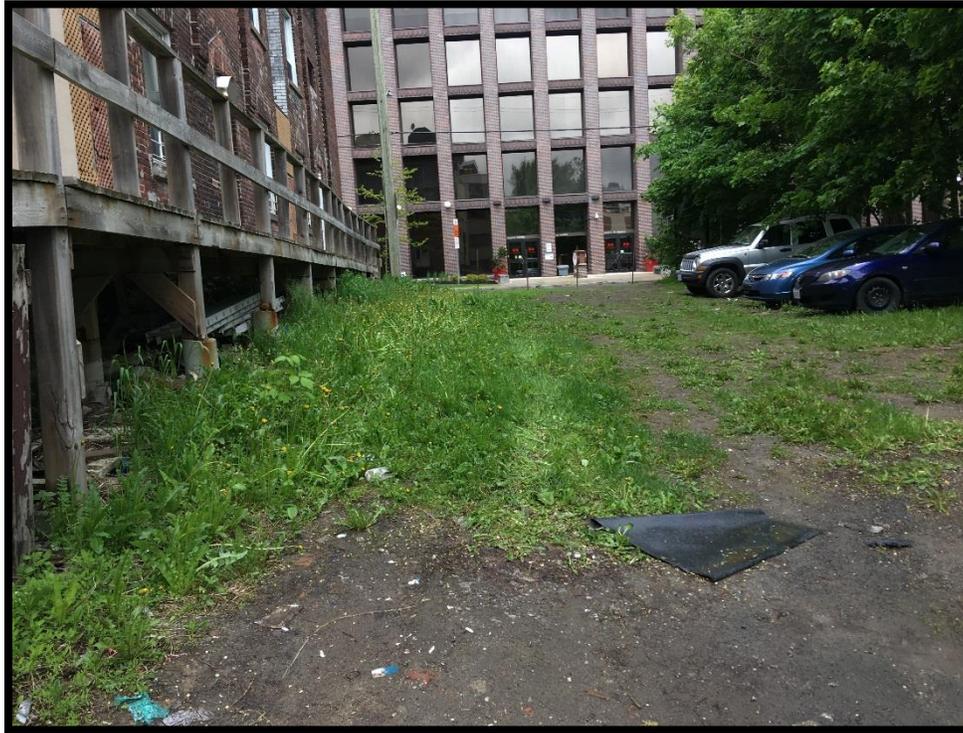
The Phase I Property exists as a vacant lot, mostly grass covered with a small area/patch of an asphaltic paved laneway, fronting Lewis Street, which was the only remaining evidence of a former structure on the subject site. No other structures were noted at the time of the site visit. It was noted at the time of the site visit that vehicles were illicitly parked on the subject site.

Photograph 1: View of the subject site, looking north towards Gilmour Street.

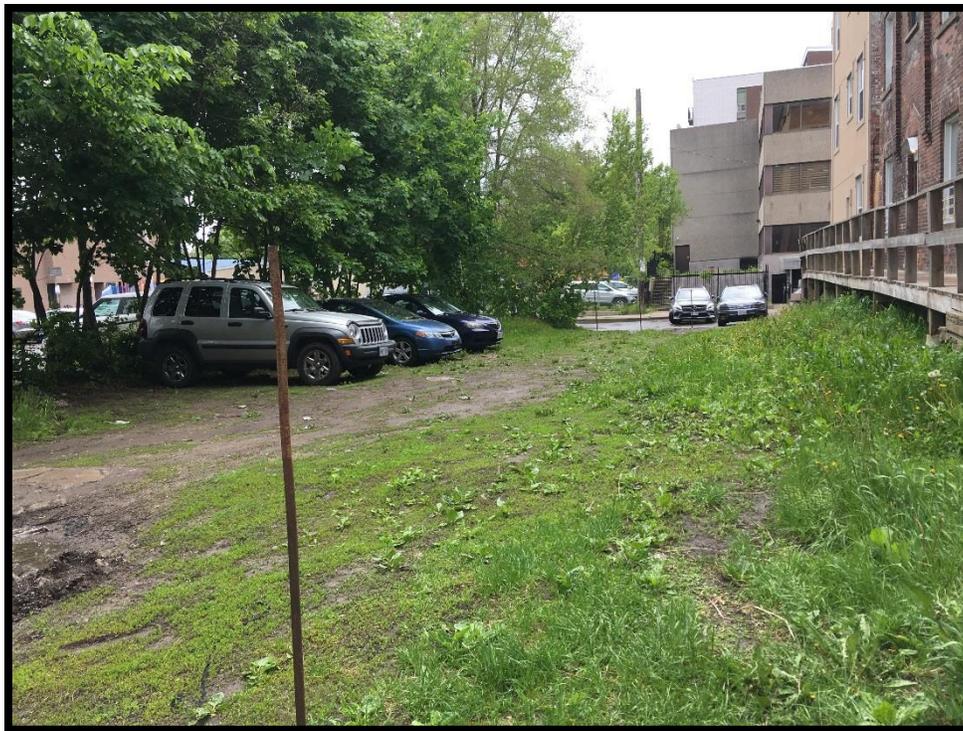
The site appears to be at the grade of Gilmour Street and gradually slopes downwards to Lewis Street. The surface of the site is exposed ground surface with some grass coverage. There were no signs of contamination, discolouration

Photograph 2: View of the subject site, looking south towards Lewis Street.
