# Phase One Environmental Site Assessment

5150 Innes Road  
Ottawa, Ontario

**Crombie REIT**

August 28, 2019

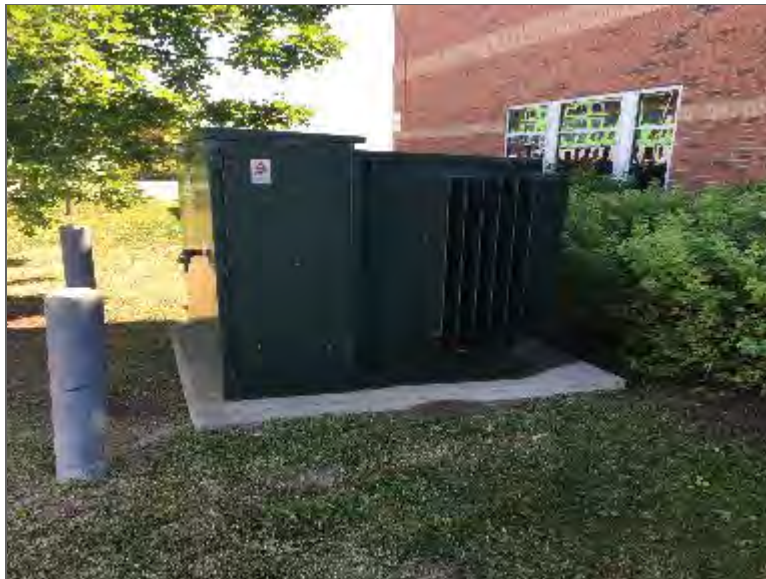
Photo 6 – Pad-mounted oil-cooled transformer located on the northwest portion of the Phase One Property (PCA #1).

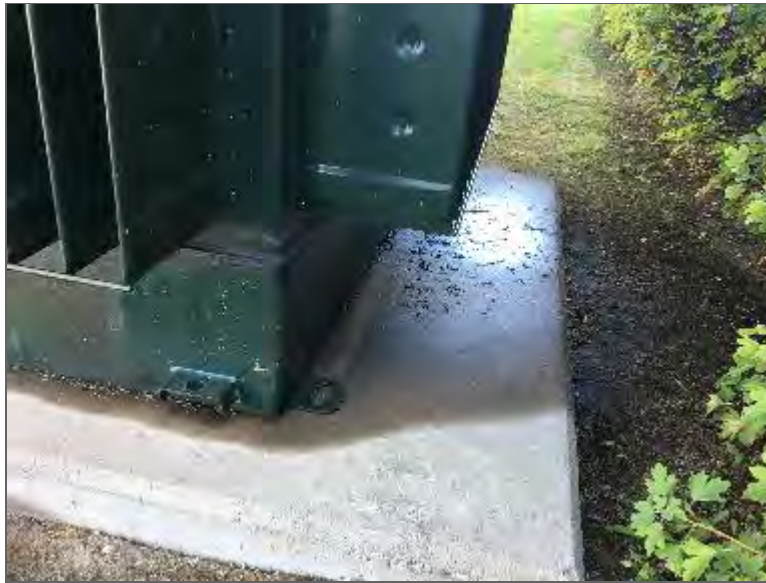
- Dark (likely mineral oil) staining was observed in the vicinity of the pad-mounted oil-cooled transformer located adjacent to the north elevation of Site Building A. The staining appeared to be surficial, and this transformer/staining was addressed as part of the 2019 Hemmera Remedial Excavation Report. Based on the results of this report (refer to Section 4.1.4), it is Pinchin's opinion that this potential environmental concern has been addressed.

Photo 7 – Dark staining observed in the vicinity of the above-noted pad-mounted oil-cooled transformer depicted in Photo 6. It should be noted that this was addressed as part of the 2019 Hemmera Remedial Excavation Report.

The 2019 Hemmera Remedial Excavation Report was completed at the Phase One Property to address a leaking pad-mounted oil-cooled transformer that was observed during Pinchin's Site reconnaissance. The transformer is located exterior to the north elevation of Site Building A, on the northwest portion of the Phase One Property. Pinchin observed and area of dark (likely petroleum hydrocarbon (PHC)) staining in the vicinity of the transformer.

- The faulty transformer was reported by the Client to Hydro One Networks Inc. on September 3, 2019, and the transformer was immediately replaced;
- Approximately 100-L of mineral insulating oil was estimated to have leaked from the transformer and onto the bare ground soil;
- Approximately 3,500-L of PHC-impacted soil slurry was removed from the Phase One Property, and subsequently disposed of at an MECP-licensed facility. The soils encountered in the excavation consisted of medium/fine grained sand and silt and coarse-grained limestone screenings, with concrete at the base of the excavation;

- A total of three soil verification samples (south, east and west walls of the excavation) were collected/submitted for laboratory analysis of PHCs in the carbon fractions F1 to F4. The analytical results were compared to Table 2 (commercial land use in a potable water condition with medium/fine textured soils) of the MECP guidelines, as outlined in their document entitled "*Soil, Groundwater and Sediment Standards for Use Under Part XV.1 of the Environmental Protection Act*", and dated April 15, 2011 (2011 Table 2 Standards). All soil samples satisfied the 2011 Table 2 Standards and as such, no further environmental work was recommended.

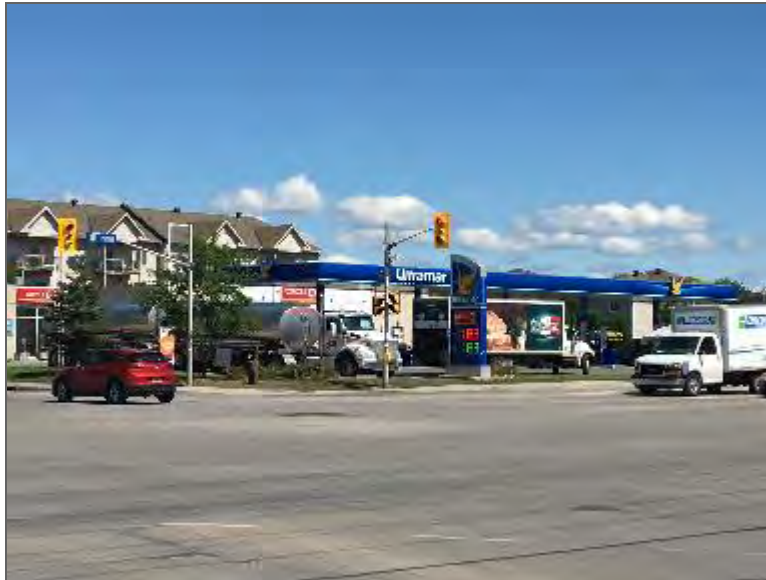
Photo 9 – RFO located northeast of the Phase One Property (PCA #2).

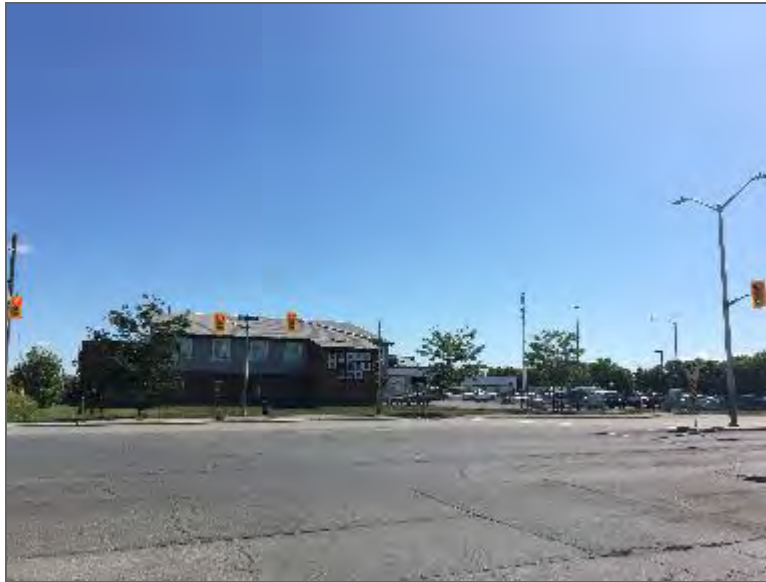
- A PFO was observed approximately 85 m southeast of the Phase One Property in the 1991 and 2002 aerial photographs. This property is situated hydraulically transgradient in relation to the inferred groundwater flow direction from the Phase One Property. Based on the distance between the PFO and the Phase One Property, as well as the inferred groundwater flow direction, it is Pinchin's opinion that this property is unlikely to result in potential subsurface impacts at the Phase One Property; and

Photo 11 – Property located southeast of the Phase One Property, where the PFO was formerly located (PCA #3).
