BRIGHTPATH EARLY LEARNING & CHILD CARE

**PHASE TWO
ENVIRONMENTAL SITE ASSESSMENT**

90 MAPLE GROVE ROAD, OTTAWA, ONTARIO

FINAL REPORT

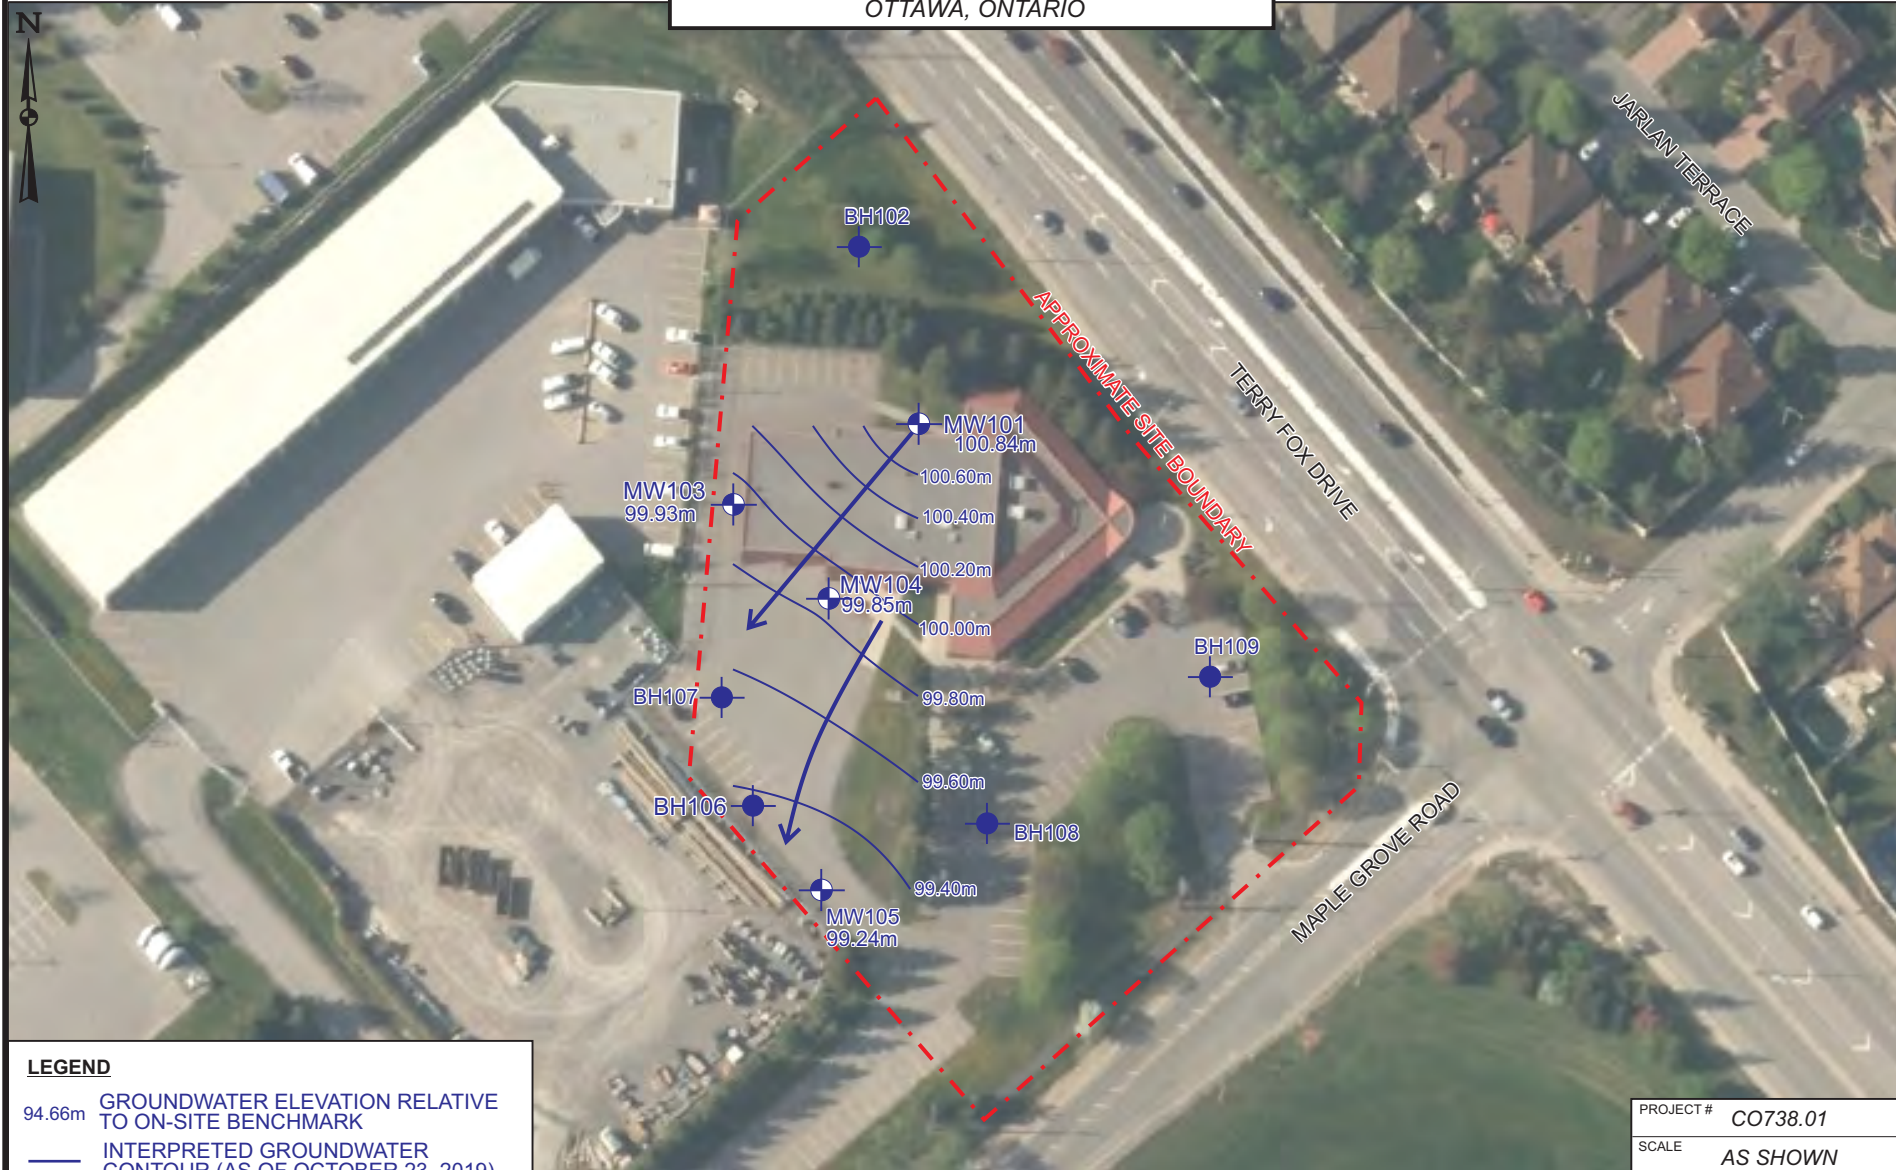
PROJECT #	CO738.01		
SCALE	AS SHOWN		
DATE	DECEMBER 2019		
DRAWN	AB	CHECKED	GS/ KB
DRAWING #	FIGURE 9

Depth to Water Table: Monitoring data is shown on Table 1. Depths to groundwater in the monitoring wells measured on October 23, 2019 were 1.60 m (MW105), 1.95 m (MW101), 2.13 m (MW103) and 2.16 m (MW104) from ground surface. Monitoring data is shown on Table 1. No evidence of either LNAPL or DNAPL was observed during monitoring, purging, or sampling of the monitoring wells during the Phase Two ESA work program.

- 94.66m GROUNDWATER ELEVATION RELATIVE TO ON-SITE BENCHMARK
- INTERPRETED GROUNDWATER CONTOUR (AS OF OCTOBER 23, 2019)
- ➔ GROUNDWATER FLOW DIRECTION
- ⊙ MONITORING WELL (TERRAPEX, 2019)
- BOREHOLE (TERRAPEX, 2019)

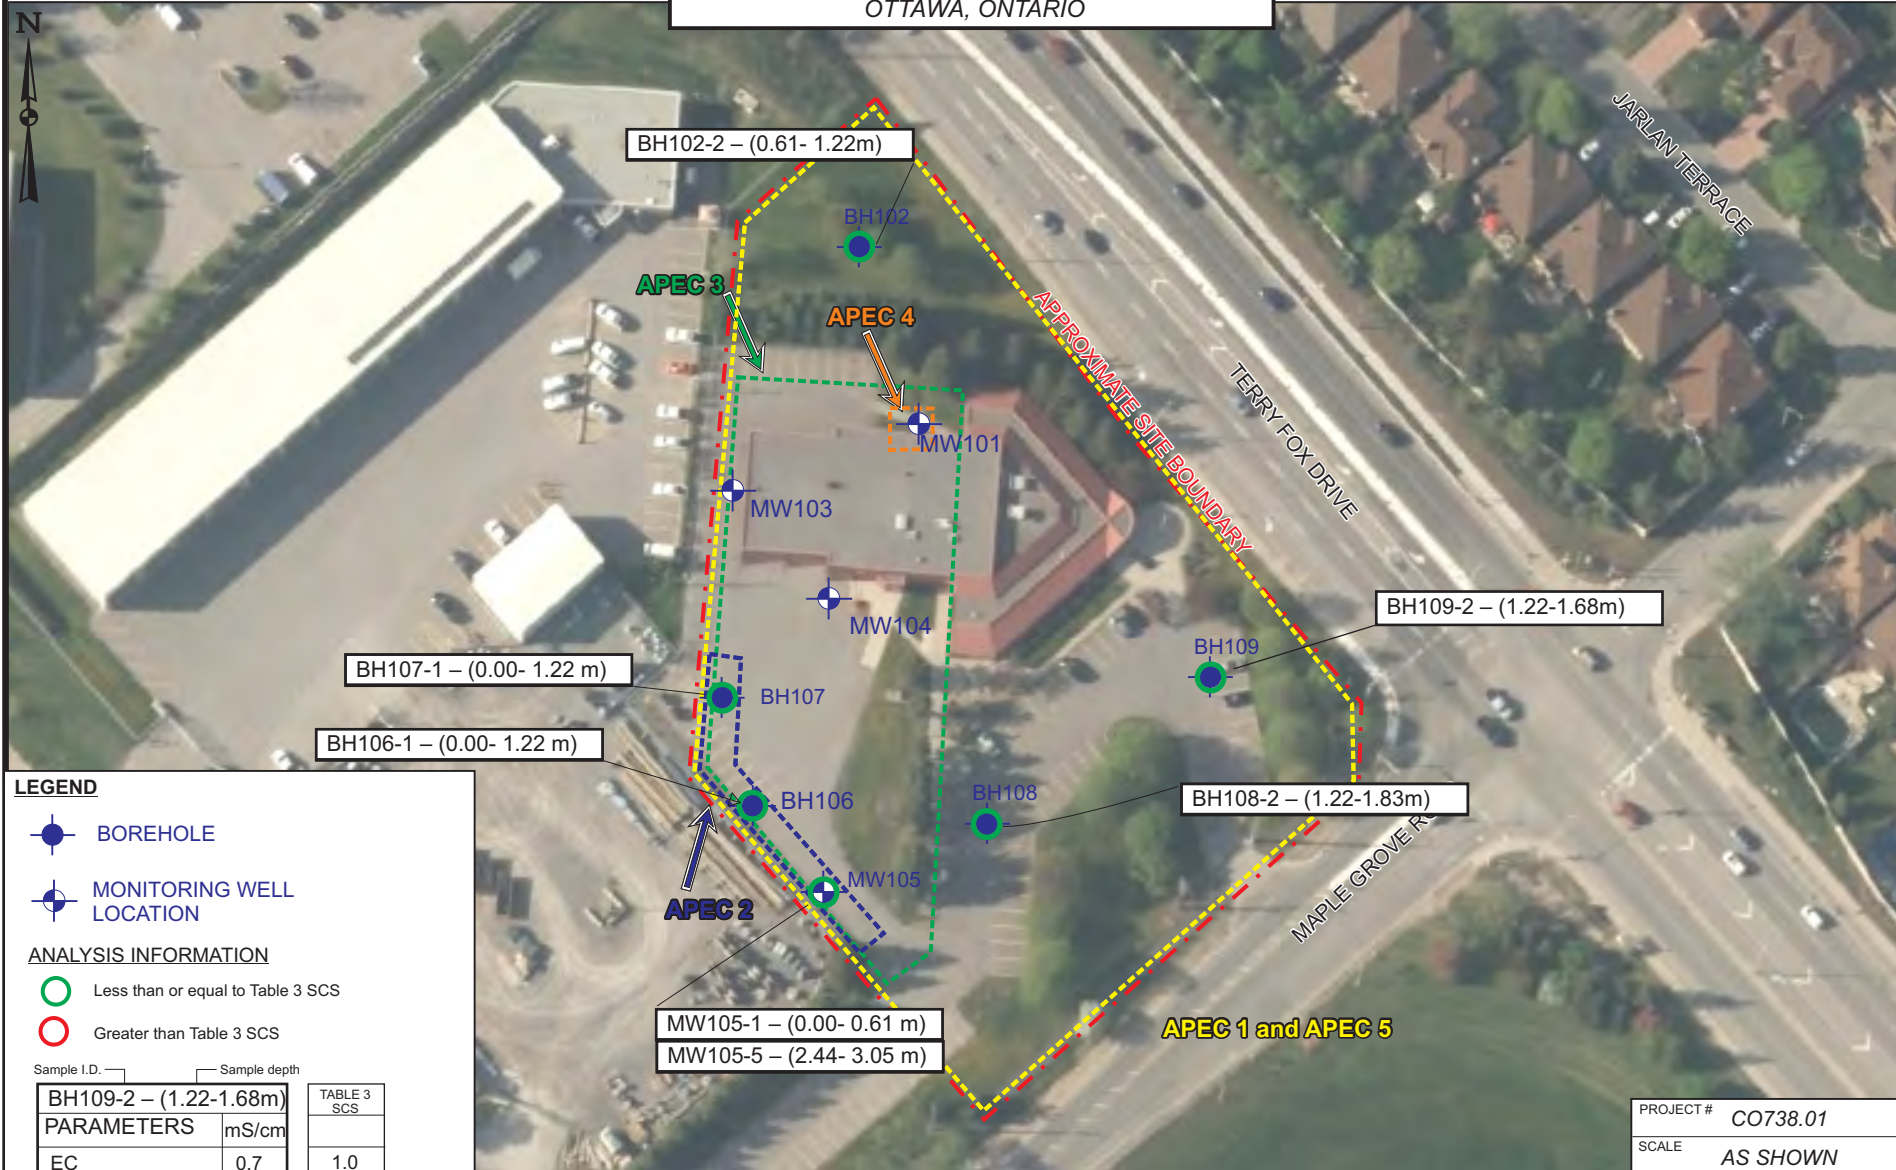
PROJECT #	CO738.01
SCALE	AS SHOWN
DATE	DECEMBER 2019
DRAWN	AB
CHECKED	GS/ KB
DRAWING #	FIGURE 17

NOTE: BH109-2 IS DEEMED NOT TO EXCEED THE TABLE 3 SCS IN ACCORDANCE WITH SECTION 49.1 OF O.REG. 153/04

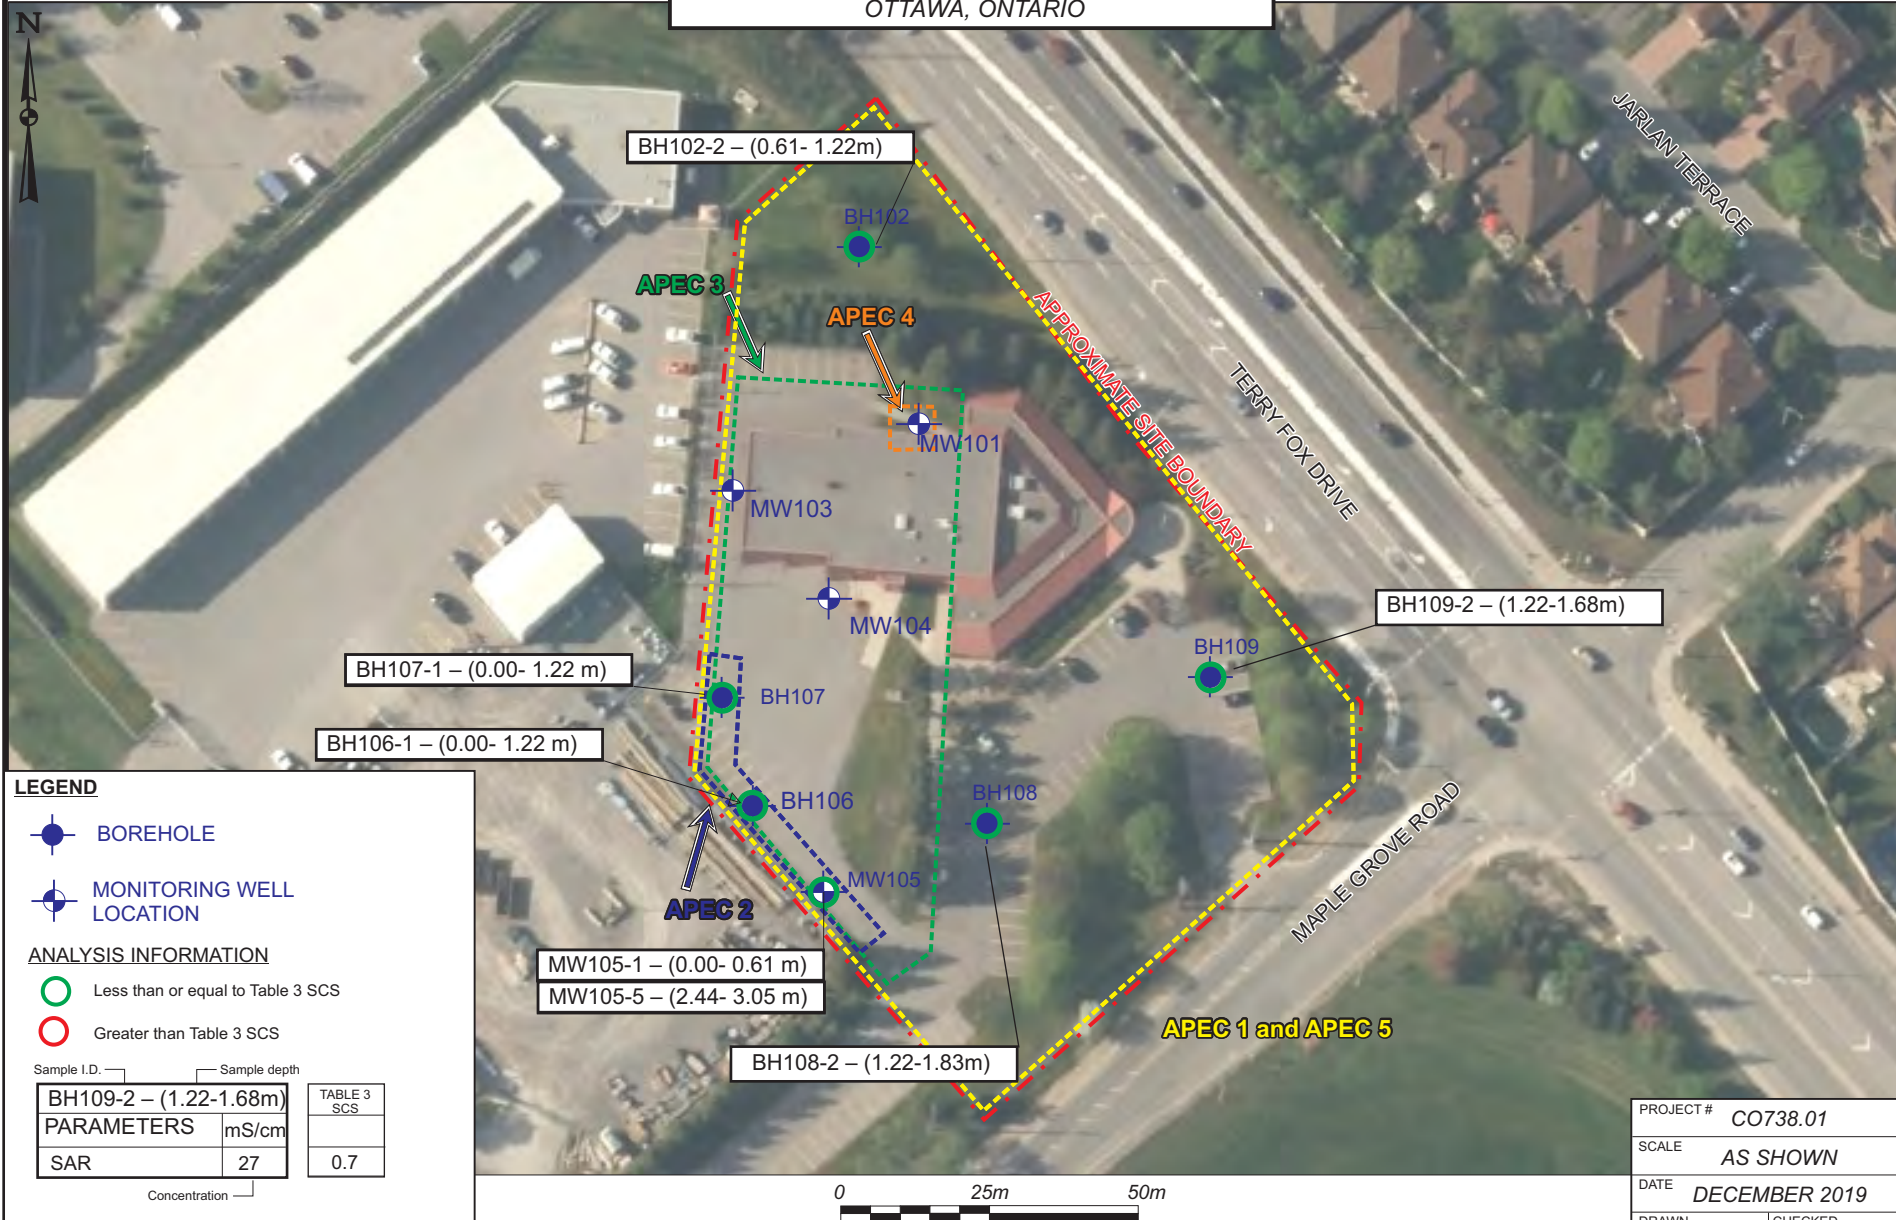
PROJECT #	CO738.01
SCALE	AS SHOWN
DATE	DECEMBER 2019
DRAWN	AB
CHECKED	GS/ KB
DRAWING #	FIGURE 18

NOTE: BH108-2 AND BH109-2 ARE DEEMED NOT TO EXCEED THE TABLE 3 SCS IN ACCORDANCE WITH SECTION 49.1 OF O.REG. 153/04.

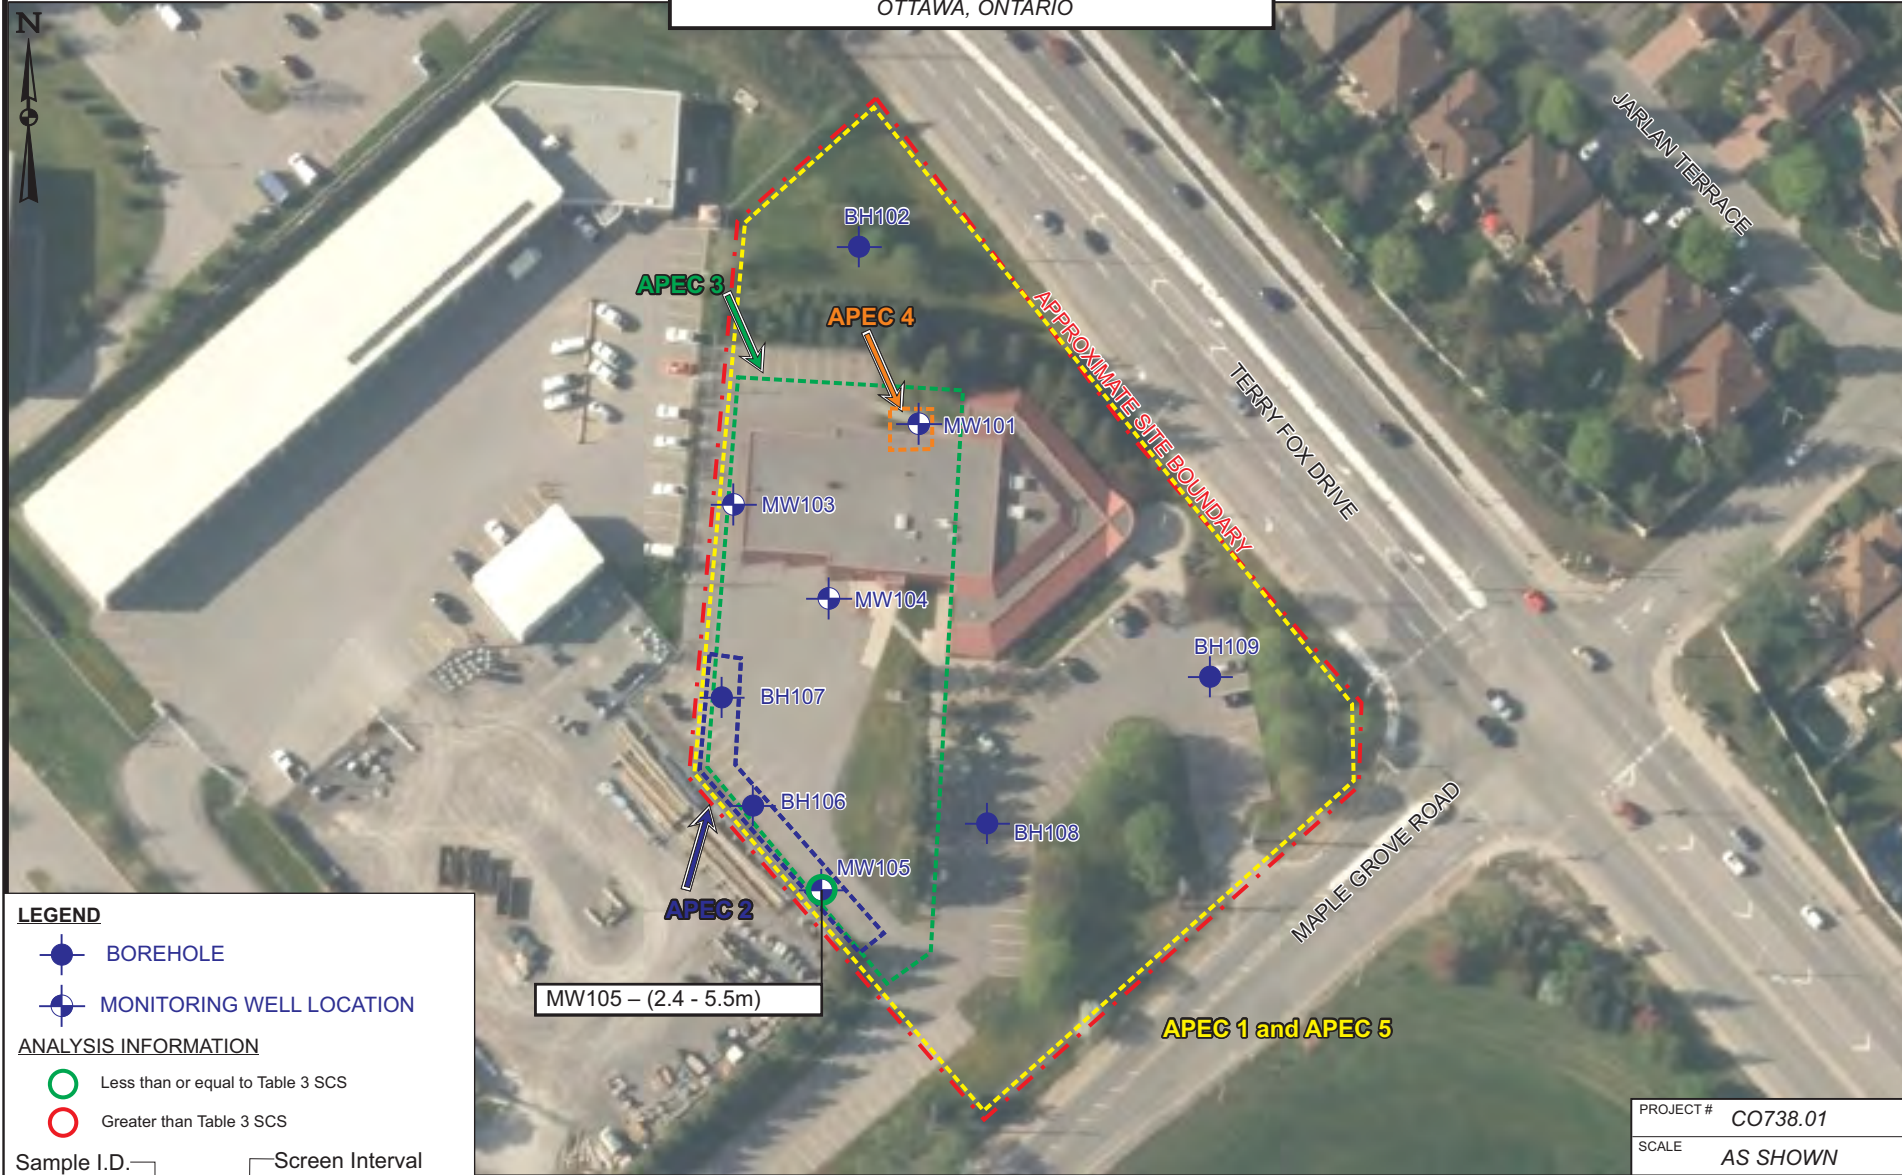
PROJECT #	CO738.01
SCALE	AS SHOWN
DATE	DECEMBER 2019
DRAWN	AB/ SW
CHECKED	GS/ KB
DRAWING #	FIGURE 24

SCS (Site Conditions Standards) refer to Standards from Table 3 of April 15, 2011 Soil, Ground Water and Sediment Standards for Use Under Part XV.1 of the Environmental Protection Act; residential/ parkland/ institutional property use for medium and fine textured soil

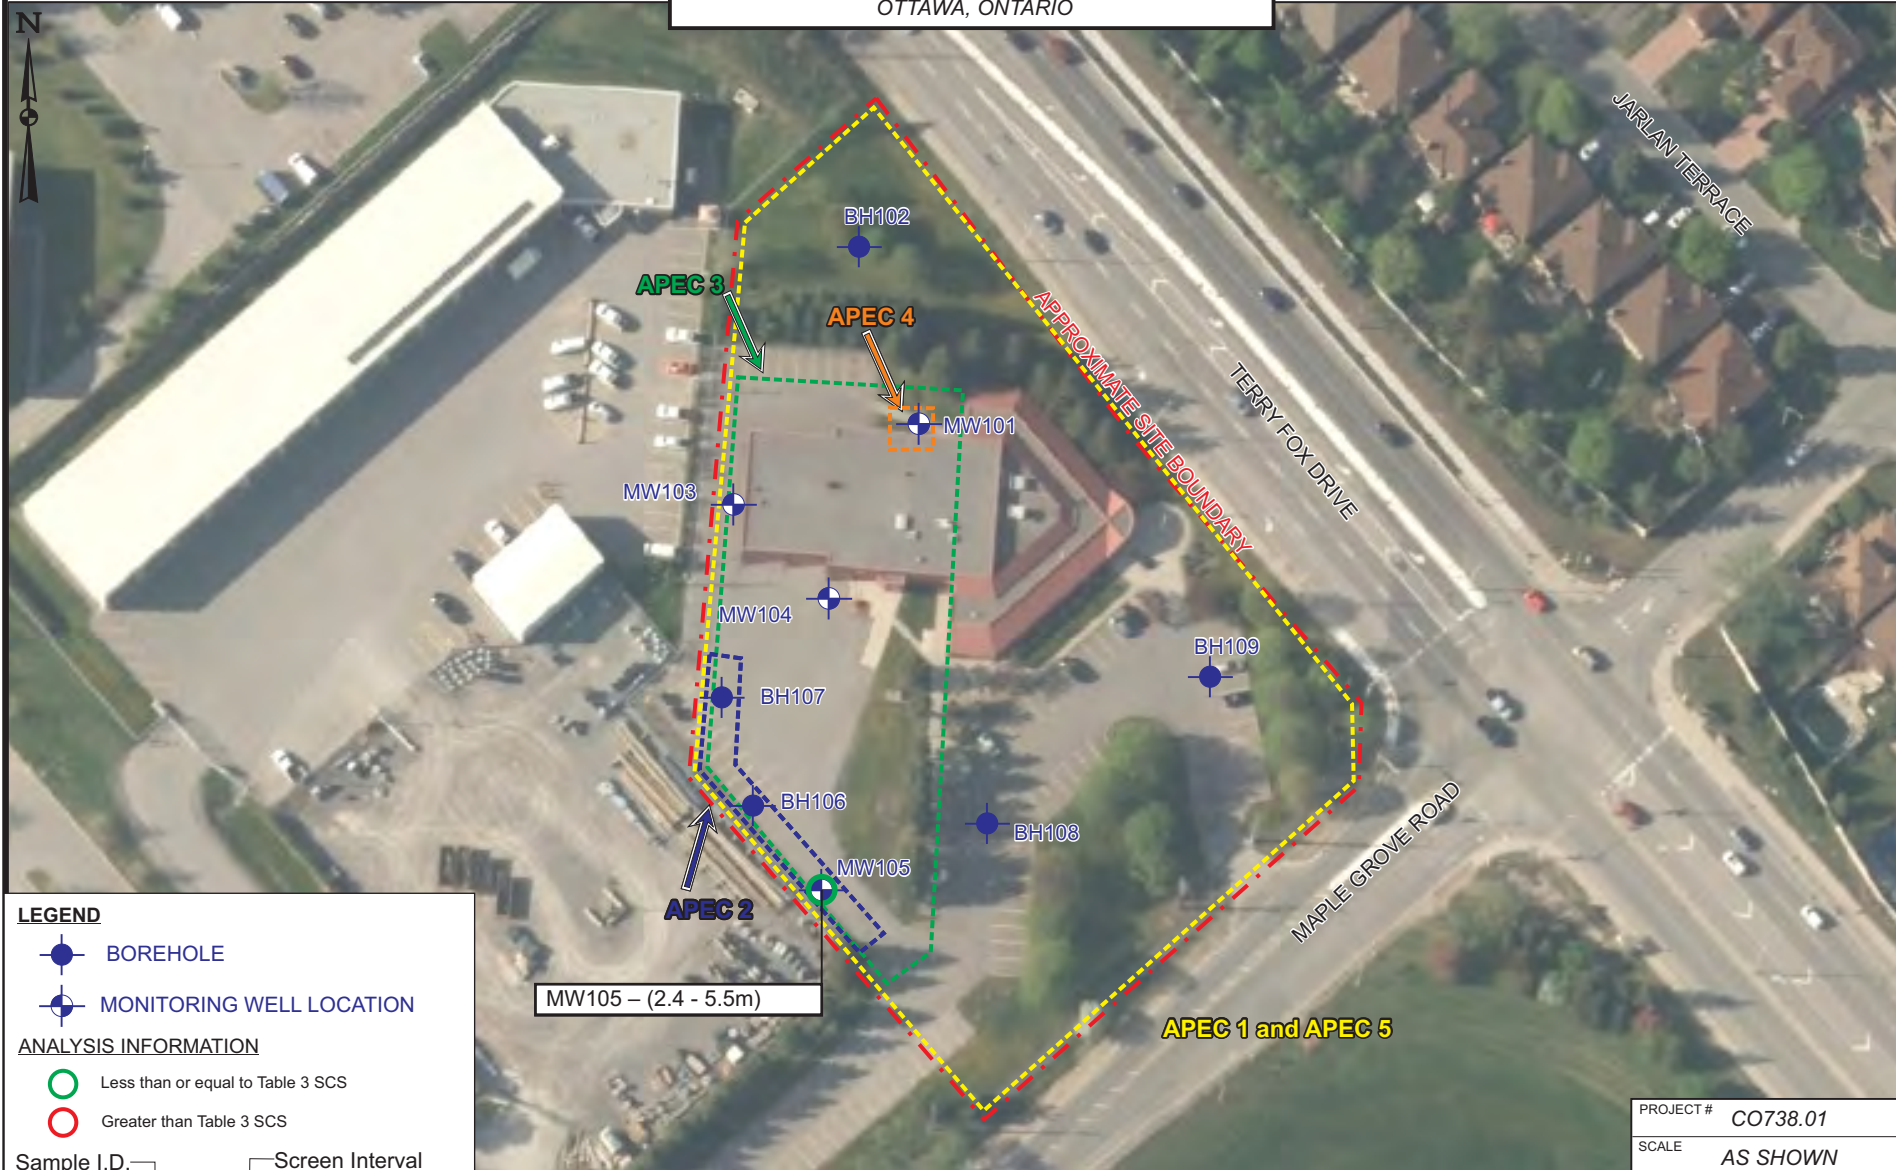
PROJECT #	CO738.01
SCALE	AS SHOWN
DATE	DECEMBER 2019
DRAWN	AB/ SW
CHECKED	GS/ KB
DRAWING #	FIGURE 25

SCS (Site Conditions Standards) refer to Standards from Table 3 of April 15, 2011 Soil, Ground Water and Sediment Standards for Use Under Part XV.1 of the Environmental Protection Act; residential/ parkland/ institutional property use for medium and fine textured soil

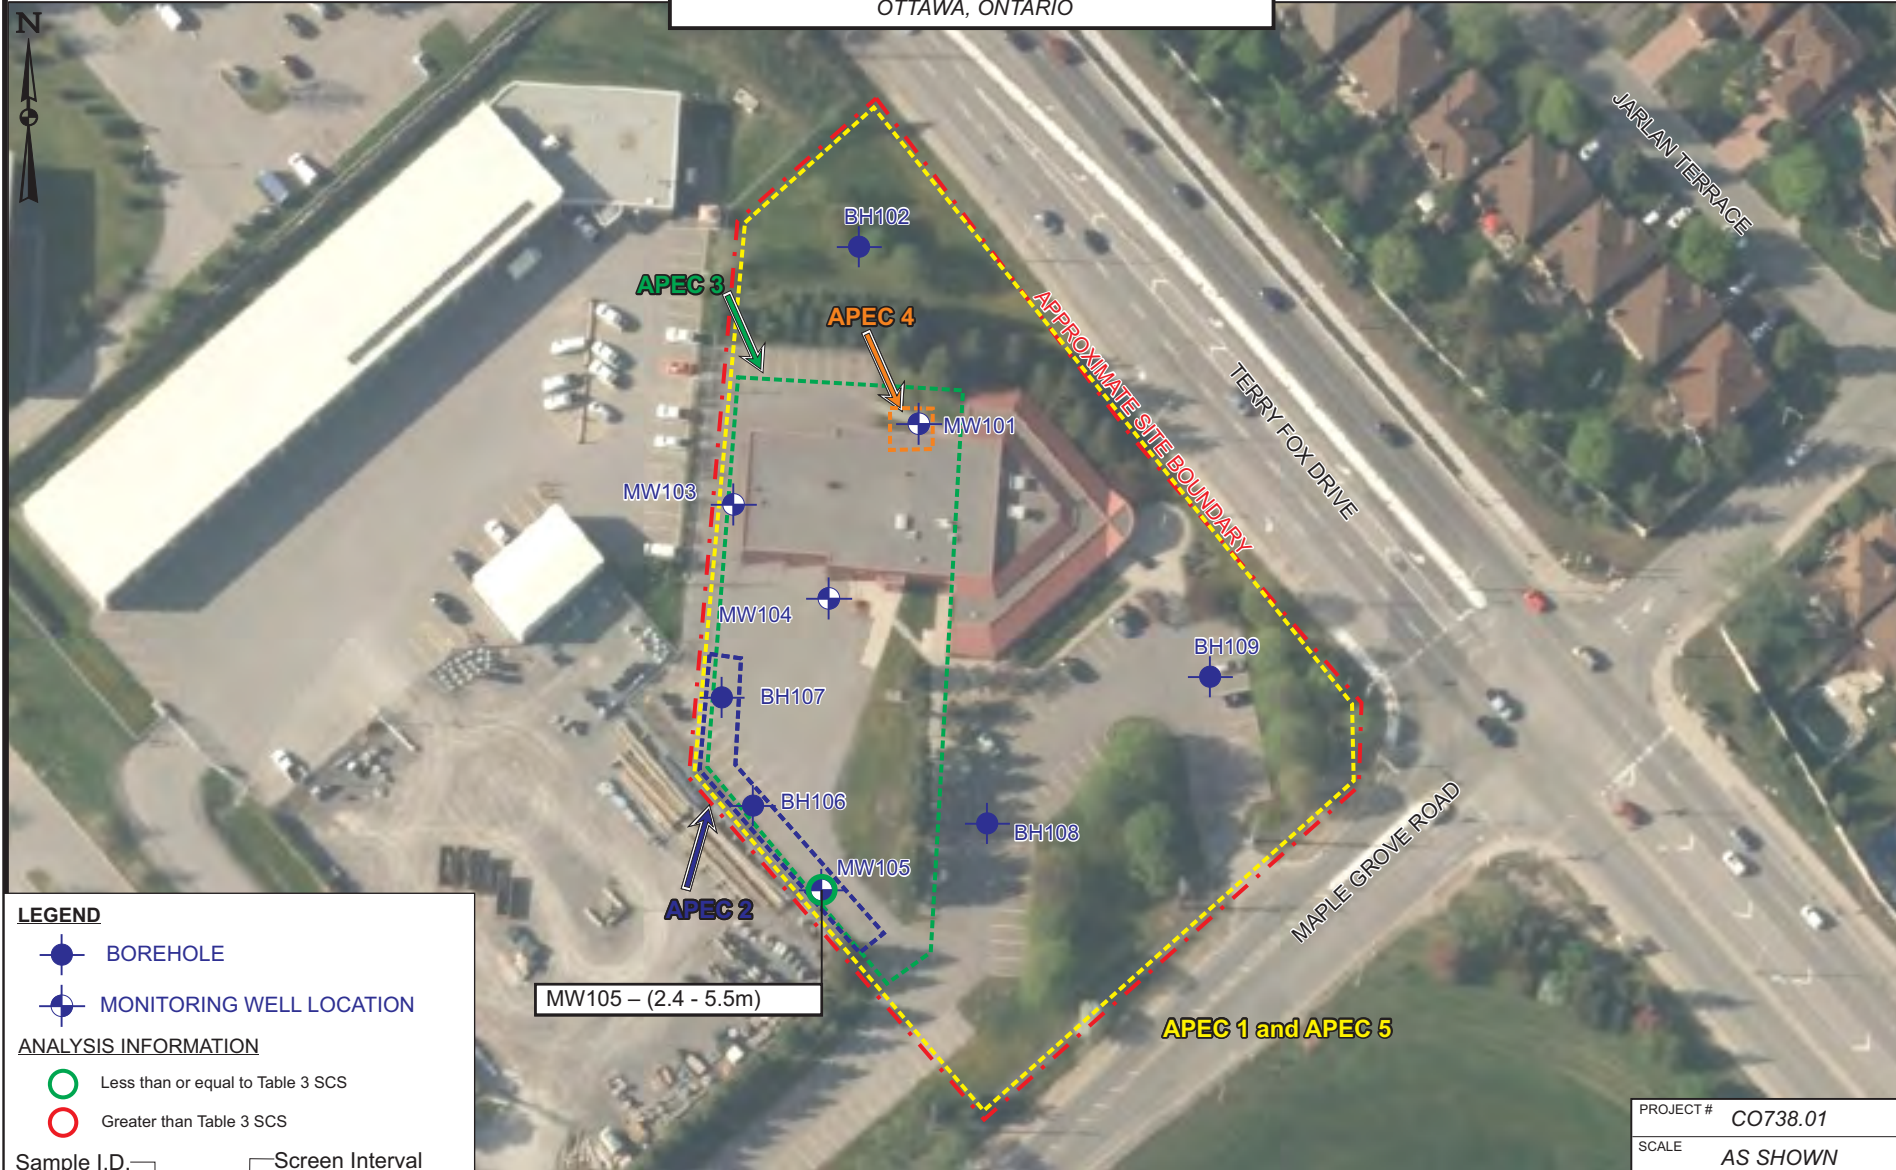
PROJECT #	CO738.01
SCALE	AS SHOWN
DATE	DECEMBER 2019
DRAWN	AB/ SW
CHECKED	GS/ KB
DRAWING #	FIGURE 26

SCS (Site Conditions Standards) refer to Standards from Table 3 of April 15, 2011 Soil, Ground Water and Sediment Standards for Use Under Part XV.1 of the Environmental Protection Act; residential/ parkland/ institutional property use for medium and fine textured soil

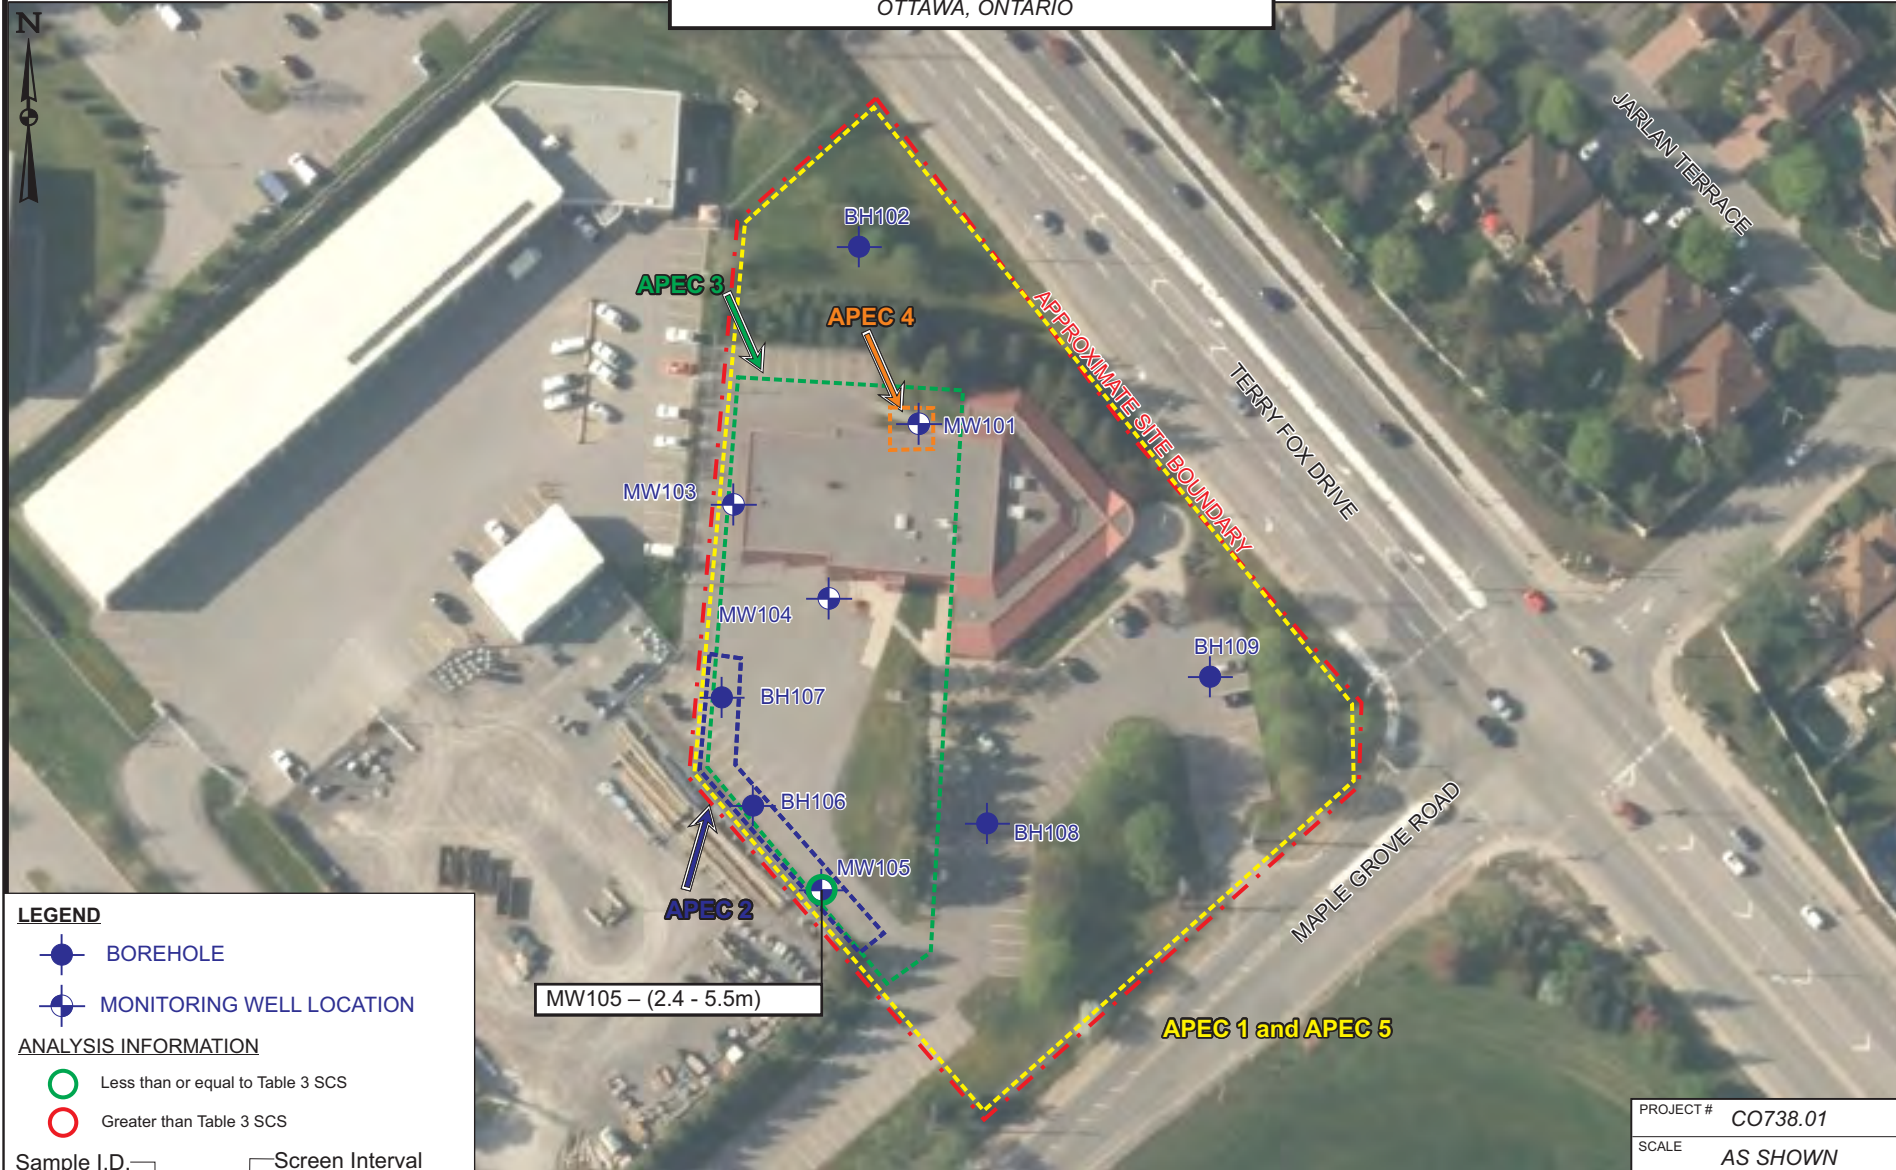
PROJECT #	CO738.01
SCALE	AS SHOWN
DATE	DECEMBER 2019
DRAWN	AB/ SW
CHECKED	GS/ KB
DRAWING #	FIGURE 27

SCS (Site Conditions Standards) refer to Standards from Table 3 of April 15, 2011 Soil, Ground Water and Sediment Standards for Use Under Part XV.1 of the Environmental Protection Act; residential/ parkland/ institutional property use for medium and fine textured soil

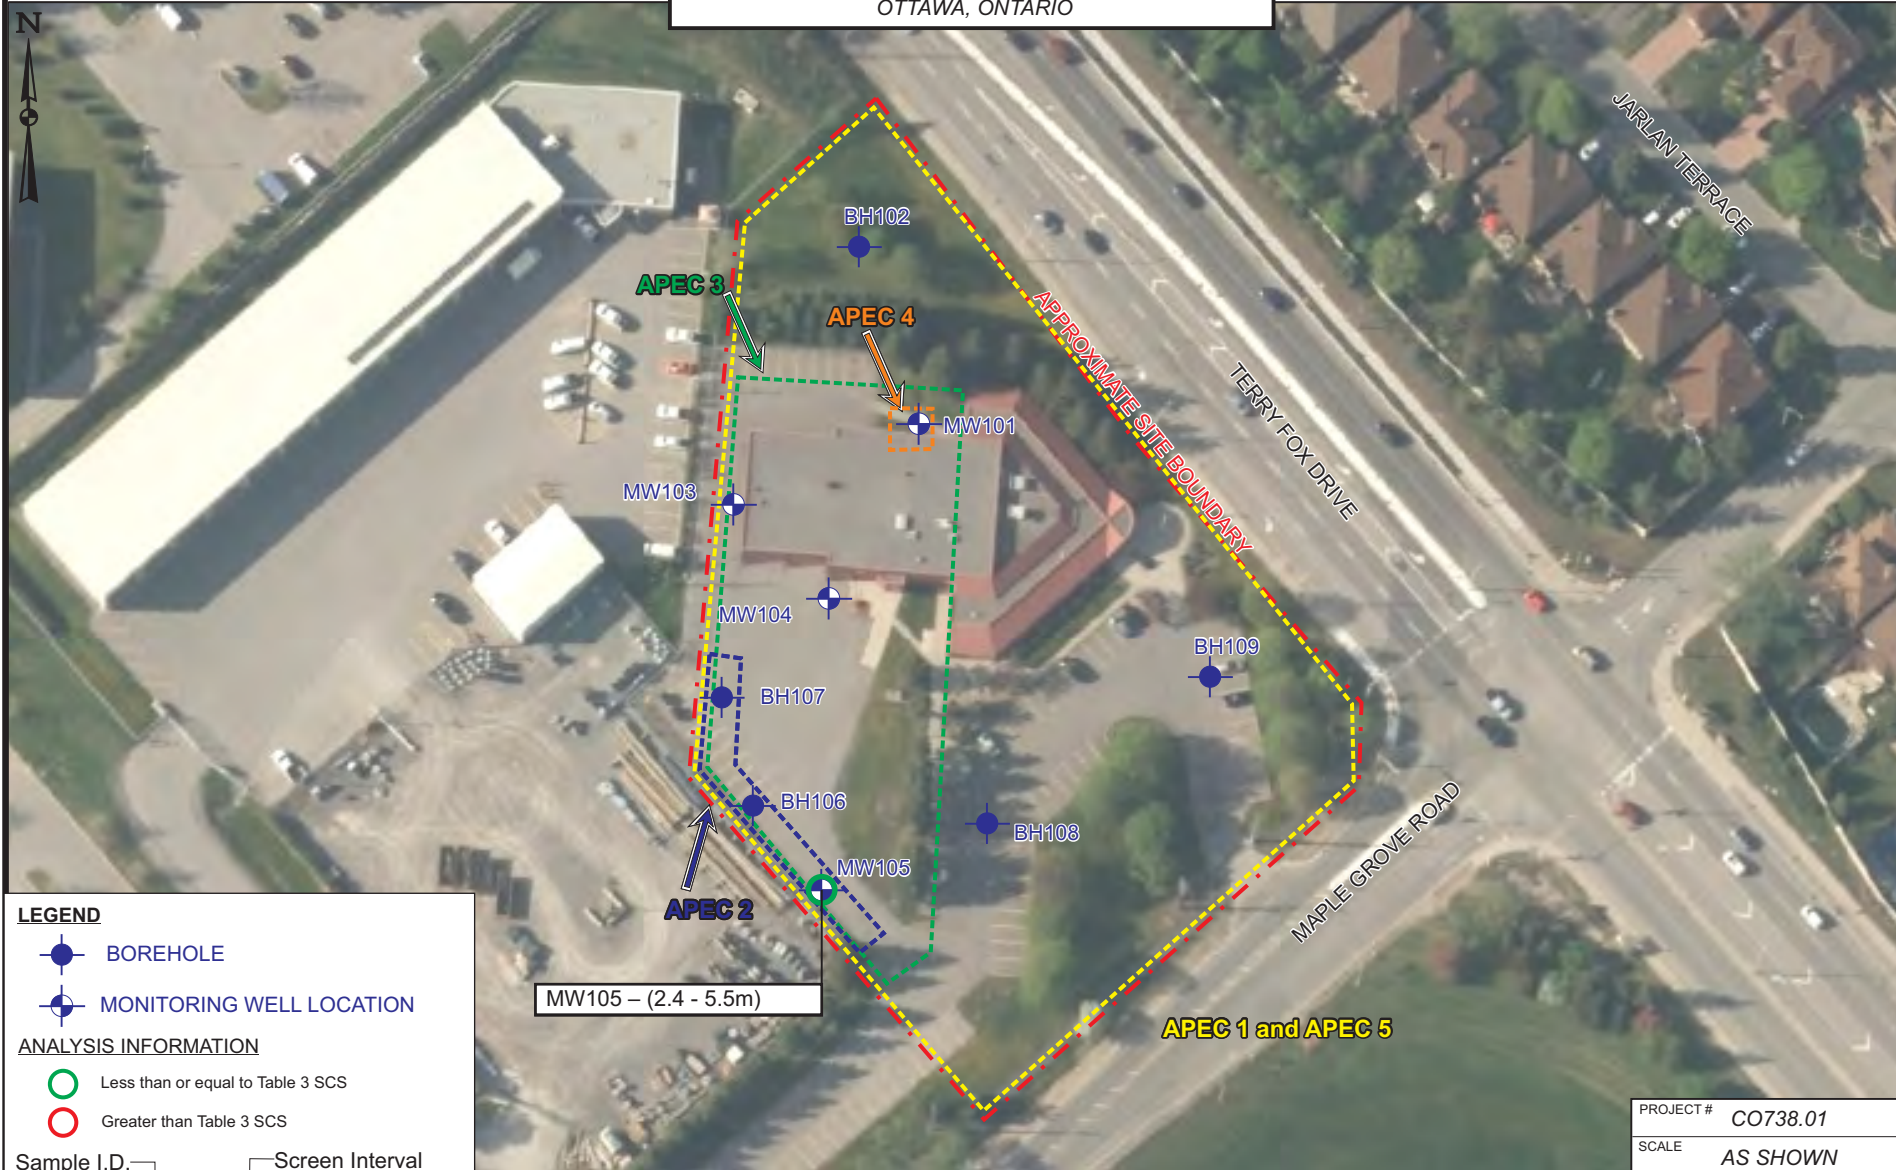
PROJECT #	CO738.01
SCALE	AS SHOWN
DATE	DECEMBER 2019
DRAWN	AB/ SW
CHECKED	GS/ KB
DRAWING #	FIGURE 28

SCS (Site Conditions Standards) refer to Standards from Table 3 of April 15, 2011 Soil, Ground Water and Sediment Standards for Use Under Part XV.1 of the Environmental Protection Act; residential/ parkland/ institutional property use for medium and fine textured soil
