**Phase I Environmental Site Assessment**

27 Monk Street  
Ottawa, Ontario

September 23, 2019

Report: PE4714-1

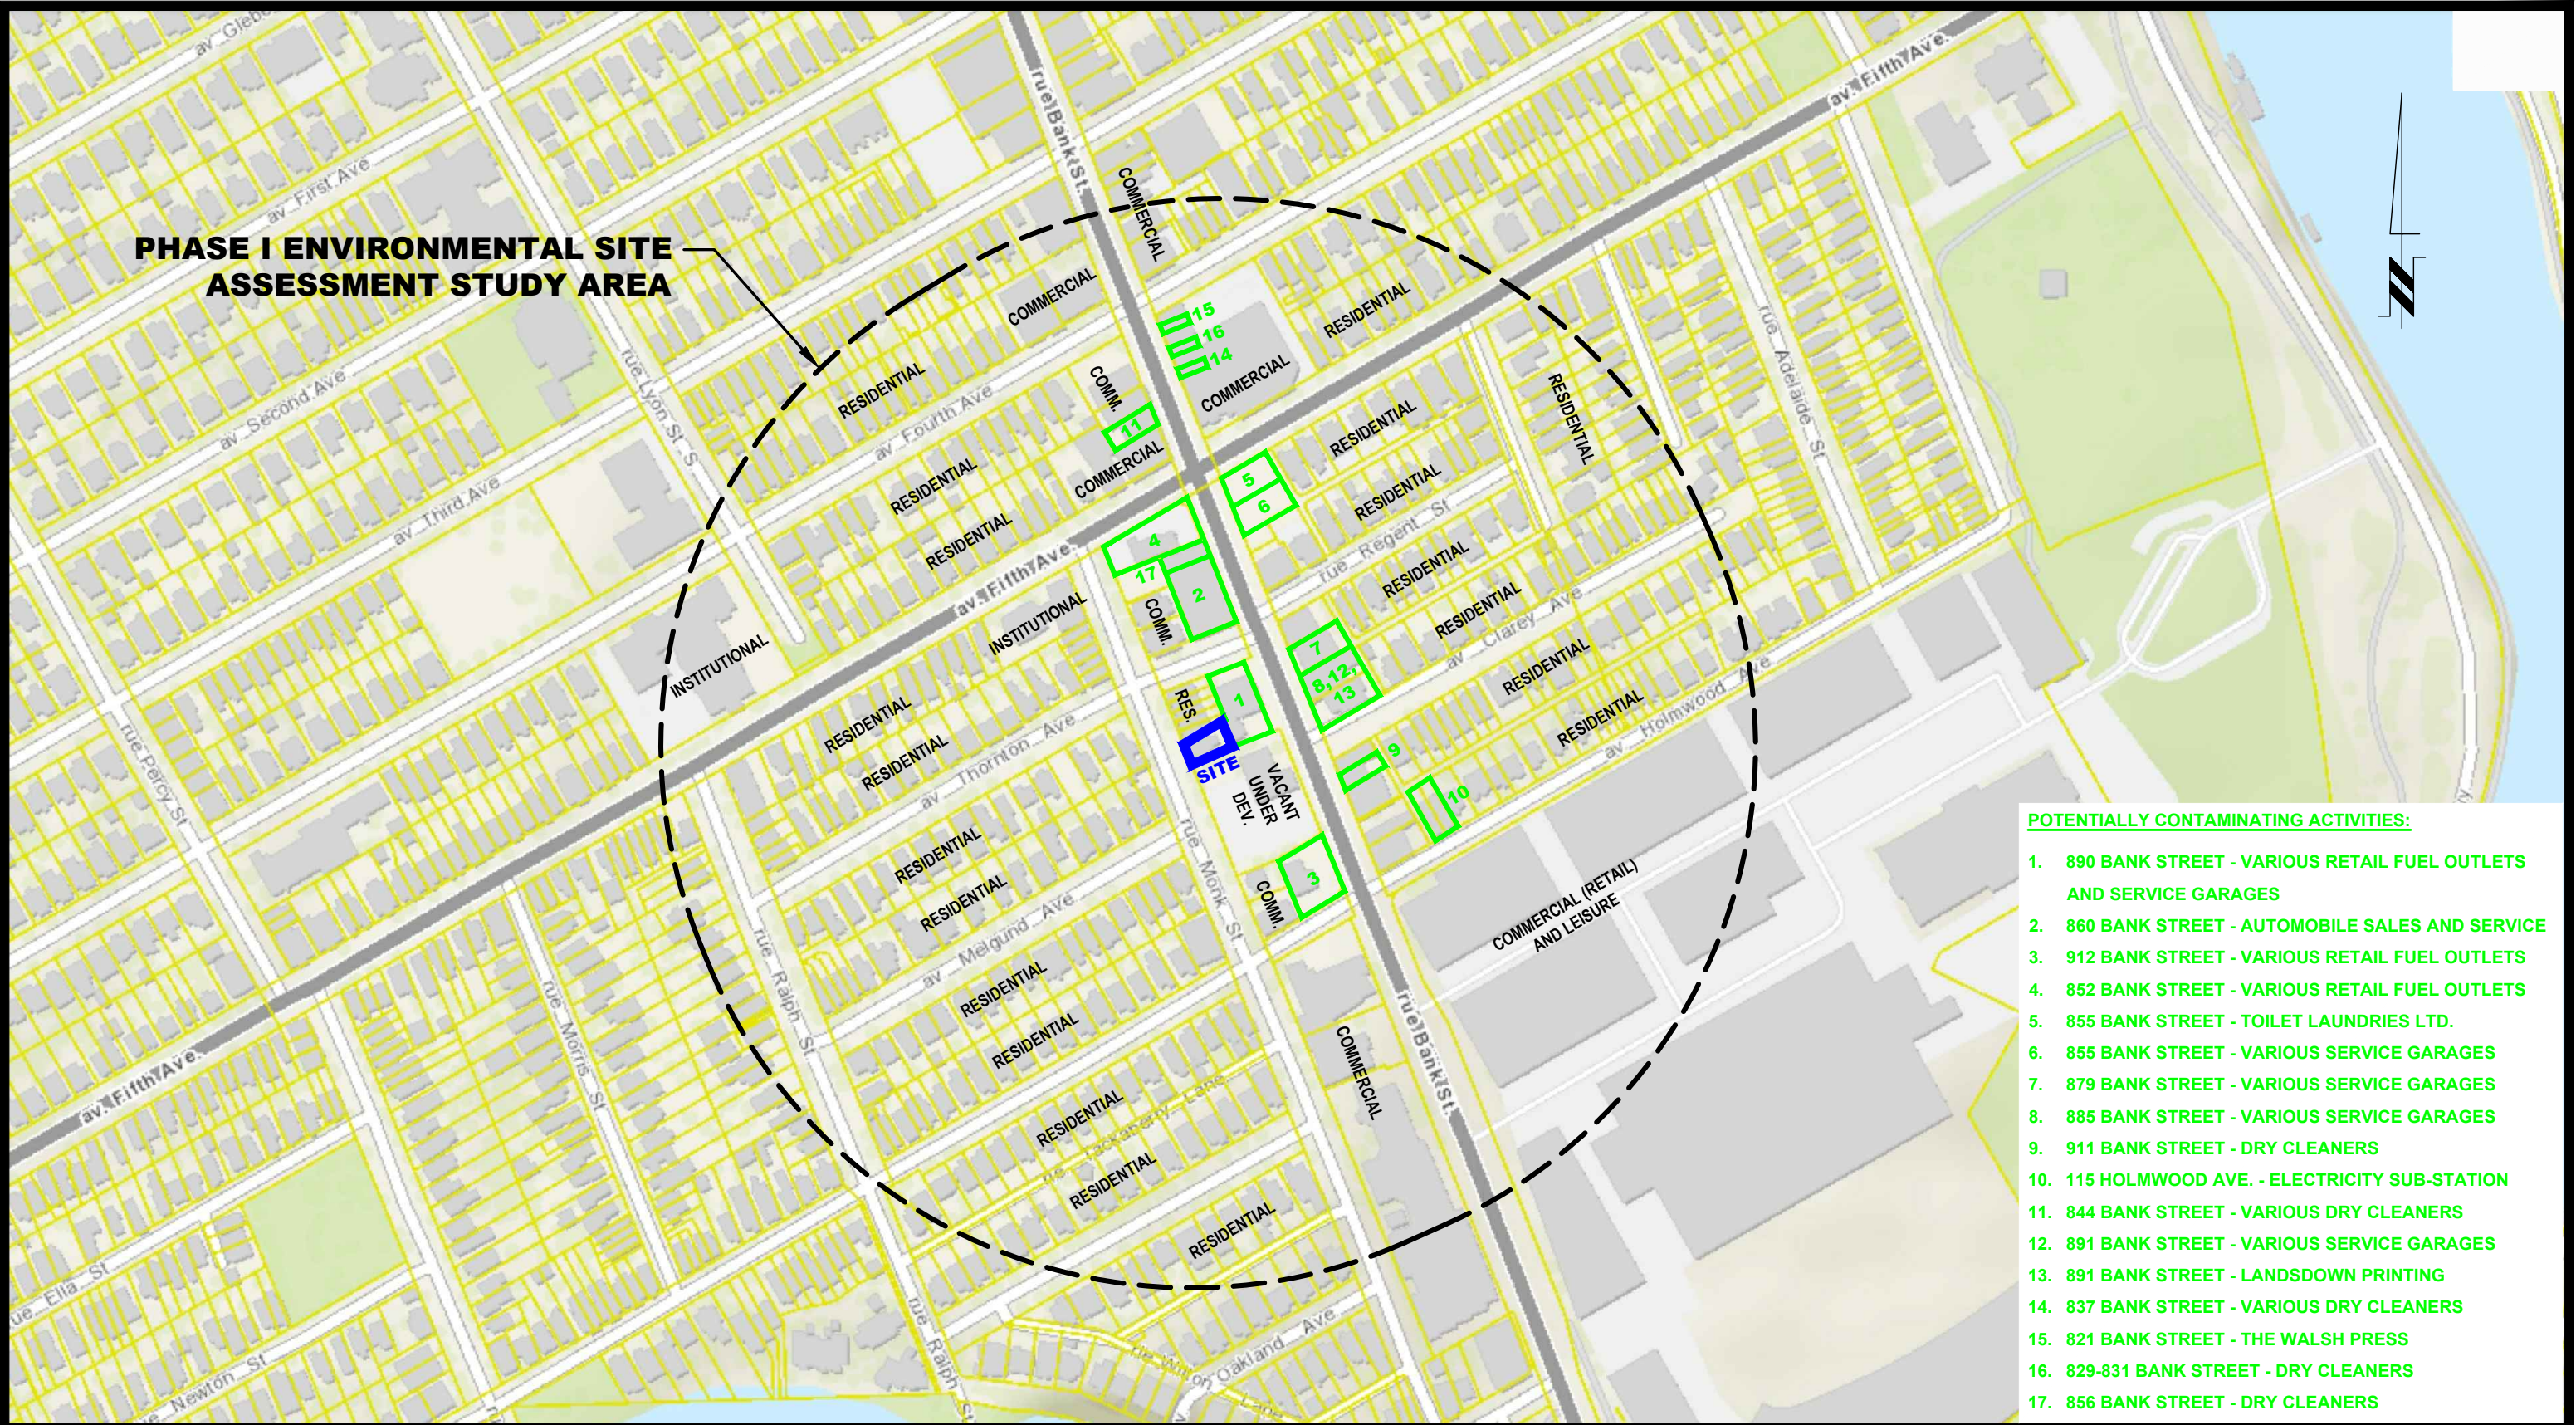
**DRAWING PE4714-2 – SURROUNDING LAND USE PLAN**

Land use within the Phase I study area is shown on Drawing PE4714-2 - Surrounding Land Use Plan. No additional PCAs were noted during the site visit.

**POTENTIALLY CONTAMINATING ACTIVITIES:**

1. 890 BANK STREET - VARIOUS RETAIL FUEL OUTLETS AND SERVICE GARAGES
2. 860 BANK STREET - AUTOMOBILE SALES AND SERVICE
3. 912 BANK STREET - VARIOUS RETAIL FUEL OUTLETS
4. 852 BANK STREET - VARIOUS RETAIL FUEL OUTLETS
5. 855 BANK STREET - TOILET LAUNDRIES LTD.
6. 855 BANK STREET - VARIOUS SERVICE GARAGES
7. 879 BANK STREET - VARIOUS SERVICE GARAGES
8. 885 BANK STREET - VARIOUS SERVICE GARAGES
9. 911 BANK STREET - DRY CLEANERS
10. 115 HOLMWOOD AVE. - ELECTRICITY SUB-STATION
11. 844 BANK STREET - VARIOUS DRY CLEANERS
12. 891 BANK STREET - VARIOUS SERVICE GARAGES
13. 891 BANK STREET - LANDSDOWN PRINTING
14. 837 BANK STREET - VARIOUS DRY CLEANERS
15. 821 BANK STREET - THE WALSH PRESS
16. 829-831 BANK STREET - DRY CLEANERS
17. 856 BANK STREET - DRY CLEANERS

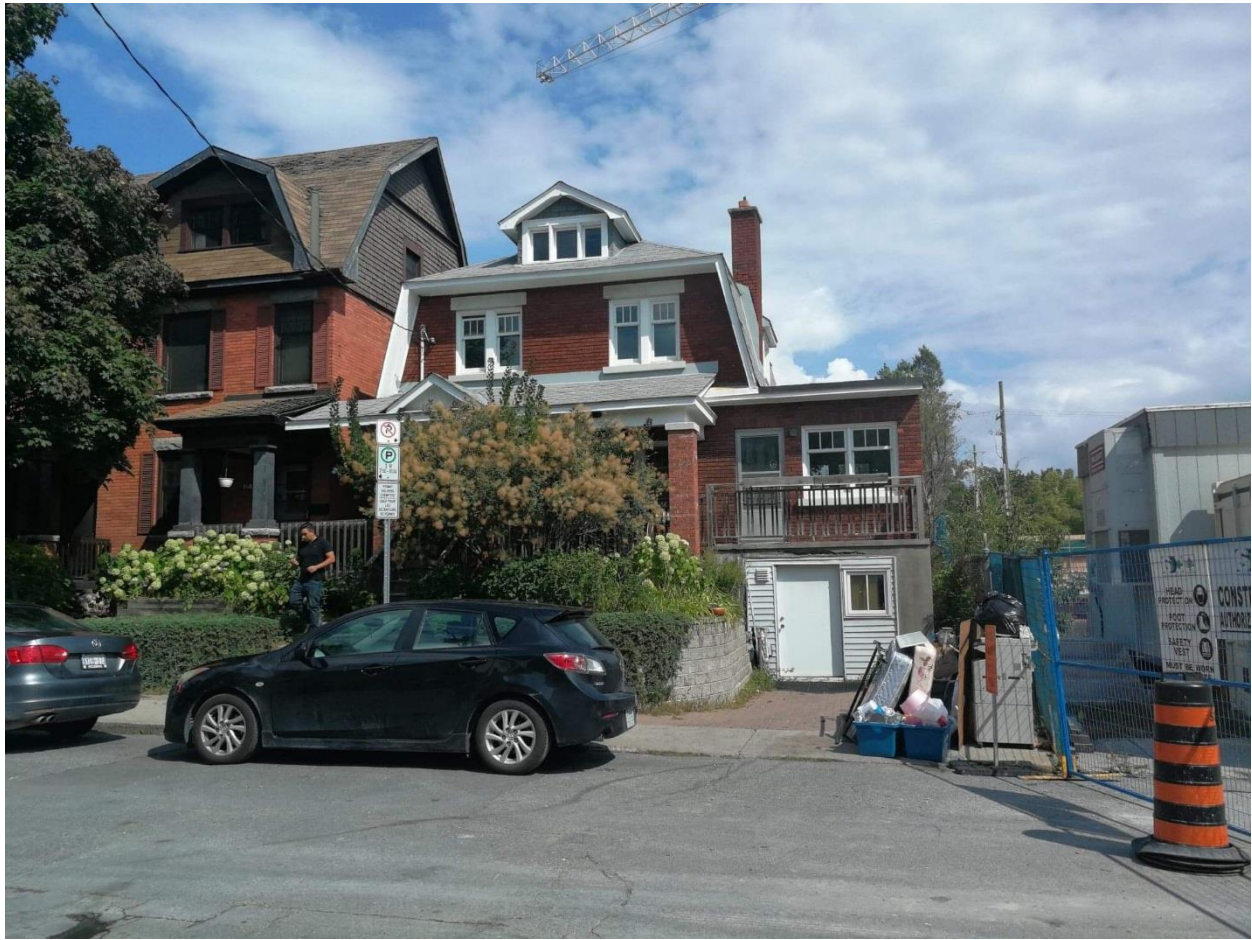
The main building was constructed on a stone foundation, finished with brick and stucco and with a sloped shingled mansard roof. Relict structures suggested the building was historically heated with coal however is now heated through a combination of gas fired furnace and electric base board heating.

Photograph 1: Exterior of the property. Facing east.

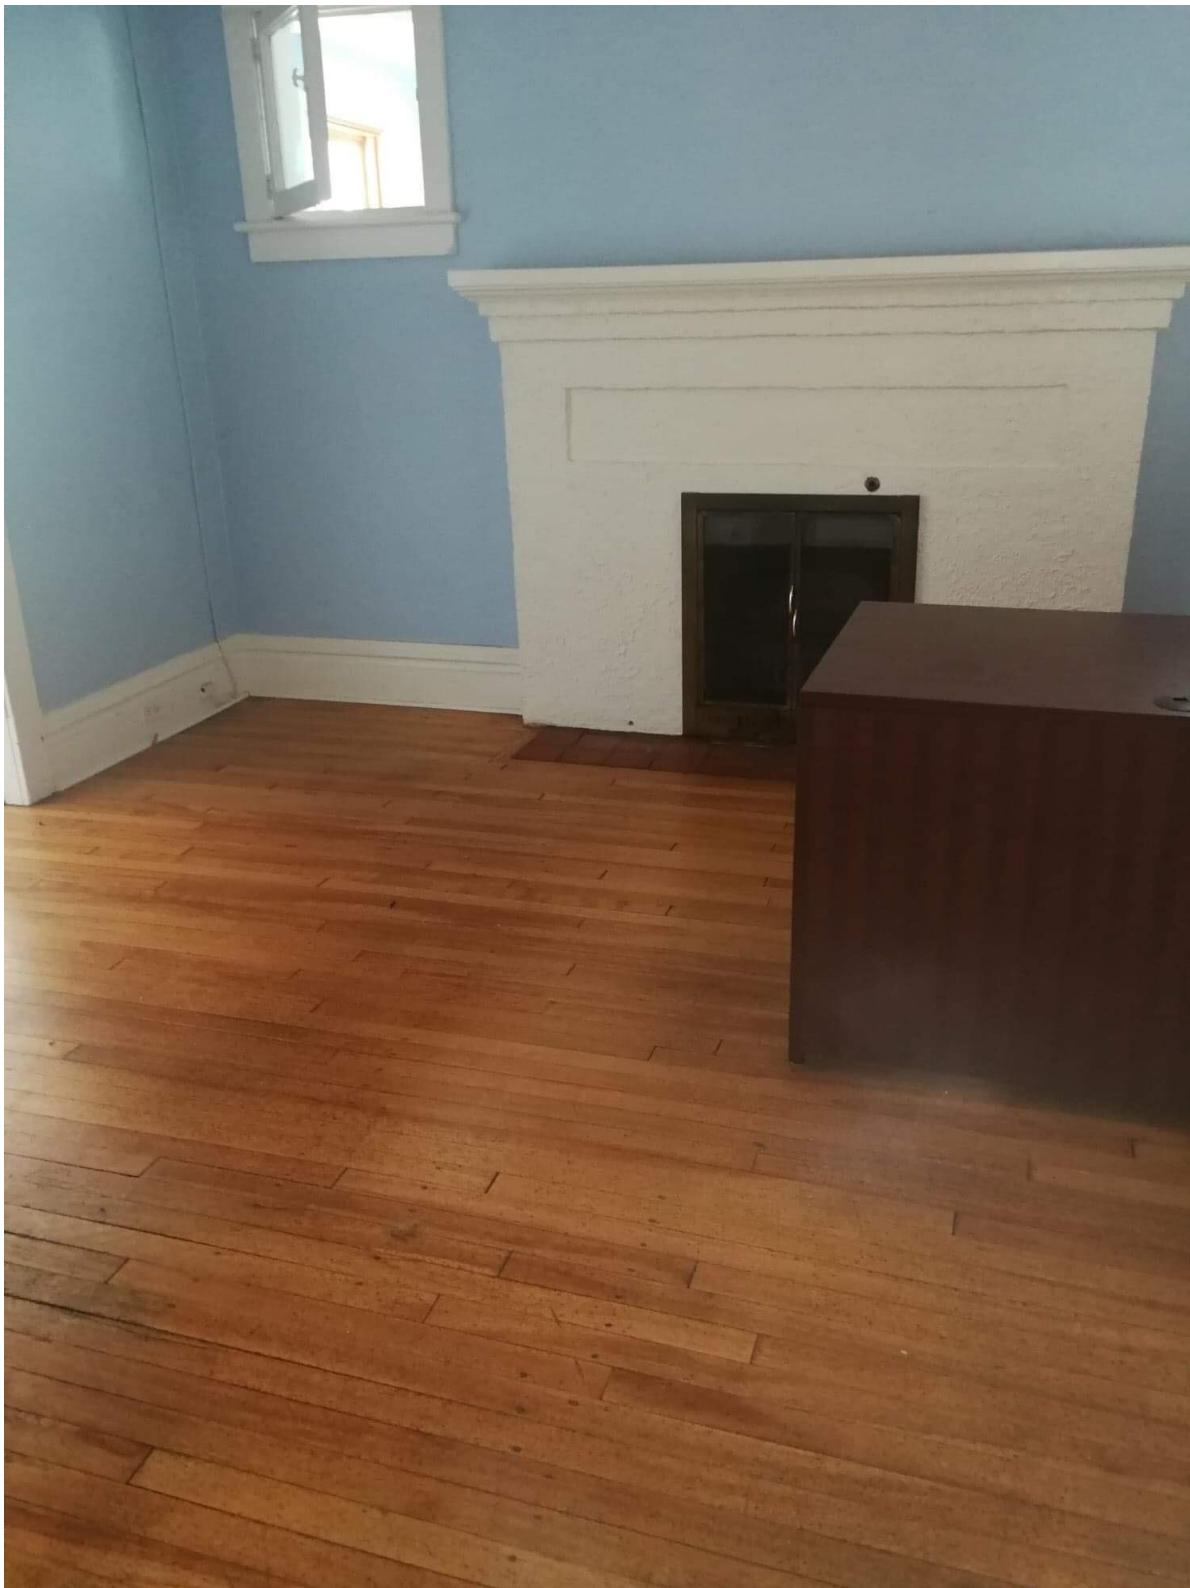
Photograph 2: Stippled finish on the first floor fireplace.

Based on the age of the subject building, asbestos-containing materials (ACMs) are potentially present in the subject structure. The potential ACMs include drywall joint compound, plaster, and stippling around the fireplace, as well as exterior stucco finishes. Both wall materials and floor coverings in the building were in generally in good condition. An asbestos survey of the building must be conducted in accordance with Ontario Regulation 278/05, under the Occupational Health and Safety Act, prior to the disturbance of these materials.

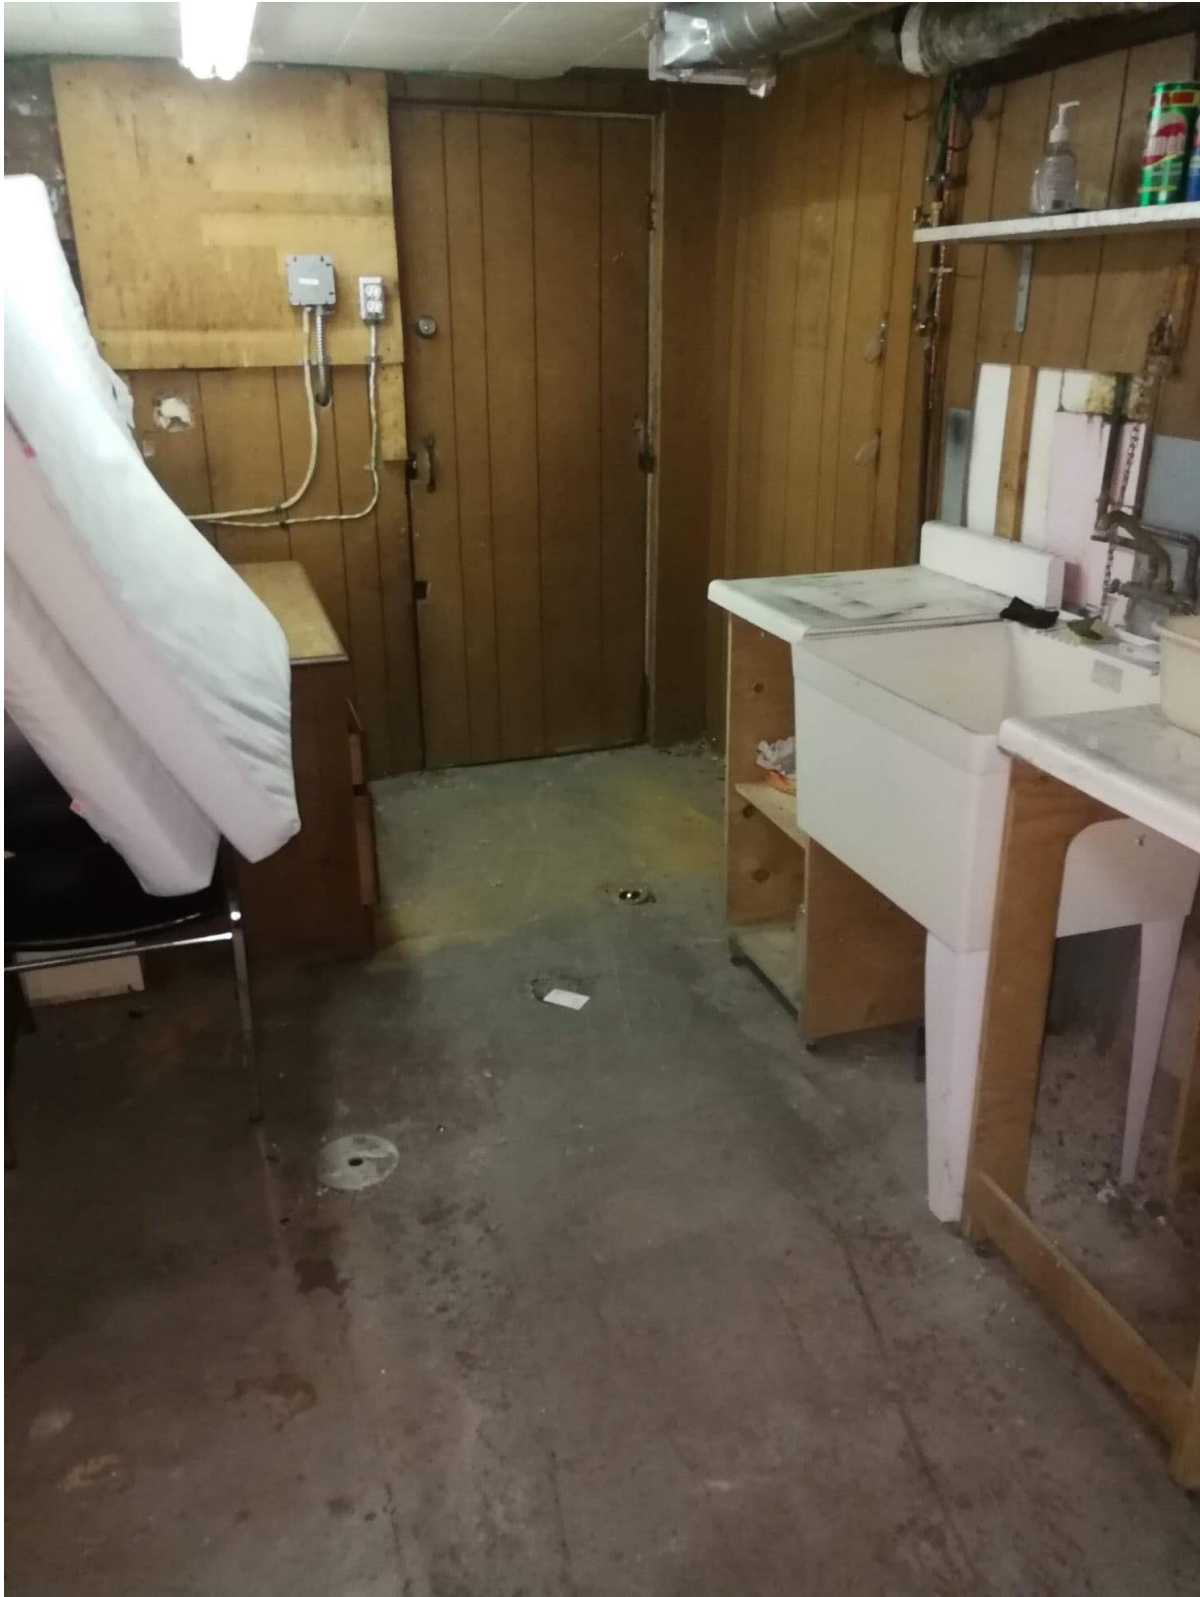
Photograph 3: Basement utility room.

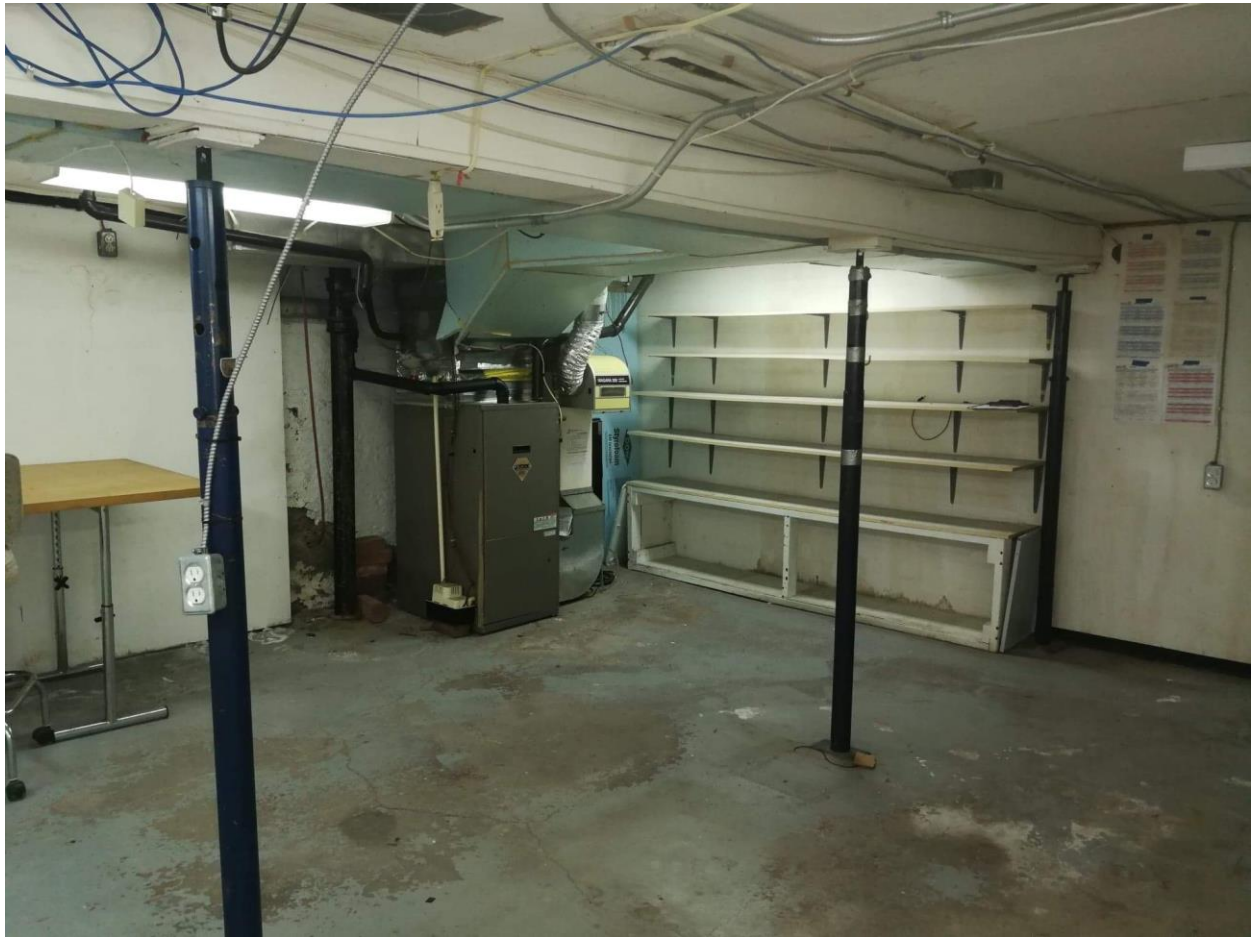
Photograph 4: Basement furnace.
