# ENVIRONMENTAL IMPACT STATEMENT

6776 Rothbourne Road, Ottawa, ON

Project No.: OCP-17-0381

ENVIRONMENTAL IMPACT STATEMENT  
6776 ROTHBOURNE ROAD, OTTAWA, ON

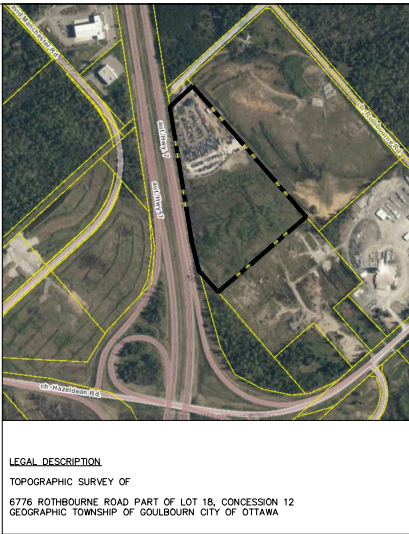
Refer to **Figure 6** for the site plan for the proposed development. The development will include clearing approximately 4.27 ha of vegetation in the south end of the study area. This will occur adjacent to a 30 m buffer around the PSW. Light duty (15 mm Granular 'A' and 350 mm Granular 'B') gravel will be placed in the cleared area which will serve as a tow yard. As part of the clearing, the construction of a clay berm has been recommended by MVCA south of the PSW to separate a 30 m buffer zone around the PSW from the tow yard. This berm will act as an ecological boundary from the tow yard and prevent runoff from entering the PSW. Additionally, a grass swale will be constructed on the north side of the existing berm separating the study area and the existing tow yard to the north. The swale will be constructed within the existing gravel of the tow yard and will have a width ranging from 9.6 m to 12 m. The purpose of the swale construction is to divert storm water from the existing tow yard eastward. A 600 mm pipe with a length of 11.21 m will be installed in the swale where the fire route access road will cross the swale. The pipe will divert stormwater under the proposed road from the west end of the swale to the east end. Level spreaders will be installed on the northwest and southwest quadrants of the proposed culvert installation. These areas will function as stormwater controls.

- Zoning side yard setback of 3 m on the west side and 15 m on the south side;
- A landscape buffer setback of 10 m on the west side, and
- Ministry of Transportation of Ontario (MTO) setback of 14 m from the Highway 7 ROW on the west side and south side.

In addition to the setbacks, an opaque 1.8 m fence will be installed along the entire property line including the existing tow yard property north of the study area.

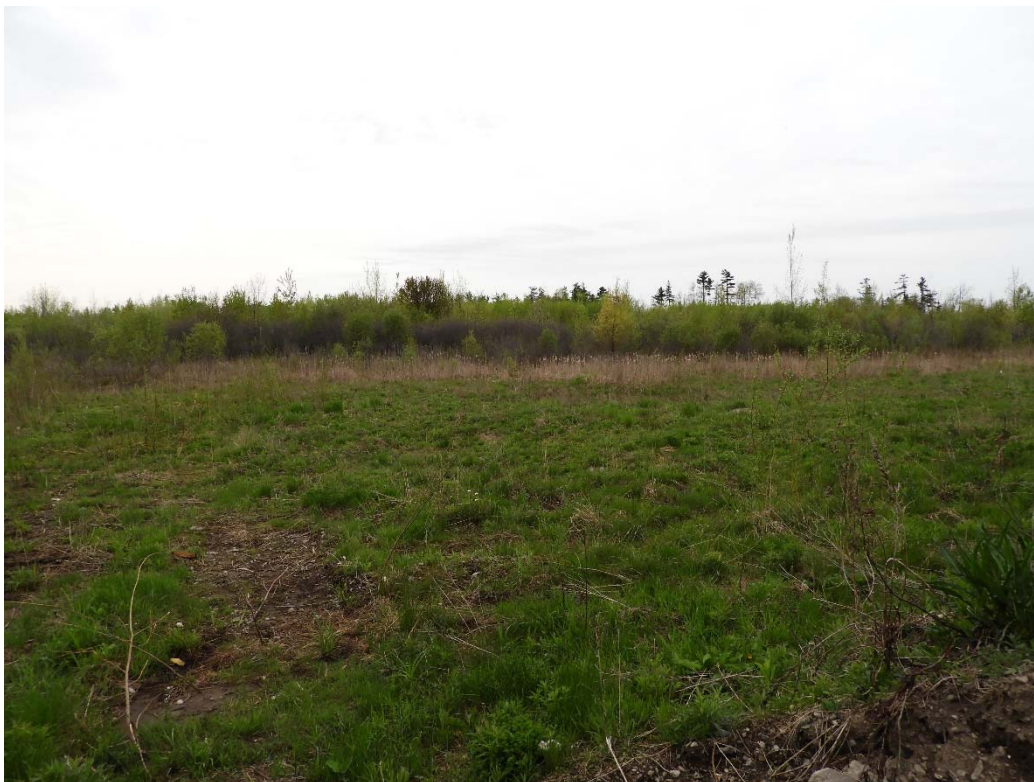
*Photo 1: Mineral Cultural Meadow (CUM1) in the northeast side of the study area. 23 May 2019.*

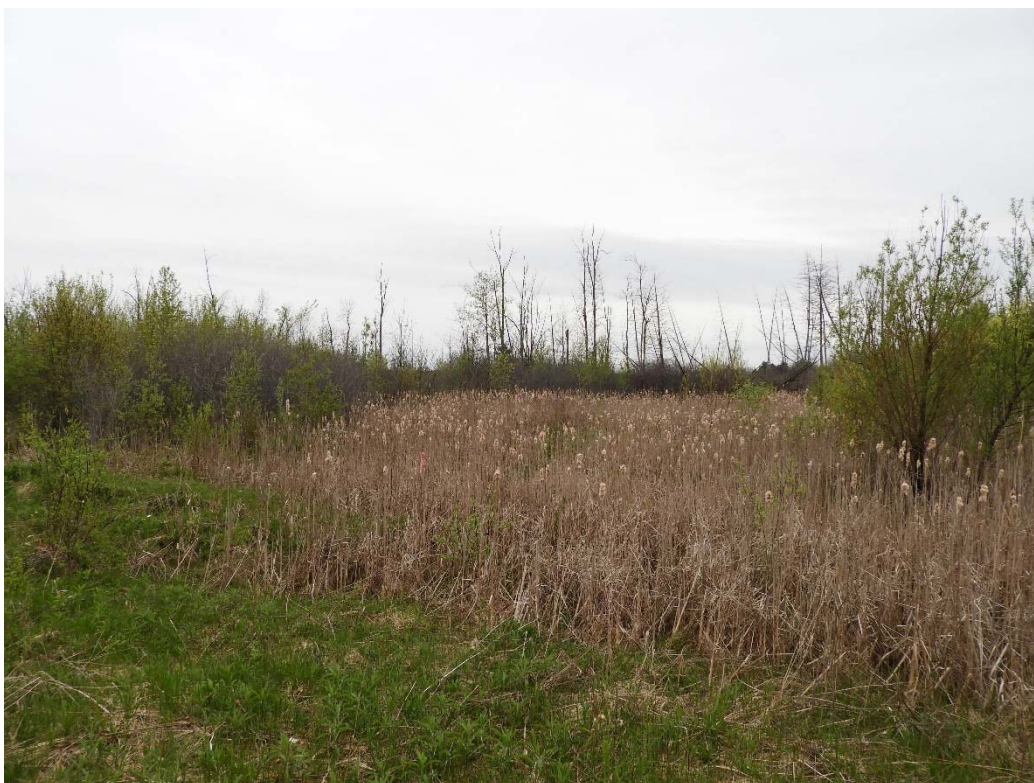
*Photo 2: Mineral Meadow Marsh (MAM2) in the north end of the study area. 23 May 2019.*

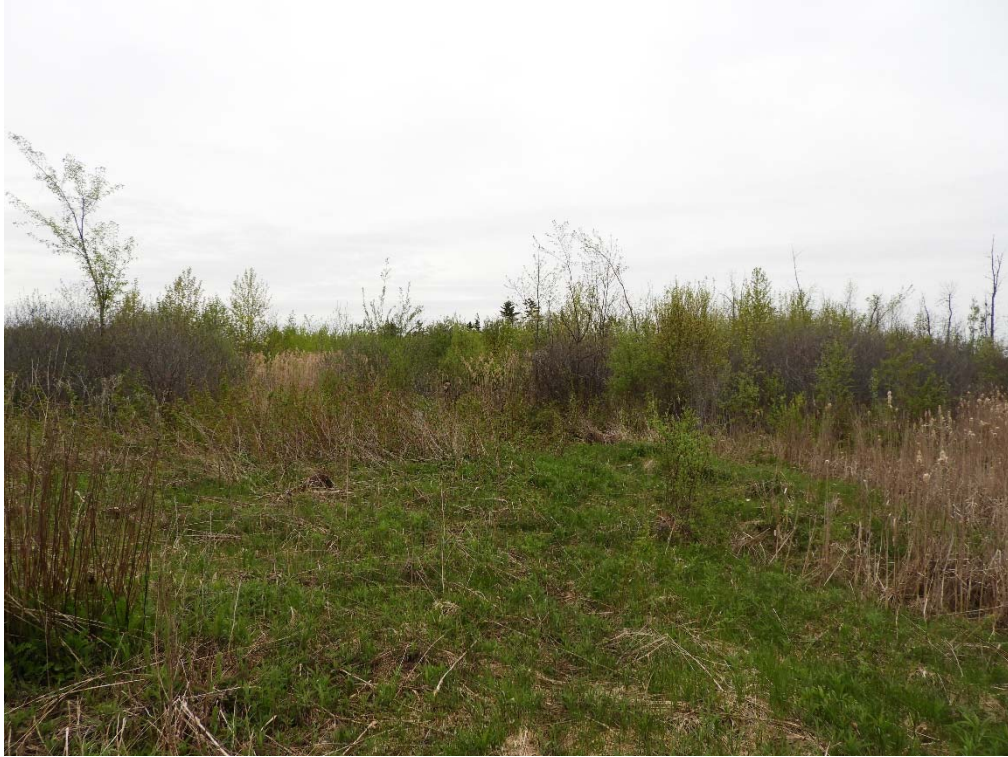
*Photo 3: North end of proposed fire route access road through the Mineral Meadow Marsh in the north end of the 20 m setback from the PSW. 23 May 2019.*

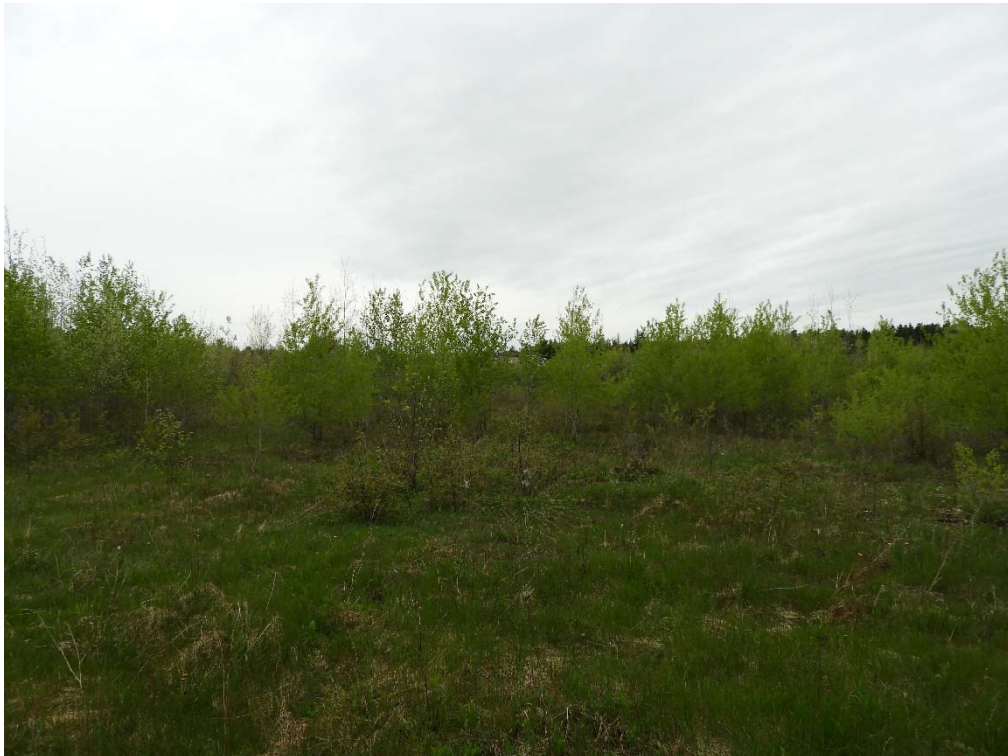
*Photo 4: Mineral Cultural Savannah (CUS1) present throughout the majority of the south and east end of the study area. 23 May 2019.*

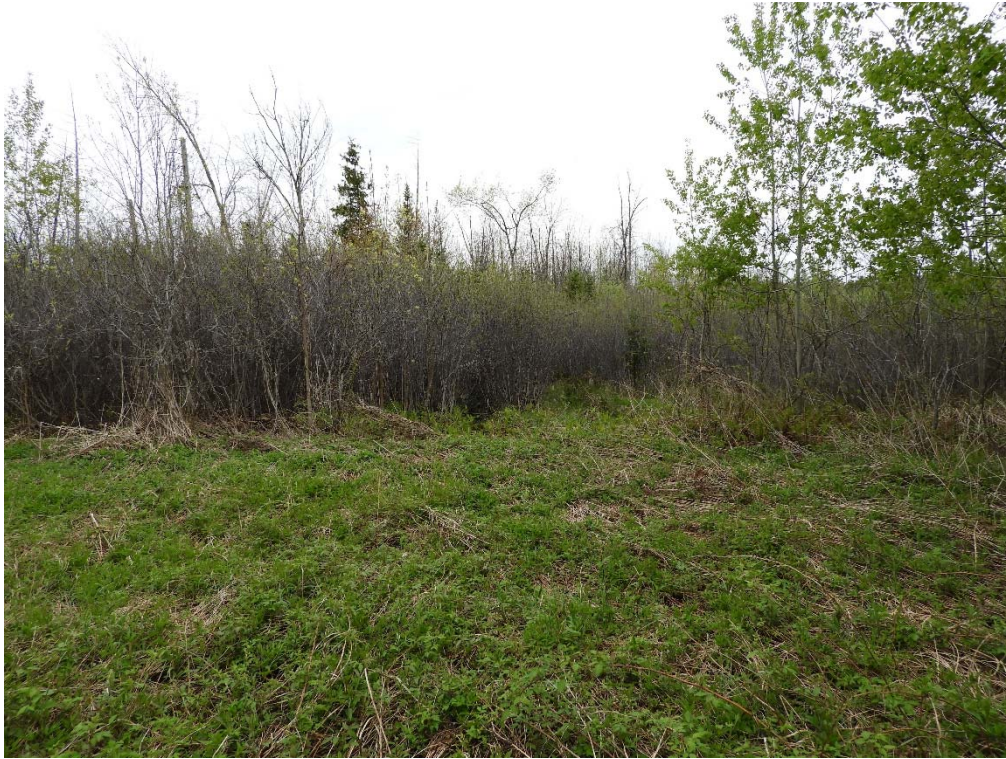
*Photo 5: Mineral Cultural Thicket (CUT1) present within the center of the study area. 23 May 2019.*

Vegetation Community 3 was classified through ELC as a Mineral Cultural Thicket (CUT1) (**Photo 5**). This is the largest community of the study area. A small area of this community was located in the northwest corner. The majority of this community was situated directly south of the PSW and occupies the center of the study area. The canopy of this community was dominated by shrub willow (*Salix* spp.) and common buckthorn (*Rhamnus cathartica*). These species are indicative of regeneration of a previously disturbed site. The understory consisted of the same species at a lower height. Various herbaceous wildflowers and grass provided ground cover in this community.

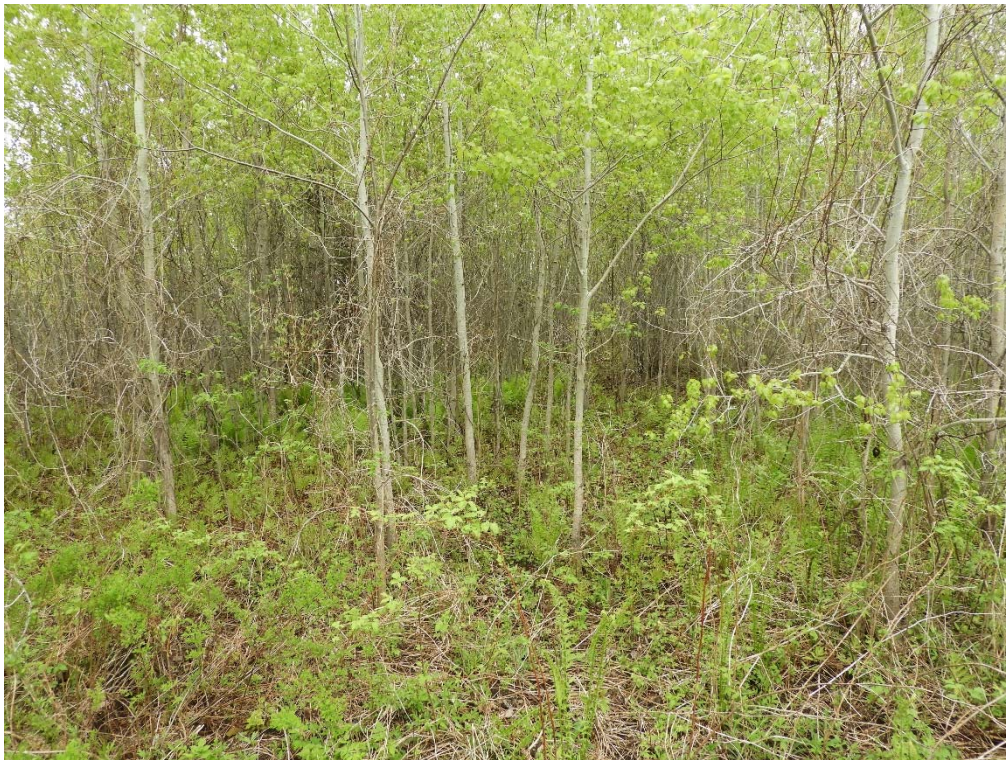
*Photo 6: Fresh-Moist Poplar-Deciduous Forest (FOD8-1) present in the south end towards the west side of the study area where the proposed fire route access road and warehouse are to be located. 23 May 2019.*

Vegetation Community 5 was classified through ELC as a Fresh-Moist Poplar-Deciduous Forest (FOD8-1) (**Photo 6**). This community was located in the southwest corner and continues in a narrow, northward direction. The canopy of the community was dominated by tall poplar species. The understory consisted of young sugar maple (*Acer saccharum*) and wild red raspberry (*Rubus strigosus*). Ground cover was sparse and consisted of moss (Bryophyta) and ostrich fern (*Matteuccia struthiopteris*).

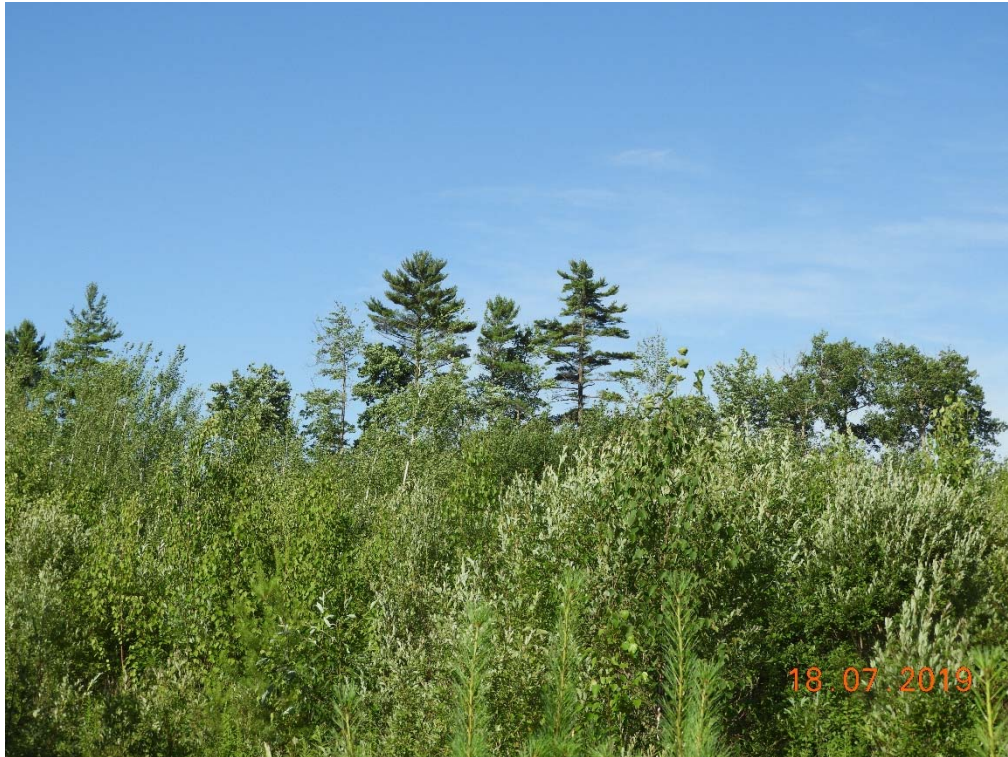
*Photo 7: Dry-Fresh White Pine-Sugar Maple Mixed Forest (FOM2-2) present along the southwest boundary of the study site near Highway 7. 18 July 2019.*

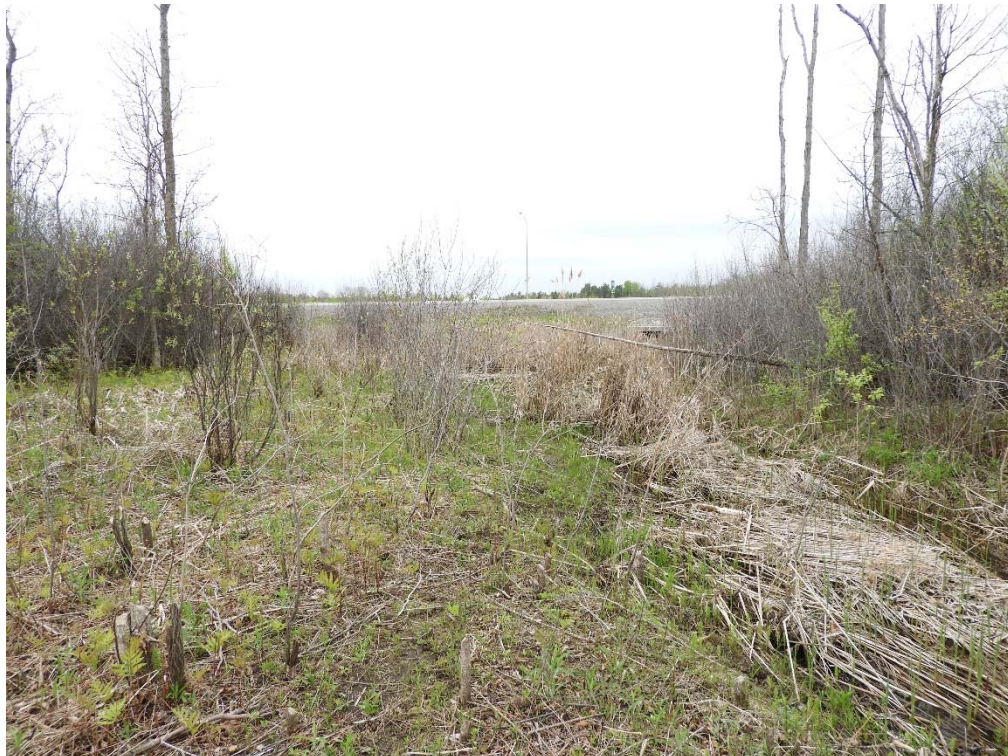
*Photo 8: Upstream view of tributary of Poole Creek entering study area from Highway 7 culvert (background) and entering PSW within study area. 23 May 2019.*

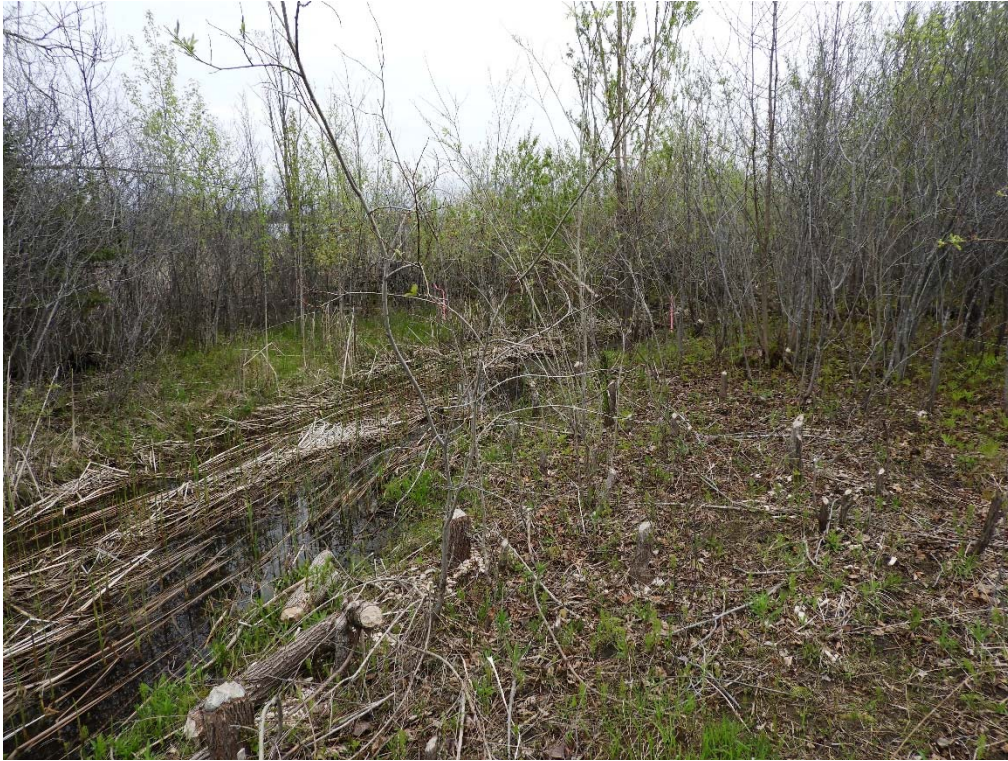
*Photo 9: Downstream view of tributary of Poole Creek within Willow Mineral Thicket Swamp (SWT2-2) of the PSW. 23 May 2019.*

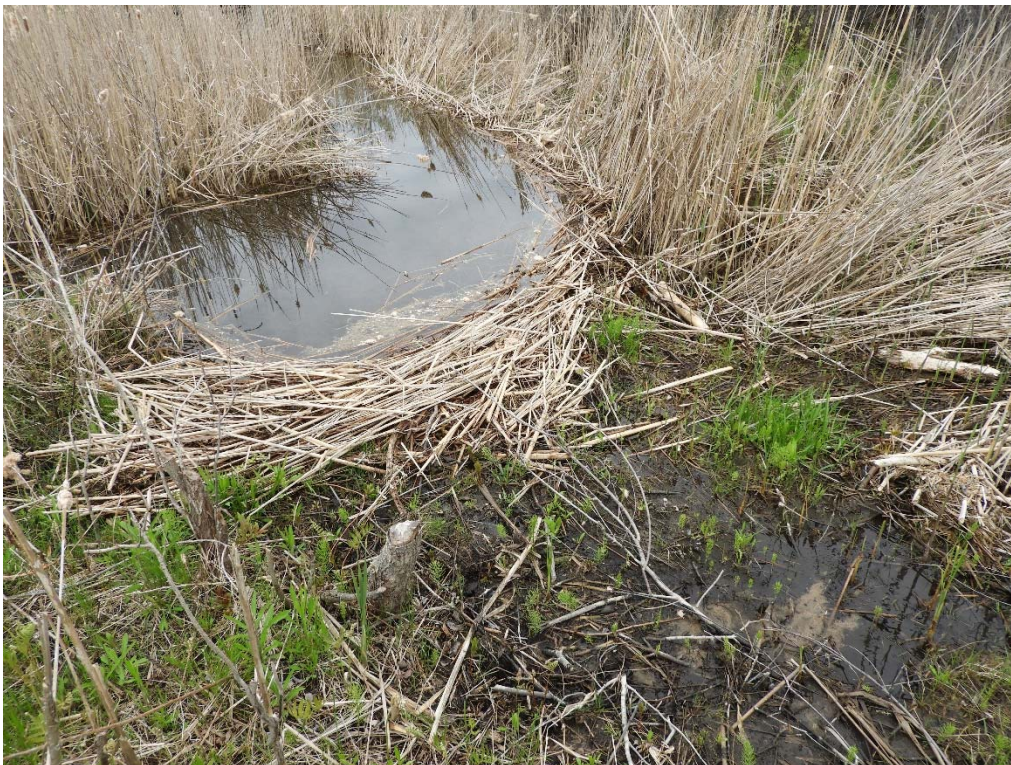
*Photo 10: Small beaver dam constructed in the tributary of Poole Creek within the PSW. 23 May 2019.*

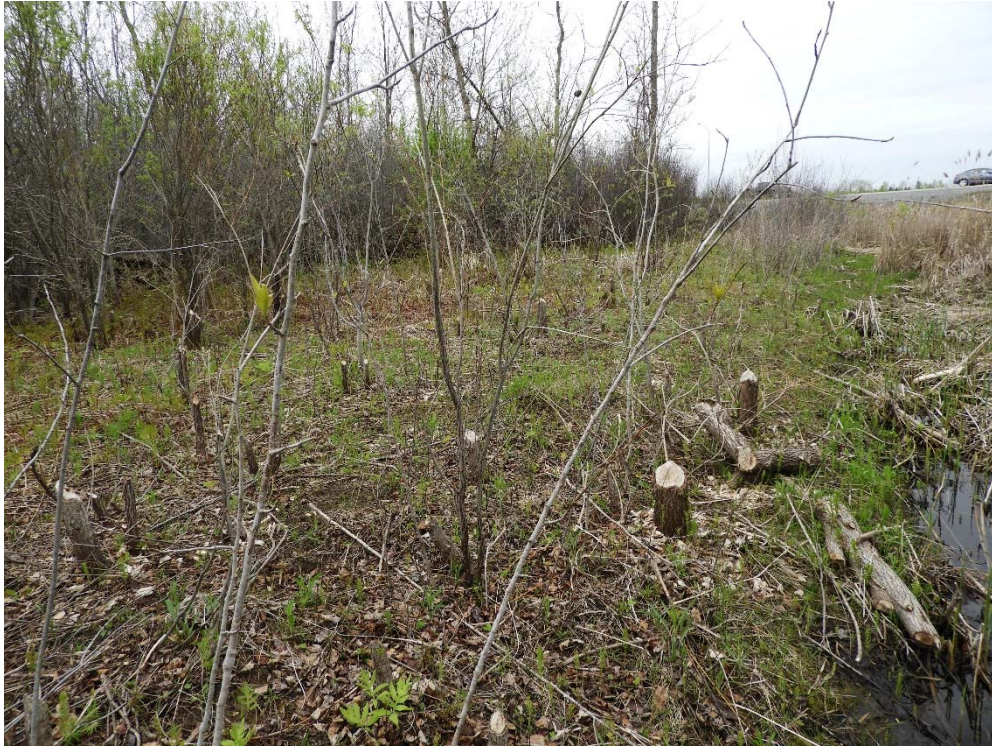
*Photo 11: North American beaver (Castor canadensis) chew evidence was present in and near the tributary of Poole Creek. 23 May 2019.*

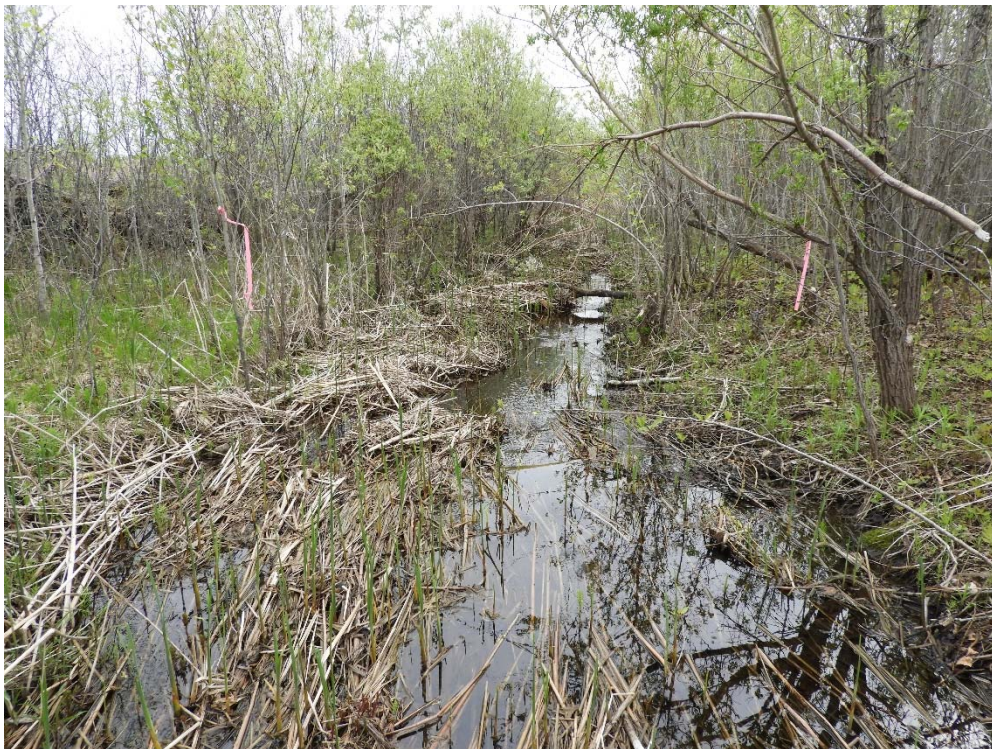
*Photo 12: Downstream view of tributary of Poole Creek within the PSW. 23 May 2019.*

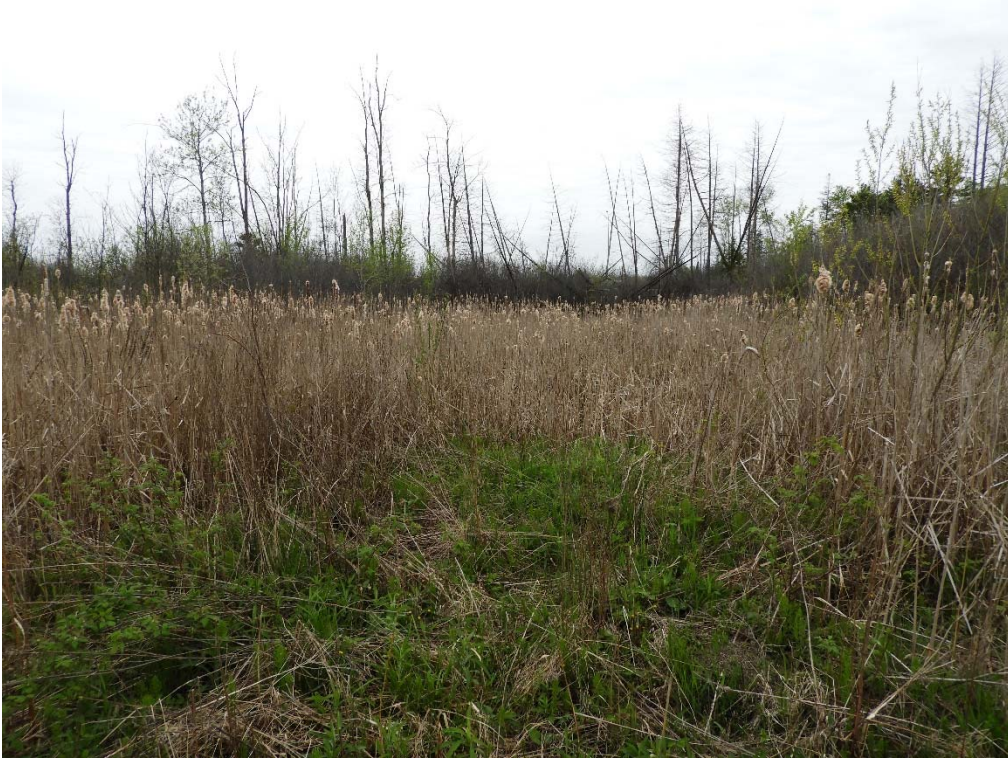
*Photo 13: Cattail Mineral Shallow Marsh (MAS2-1) of the PSW. 23 May 2019.*

Vegetation Community 9 was classified through ELC as a Cattail Mineral Shallow Marsh (MAS2-1) (**Photo 13**). This community is located on the north and south sides of Vegetation Community 8. These areas consisted of low-lying

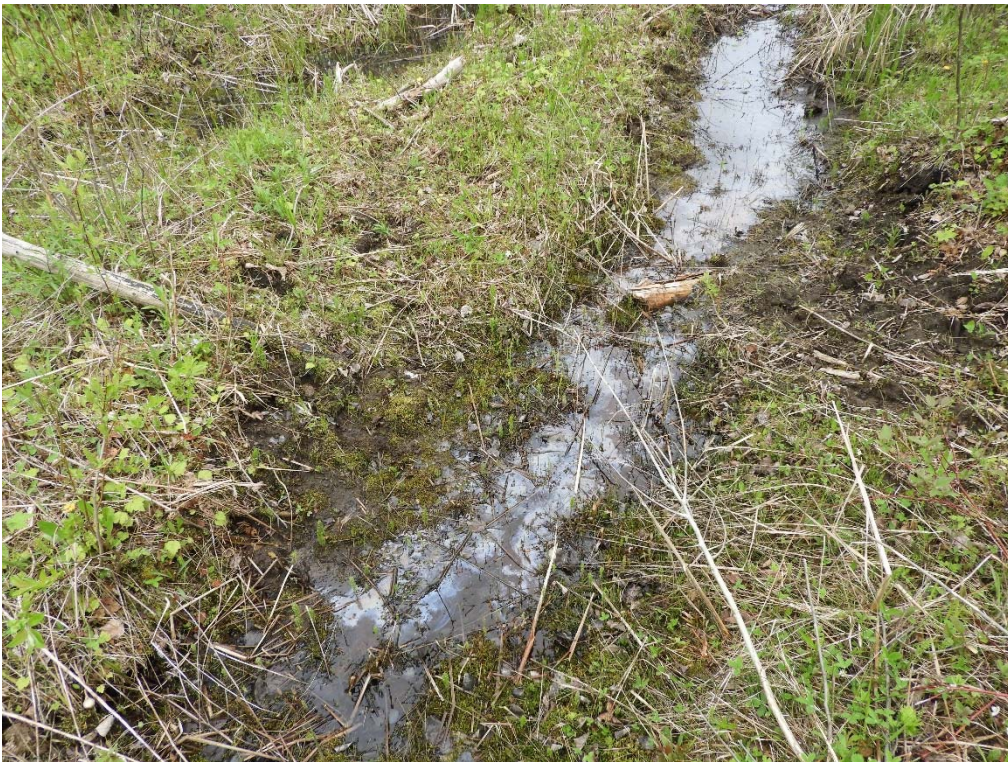
*Photo 14: Film on standing water which may indicate groundwater upwelling within the PSW. 23 May 2019.*

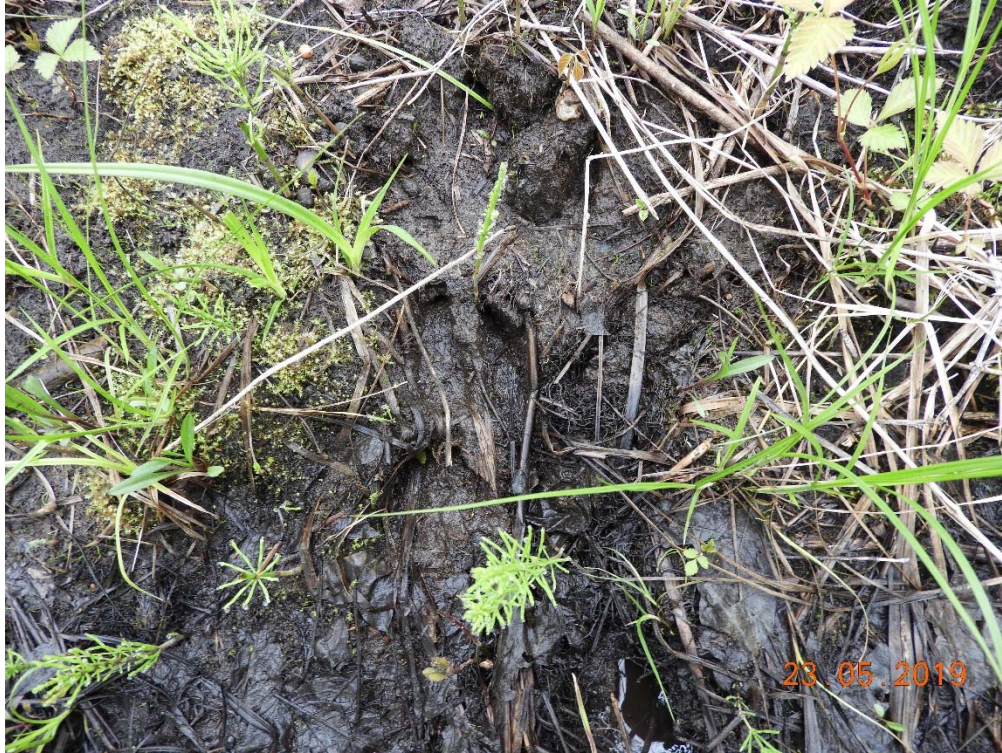
*Photo 15: White-tailed deer (Odocoileus virginianus) tracks and an adult were observed within the study area during the 2019 field investigations. 23 May 2019.*

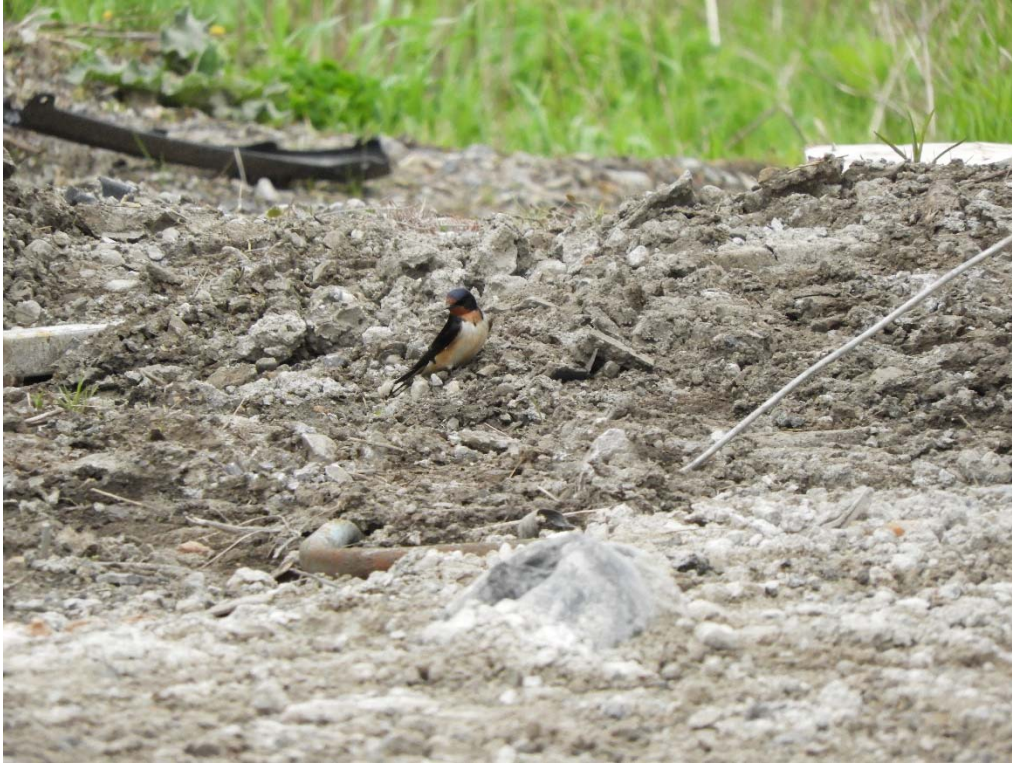
*Photo 17: Barn Swallow (Hirundo rustica) observed in the existing tow yard just outside the study area which was also observed foraging in the study area. 23 May 2019.*

utilize adjacent property consisting of gravel lots (north of the study area) for nesting, however no nesting habitat was identified within the study area. A Barn Swallow was identified directly north of the study area in the gravel lot, perched on the ground and also foraging within the study area (**Photo 17**). This species may utilize the study area for aerial foraging, however it does not provide any nesting habitat (i.e. bridges, box culverts, other artificial structures with covered ledges) or significant habitat for its life processes. These species will not be discussed further in this report.

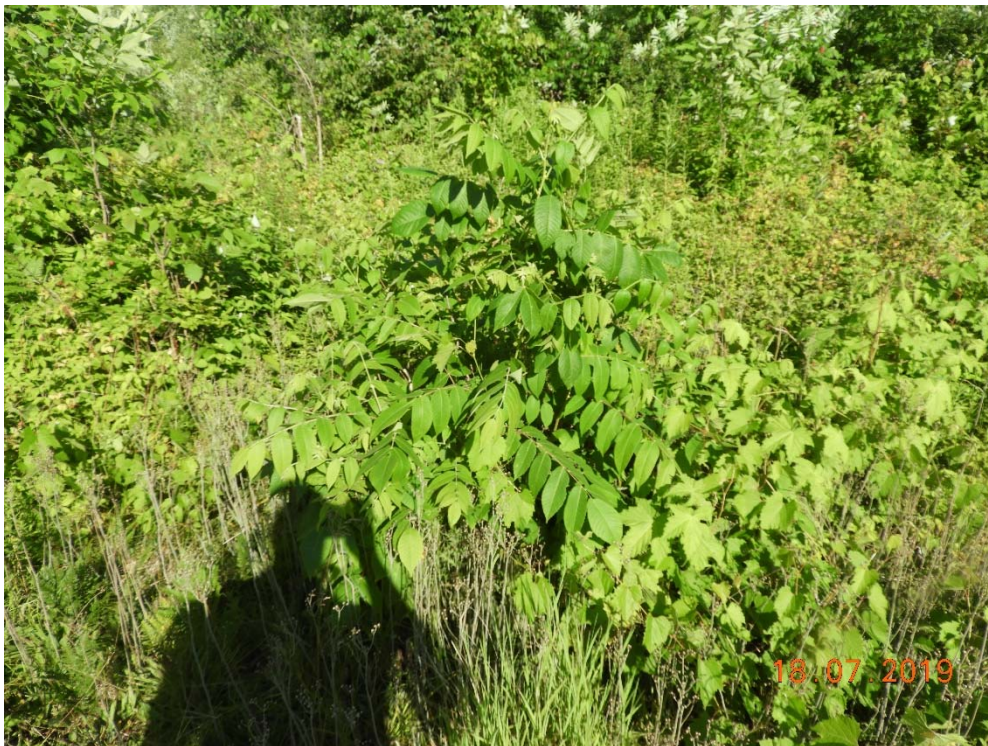
*Photo 18: Immature Butternut (Juglans cinerea) observed within the study area. 18 July 2019.*

The Butternut is listed as 'Endangered' under the *Endangered Species Act* (ESA) (2007) and the *Species at Risk Act* (SARA) (2002). Habitat for this species and individuals of this species are afforded protection. Habitat is available within the study area due to the wide range of habitat preferences for Butternuts in which to grow. Butternuts are shade intolerant and prefer open areas but often become crowded out by other pioneer species (i.e. regenerating areas). Ten (10) Butternuts were identified and located within the study area during the July 18, 2019 field investigation. Three (3) of these individuals appeared to be mature trees with at least one (1) fruiting (**Photos 18 - 22**). The Butternuts were identified within the Mineral Cultural Savannah (CUS1) and Mineral Cultural Thicket (CUT1) south of the PSW. Under the ESA, individuals must be assessed by a qualified Butternut Health Inspector to determine the general health and viability of the individual to resist the butternut canker (*Sirococcus clavigignenti-juglandacearum*) and produce immune offspring.

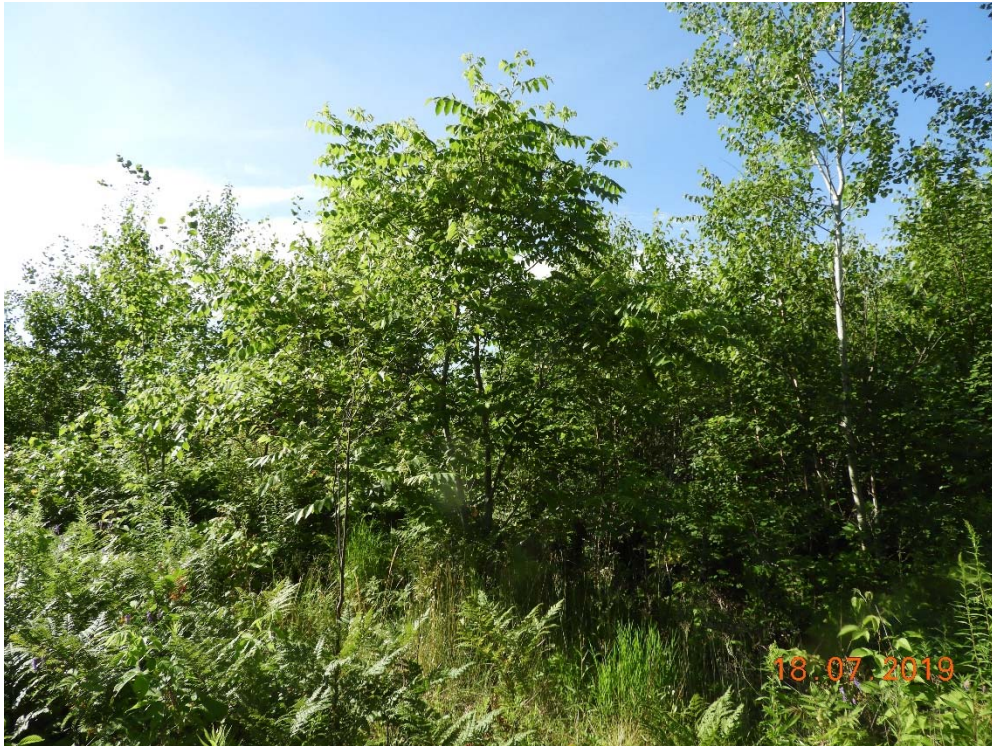
*Photo 19: Mature Butternut (Juglans cinerea) observed within the study area. 18 July 2019.*

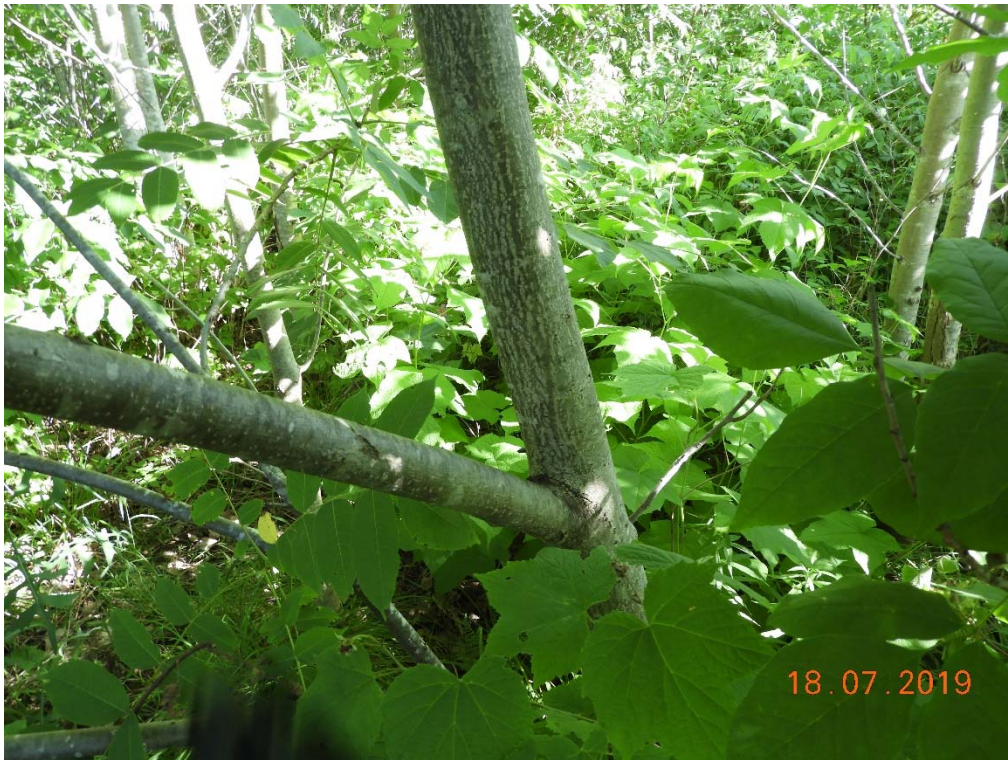
*Photo 20: Bark of mature Butternut (Juglans cinerea) with low rate of damage from Butternut canker. 18 July 2019.*

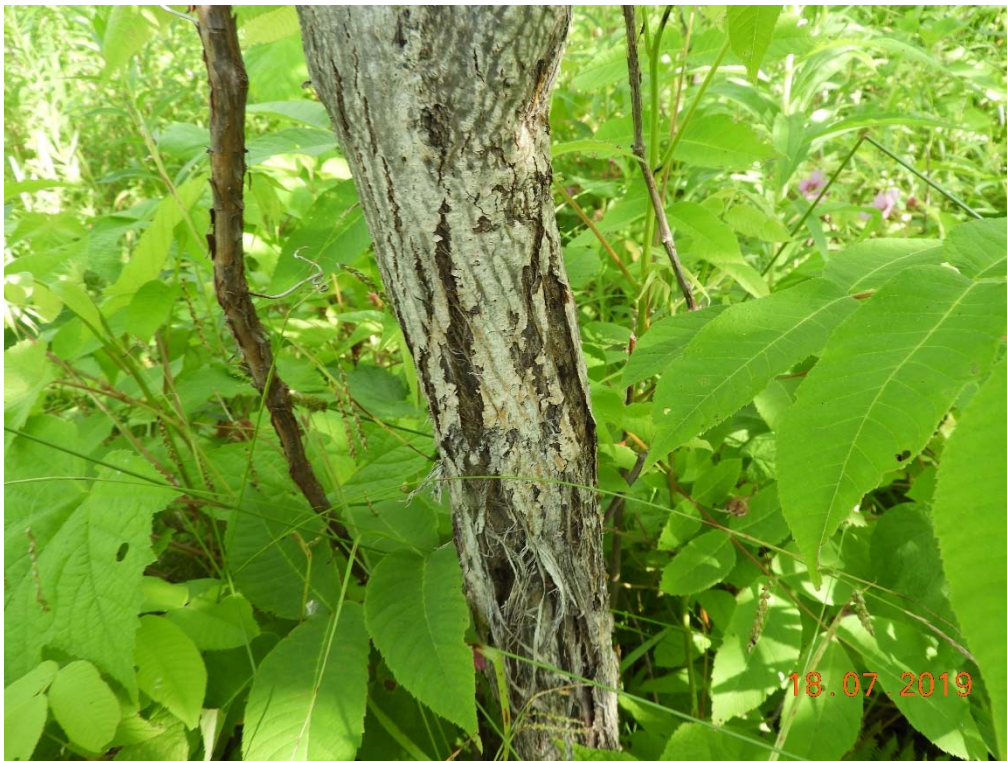
*Photo 21: Bark of mature Butternut (Juglans cinerea) with moderate rate of damage from Butternut canker. 18 July 2019.*

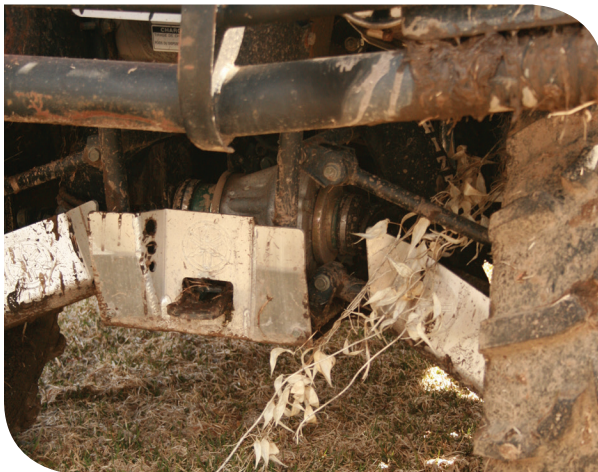
**Dog-strangling Vine plants attached to ATV.**

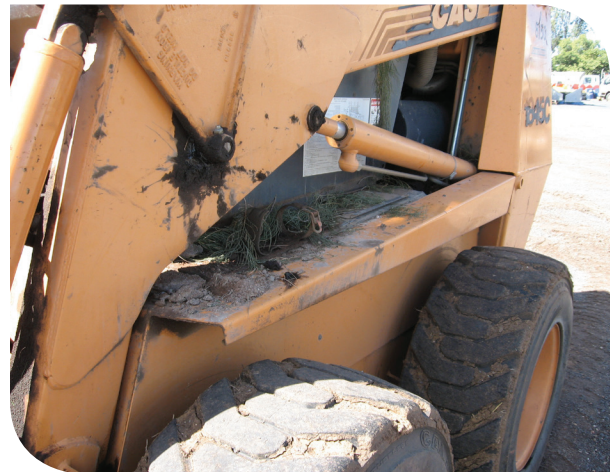
**Plant material attached to bobcat.**

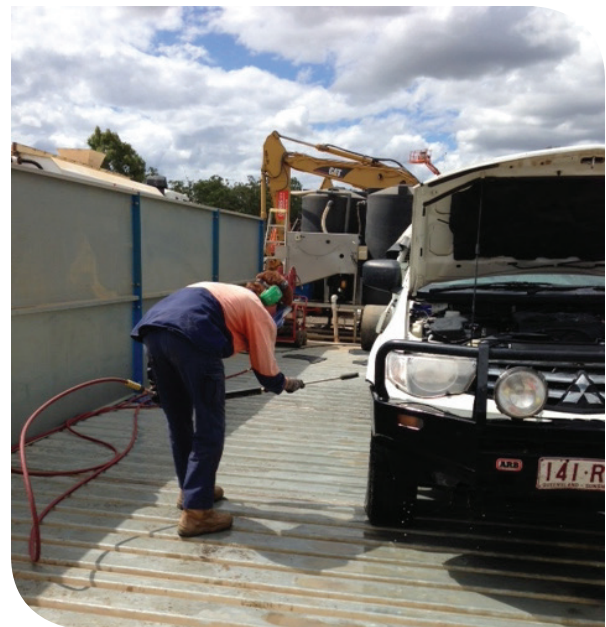
**Hosing down a vehicle in Queensland Australia**

For equipment such as water trucks that may be exposed to aquatic invasive species, trucks should be disinfected with bleach solution before conducting work in a new area. For further information please refer to the Invading Species Awareness Program's Technical Guidelines listed under Contacts and Resources.

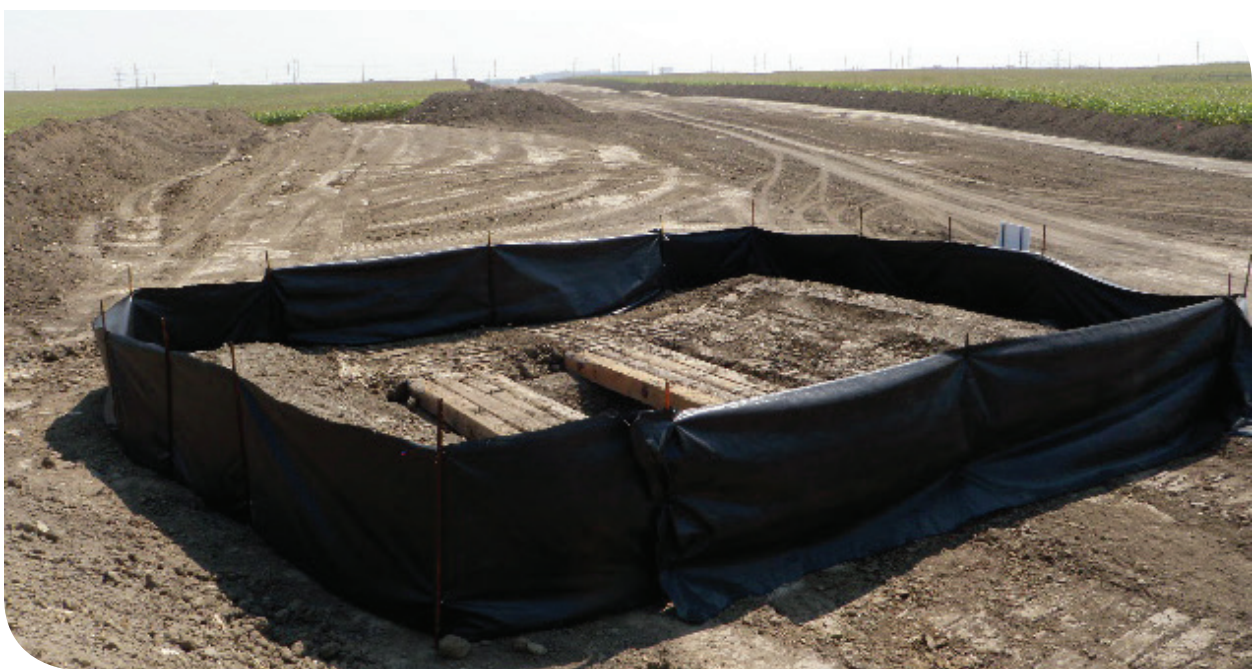
**Cleaning station at construction site.**

- A pump and high pressure hose OR High pressure water unit
- Minimum water pressure for vehicle cleaning should be at least 90 pounds per square inch. Water can be supplied as high volume/low pressure or low volume/high pressure (NOAA Fisheries Service).
- Air compressor and blower OR Vacuum
- Shovel
- Pry bar
- Stiff brush or broom

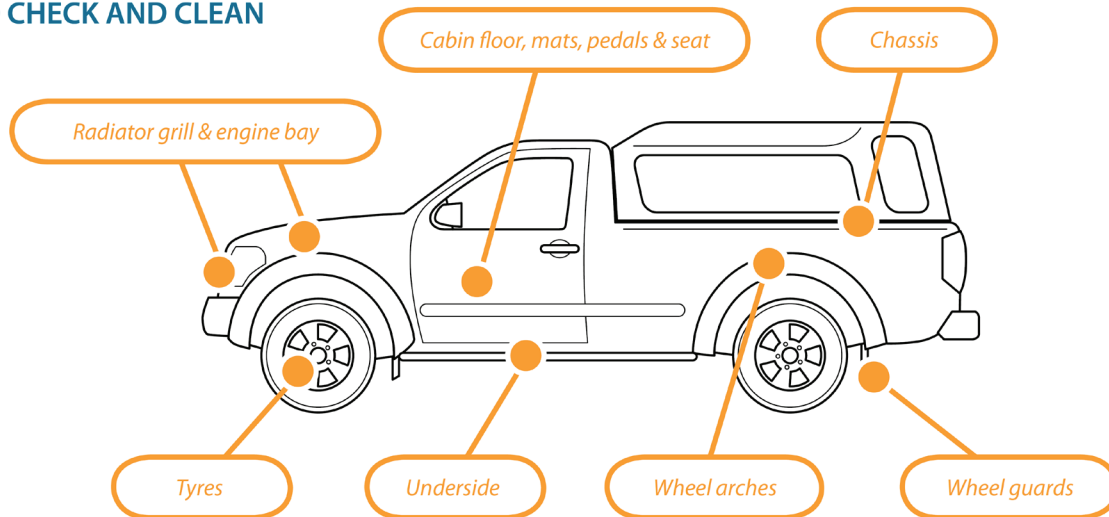
### 4WD VEHICLE WITH KEY SPOTS TO CHECK AND CLEAN

✓
<b>Cabin</b>	Floor, mats, pedals, seats	
<b>Engine</b>	Radiators, engine bay, grill	
<b>Body</b>	Underside, chassis, crevices, ledges, bumper bars	
<b>Wheels</b>	All wheels (including spare), wheel arches, guards	
<b>Tray</b>	Floor, canopy (if included)

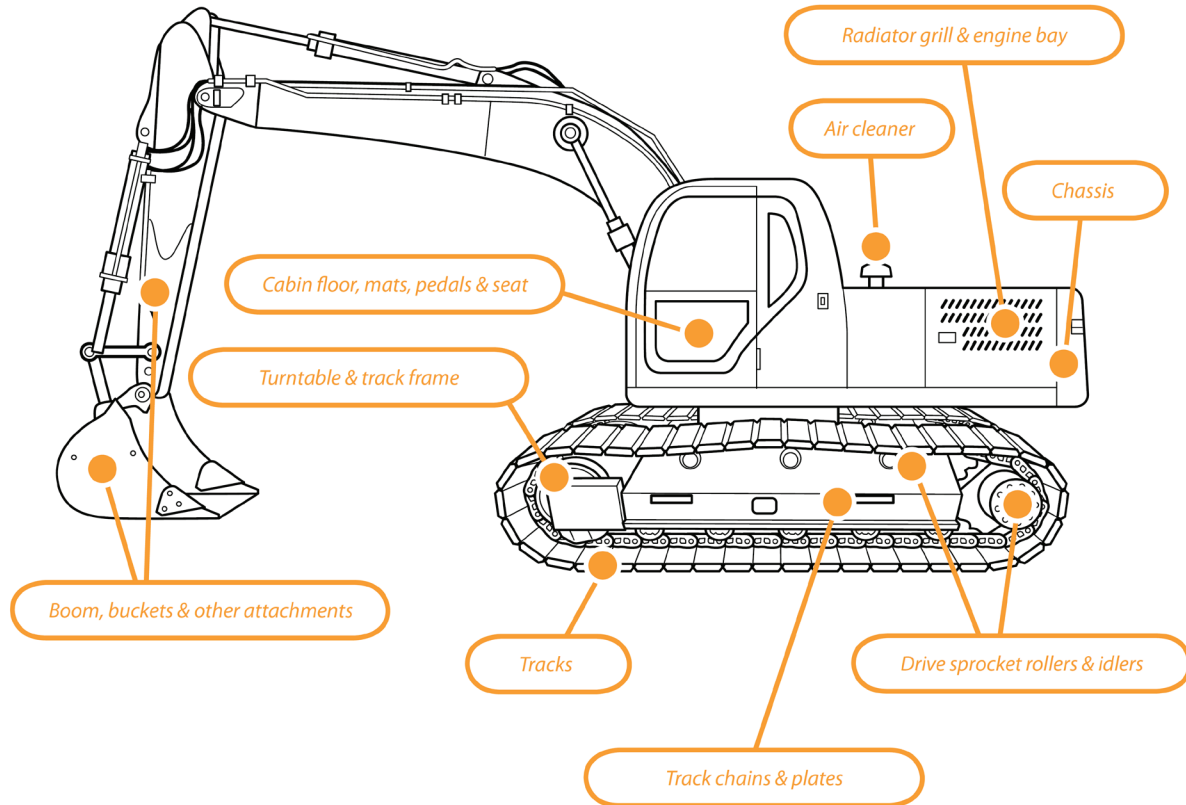
## EXCAVATOR WITH KEY SPOTS TO CHECK AND CLEAN

✓
<b>Cabin</b>	Floor, mats, pedals, seats	
<b>Engine</b>	Radiators, engine bay, grill, air cleaner	
<b>Tracks</b>	Tracks, track frame, drive sprocket rollers, idlers	
<b>Body Plates</b>	Plates of cabin	
<b>Body</b>	Ledges, channels	
<b>Bucket</b>		
<b>Booms</b>		
<b>Turret Pivot</b>

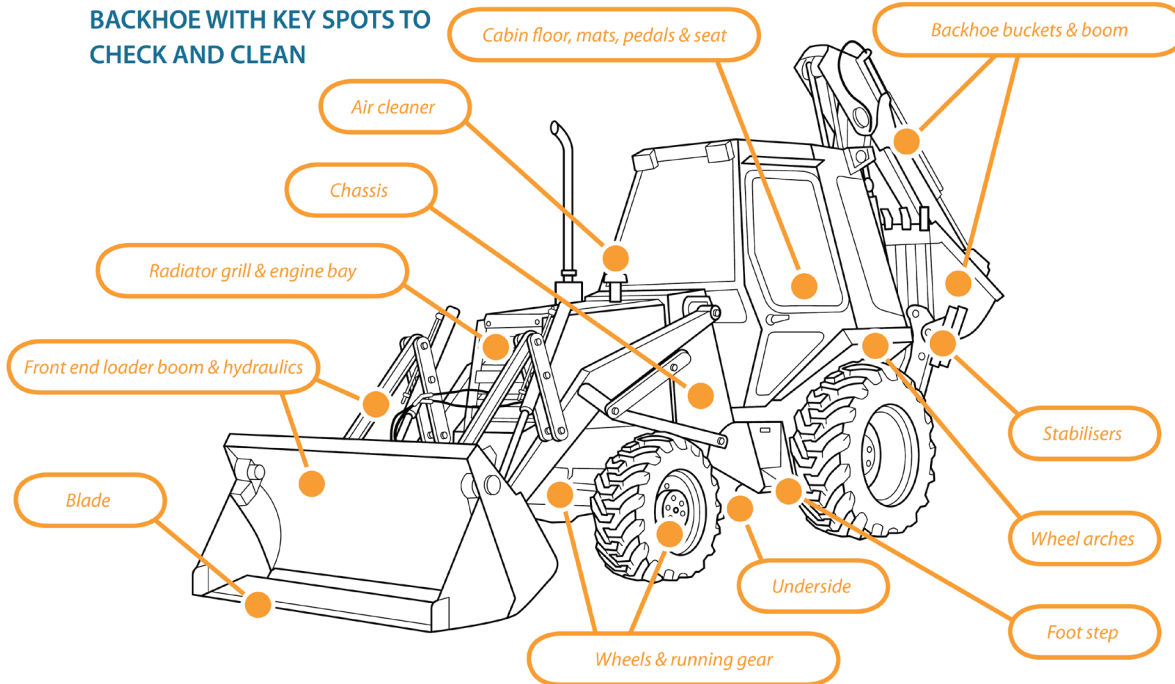
### BACKHOE WITH KEY SPOTS TO CHECK AND CLEAN

✓
Cabin	Floor, mats, pedals, seats, foot step	
Engine	Radiators, engine bay, grill, air cleaner	
Wheels	All wheels (including spare), wheel arches, guards	
Front end loader	Blade, hydraulics, booms	
Backhoe	Buckets, boom, hydraulics, stabilizers

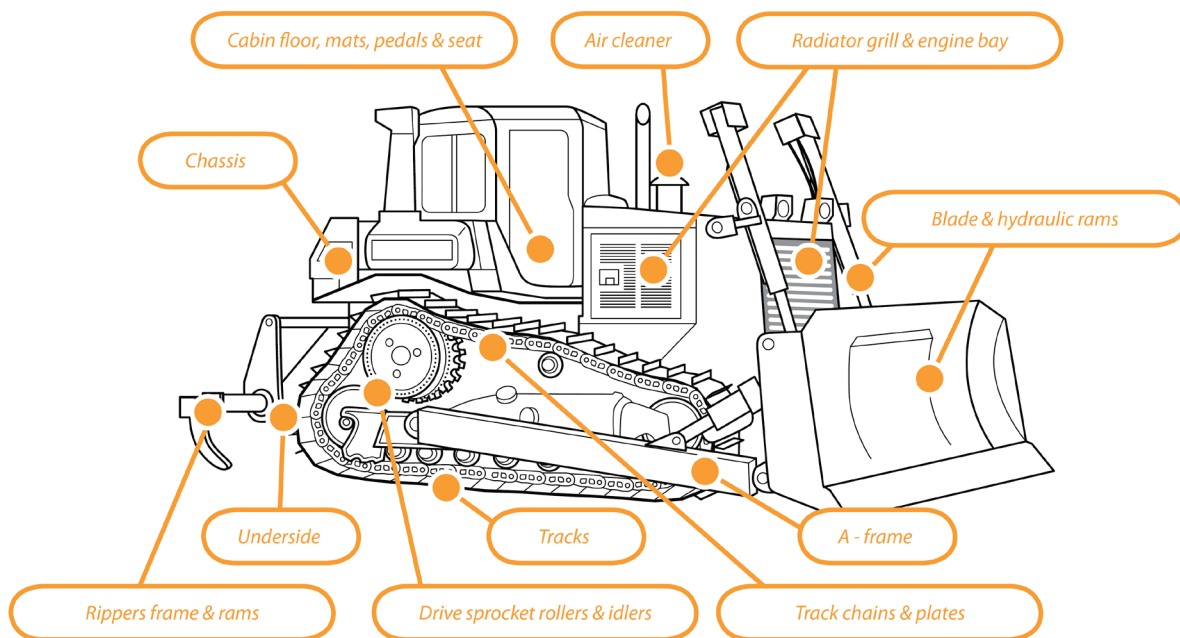
### BULLDOZER WITH KEY SPOTS TO CHECK AND CLEAN

✓
Cabin	Floor, mats, pedals, seats	
Engine	Radiators, engine bay, grill, air cleaner	
Tracks	Tracks, track frame, drive sprocket rollers, idlers	
Body Plates	Belly plates and rear plates	
Body	Ledges, channels	
Blade	Pivot points, hydraulic rams, a-frame	
Ripper	Ripper frame, ripper points
