Phase I-Environmental Site Assessment

Proposed Athletic Recreation Complex (ARC)

Algonquin College

Report: PE4406-1

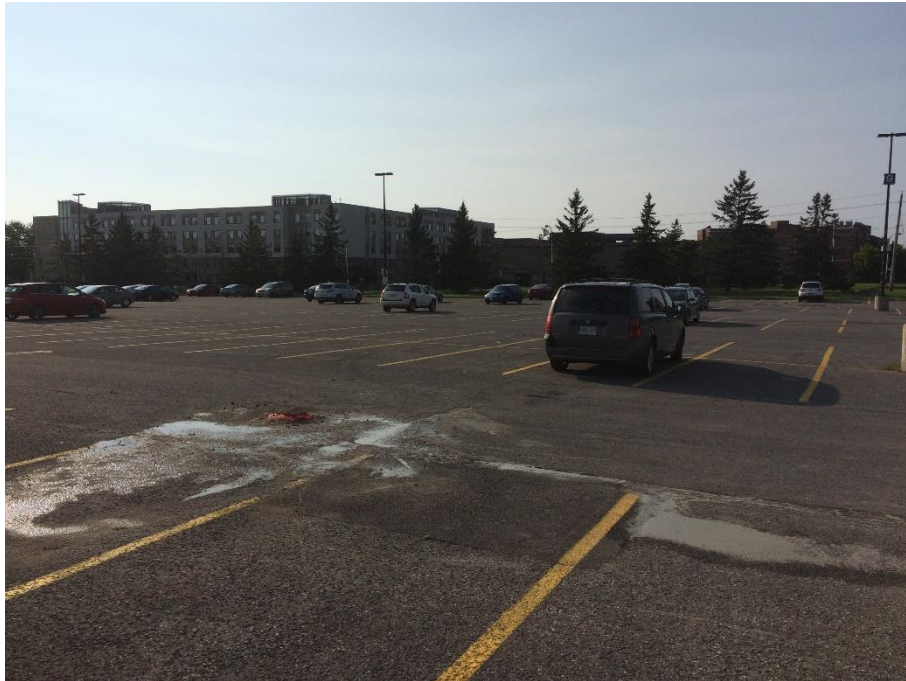
Photograph 1: Photograph illustrates the Phase I Property, facing northwest. Photograph illustrates the Residence and G Building to the north.

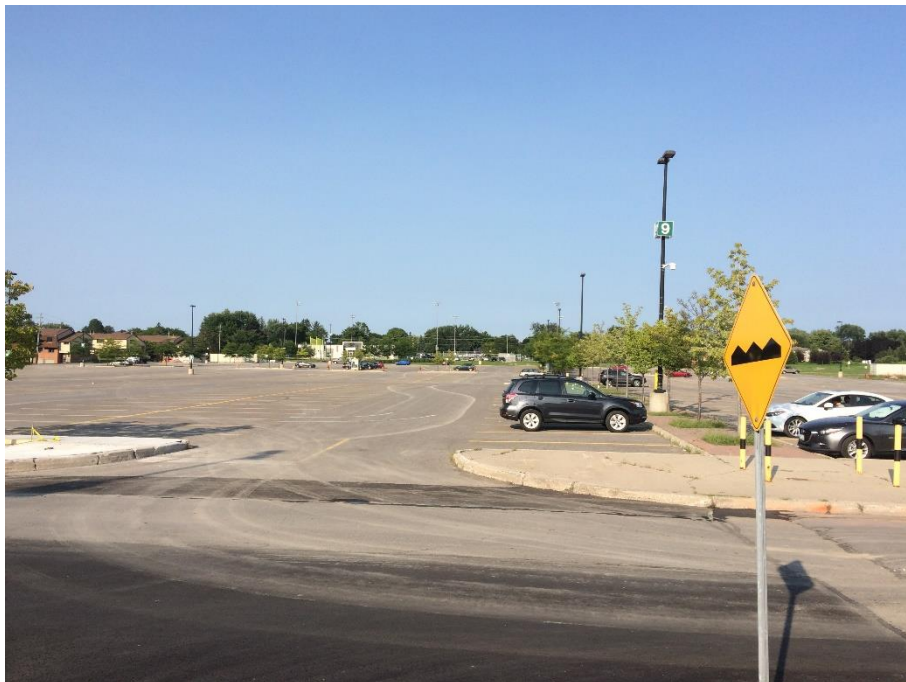
Photograph 2: View of land adjacent to the Phase I Property, facing east. Photograph illustrates the parking lot to the east.

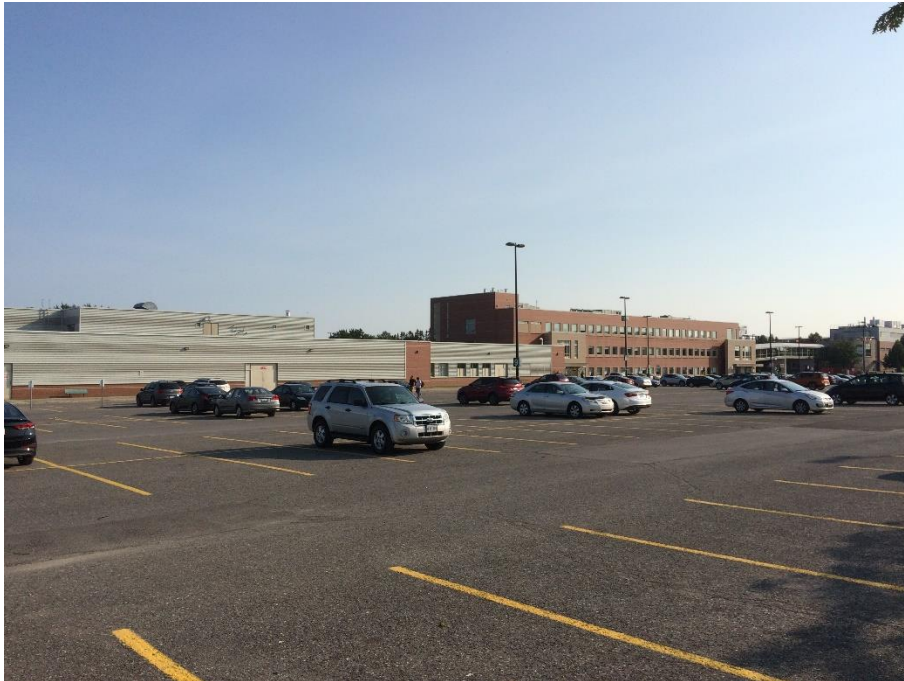
Photograph 3: View of land adjacent to the Phase I Property, facing southwest. Photograph illustrates the adjacent parking lot and P Building to the south.

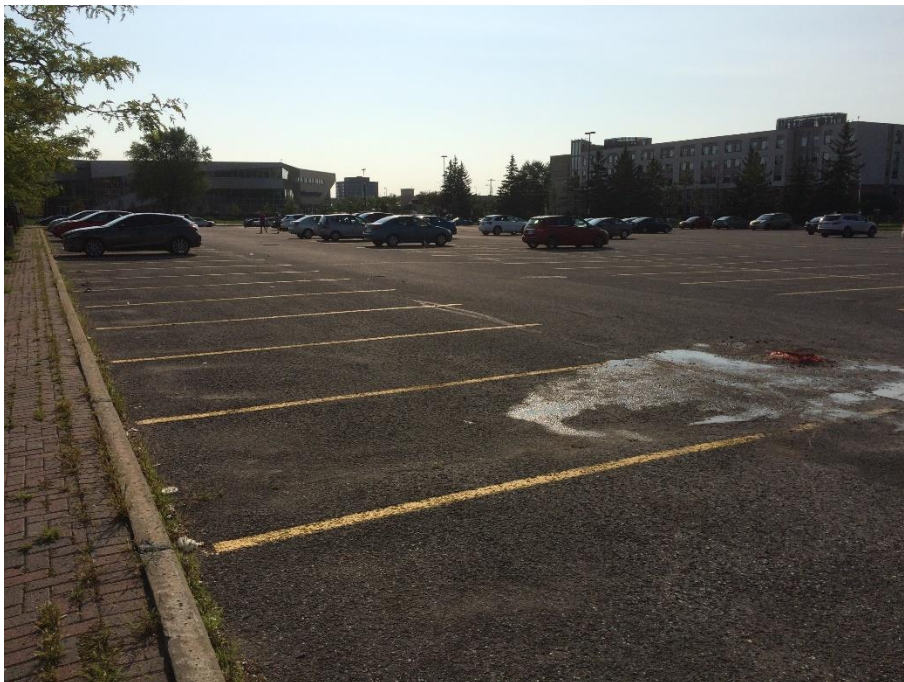
Photograph 4: View of Phase I Property facing northwest. Photograph illustrates the majority of the Phase I Property, Student Commons Building to the west, and the residence building to the north.
