Muncaster
Environmental
Planning Inc.

December 31, 2019

RE: 2707 Solandt Drive
Tree Conservation Report and Environmental Impact Statement - Revised

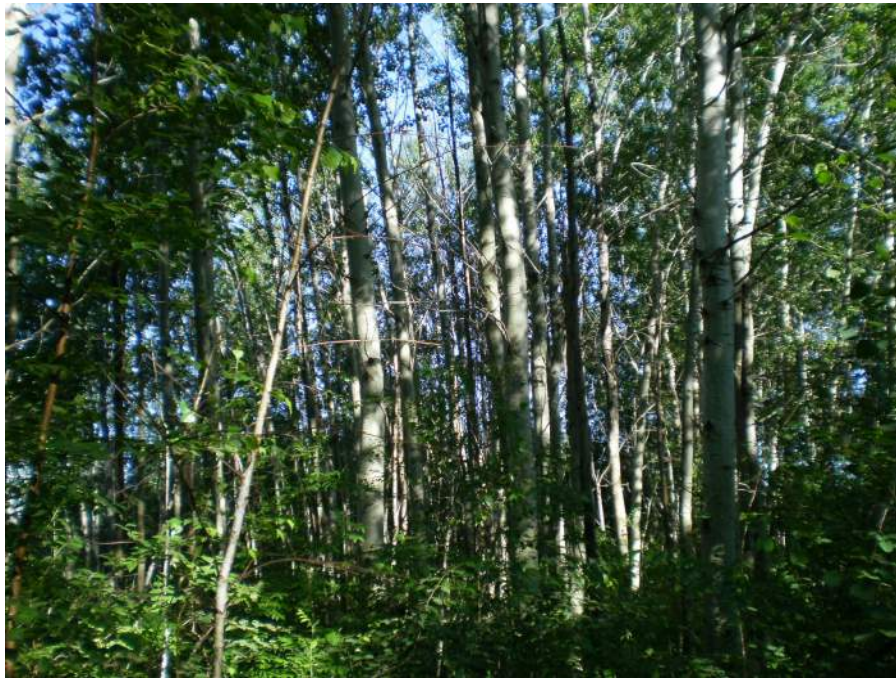
*Photo 1 – Typical poplar trees in the centre portion of the upland deciduous forest.
View looking northwest*

The site is dominated by a young upland poplar-birch deciduous forest (Map 1, Photos 1, 2 and 3) dominated by trembling aspen and large-toothed aspen up to 36cm dbh, with white birch, grey birch, red maple, and white spruce in the 20cm to 23cm dbh and Scot's pine up to 30cm dbh. Young birch trees were more dominant in the west portion of the site (Photo 3). Windthrow was extensive in areas, especially in the west portion of the forest. Fungus and bark damage were common on many of the poplar and birch trees. A twin-stem white pine, with the larger stem 38cm dbh, in the west portion appeared to be in good condition, but similar sized white pines in the southeast corner showed bark damage and had poor form (Photo 4). The conifer component, including white spruce, white pine, and Scot's pine, was greater in the south portion. Many trails were throughout the small forest (Photo 2). The east edge of the forest, west of the stormwater channel described below, is dominated by regenerating poplar and birch stems.

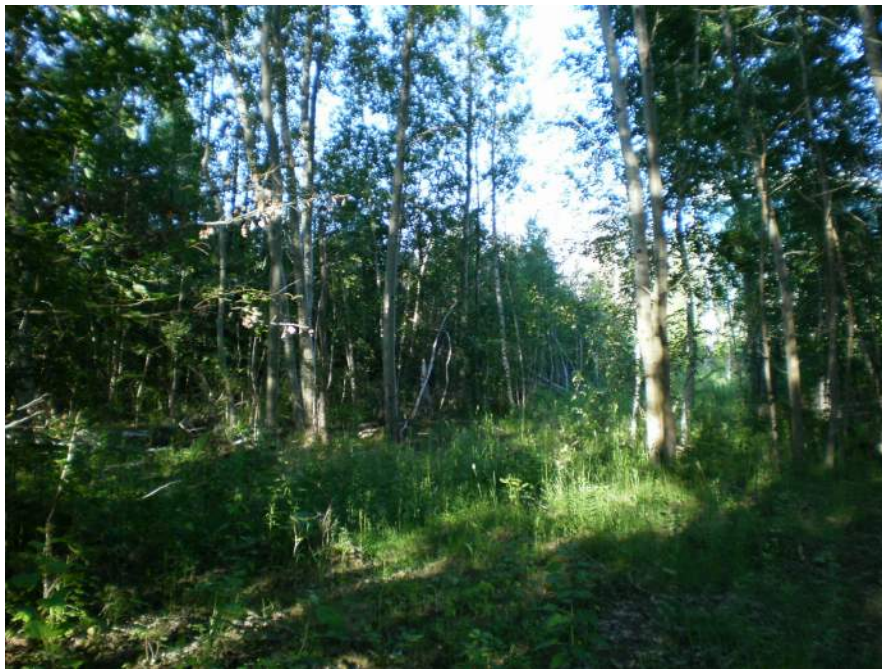
*Photo 2 – There are many open areas in the upland deciduous forest.
This example is in the central portion of the forest, with view looking west*

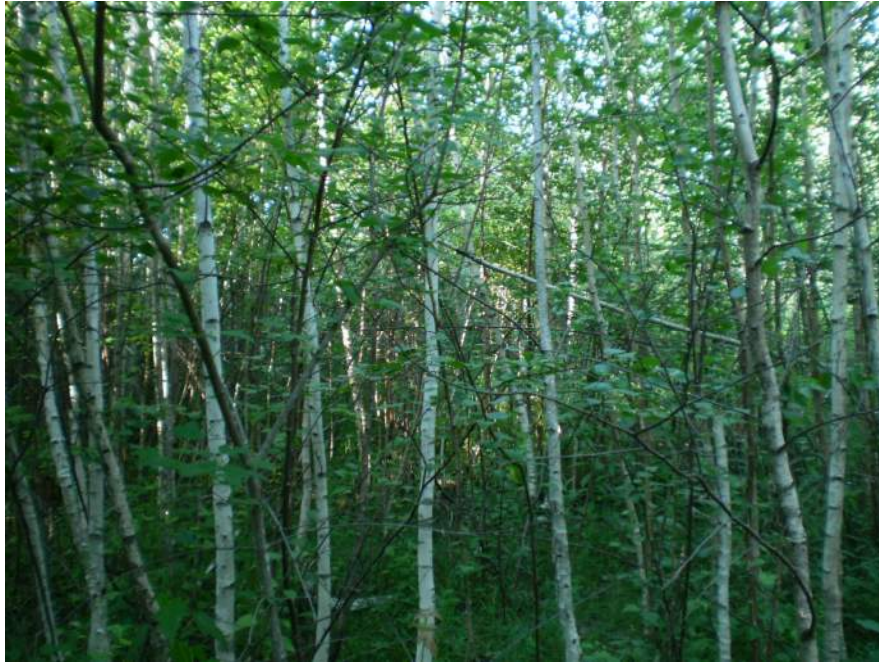
*Photo 3 – Young birch were dominant in the west portion of the upland deciduous forest.
View looking southwest*

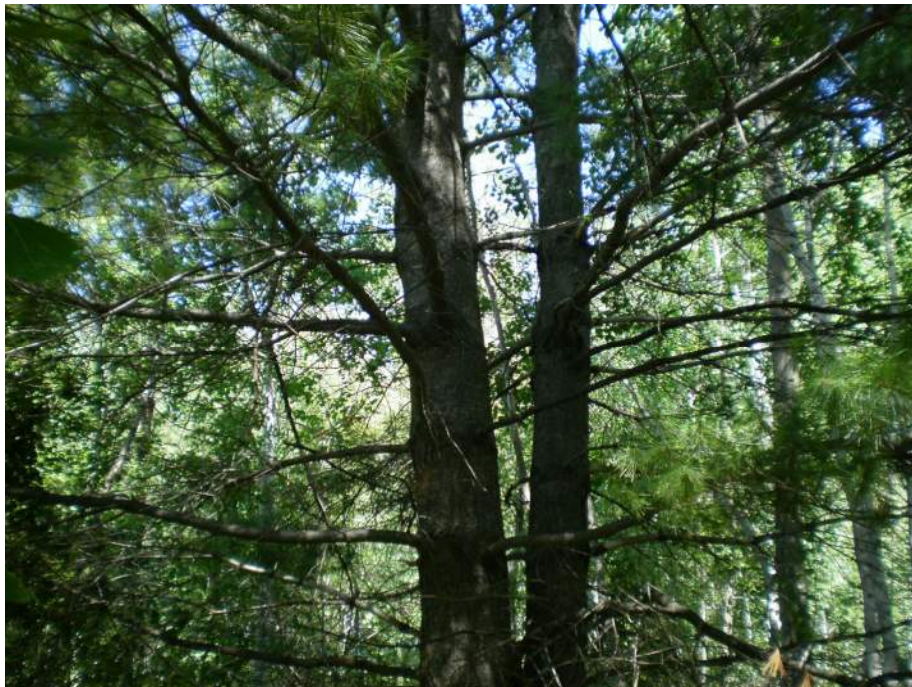
*Photo 4 – The largest trees on-site were a couple of white pines in the south portion of the
upland forest. This example is in the southwest corner of the site. View looking north*

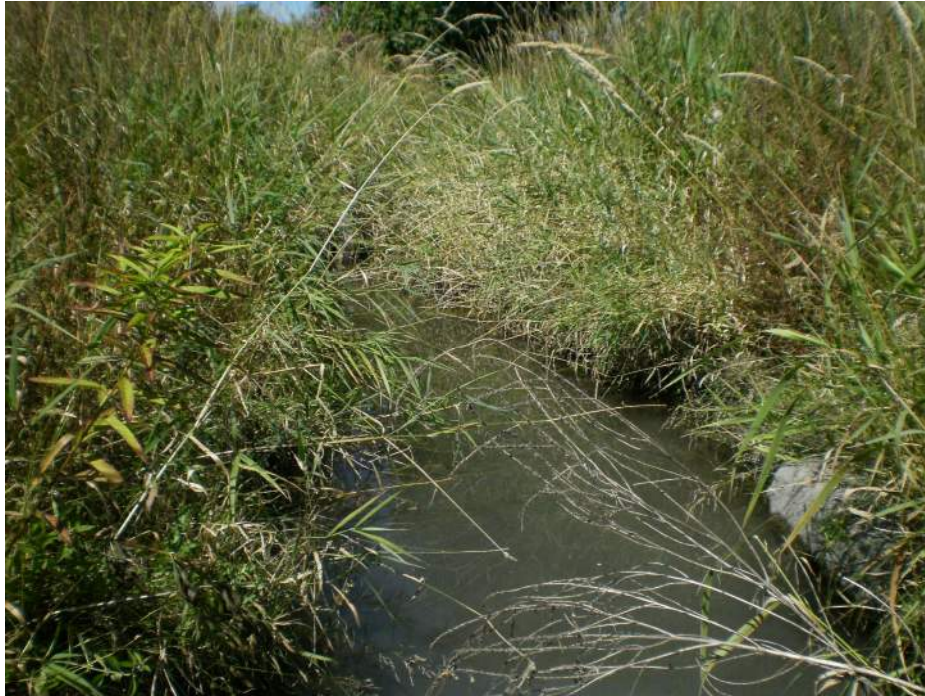
Photo 5 – Shirley’s Brook is the northwest edge of the site. View looking north

The Kanata North Environmental /Stormwater Management Plan (CH2MHill, 2000) concluded that the aquatic habitat potential of Shirley's Brook in the general vicinity of the site is generally limited by the lack of runs and riffle habitat and the dominance of clay, silts or exposed bedrock substrate. This appears to still be the situation in the northwest corner of the site where fines were the dominant substrate and the channel is clearly entrenched as part of an extended homogeneous reach (Photo 5). However, some cobble substrate was present and other forms of aquatic habitat structure included undercut banks, a meandering alignment with permanent flow, clear water, and submerged and floating vegetation (common waterweed and variable-leaved pondweed). Several forage fish were observed, including brook stickleback. Fish diversity was low in past fish community sampling in the general vicinity of the site, with common shiner, white sucker, brook stickleback, central mudminnow, and bluntnose minnow noted. Shirley's Brook was considered to support a tolerant warm-water fish community. The wetted width of the channel on July 7th averaged 1.8 metres, with average water depths estimated in the 50cm range. After an extended period of minimal precipitation, flow was still present in Shirley's Brook in the northwest corner of the site on August 26th, with water depths averaging 30cm. The Shirley's Brook and Watt's Creek Subwatershed Study (Dillon, 1999) noted that groundwater flows in the clay and till surficial geology units were too slow to be of significance in terms of base flow contributions to the channel.

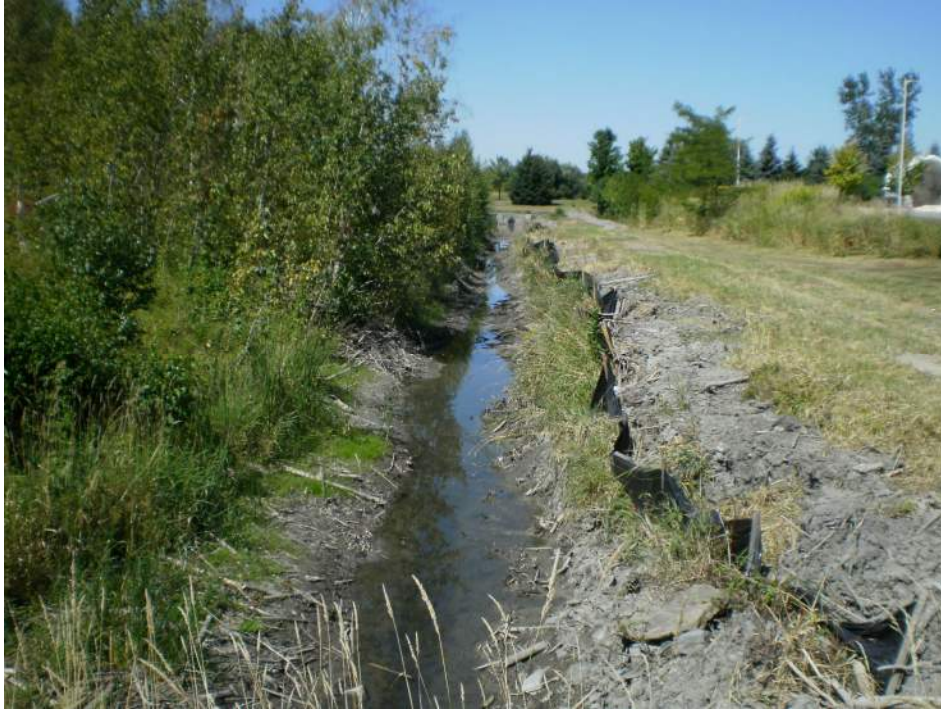
Photo 7 – North-south stormwater channel in the stormwater easement in the east edge of the site. View looking north from Solandt Road

The City's north-south stormwater easement on the east edge includes an open channel dug in the late 1990s and modified in the 2000s with construction south of Solandt Drive (Photo 7). The City's infrastructure mapping shows the channel is the outlet for all stormwater off Solandt Drive east of March Road. It is a channel dug and maintained to provide a connection between two concrete headwalls. There was no natural channel in this area before the stormwater infrastructure was dug. The stormwater channel is open for approximately 125 metres between concrete headwalls. The water depth was generally less than 5cm, with some ponding south of the north headwall. Evidence of former beaver dams were noted adjacent to the channel and as indicated below beaver cuttings were common in the east portion of the upland forest. Reed canary grass, soft-stem bulrush and broad-leaved cattail were common vegetation along the channel, with a small area of cattails adjacent to the west side of the north portion of the channel.

Although the north-south stormwater channel in the east portion of the site is not fish habitat by definition and no fish were observed in the stormwater channel during the field surveys, there is the potential for forage fish to be in the channel. The channel will be retained in its existing location but a culvert will be installed to provide access to the existing surface parking to the east at 2705 Solandt Drive. The following additional mitigation measures are recommended for the culvert installation:

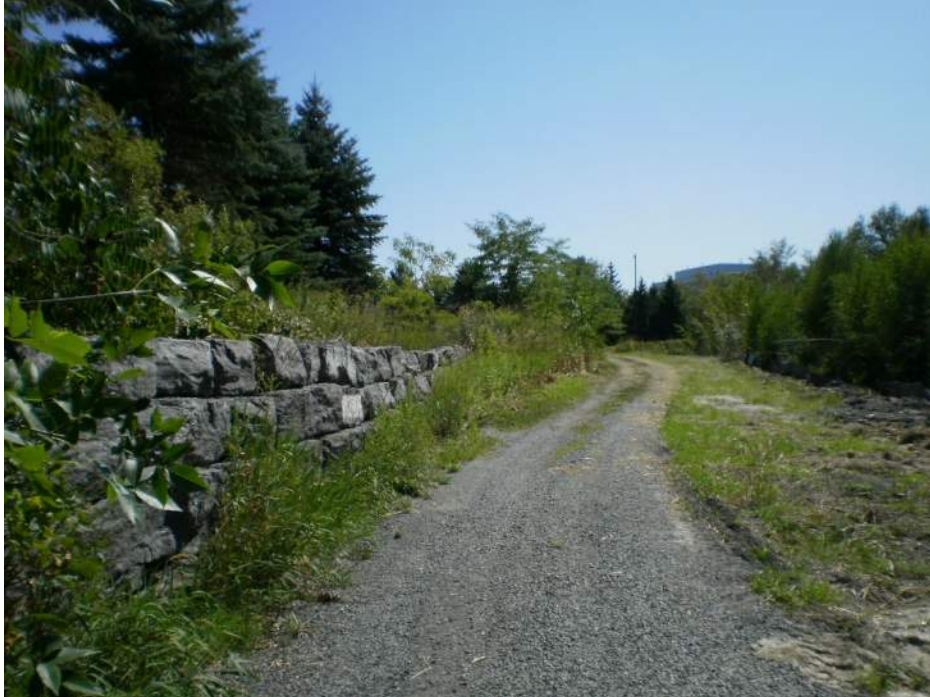
Photo 8 – Access trail, retaining, wall, berm and coniferous plantings on and adjacent to the east edge of the site. View looking south from the north property line

Another cultural meadow is along the east edge of the site and includes an access trail from Solandt Drive to the golf course north of the site and a sanitary sewer (Photo 8). Common ground flora in the meadow habitat included June meadow grass, timothy, common brome grass, common burdock, cow vetch, bladder campion, field horsetail, thicket creeper, tall goldenrod, white clover, wild carrot, common yarrow, ox-eye daisy, and black swallowwort.

A retaining wall and berm separate the site from the surface parking lot to the east. Conifer plantings up to 25cm dbh are to the east of the retaining wall on the berm. The critical root zones of these plantings would not extend onto the site. Along the north property line, white pine plantings up to 30cm dbh are common, with smaller white spruce. The critical root zone of these trees would extend onto the north edge of the site by up to three metres. There is a sidewalk north of Solandt Drive and thus no trees are to the south of the site. Meadow habitat is common to the west of the site, with poplar and birch trees up to 20cm dbh adjacent to the site further north of Solandt Drive. The critical root zone of these trees would extend onto the west edge of the site by up to one metre.

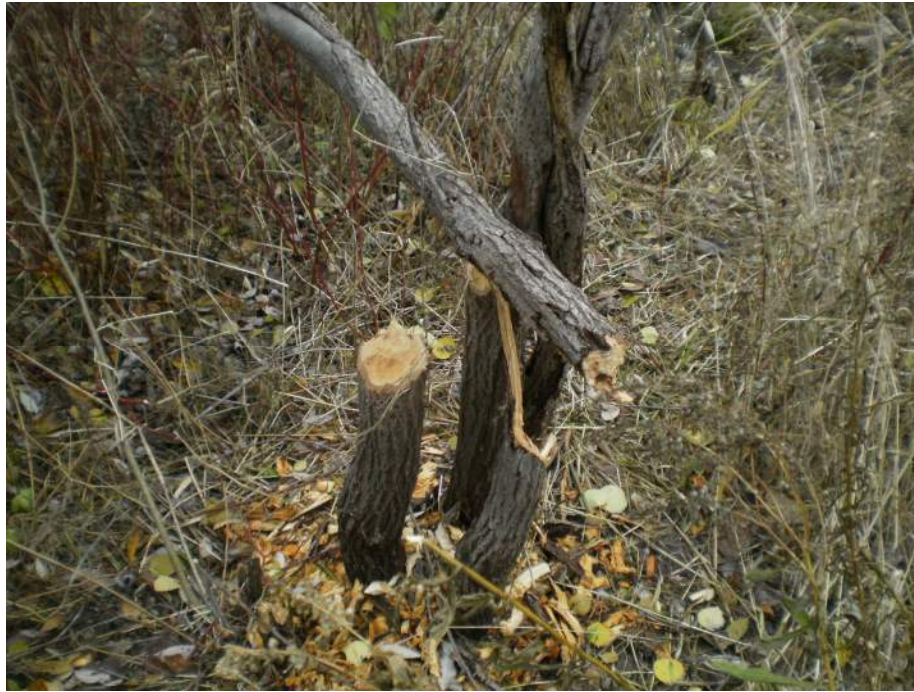
Photo 9 – Beaver cutting in the east edge of the site, west of the stormwater channel

The only Species at Risk observed on or adjacent to the site during the field surveys were barn swallows flying over the golf course to the north. No structures are present on the site that may be used for barn swallow nesting. Other wildlife observed included American crow, Canada goose, European starling, black-capped chickadee, American woodcock, great-crested flycatcher, yellow warbler, common yellowthroat, American robin, northern cardinal, common grackle, red-winged blackbird, gray catbird, barn swallow, cedar waxwing, song sparrow, American goldfinch, red squirrel, grey squirrel, woodchuck, green frog, and many beaver cuttings in the

east portion of the forest (Photo 9). No cavity trees, stick nests, or other evidence of raptor use were observed on or adjacent to the site.

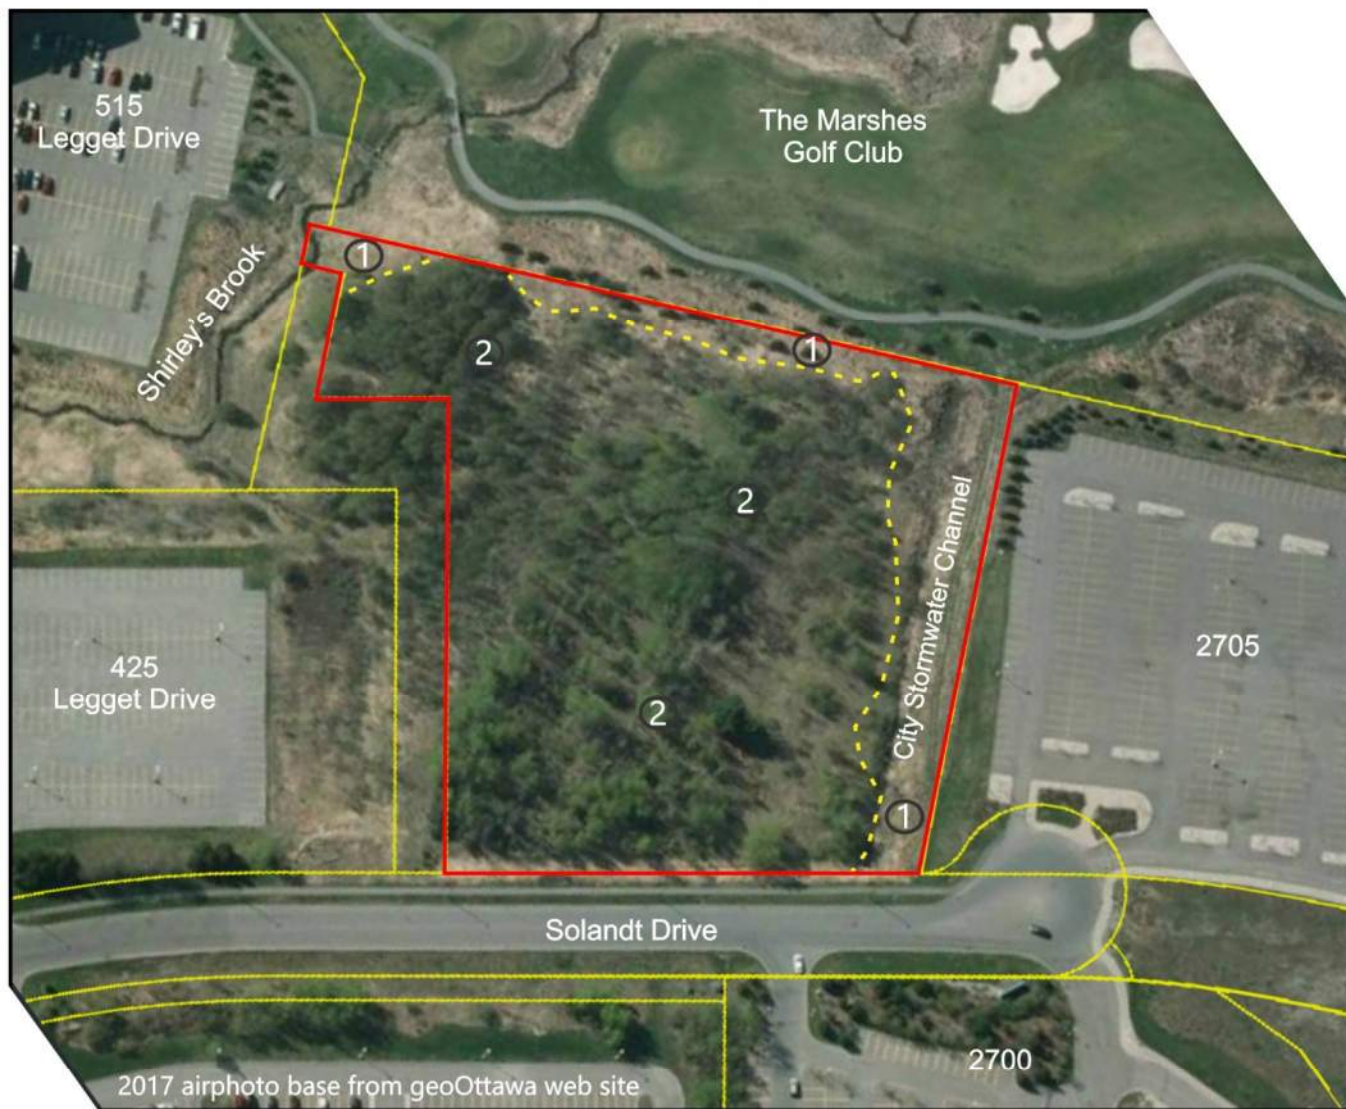
Map 1

- ① Cultural Meadow
- ② Upland Poplar - Birch Deciduous Forest

**ENVIRONMENTAL IMPACT STATEMENT/TCR
CURRENT CONDITIONS**

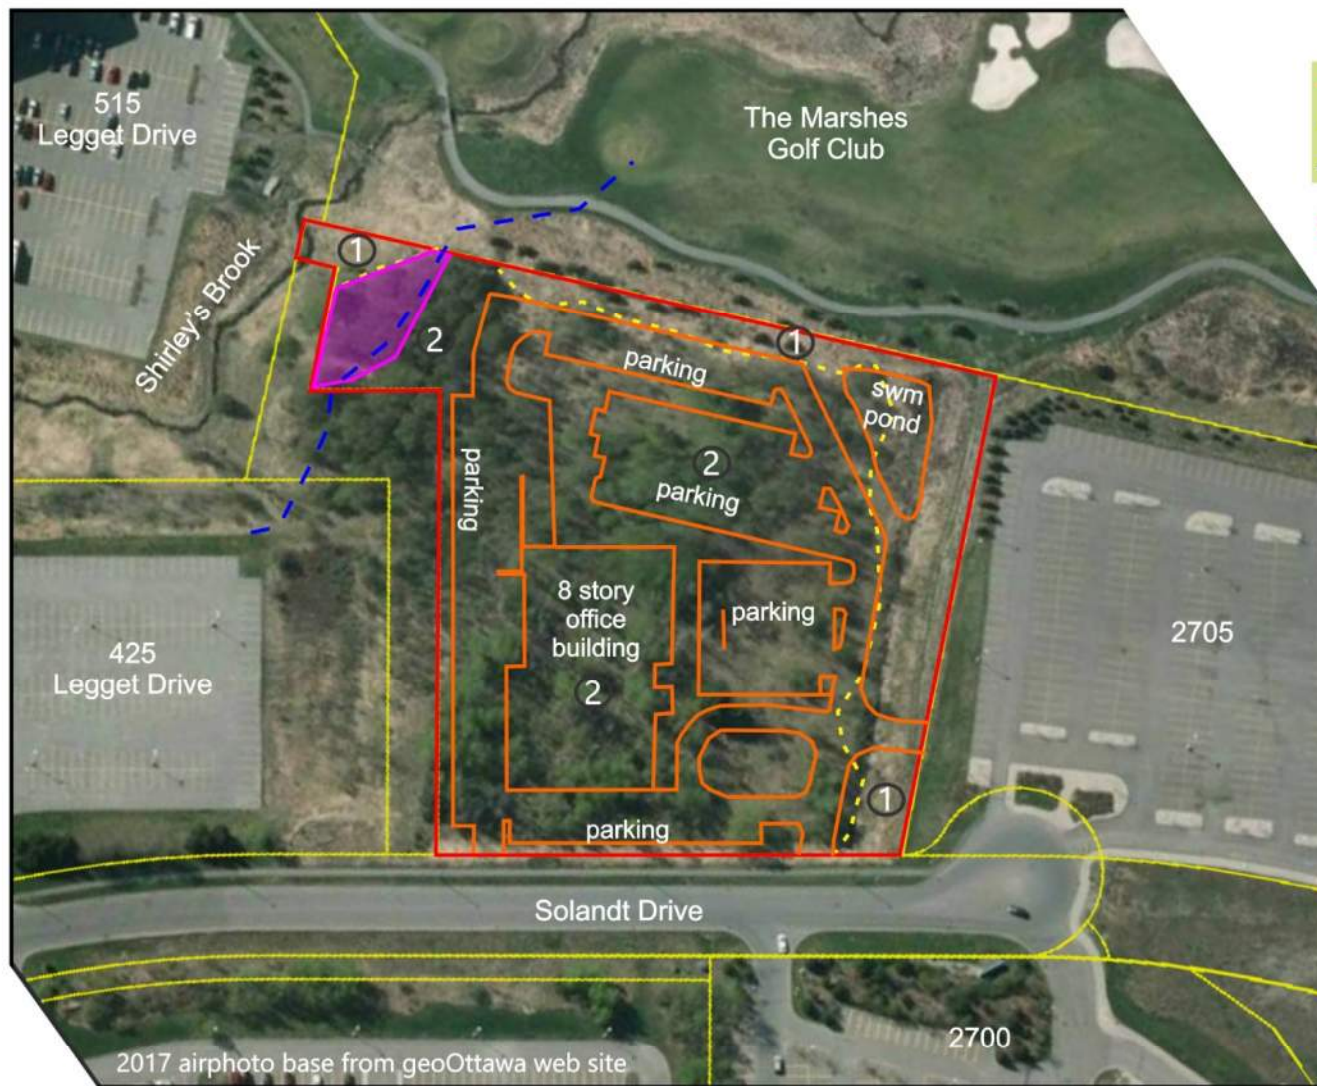
- Site
- Vegetation Community
- 30 m Shirley's Setback
- Area of tree retention

ENVIRONMENTAL IMPACT STATEMENT/TCR PROPOSED CONSERVED VEGETATION

1. No tree removal or other site disturbances within 30 metres of Shirley's Brook as shown on Map 2 and described above;
2. To protect breeding birds, no tree removal should occur between April 15th and August 15th, unless a breeding bird survey conducted by a qualified biologist within five days of the woody vegetation removal identifies no active nests in the vegetation to be removed. Tree removal should begin in the south portion of the site and extend north, allowing any wildlife to relocate to the golf course to the north;
