**Holly J. Bickerton**  
**Consulting Ecologist**

RE: Scoped EIS, 35 William St.

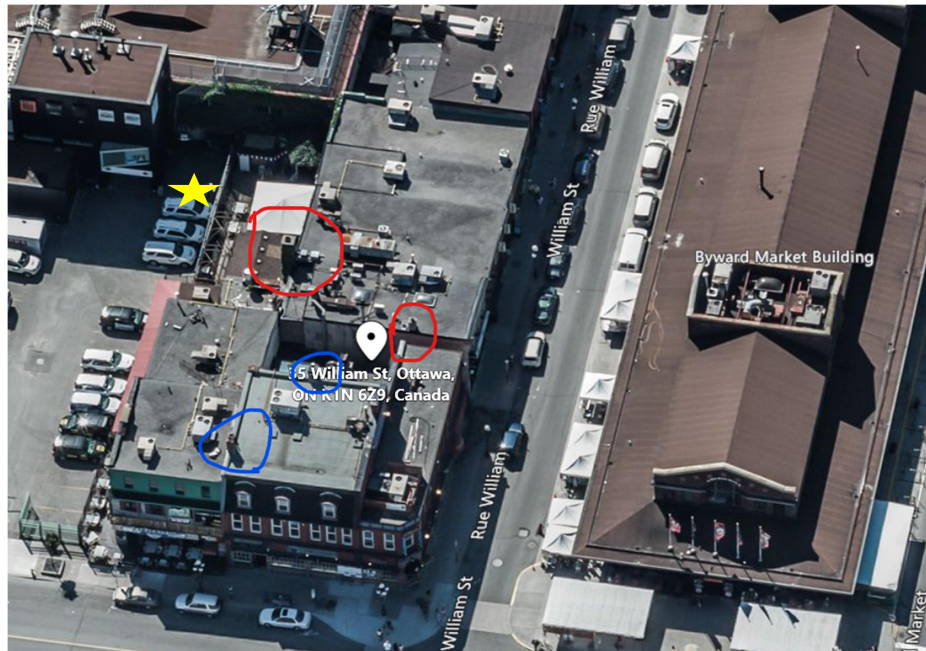
Figure 1. Aerial view of 35 William St. preceding 2019 fire. Only chimneys circled in red are on the subject property. Chimneys in blue are on the neighbouring property and not subject to this application. The photo in Figure 2 was taken from approximately the yellow star on the photo, facing William Street.

The City identified concern that the site may offer potential habitat for species at risk, namely the Chimney Swift, or three bat species at risk, suggesting the need for a Scoped EIS. Today, I have visited the site and can confirm that there is no habitat for any of these species on the current site. Not only are there no open chimneys on the site, but there is no roof remaining, and only the William St. façade was able to be retrieved. Please see Figures 1 and 2, attached.

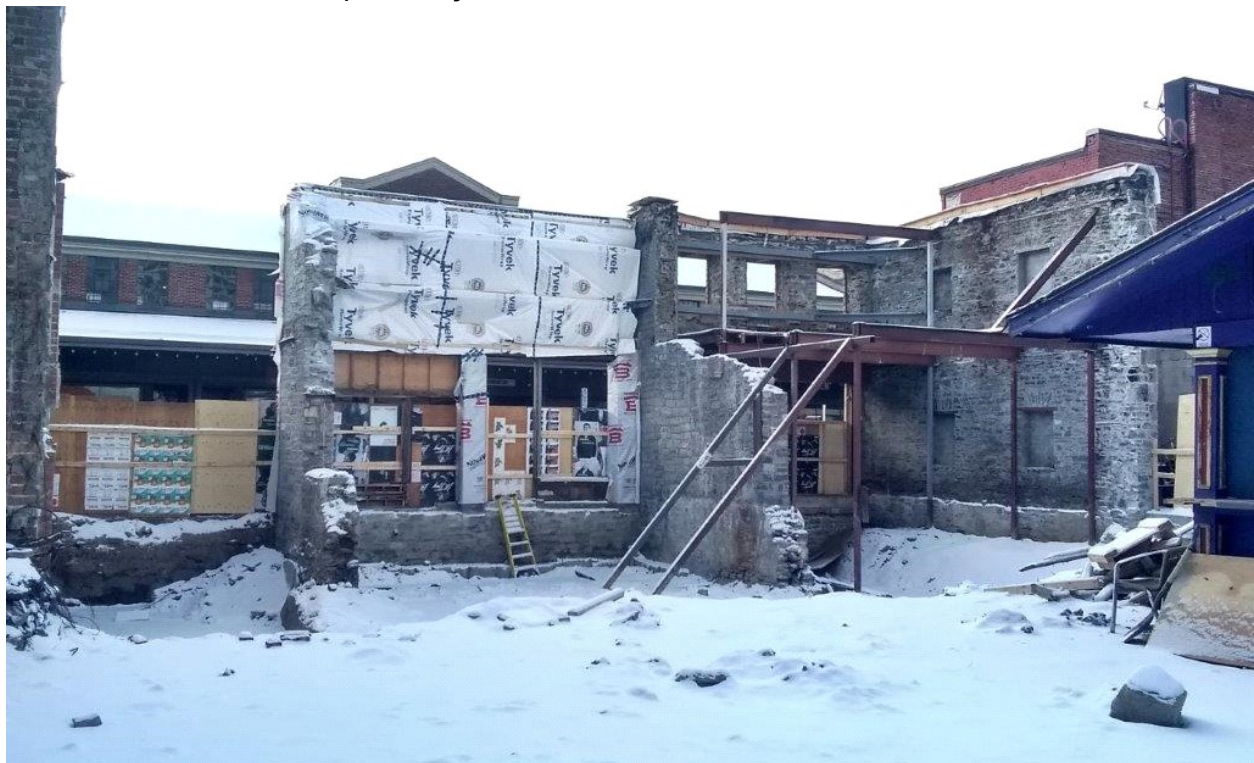
Figure 2. Photo taken facing William Street. Note that none of the former structure on the plan view above remains, except the façade.
