**HYDROGEOLOGICAL
STUDY
PROPOSED COACH HOUSE
2050 RIVER ROAD
OSGOODE WARD
CITY OF OTTAWA, ONTARIO**

DATE February 3, 2020

RE: HYDROGEOLOGICAL AND TERRAIN STUDY
PROPOSED COACH HOUSE
2050 RIVER ROAD
OSGOODE WARD
CITY OF OTTAWA, ONTARIO

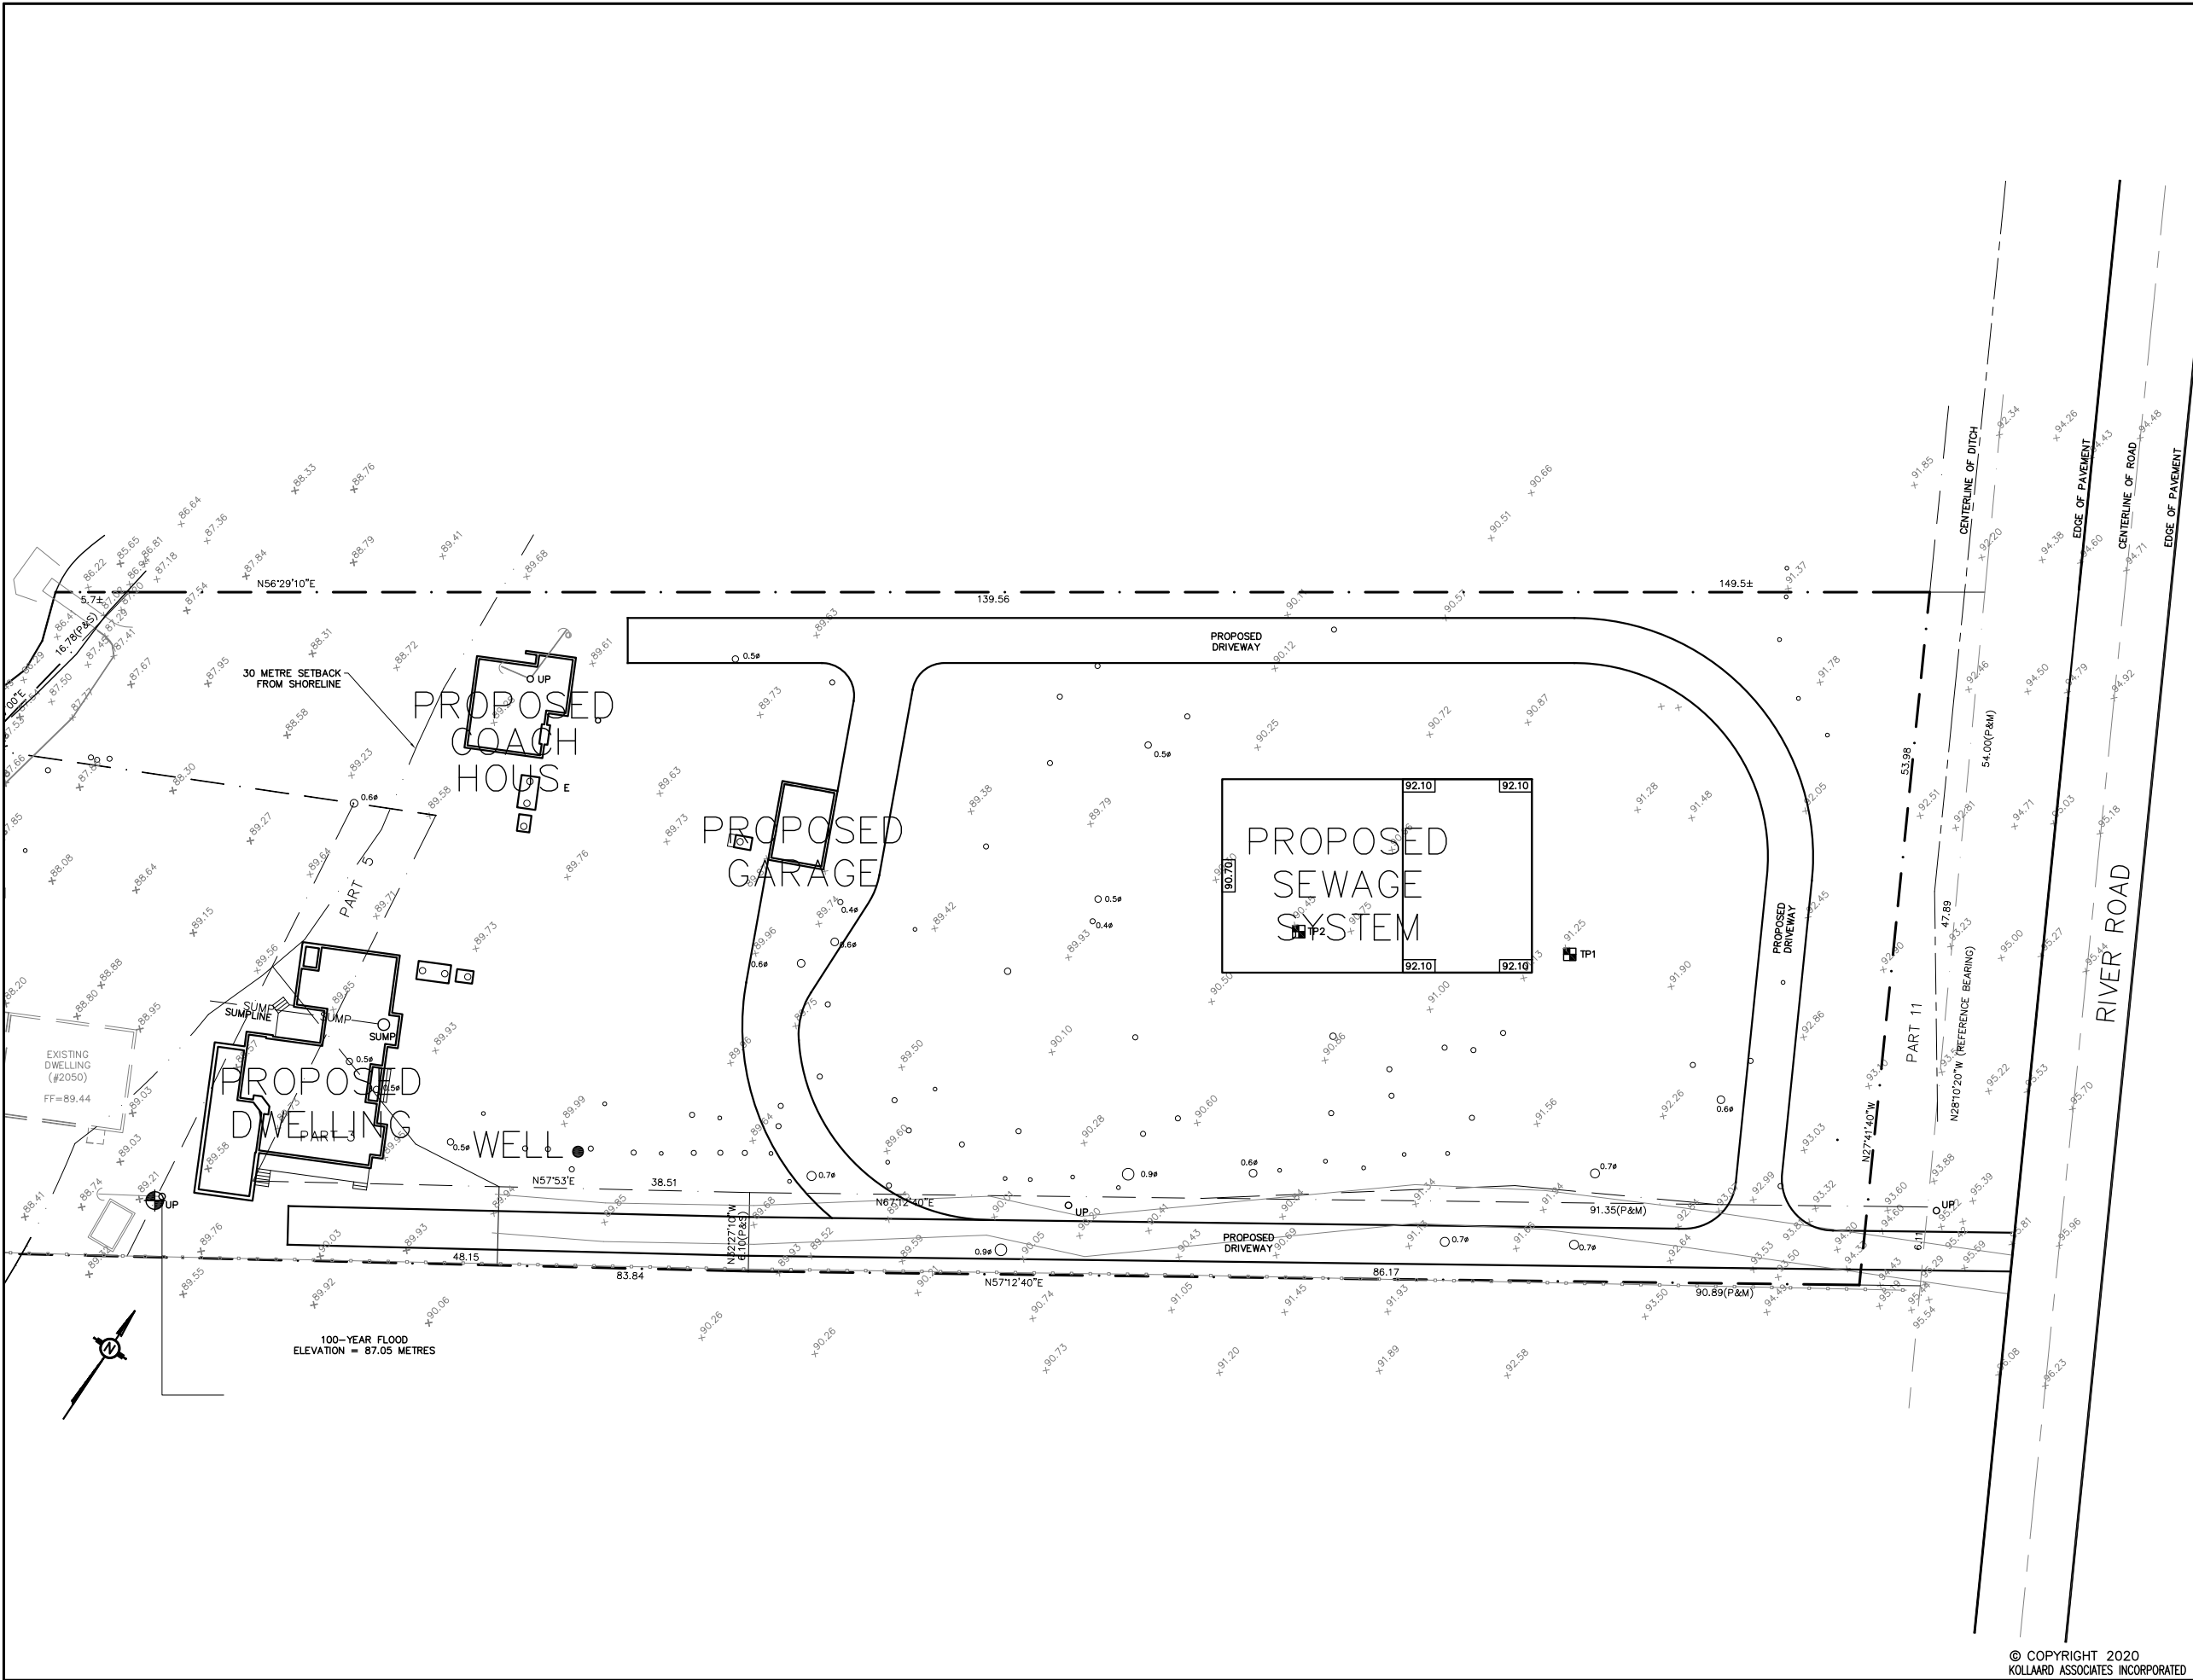
DRAWING NUMBER:
FIGURE 2, SITE PLAN

Two test pits were put down at the site on August 17, 2017, using a hand shovel. The approximate locations of the test pits are shown on the attached Site Plan, Figure 2. The test pits encountered topsoil overlying silty clay. There was no groundwater intrusion into the test pits which were terminated at depths of 0.85 to 0.90 metres below existing ground surface. The test pit logs are provided as Table II.

● Well (location approximate)

It is understood that it is being proposed to construct a coach house on the existing ~0.82 hectare (~2.04 acre) property. There is an existing dwelling on the property that is to be abandoned in favour of a new main house, coach house and a separate garage. A recently constructed well exists on the property. The main and coach houses will share both a well and a (proposed) sewage system. The attached Site Plan, Figure 2, indicates the approximate location of the proposed main house, proposed coach house, proposed garage, existing well and the proposed sewage system location.
