Phase I-Environmental Site Assessment

77 and 81 Harvey Street Ottawa, Ontario

Concorde Properties

Report: PE4704-1

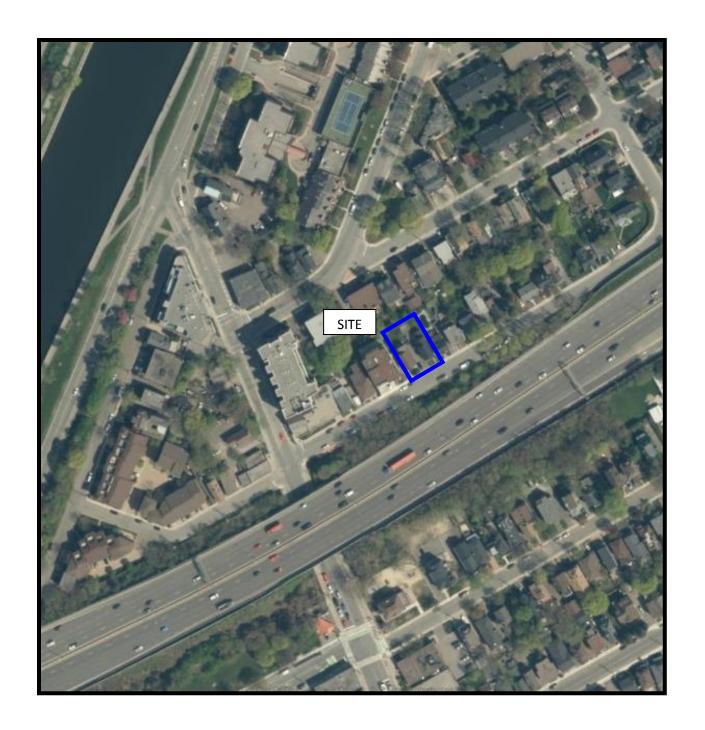
AERIAL PHOTOGRAPH 2017

2002	Neighbouring lands to the west and north have been redeveloped with residential buildings, while the remaining lands and the subject site appear unchanged from the previous photograph.
2017	No significant changes are apparent to the subject site or surrounding lands.

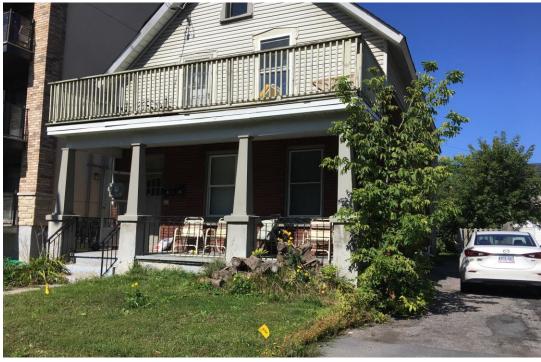
Photograph 1. View of the south side of 77 Harvey Street, taken from Harvey Street.

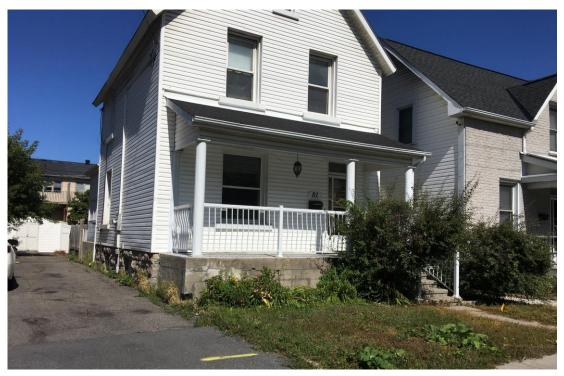
81 Harvey Street is occupied by a vacant two (2) storey residential dwelling with a basement level and a private wooden shed. The exterior of the building is finished in vinyl siding with a sloped shingle style roof. A paved concrete driveway is present on the west side of the building with a landscaped area on the northern and southern portions of the property. Both structures were built circa 1912 with a stone and mortar style foundation.

Photograph 2: View of the south side of 81 Harvey Street, taken from Harvey Street.
