Phase I Environmental Site Assessment

114 Isabella Street
Ottawa, Ontario

August 30, 2019

Report: PE4701-1

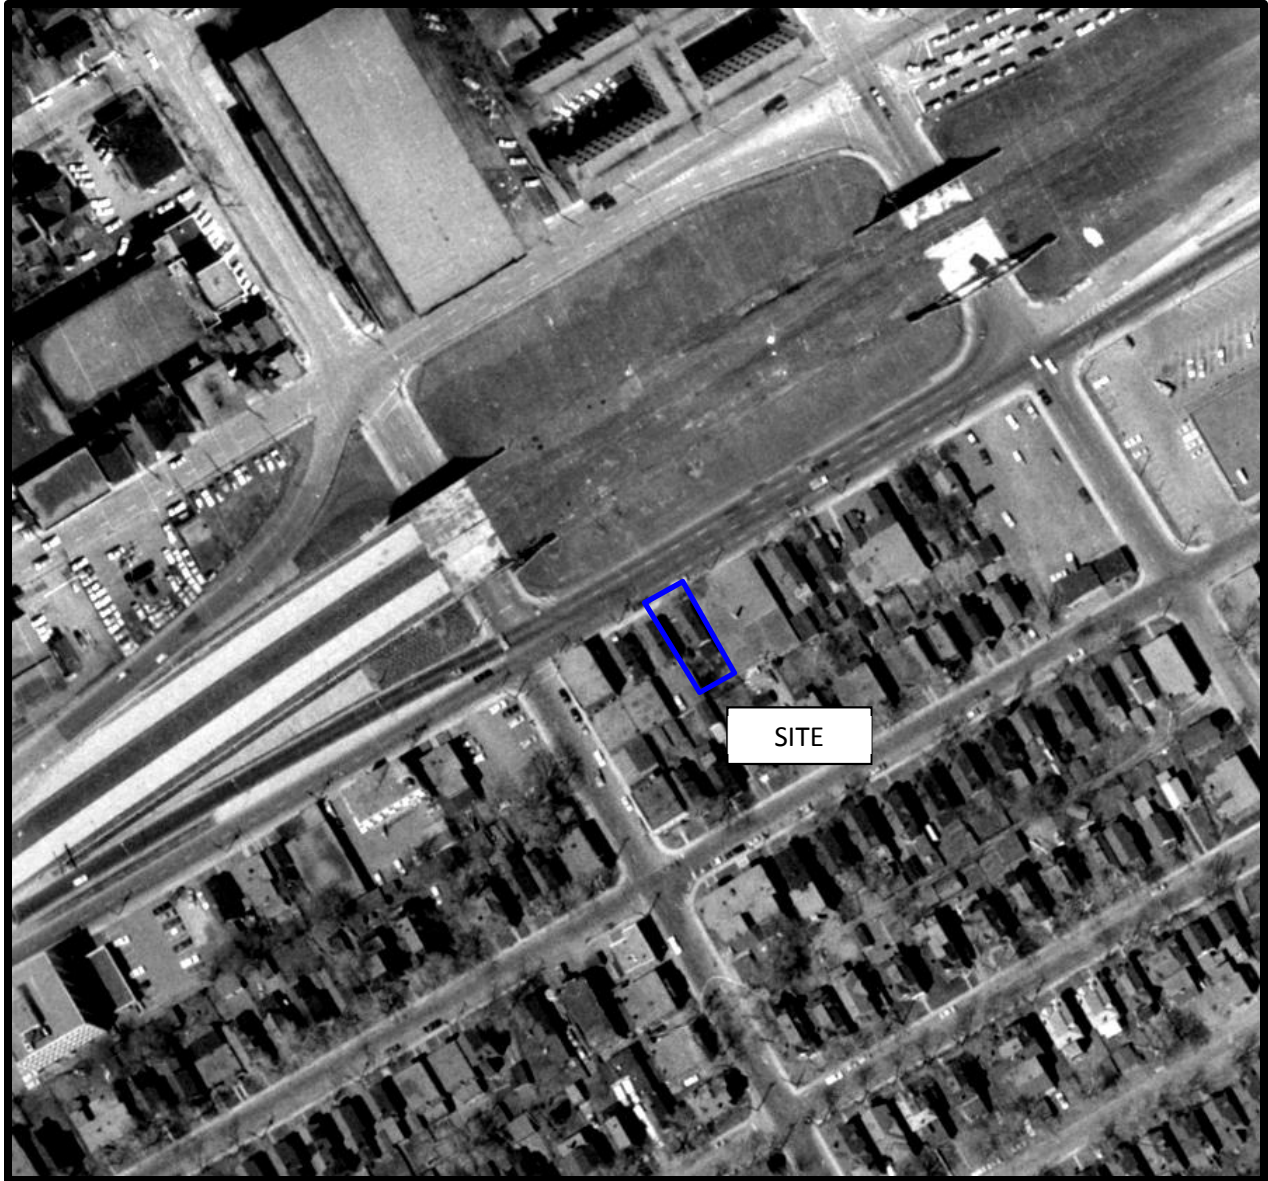
AERIAL PHOTOGRAPH
1965

| 1965 | No significant changes have been made to the subject site. Further extension of the building immediately east of the subject site has occurred. Many of the properties fronting onto Isabella Street have been removed and replaced with larger buildings or parking lots. Properties fronting onto and south of Pretoria Avenue appear to remain residential in nature. North of Isabella Street, the railway has been demolished and the Highway No 417 is under construction. |

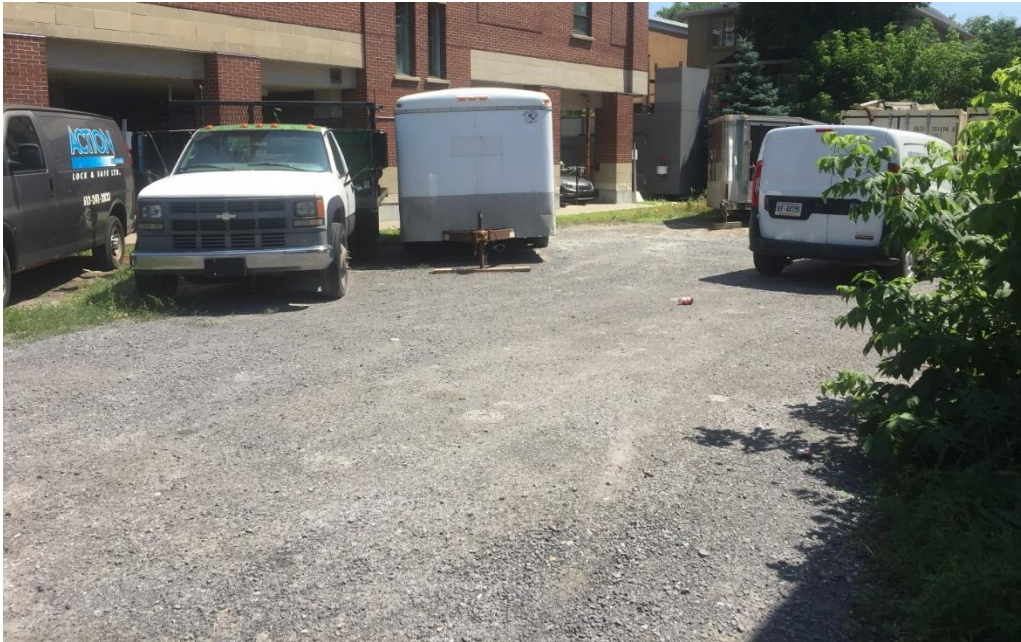
Photograph 1: Centre and rear of the site facing southeast.

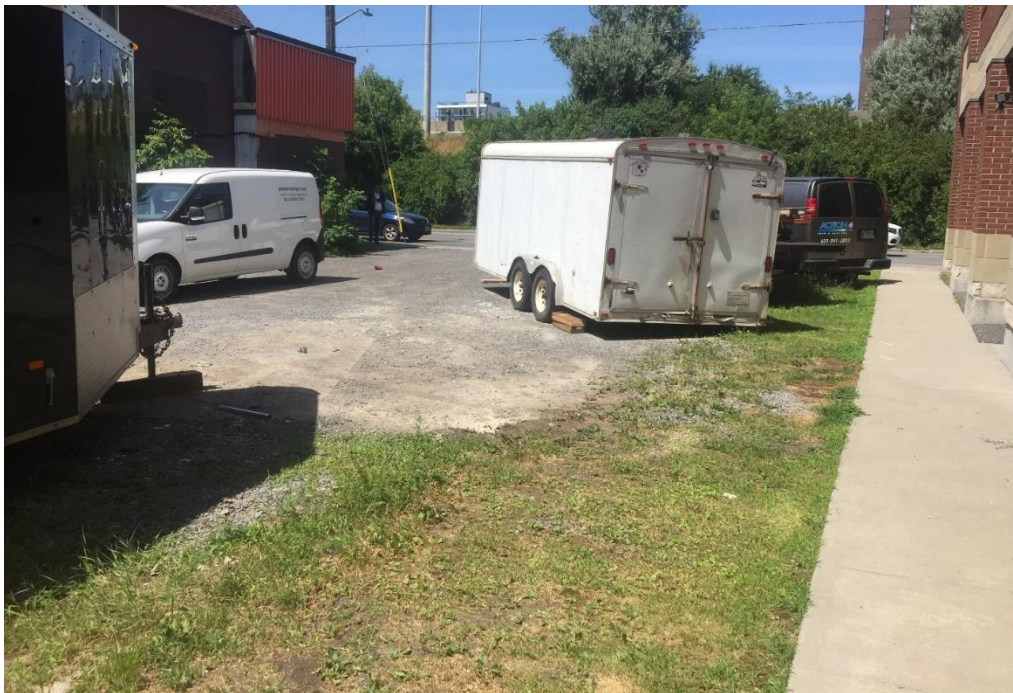
Photograph 2: Site frontage and Isabella Street facing northwest.

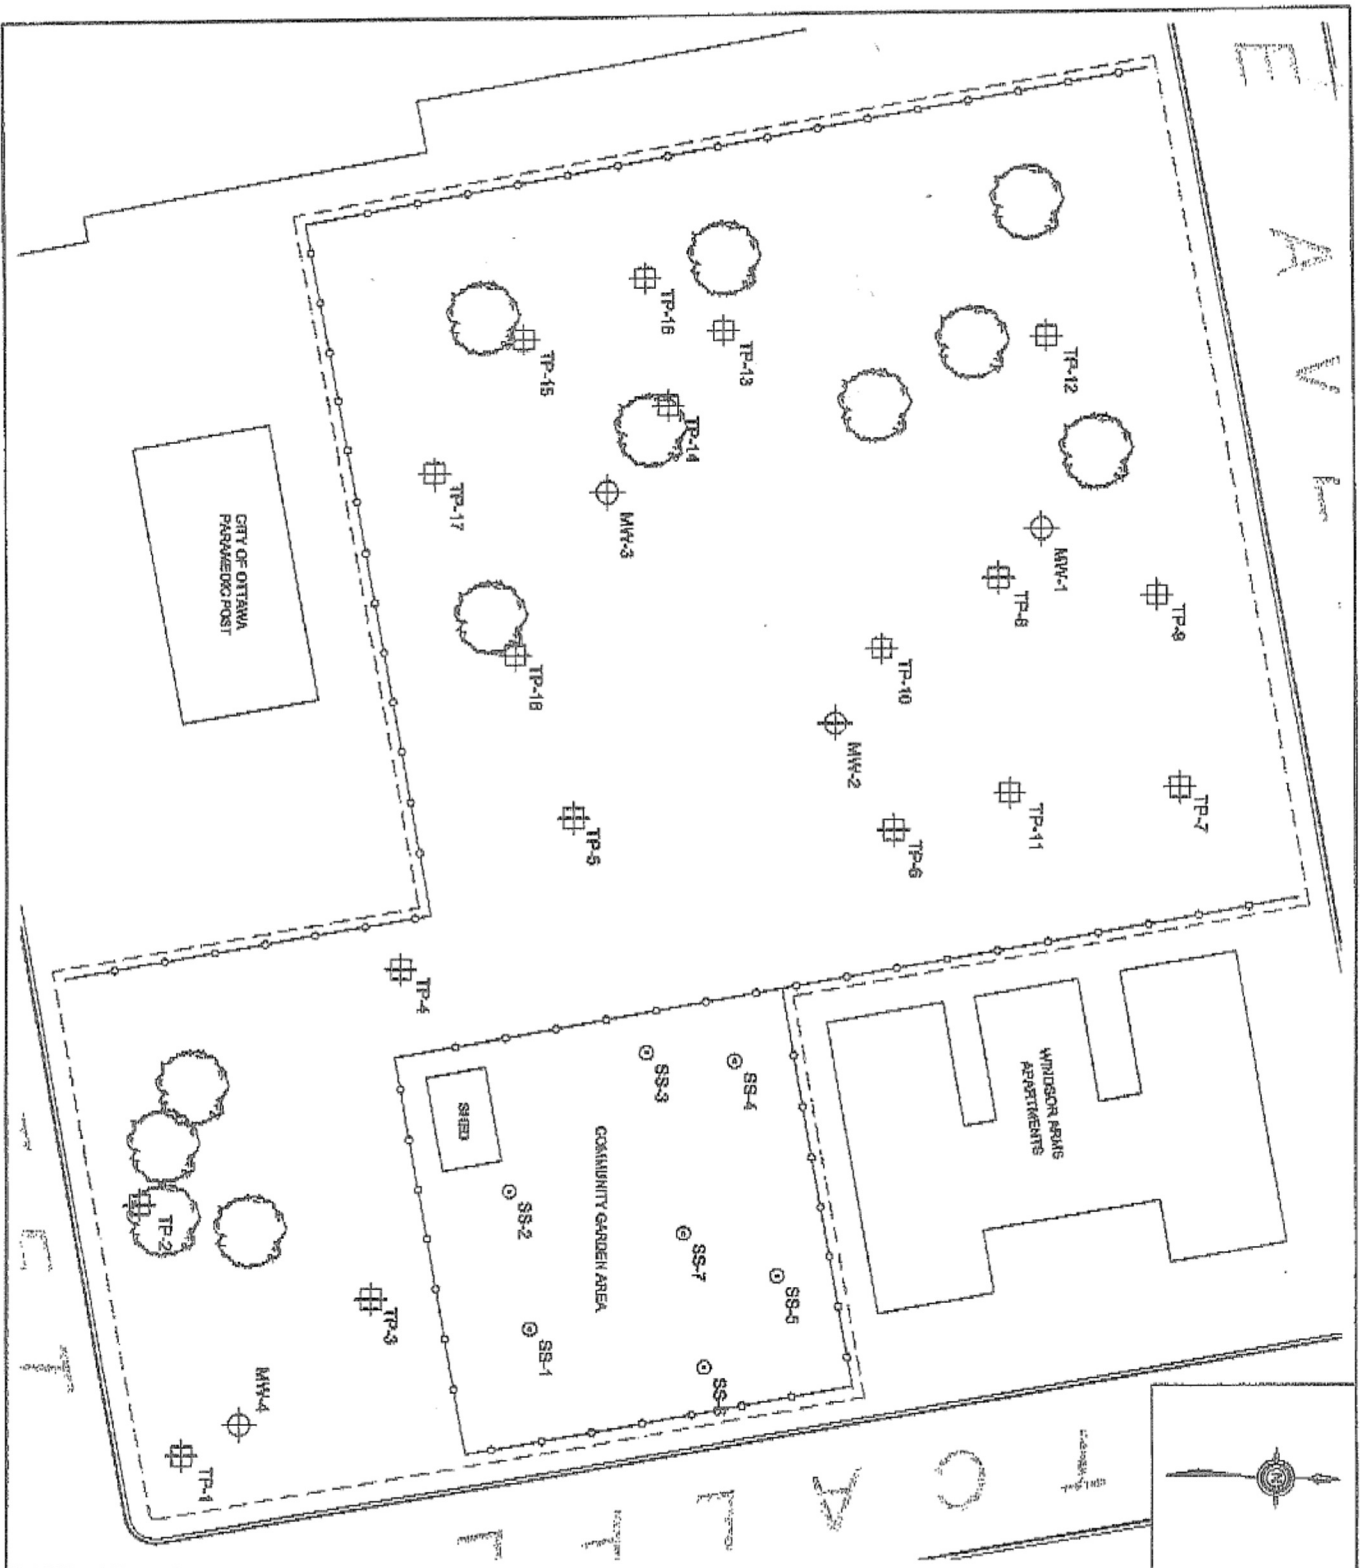
Location of Well
In diagram below show distances of well from road, lot line, and building. Indicate north by arrow.

Please see attached site plan.
