**PHASE II  
ENVIRONMENTAL SITE ASSESSMENT  
114 ISABELLA STREET  
CITY OF OTTAWA, ONTARIO**

Ashlar Homes  
22 Huntview Private  
Ottawa, Ontario K1V 0M5

DATE November 25, 2013  
REVISION DATE March 28, 2014

130293-2 (rev.1)

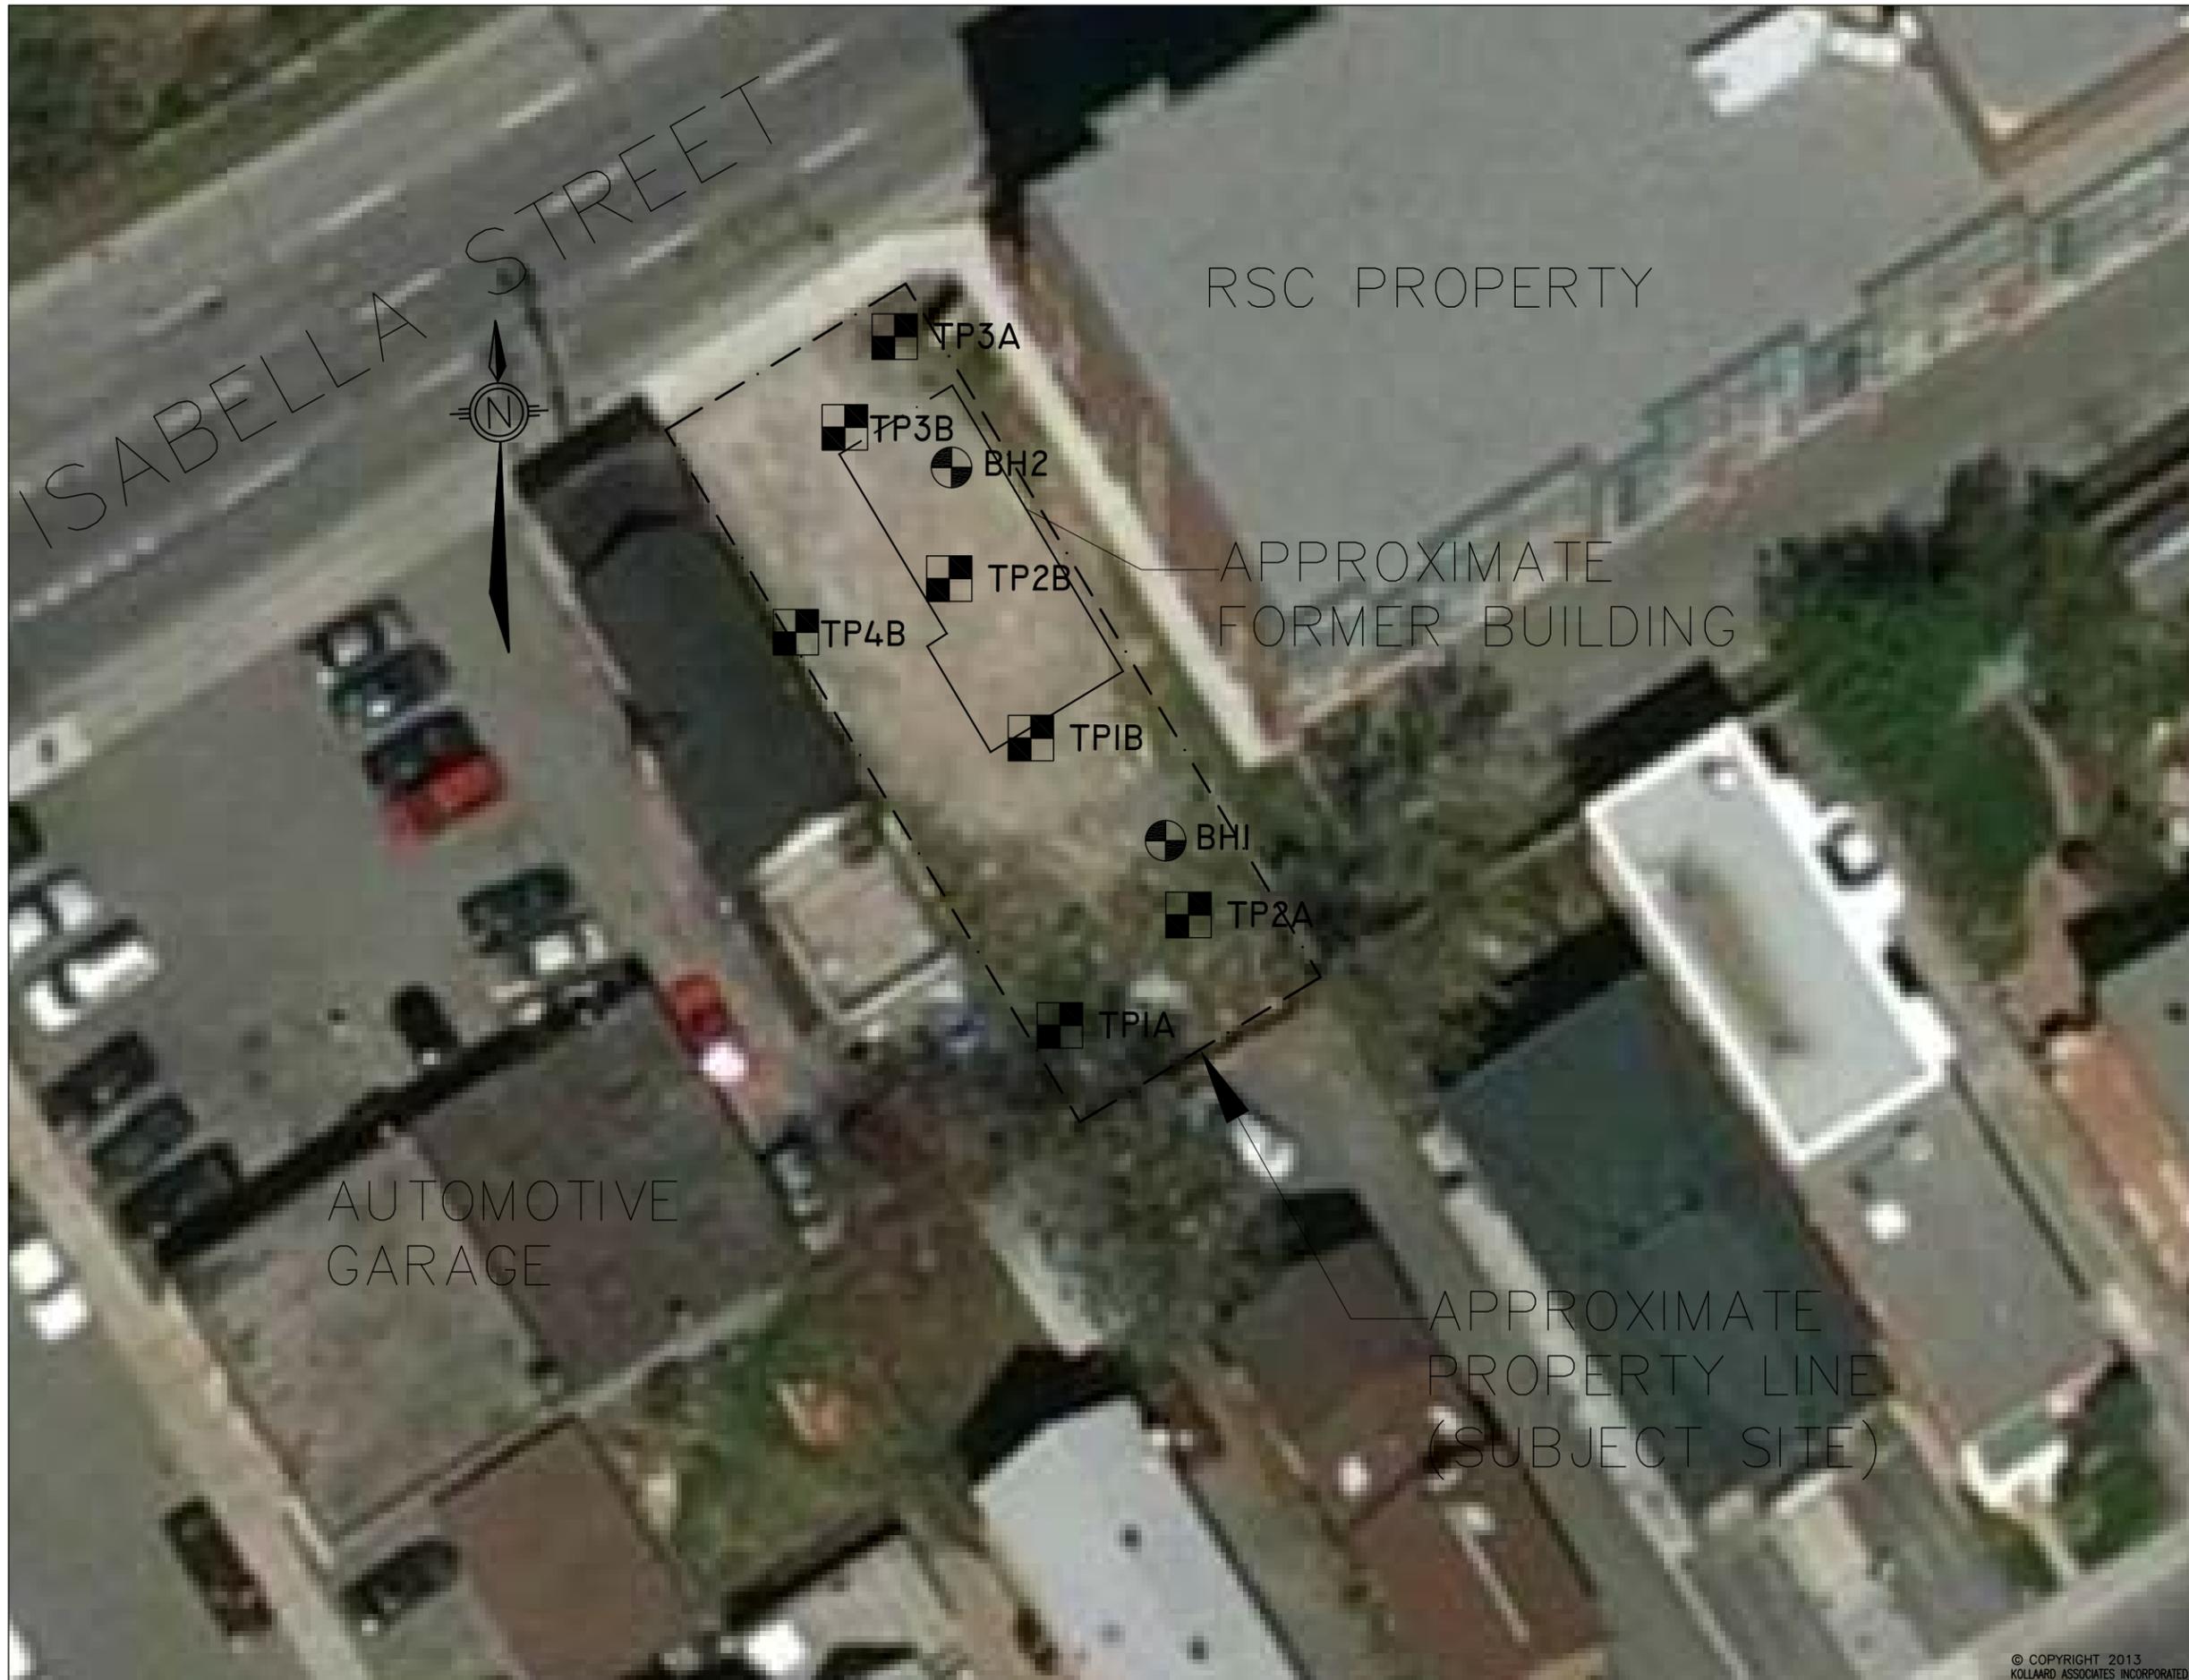
DRAWING NUMBER:  
SITE PLAN, FIGURE 1

The soil and groundwater quality at the subject site was investigated at the locations shown on Figure 1 through test pit excavating and the installation of a groundwater monitoring well (at BH1 only.) The investigation methods are described in the following sections.

The field work was supervised throughout by a member of our engineering staff, who logged the test pits and cared for the samples obtained. The test pit locations are approximately as shown on the attached Site Plan, Figure 1. The test pits logs are provided as Table II.
