Phase One Environmental Site Assessment

36 Robinson Avenue
Ottawa, Ontario

Robinson Village LPIV Limited
Partnership
C/o TC United Development
Corporation

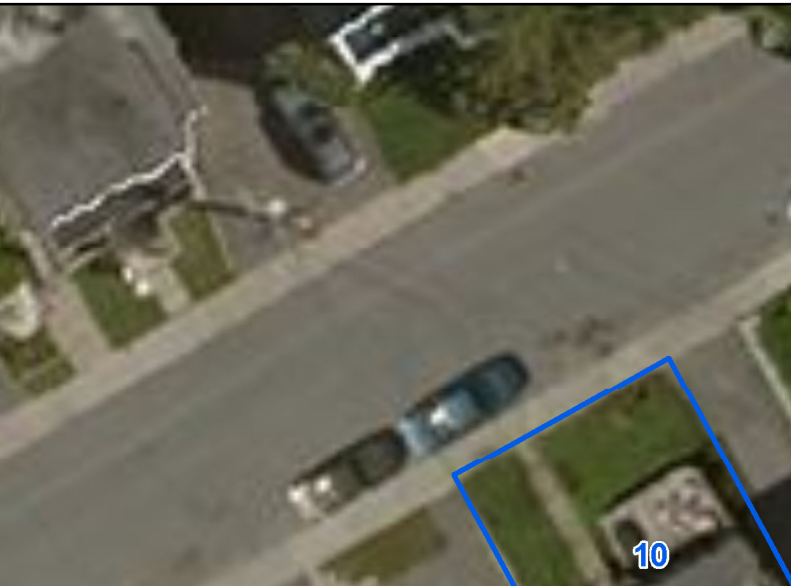
The Site buildings were observed to have two exterior entry/exit points, including a main entrance and a back door exiting into the backyard. These entry and exit points are depicted on Figure 2: Site Plan.

- Door
- Bay Door
- In-Ground Hoist Piston Location
- Potentially Contaminating Activities Interpreted As Areas of Potential (APEC)
- Other Potentially Contaminating Activities (PCA)
- Approximate Location of Former AST
- Approximate Location of Former UST/AST
- Current AST
- Approx. Site Boundary

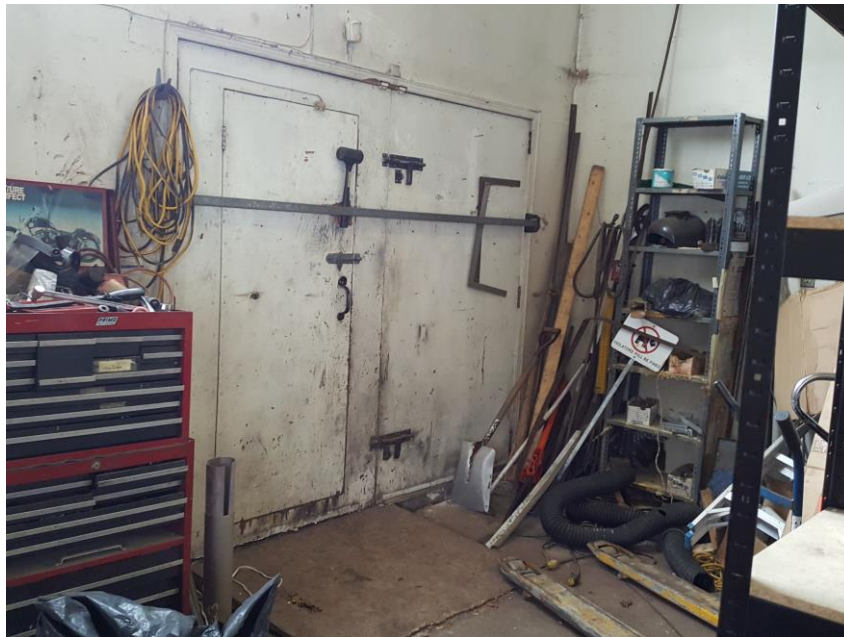
Photo 3 - 36 Robinson Avenue - general condition of previous motorcycle service shop

Two in-ground hydraulic motorcycle service hoists were observed in 36 Robinson Avenue and were confirmed by Mr. Gary Courville. The portion of the in-ground motorcycle lift that was visible above ground was approximately a 12" by 12" square plate. The presence of these in-ground lifts is considered to be associated with a PCA (item 27: Garages and Maintenance and Repair of Railcars, Marine Vehicles and Aviation Vehicles) and contribute to an Area of Potential Environmental Concern (APEC) for the Site.

There was evidence of minor historical surface spills/stains on the concrete floor of both 36 and 40 Robinson Avenue, which have both been used as motorcycle service and repair shops. There were no signs of surface cracks through the concrete floors at the time of the Site visit.

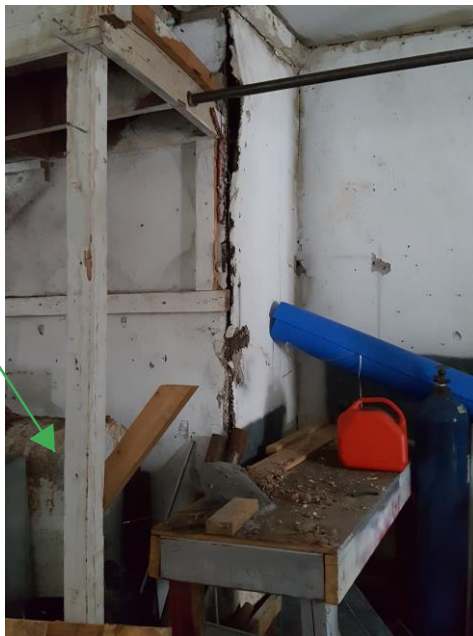
Photo 12 - 44 Robinson Avenue - interior view with AST (905L)

The presence of one current interior AST was observed by GHD at the time of the Site visit; this AST was located on the interior east wall of 44 Robinson Avenue. The AST was originally used to store furnace oil, however, at the time of the Site visit, the building was vacant, not heated and the AST was empty and not actively in use. The AST was approximately 905 L in size and was constructed of

steel. No fuel odor was observed within the area of the AST. The presence of this AST is considered a PCA and contributes to an APEC for the Site.

Empty AST in 44 Robinson Ave.
